PROJECT SEGL21
Scotland England Green Link 2
North Yorkshire and
East Yorkshire

CLIENT AECOM

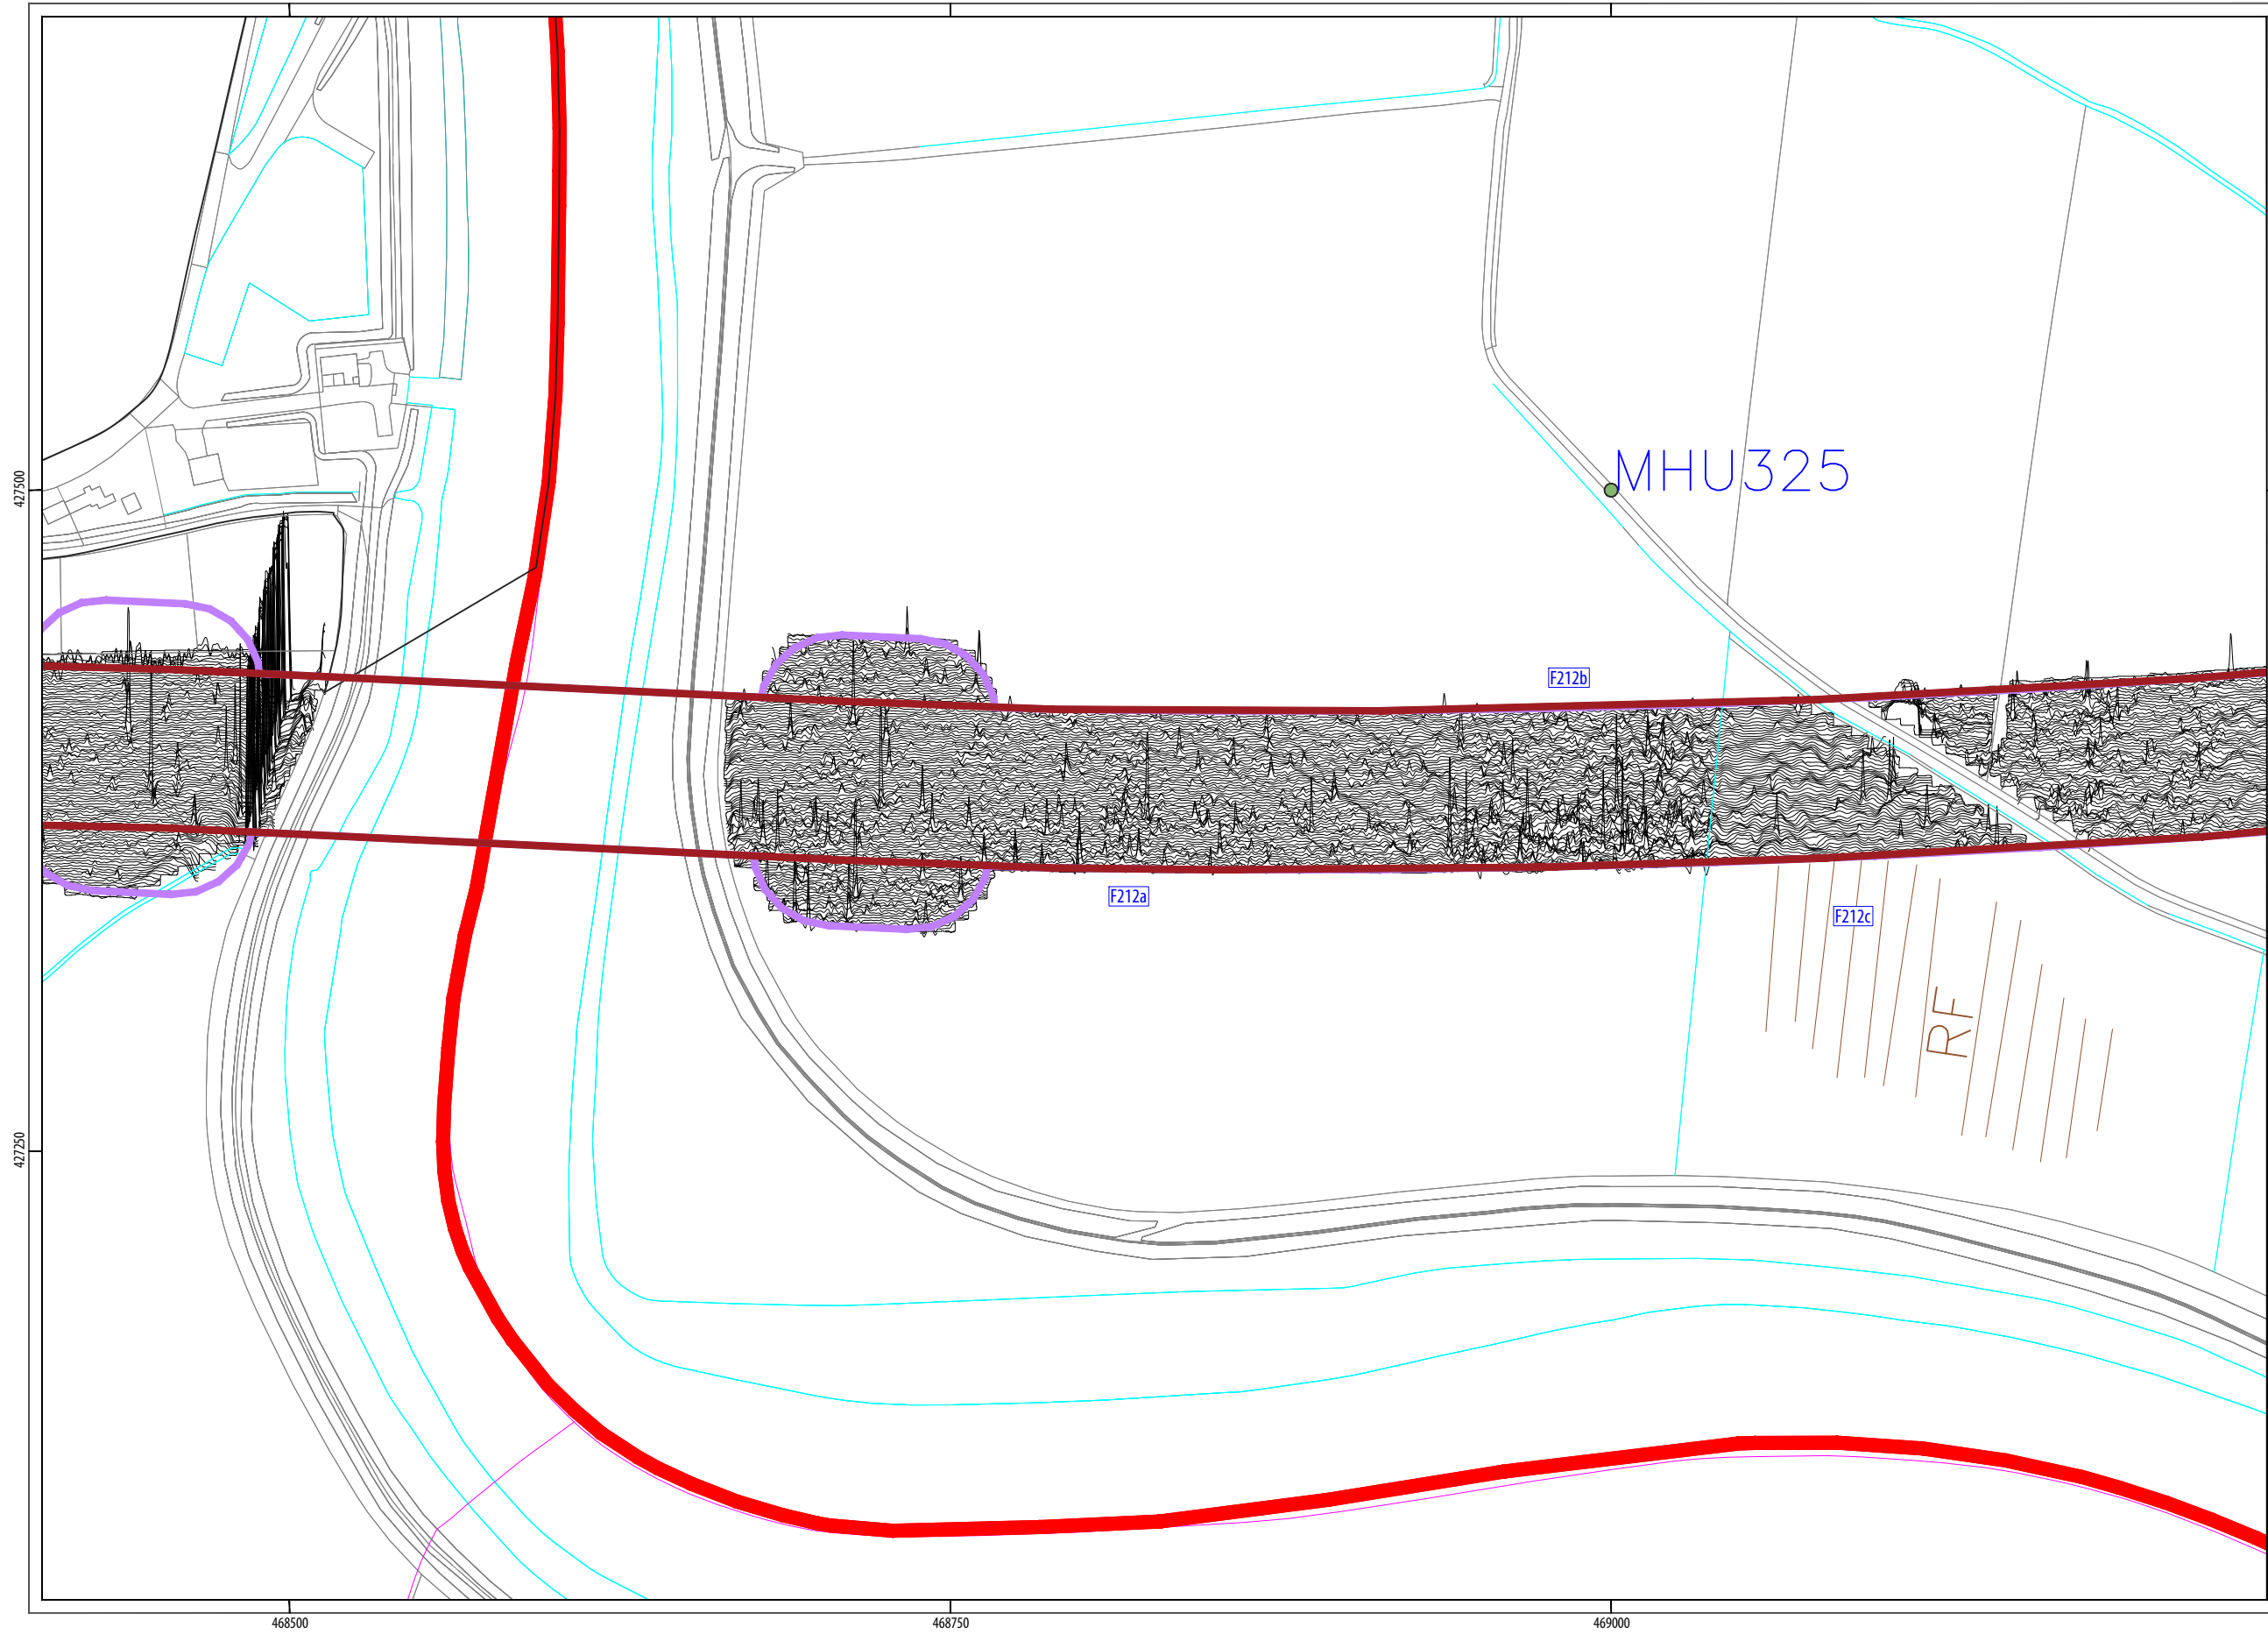
ILLUS 268 XY trace plot of minimally processed magnetometer data; Sector 76

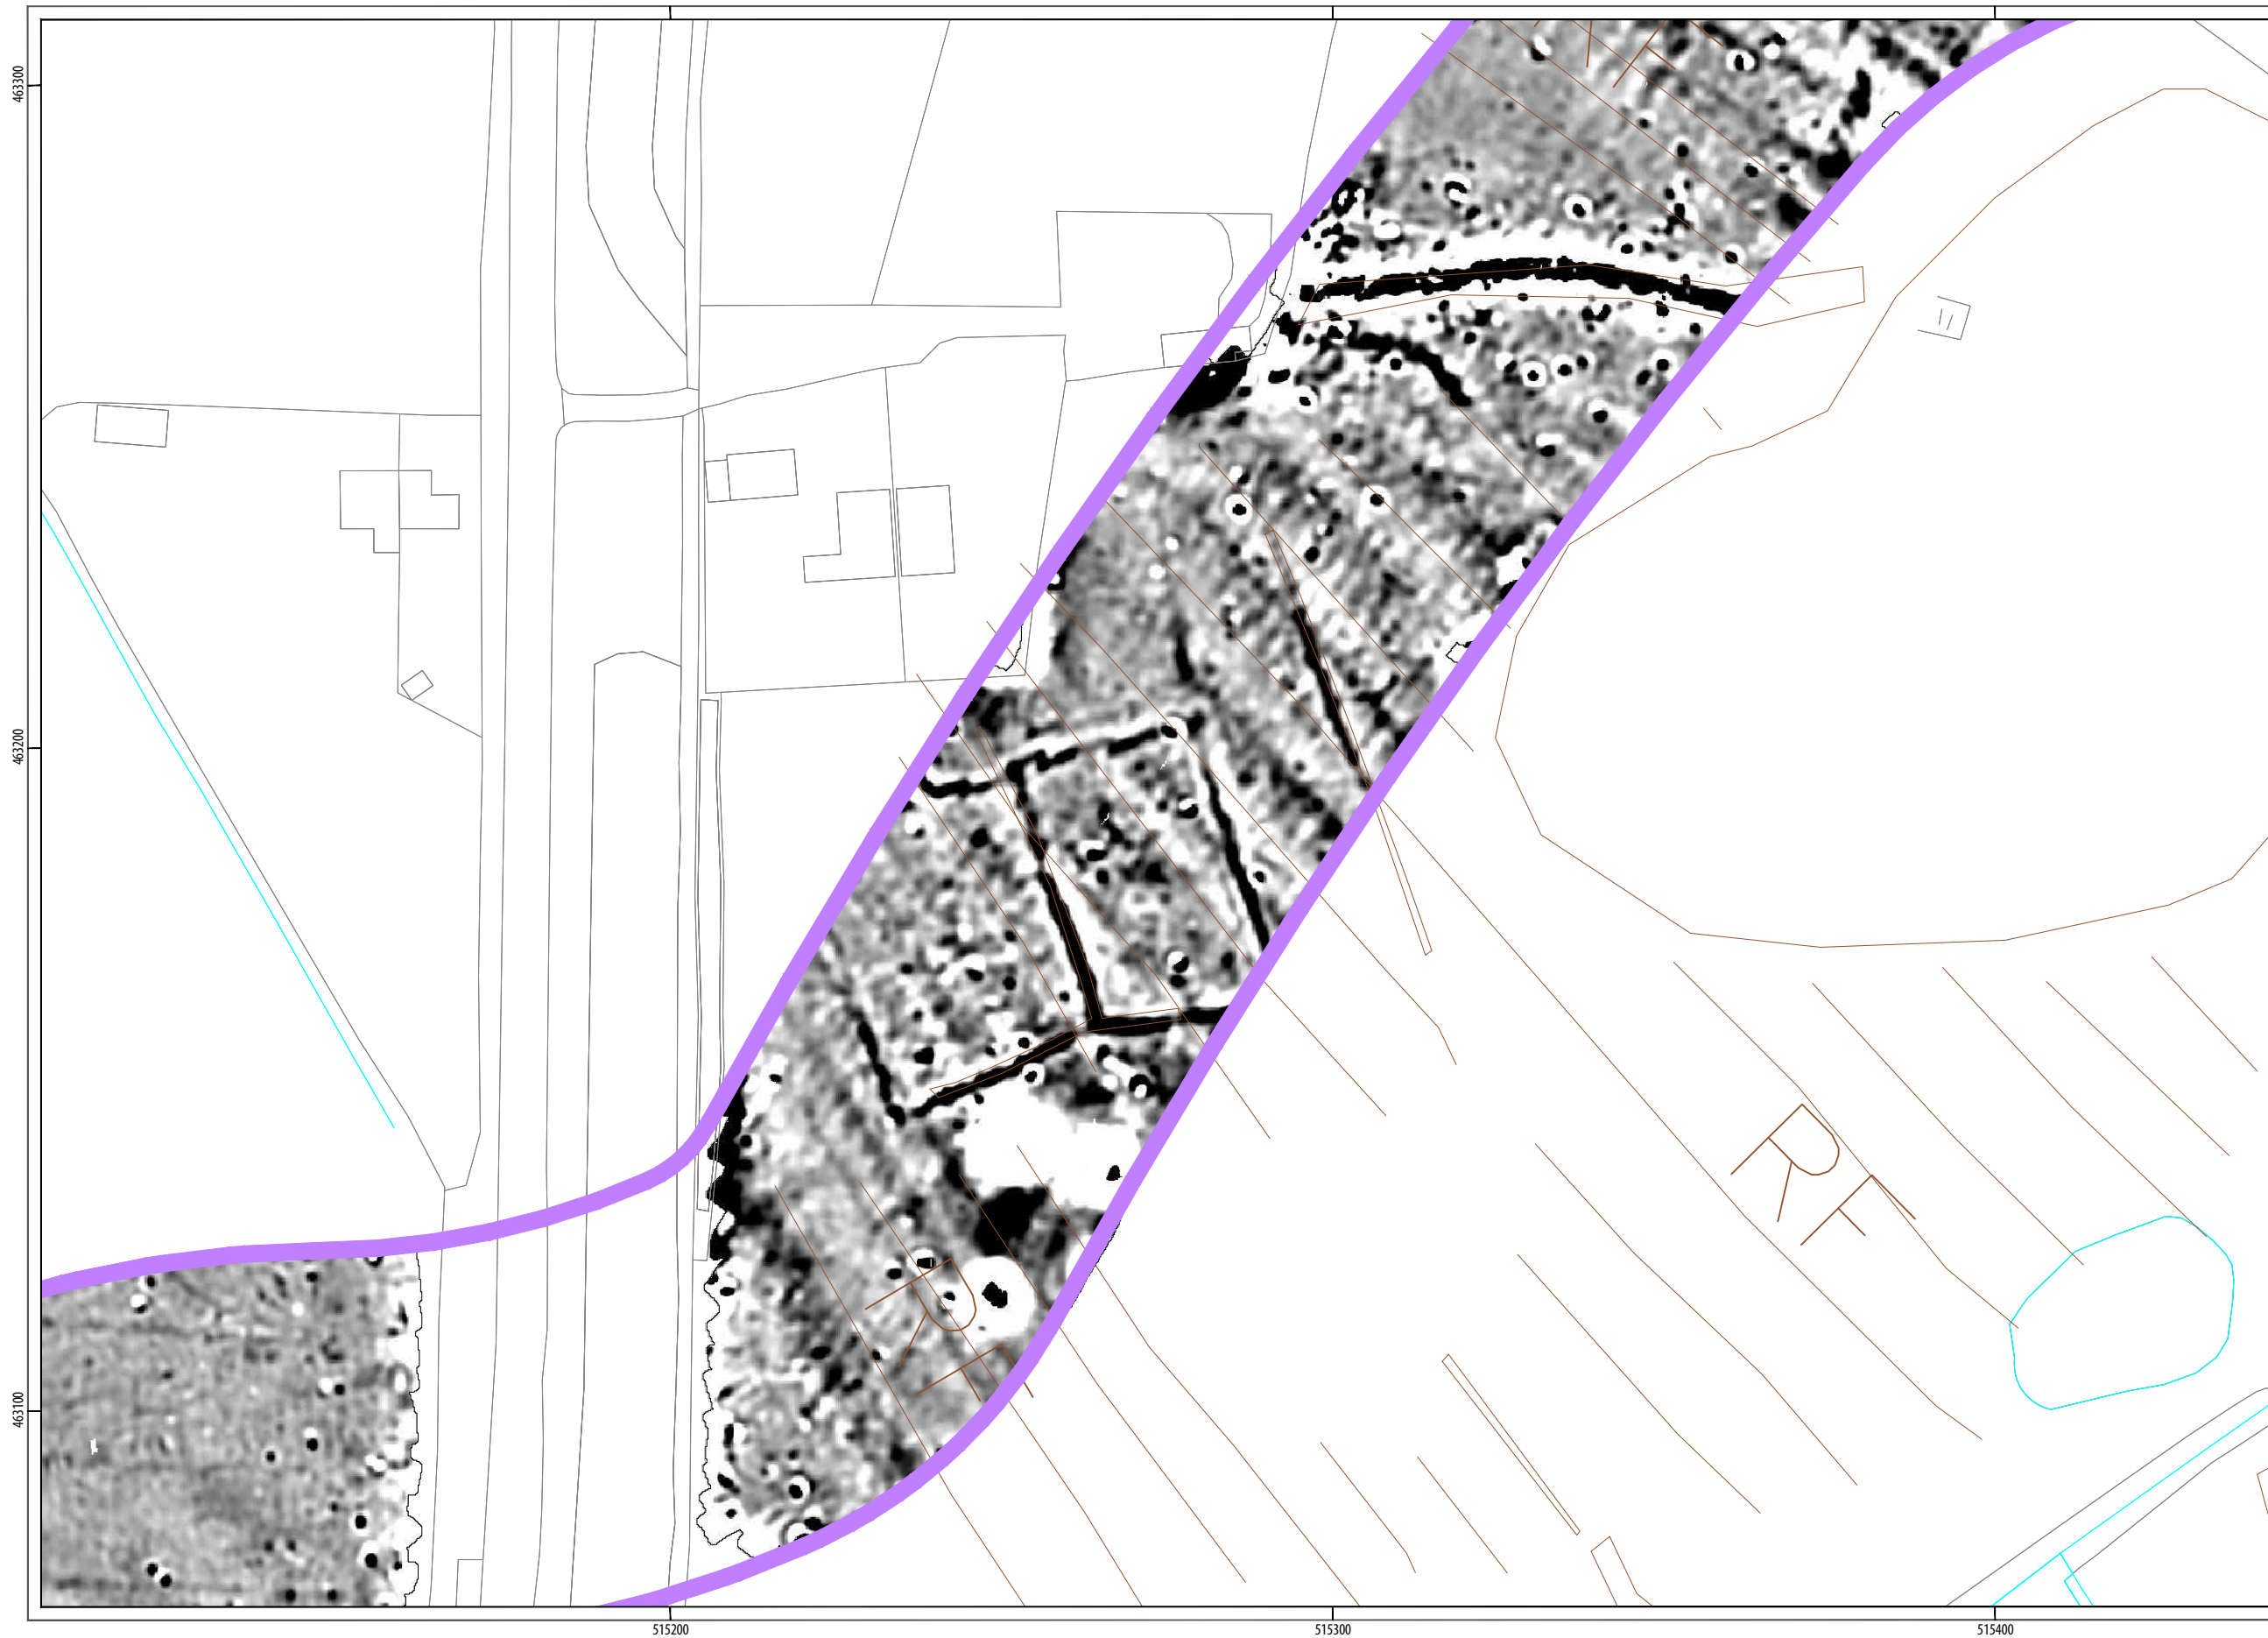
ILLUS 279 Processed greyscale magnetometer data; AAA2

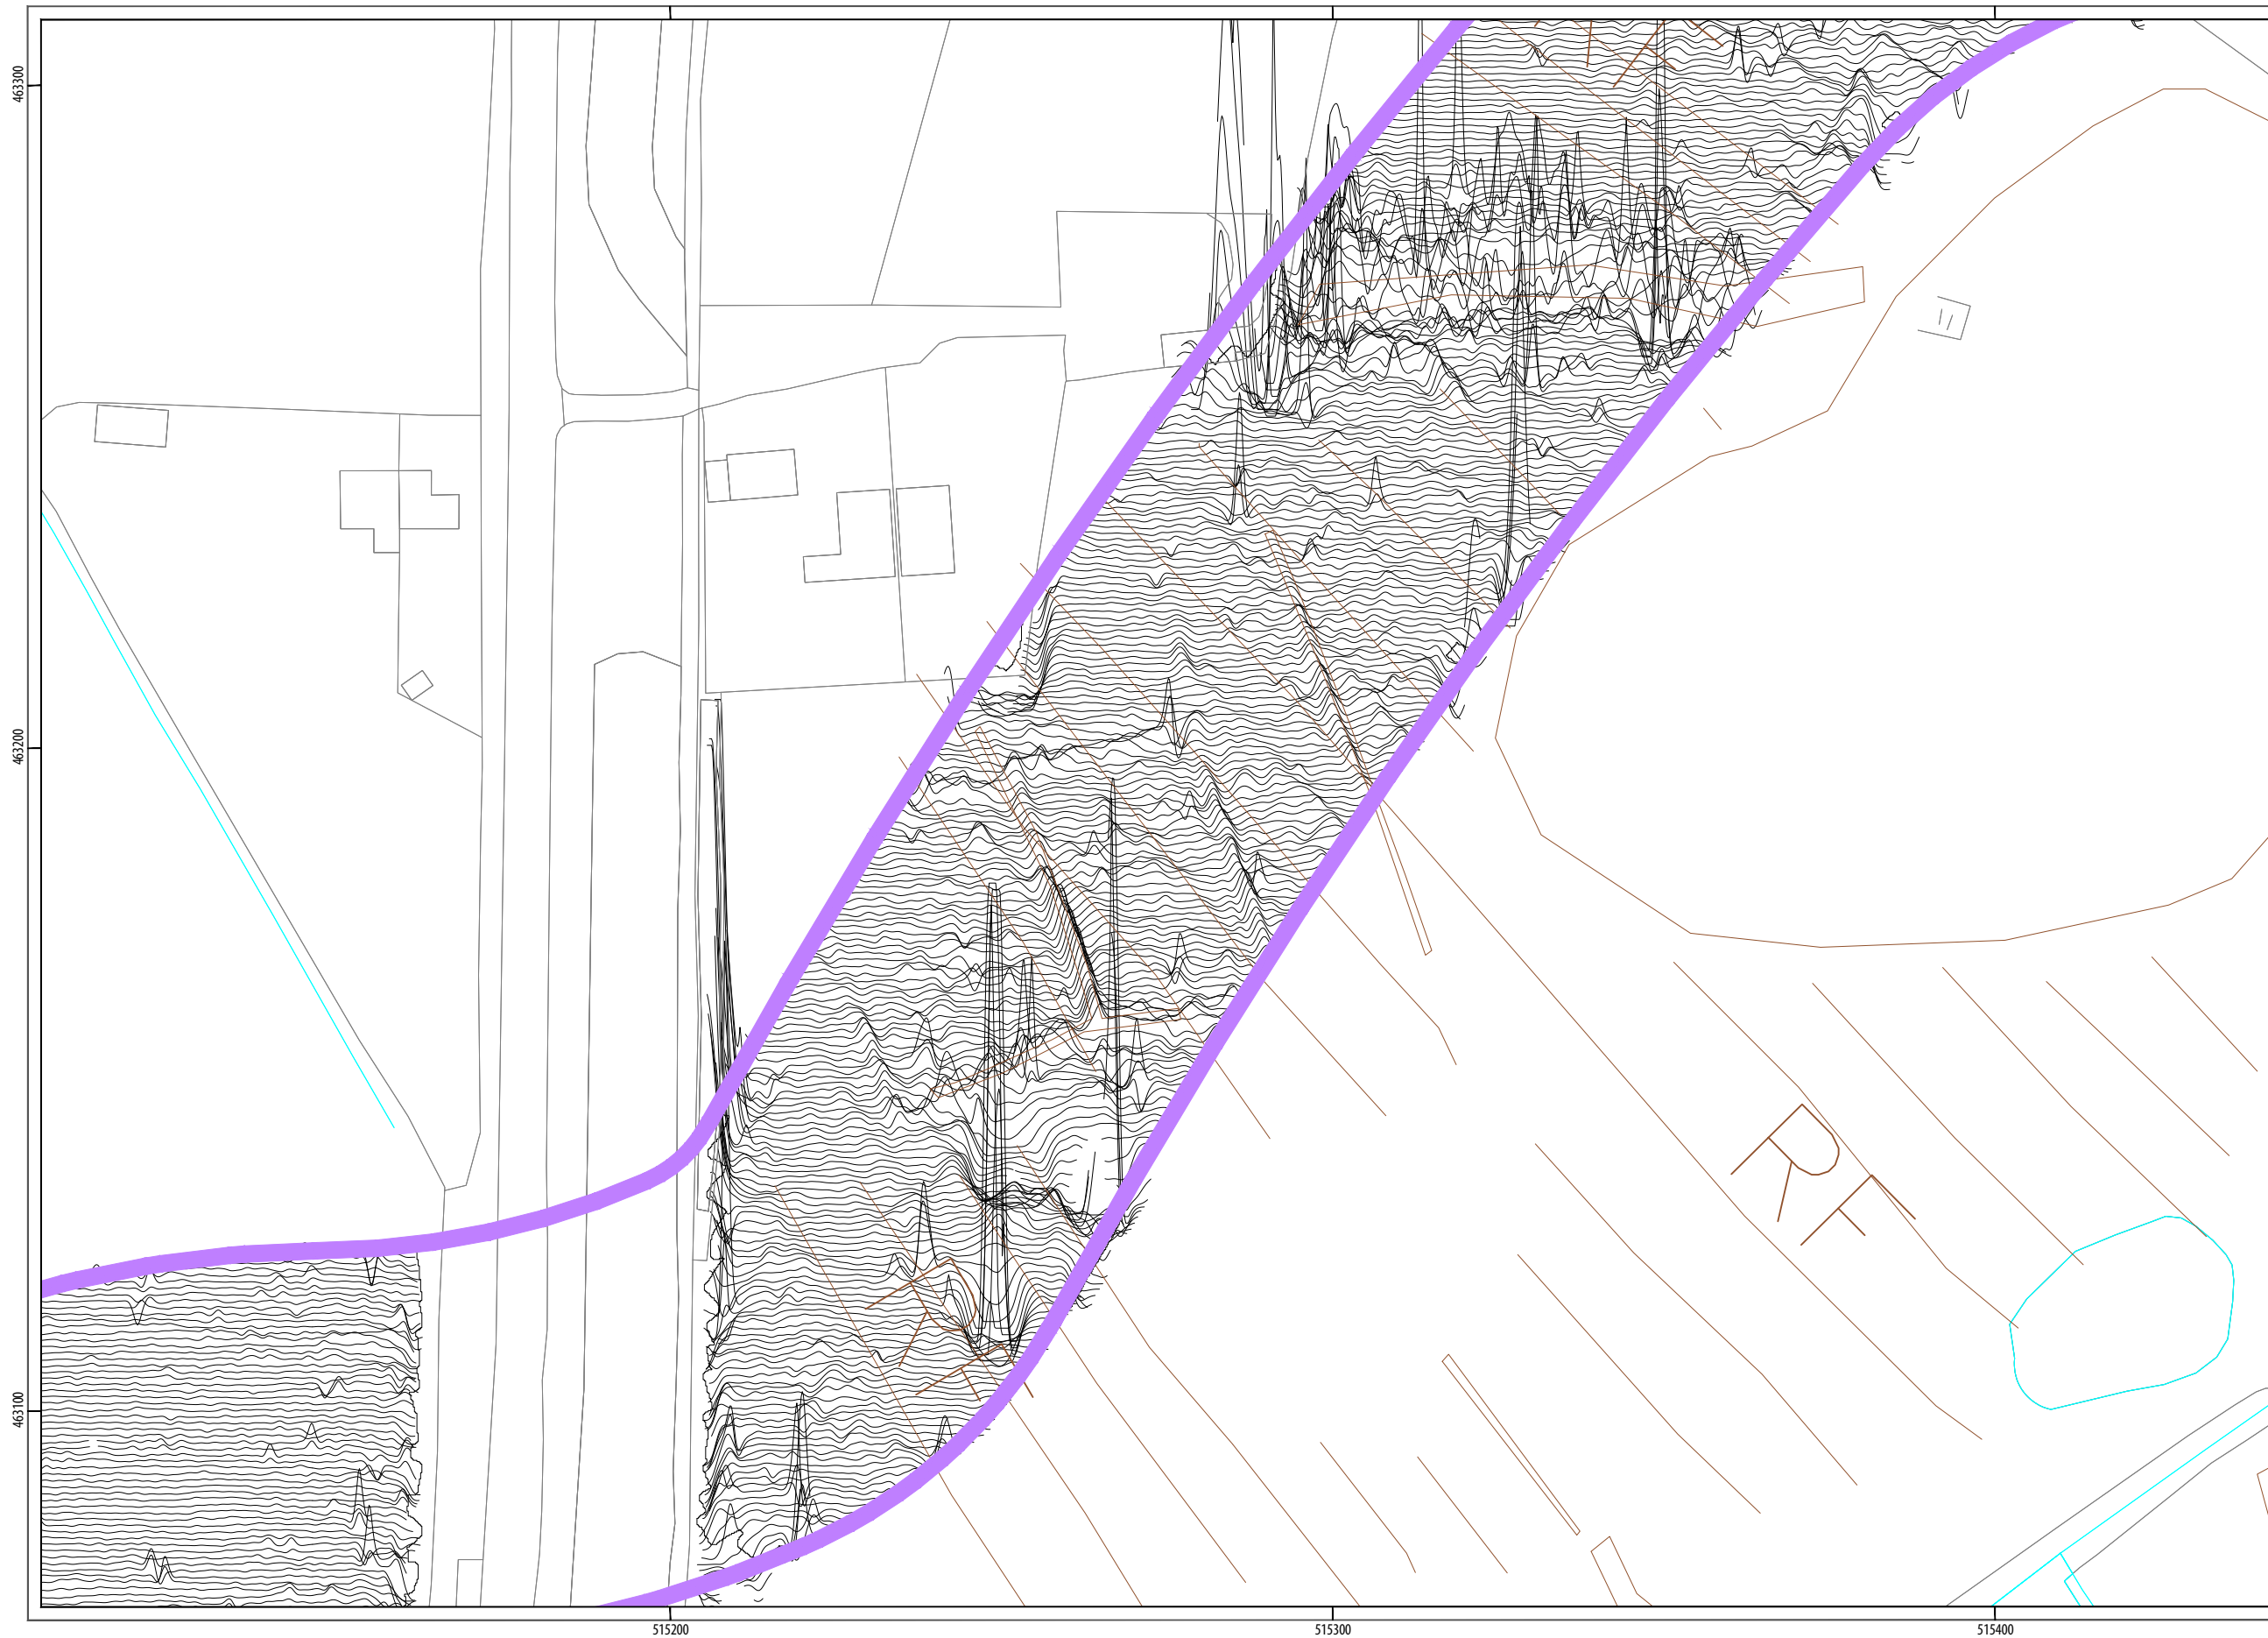
ILLUS 280 XY trace plot of minimally processed magnetometer data; AAA2
