Stockbridge Surgery, Stockbridge
Preliminary Roost Assessment
Stockbridge Surgery

Document:	Preliminary Roost Assessment
Project:	Stockbridge Surgery
Client:	Stockbridge Surgery
Job number:	4940
Document reference:	4940.1
Date of issue:	November 2023
Prepared by:	Daniel Ahern Home Farm House, Tidworth SP9 7BE Email: [REDACTED] Telephone: [REDACTED]
Project manager:	Beth Dean
Primary Author	Daniel Ahern
Field team:	Daniel Ahern, Mike Tennick

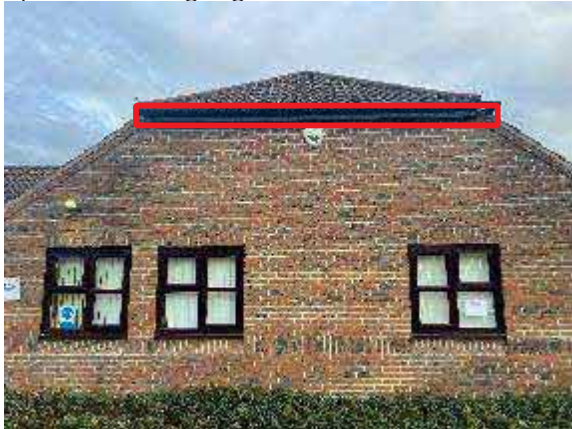
Evidence of brown long-eared bats was found in the western roof void of Building 1. It believed they are accessing the roof void via the open soffits at the southern end of the structure.

Photo 1 – southern elevation of building 1, open soffits highlighted.

Complete two static monitoring surveys of the western roof void, to confirm whether brown long-eared bats are using this as a hibernation roost. Each survey should last for at least 7 days and take place during January and February.

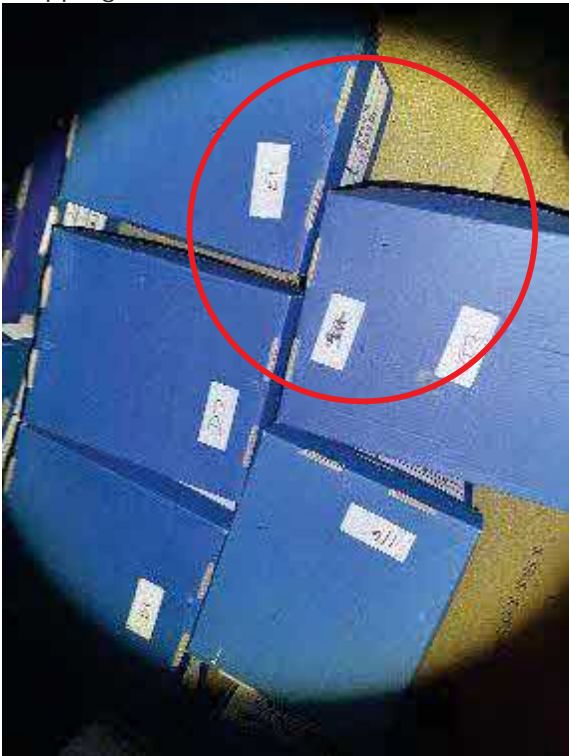
Building	Bat Roost Potential	Reason	Recommendations
Building 1 – Stockbridge Surgery	CONFIRMED ROOST	<ul style="list-style-type: none"> Open soffits at the southern end of the western roof void. Approximately 150 droppings from brown long-eared bats recorded on the floor of the western roof void. Absence of PRFs found in the eastern roof void. No evidence of bats recorded in the eastern roof void. 	Static bat monitoring to confirm whether the western roof void is a hibernation roost

Photo 2 – scattered brown long-eared bat droppings in the western roof void.

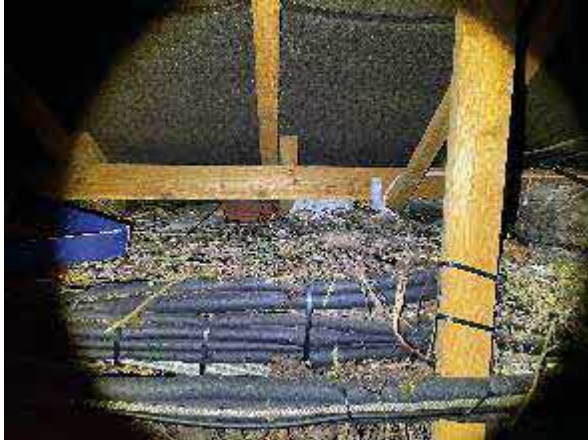
A well established jackdaw nest was recorded at the northern end of the western roof void.

Photo 3 – jackdaw nest at the northern end of the western roof void

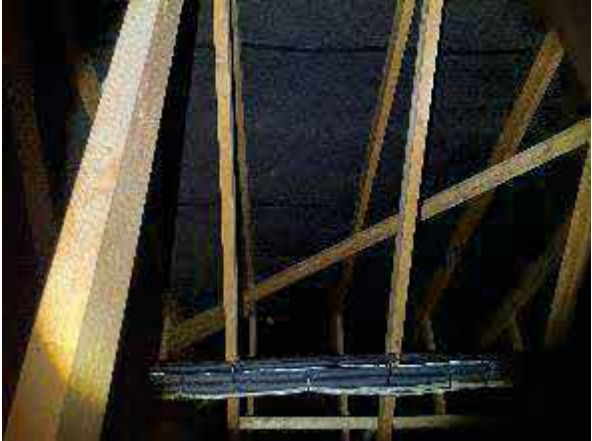
Photo 4 – underside of the roof in the western roof void
