**11A Pine Grove**

**Bat and Breeding  
Bird Survey**

**Client: Mr M. Lane  
Project no. 2324114  
Issued: March 2024**

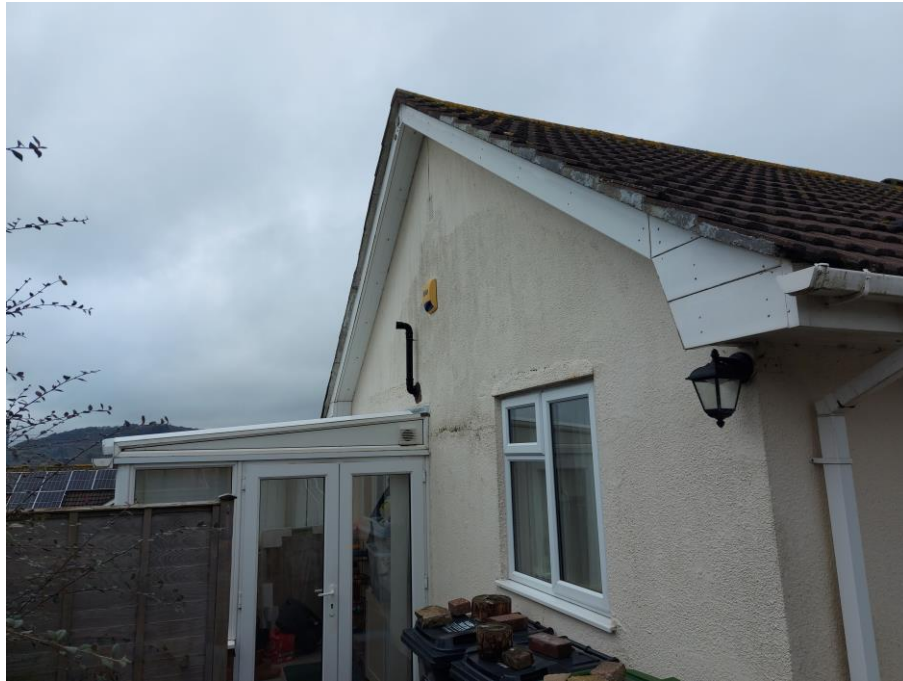
<b>Wall construction</b>	Rendered block and brick work (refer to Photograph 1)
<b>Roof construction</b>	Concrete interlocking tiles in excellent condition with a bitumen felt lining. UPVC soffits sealed to the wall tops

**Photograph 1: Southern elevation where the extension will be located**

The building was in excellent condition (refer to Photograph 1). It had clearly been well maintained. The soffit boxes were in excellent condition around the dwelling, including the area where the extension will be located. The render of the wall top and the gable boards were sealed and offered no potential bat access points. The interior of the gable wall was inspected for any signs of bat use such as droppings clinging to the interior wall surfaces or droppings on the loft floor. None were found. The remainder of the loft was also clear of any signs of bat roosting.

The mortar fillet to the tiles was complete and in good condition, so no potential bat access points existed for bats to access the space between the tiles and bitumen lining felt.

The impacted area of the building was assessed as being of negligible bat roost potential due to its construction methods and materials along with its excellent condition.
