PRELIMINARY ECOLOGICAL APPRAISAL

LAUREL FARM

Project name: Laurel Farm, Pilning Street, Pilning, BS35 4HN

Date: 31/01/2024

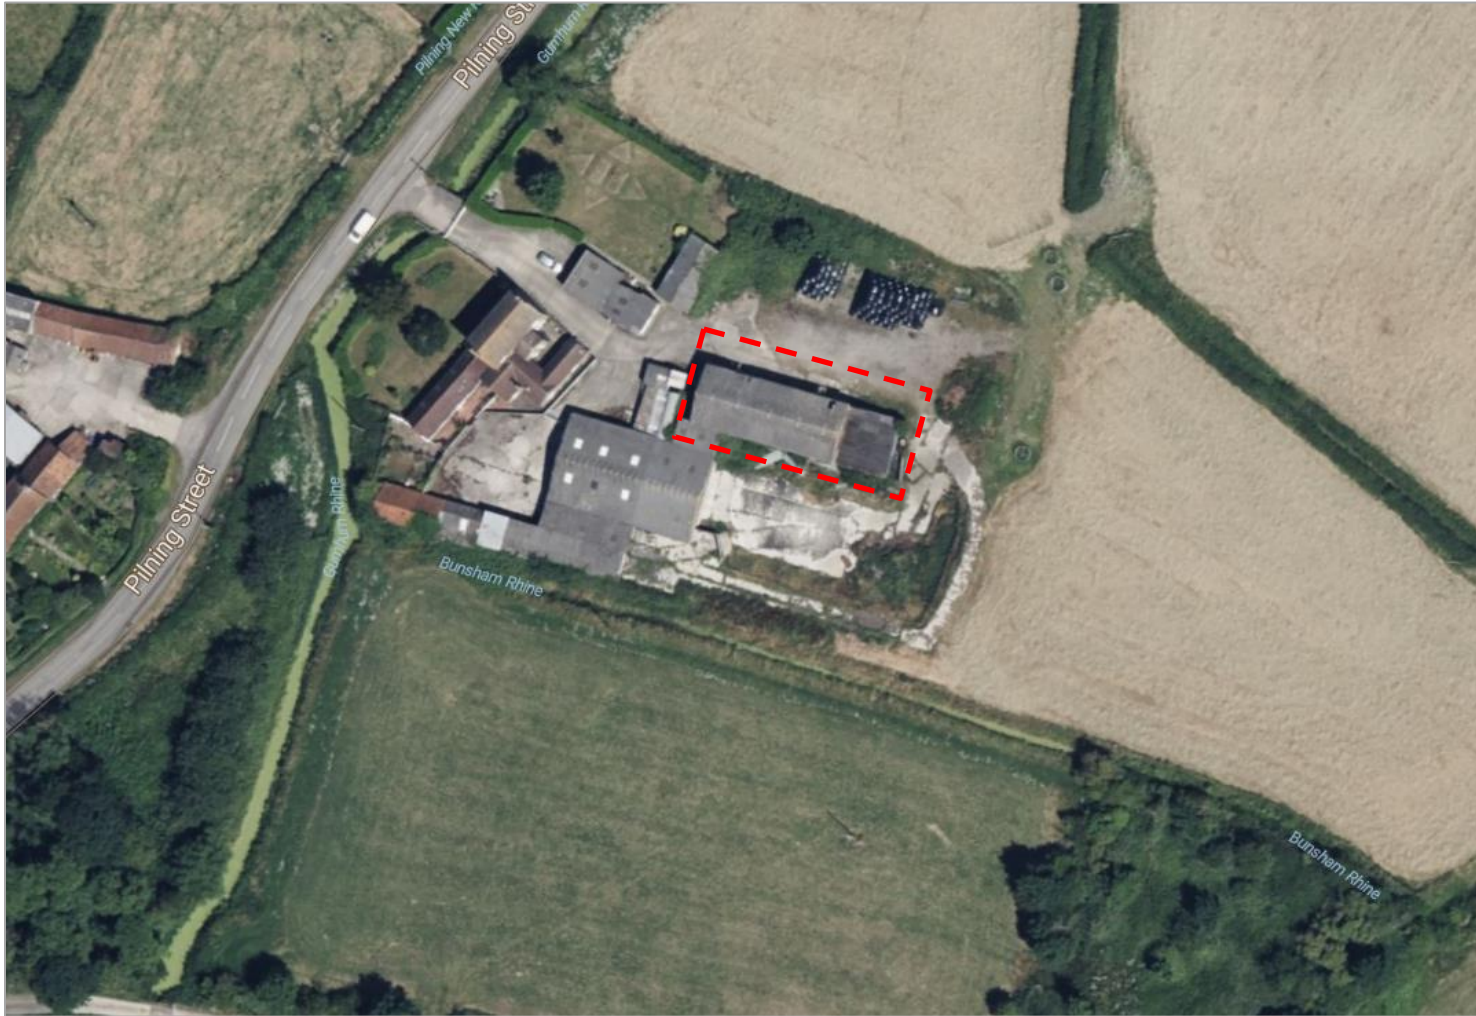
FIGURE 3 WATERCOURSES AROUND LAUREL FARM

The site itself does not offer suitable terrestrial opportunities for otter. The surrounding Rhines were surveyed during the visit and no evidence of otter was found although this does not mean that the species is not active in the surrounding landscape.

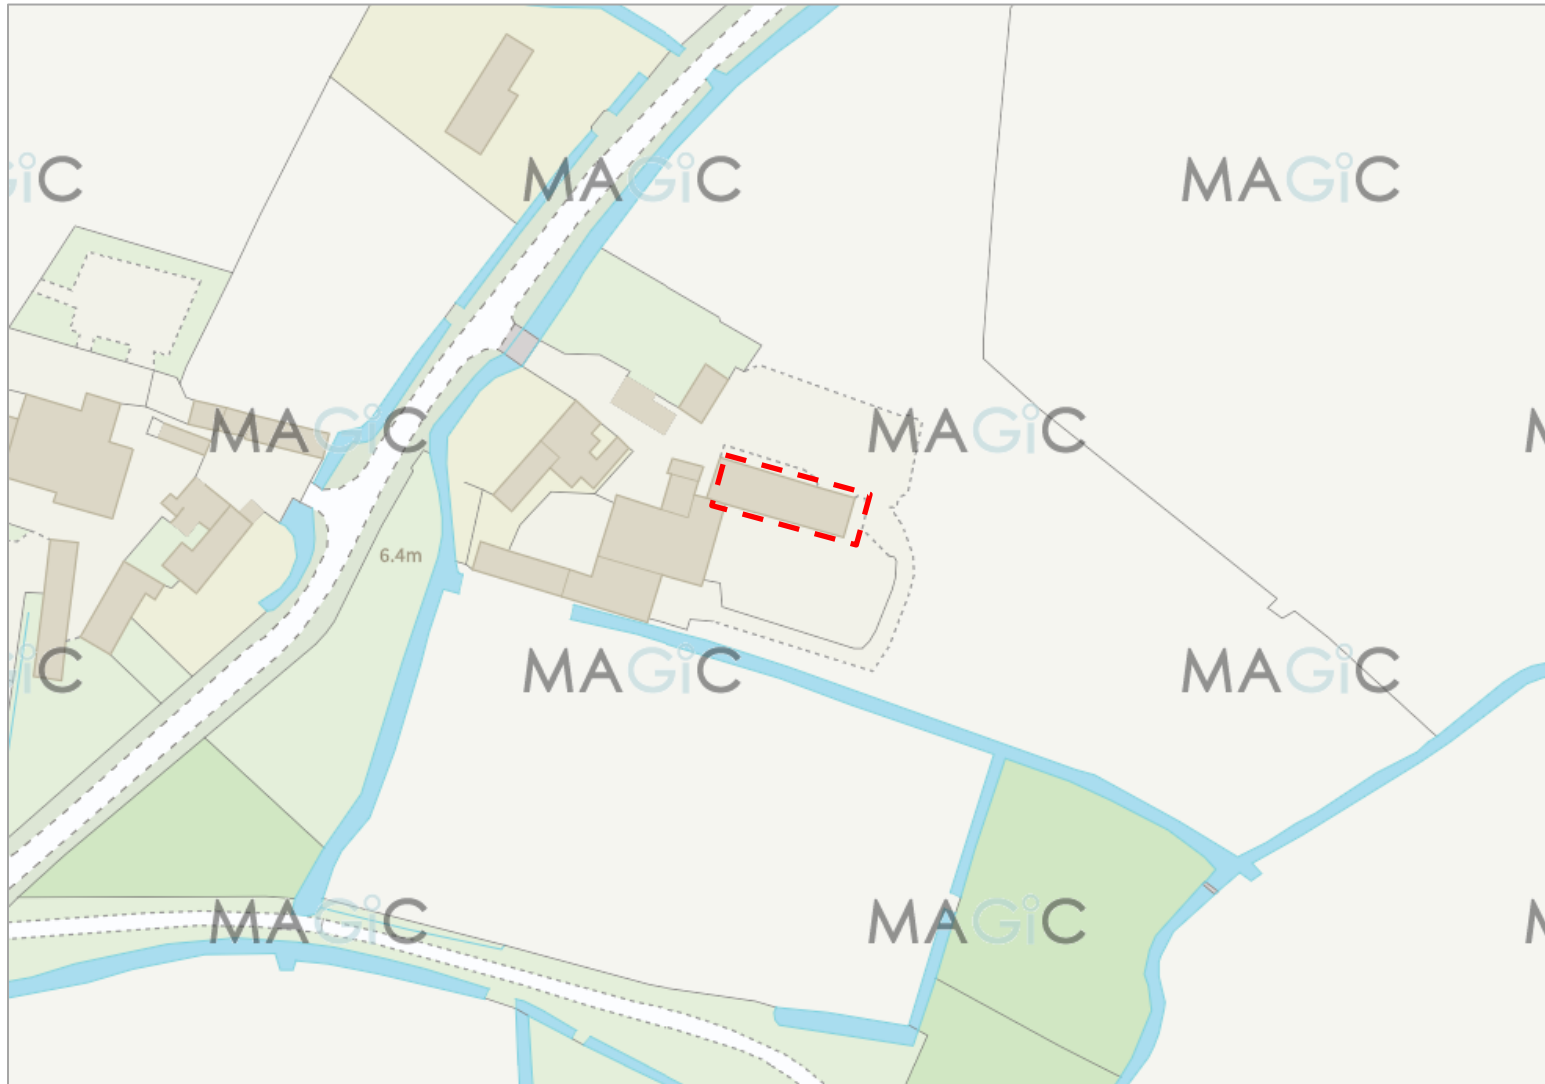
There are a number of Rhines located within 100m of the site including:

Bunsham Rhine 27m south

Gumhurn Rhine 45m west

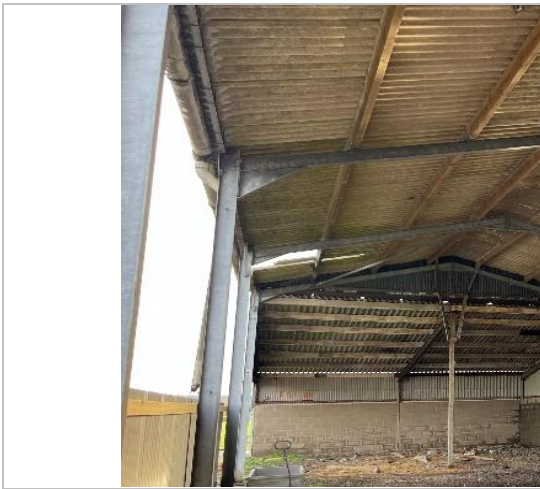
Building 1

Building 1: The barn to be converted is a steel framed structure, open at the north elevation. The west, south and east elevations are clad with a single layer of corrugated tin, with a single course of blockwork at the base. The roof over the main structure is pitched, and covered with corrugated fibre cement. There is a lean-to section at the east gable which is also covered with corrugated fibre cement.

The floor within the barn is part concrete and part bare ground. There are no enclosed sections or cavities present within the barn.

Building 1: The structure is very light and open, with modern construction materials being the only features present. There are no enclosed loft spaces or cavities, and no potential roosting features were identified. No evidence of bats was identified whilst on site.

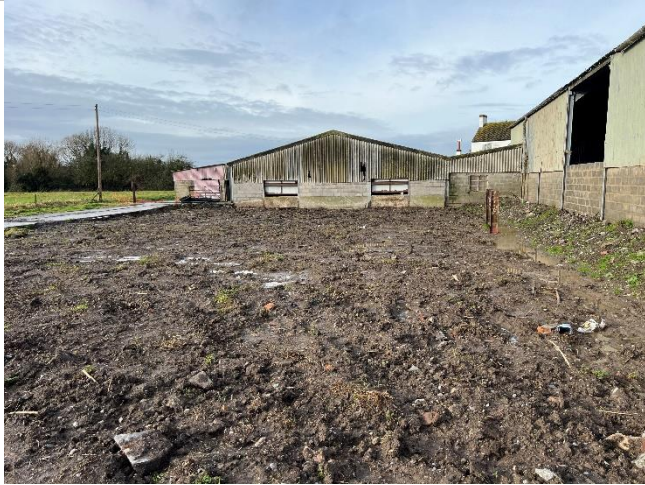
Former slurry pit

The area marked as 'slurry bed' is now an area of bare earth.

The former slurry pit is now an area of bare earth. Alteration to this will have no impact upon ecologically significant features.

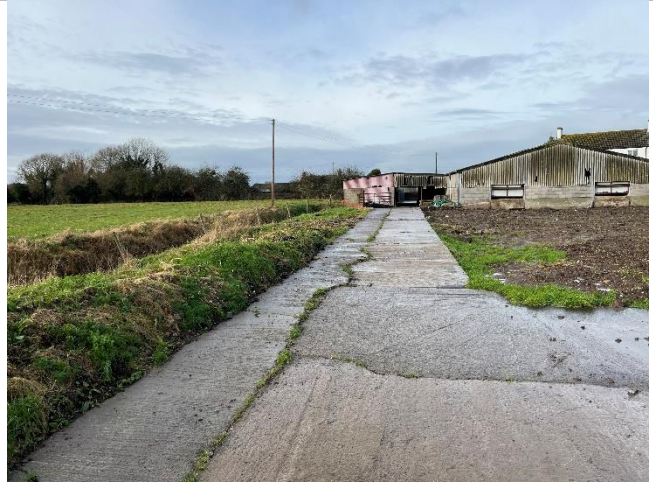
Concrete farm track

There is a concrete road which runs around the east side of building 1 and extends around the old slurry bed, before re-joining the farm yard.

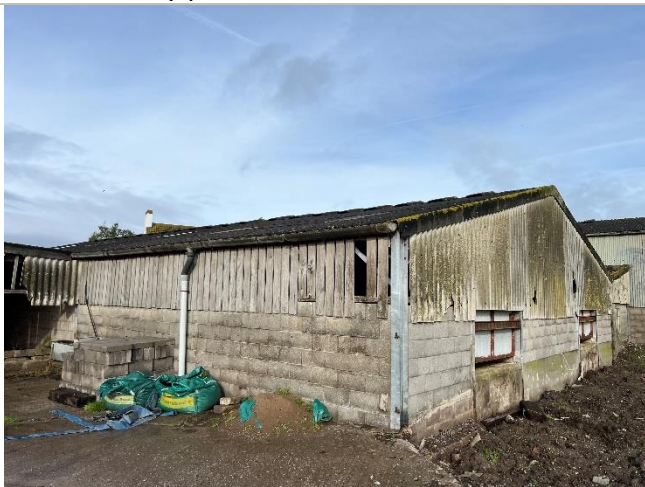
Building 2

Building 2: A large steel framed cow shed, adjacent to the barn for conversion. The roof is pitched and covered with fibre cement sheets and there are numerous transparent skylight sections. The flooring is concrete throughout and the elevations are clad with corrugated fibre cement and vertical Yorkshire boarding, atop single course blockwork walls.

Building 2: There are no suitable roosting features present and no evidence of bats was found during the survey.

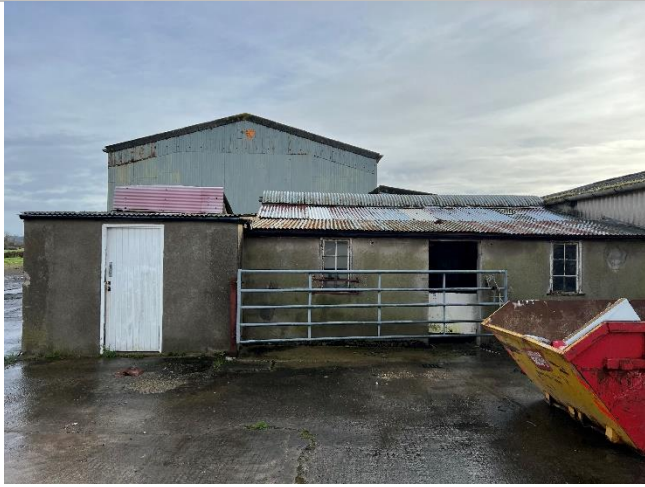
Building 3

Building 3: Adjoining B2 at its north elevation, this structure is a small blockwork building with a corrugated tin roof with numerous transparent skylights. The floor is concrete and around half of the roof structure is half-rounded.

Building 3: No suitable potential roosting features were identified and no evidence of bats was found.

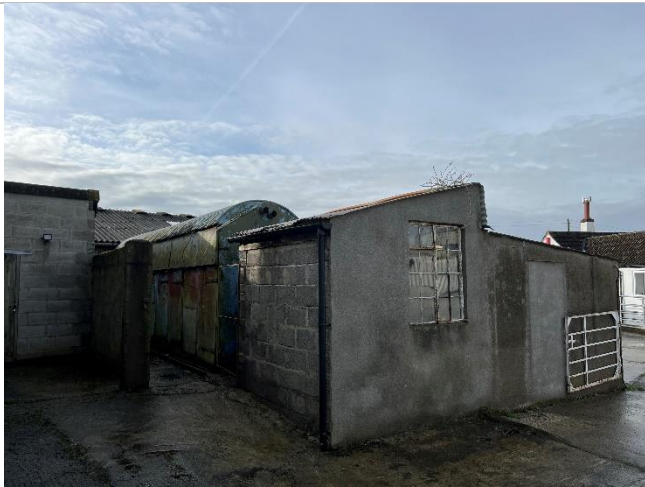
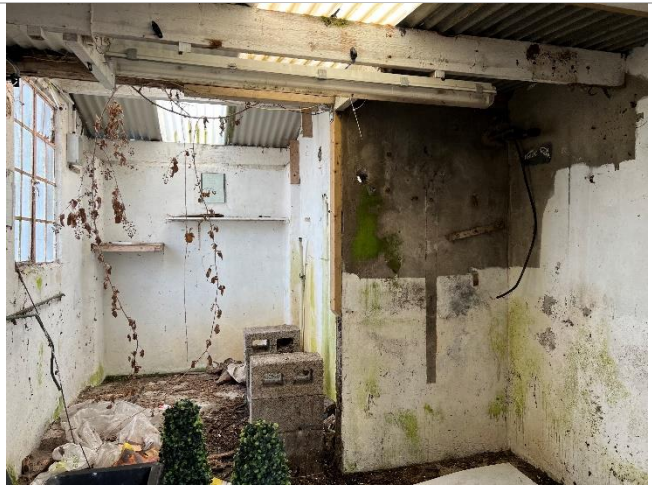
Building 4: Another small blockwork structure with a half-pitch corrugated tin roof, adjoining B3 at its northern elevation. Concrete floors extend throughout.

Building 4: No suitable potential roosting features were identified and no evidence of bats was found.

Two swallow nests were found in Building 4. One of these has been adopted by a wren.

Works to Building 4 need to be carefully timed so as to not disturb breeding birds. If the building will be altered or replaced, this will need to be done outside the breeding bird season i.e. September – February.

Replacement nesting sites for swallow and wren will be required in another building on site, to be retained. One Woodcrete swallow nest and one roundhouse Wren's nest will be installed into the building identified as 'bike shed' on plans. These will be in place before removal of the existing nest site.

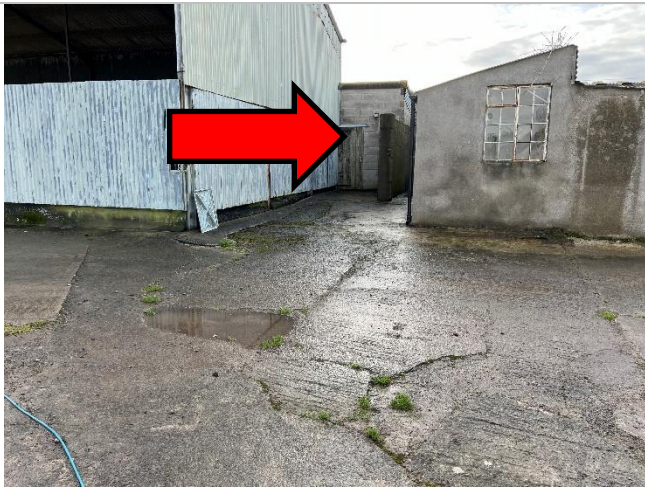
Building 5 and concrete yard

Building 5: A third small blockwork structure with a half-pitched roof covered with corrugated fibre cement. The bottom 2/3 of the walls are blockwork, with corrugated fibre cement cladding at the top third.

Building 5: No suitable potential roosting features were identified and no evidence of bats was found.

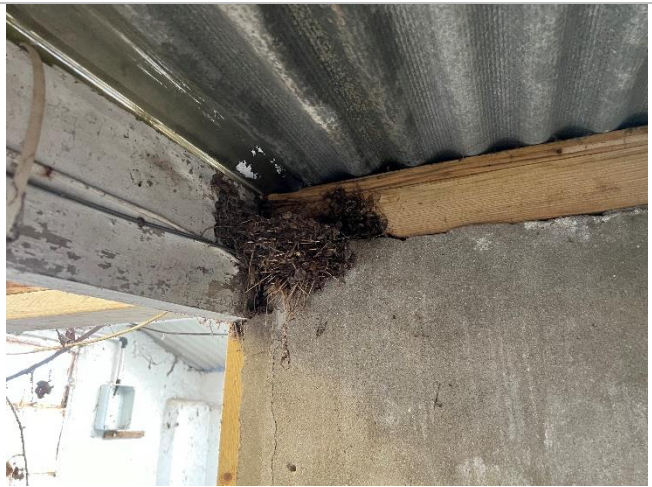
Building 4 interior

One swallow nest and one wren's nest were found in Building 4. Mitigation measures and replacement nesting features will be required.

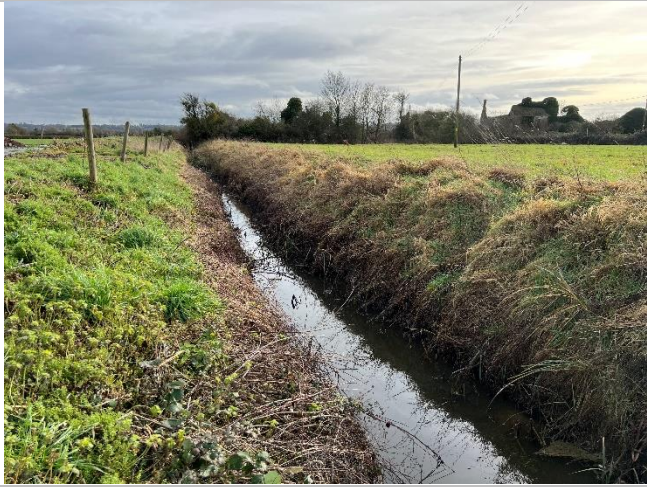
Rhine to the south

The site does not offer suitable habitat for water voles but the surrounding Rhines offer good quality habitat for this species. No confirmed evidence of water voles was identified in the Rhines surrounding the property but it is possible that some burrow entrances and runs exist in the south bank of Bunsham Rhine, some 50m from the site. Water vole activity between December-February is reduced, rarely venturing out of their burrows. Evidence is therefore scarce.

- No work will take place within 10m from Bunsham Rhine. This is approximately the north edge of the concrete track which in place.
- No materials will be stored along the banks of the Rhine.

Bunsham Rhine along the south side of the farmyard is currently partly fenced, and open. It is recommended that a new, native species-rich hedge is planted along the south boundary of the yard to shelter the Rhine from all on-site activity. Planting will take place no less than 1m from the top of the bank, and include a mixture of native woody species. This could be: hawthorn, hazel, holly, field maple, oak, elder, dogwood, Guelder rose, dog rose.

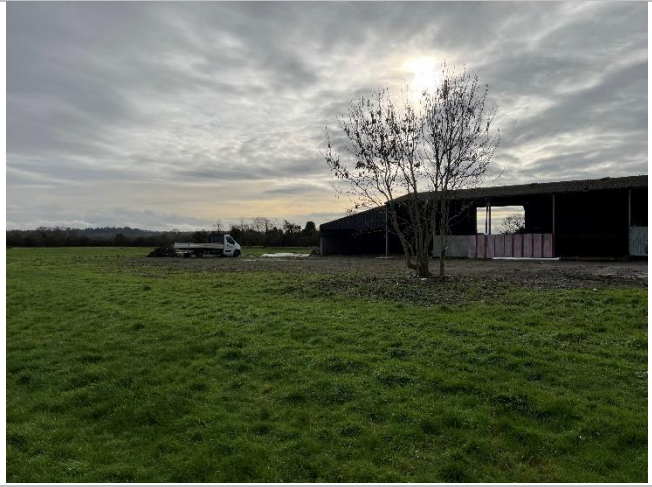
Land to the north
