Existing Building Condition

Project: Will Thorne Pavilion
 Client: Newham Council
 Drawing: Existing Elevations
 Drawing no: 2306-3-012
 Rev: Status: Planning
 Date: 14/02/2024
 Scale: 1:100@A1

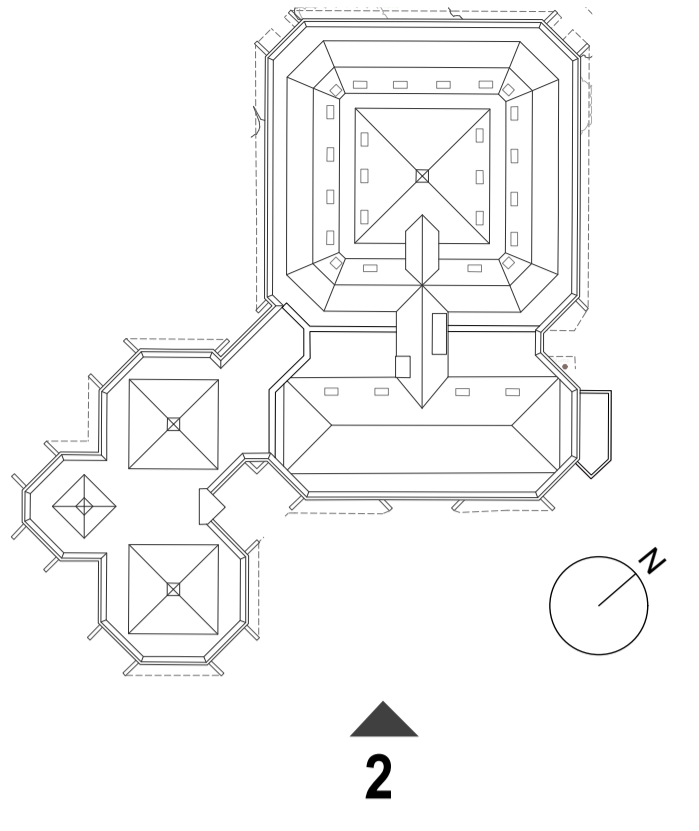
Roof

- 1 - Pitched pyramid roof with concrete tiles
- 2 - Flat concrete roof with bitumen waterproof covering
- 3 - Metal louvred roof cap to pyramid tops
- 4 - Louvred ventilation riser
- 5 - Brick buttress

Openings

- 8 - Full height single glazed timber windows
- 9 - Single glazed timber double doors
- 10 - Full height opening to kiosk
- 11 - Galvanised or painted metal security shutters with timber cladding to head box

External

- 12 - Concrete paving slabs with uneven edges
- 13 - Existing bench with table on paved surface
- 14 - Overgrown planters
- 15 - Existing lamp posts out of service
- 16 - Existing painted metal fencing and gate
