## **BS5837 TREE SURVEY**

For  
Land South of Hadnall Hall

Grid ref: SJ523200

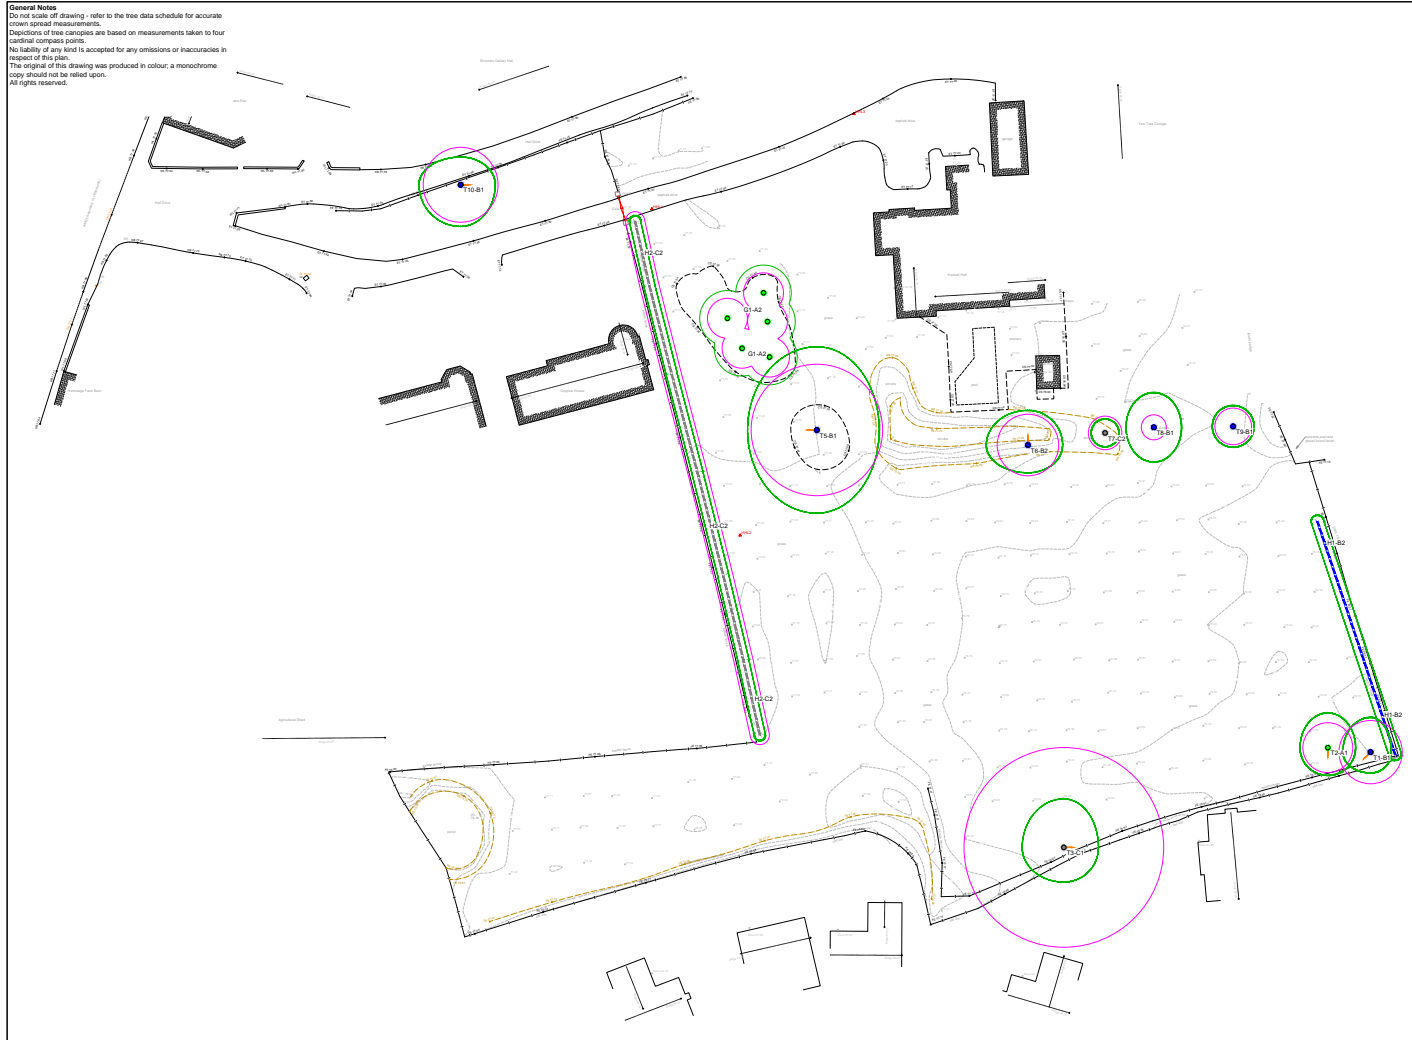
- 5.1 Above ground constraints arising from the current height and spread of the trees are marked on the Tree Constraints Plan. The height and direction of the first significant branch and any notable characteristics such as decay pathogens or pronounced lean are described in the Tree Survey Schedule.

- 5.2 The below ground constraints are marked as root protection areas (RPA) on the Constraints Plan. These represent the **minimum** area of protection. For single stemmed trees, the radii of RPAs are assumed to be twelve times the diameters of the enclosed trees, for multiple stemmed trees the radii are derived from the square root of the squared sum of the diameters of the stems. Irrespective of these rules, the Standard indicates that the radius of an RPA should rarely (if ever) exceed 15 metres. The plan accompanying this report shows, in most cases, the nominal RPA indicated as circles centered upon the trunk of a radius such that they enclose an area equal to the relevant RPA. In practice the distribution of roots around a tree will frequently prove to be uneven due to a variety of constraining influences such as physical barriers, waterlogging or soil compaction. The area and shape of an RPA may therefore be changed if local conditions dictate or the tree's condition indicates that a larger zone is required.

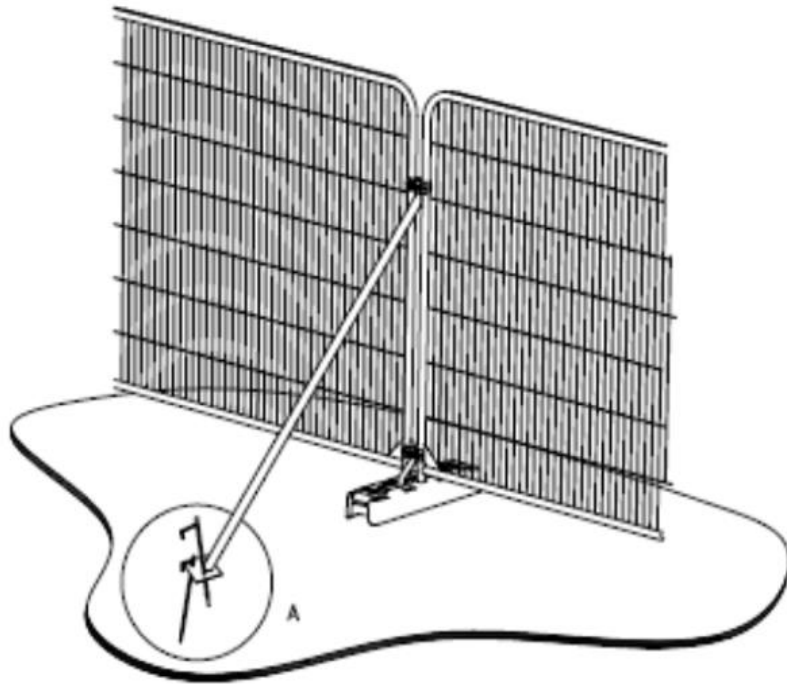
## APPENDIX 7 – Tree Protection fencing

1. 2m high welded mesh panels.
2. Placed upon rubber or concrete feet.
3. Joined using a minimum of 2 anti-tamper couplers placed at least 1m apart.
4. Panels to be supported on the inner side by stabilizer struts with ground pins
5. Signs to be affixed to fencing every ten metres. See below for example.

7.4 Construction Exclusion Zone (CEZ) fencing shall be erected as shown on the plan and in conjunction with the marked RPA's to exclude those trees from harm where work is occurring. There is not a requirement for exclusion zones on all trees. "Heras" or similar type fencing is less invasive but must however be braced and pinned to the ground to make it less conveniently movable (see appendix 7 for diagram). Weatherproof notices shall be attached to any protective fencing displaying the words "*Construction Exclusion Zone*" and listing all restrictions that apply. All personnel must be made aware of these restrictions. It shall be checked by an arboriculturalist before excavation works commence.

7.5 Tree protection and the CEZ (See Appendix 7)

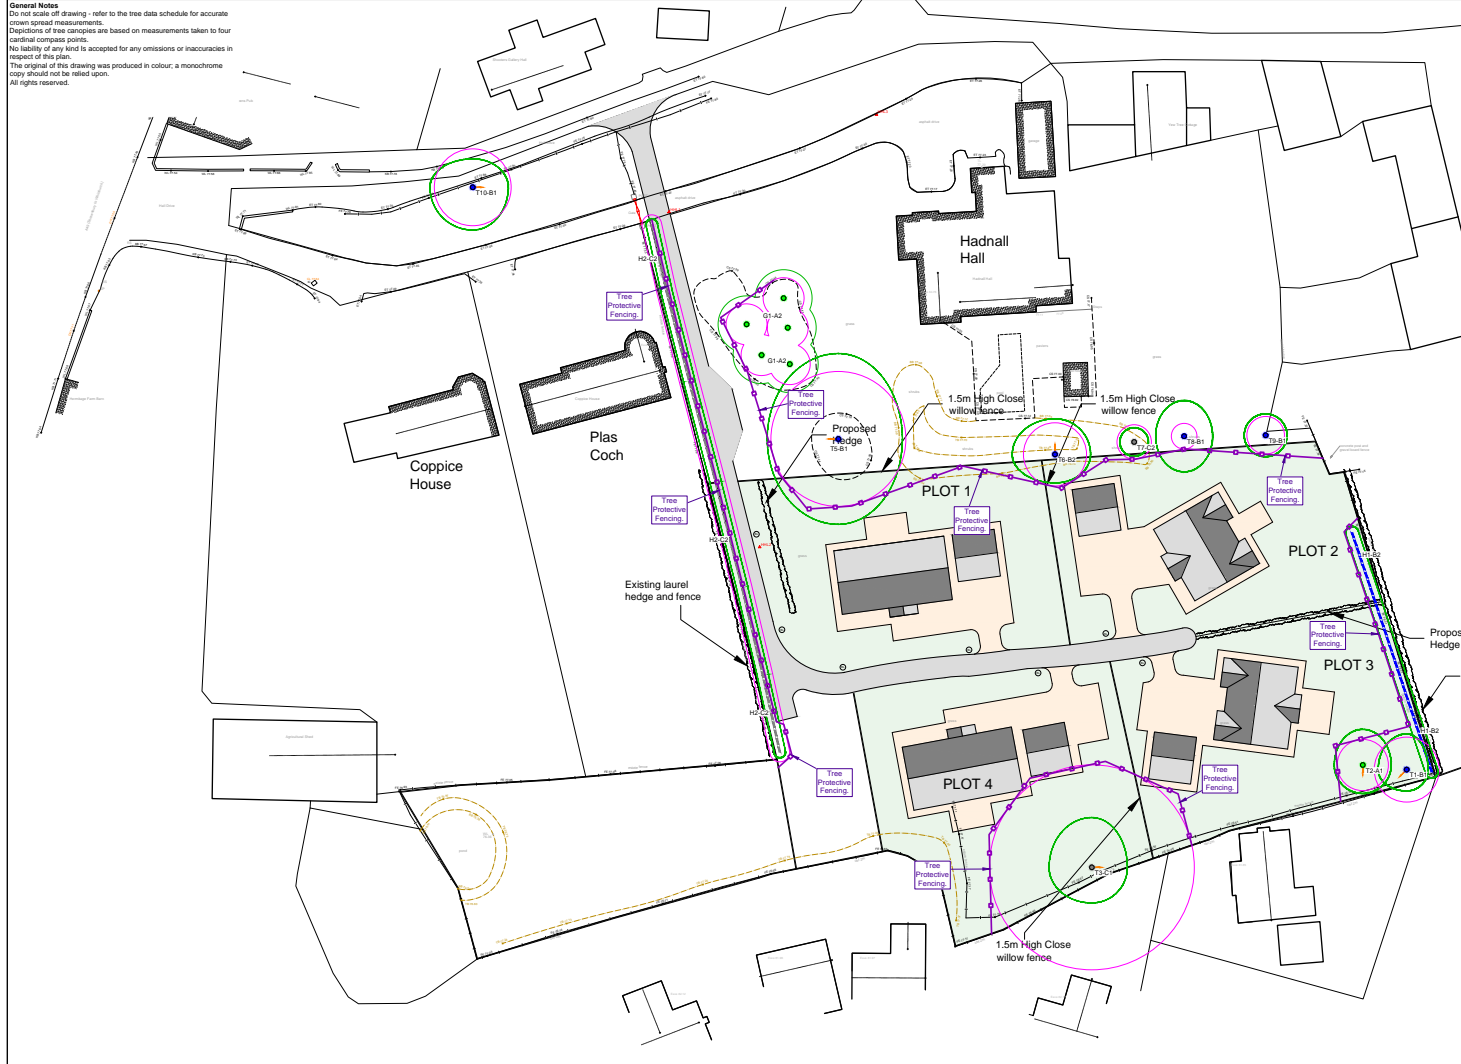
- 6.1 Without mitigation the construction could cause root compaction and/or root severance to trees by construction machinery and repeated footfall.
- 6.3 The hedge H2 and trees of G1 must be protected with fencing from the construction processes causing damage. (see appendix 7).

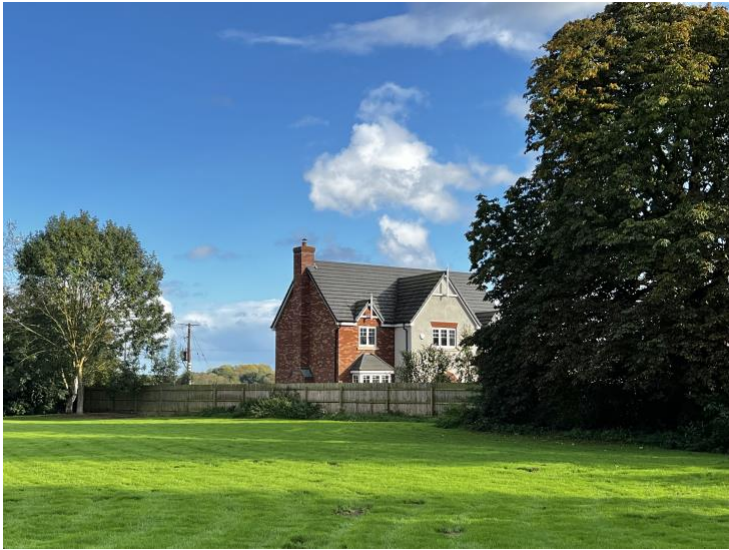
**Figure 1** Trees 1 and 2 on the left and T5 on the right  
14/10/2023

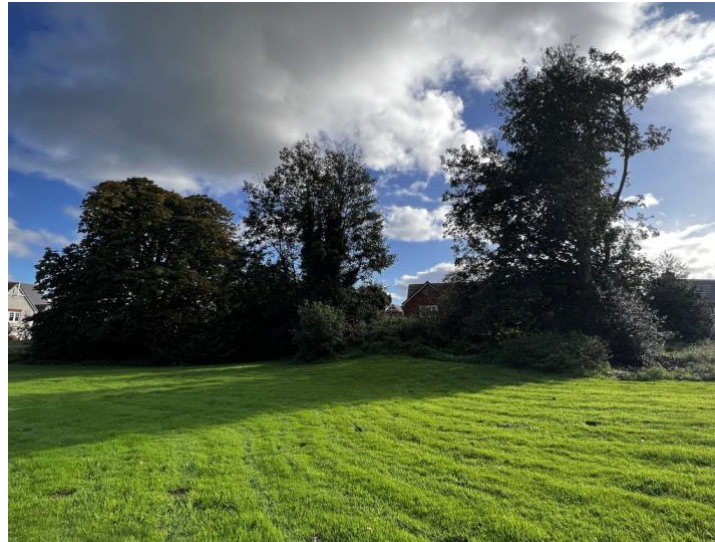
**Figure 2** Trees 5, 6 and 7 14/10/2023
