BAT, BARN OWL AND NESTING BIRD SURVEY

**THE SCHOOL ROOM, PENRYN METHODIST CHURCH,
THE TERRACE, PENRYN, CORNWALL**

February 2024

**BAT, BARN OWL AND NESTING BIRD SURVEY ON THE SCHOOL ROOM,
PENRYN METHODIST CHURCH, THE TERRACE, PENRYN, CORNWALL**

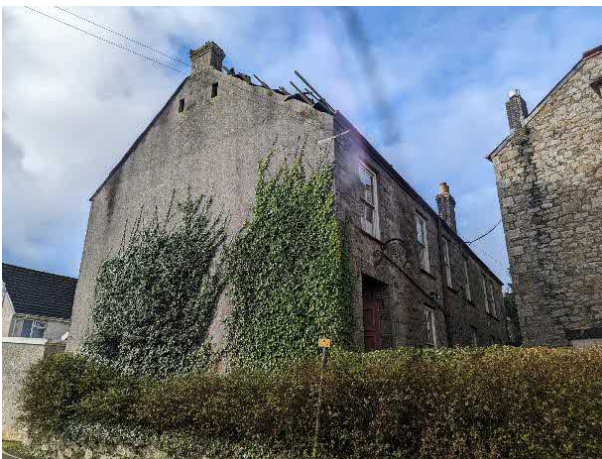
Photo 1. Showing the School Rooms from the north east with the northern elevation and eastern gable end being in view

Externally the roof has been cement washed, the eaves on the gable ends and southern side of the building are well sealed, with cement pointing or render, and the lead flashings appear well sealed. There is a gap between the stone wall and fascia board the length of the northern side of the building (see Photo 1) and there are a small number of gaps below some of the ridge tiles, which have the potential to be used by roosting bats or to access cavities behind. In addition there are the louvred opening in the eastern gable end with the potential to be used by bats or birds to access the small roof void (see Photo 1). There is also a hole in the base of one of the sash windows on the southern side of the building which has the potential to be used by roosting bats, see Photo 9.

As the building support features with the potential to be used by roosting bats which will be impacted by the proposed work, further bat survey work should be undertaken.

The building is considered to have moderate potential to be used by roosting bats, based on the number of features present and location of the building, and so the further survey work should take the form of a pair of emergence surveys, using two surveyors. This further survey work can only be undertaken during the active bat survey season, May to September, with at least one of the surveys being undertaken during the peak survey period before the end of August. The emergence surveys should be undertaken at least four weeks apart.

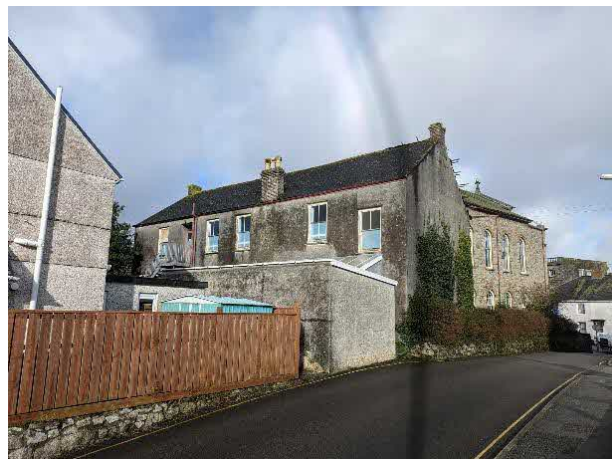
Photo 2. Showing the School rooms from the south

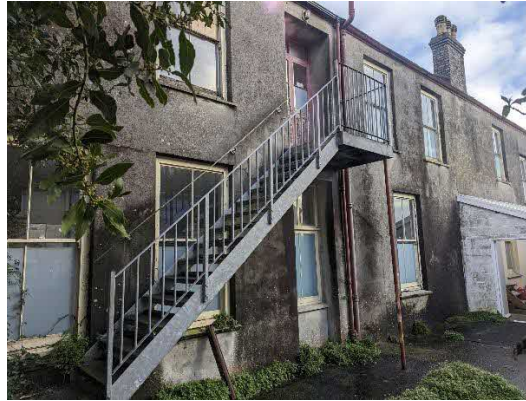
Photo 3. Showing the School Rooms
from the south west and the external staircase

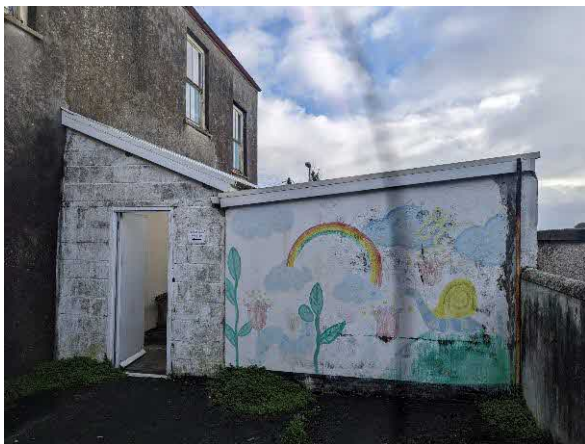
Attached to the eastern end of the southern side of the building is a single storey blockwork toilet block and covered courtyard. These are attached to one another and have mono pitched clear plastic sheeting covered roofs which slope towards one another, see Photos 4 and 5.

Photo 4. Showing the toilet block and
covered courtyard from the west

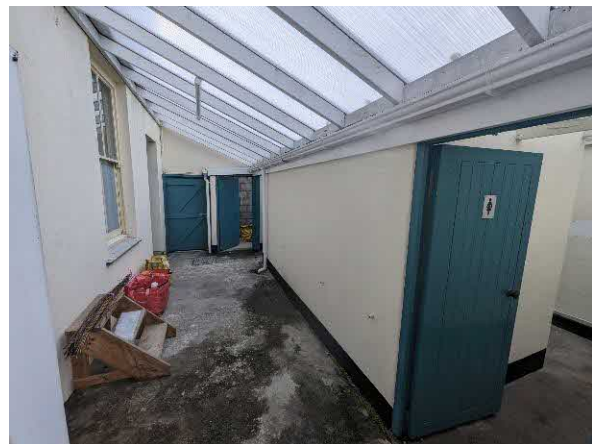
Photo 5. Showing the interior of the toilet block
and covered courtyard

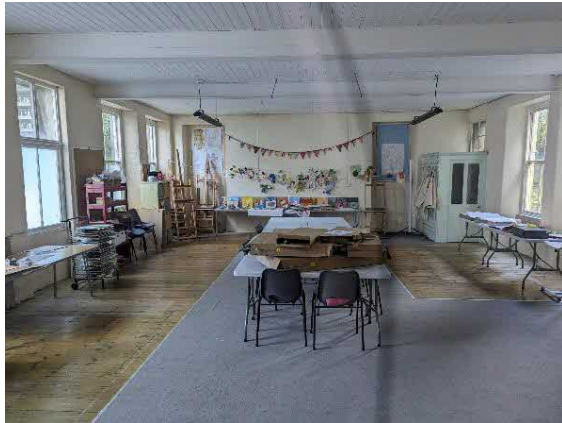
Internally the building is arranged as one large room at the western end of the building on both the ground and 1st floor with smaller rooms and a stairwell at the eastern side of the building, see Photo 6. On the 1st floor the large room has a stage against the western gable and is open from the timber floor to the underside of the roof which is supported by trusses and is lined with timber, see Photo 7. Against the eastern gable end, over the small room and stairwell is a partially vaulted ceiling with a small roof void above, see Photo 8. There is a loft hatch but the roof void could not be accessed due to what is believed to be nesting material on top of the hatch. This is also where the patched hole in the roof is located.

Photo 6. Showing the large room at the western end of the ground floor

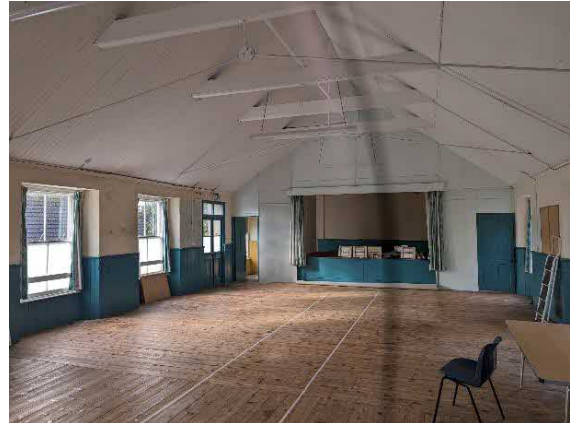
Photo 7. Showing the large room at the western end of the 1st floor

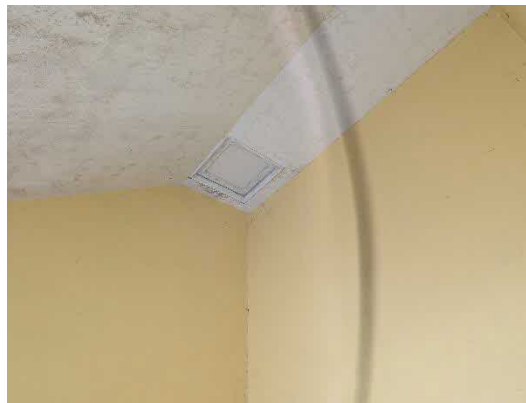
Photo 8. Showing the partially vaulted ceiling and small roof void above the room and stairwell at the eastern end of the building on the 1st floor

Jackdaws were seen perching on the ends of the battens used to cover the hole in the roof and seen to enter the roof void via the openings in the eastern gable end during this survey. In addition, House Sparrow were heard and seen perching on the roof in the vicinity of the chimneys. This, along with the volume of material noted on the top of the loft hatch, indicates that these two species are likely to nest in the building.

Care should be taken to ensure birds are not nesting within the building when works commence. Ideally the works should commence outside the nesting bird season, March to the end of August. If this is not possible a careful inspection of the building for the presence of nesting birds and active nests should be carried out immediately prior to the work starting. If nesting birds are found to be present the works in the vicinity of these nests will need to be suspended until after the chicks have left the nest and the nest is no longer considered to be active. This is because birds are protected by law whilst nesting.

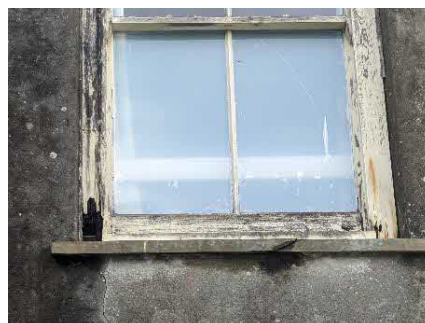
Photo 9. Showing the hole in the base of the sash window

No evidence of the use of the building by roosting bats was found but the building does support a number of features with the potential to be used for roosting by bats. These include the gap between the stone wall and fascia board the length of the northern side of the building, the hole in the base of one of the sash windows on the southern side of the building, the gaps below some of the ridge tiles and the small roof void which could not be accessed.
