PRELIMINARY ROOST
APPRAISAL

16 MILL HILL, BAGINTON
COVENTRY CV8 3AG

Date: 29th February 2024

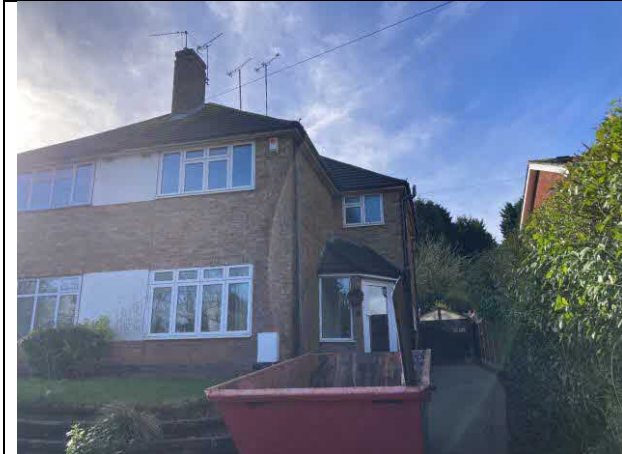
3.1.1 The house was a brick, two storey dwelling that appeared to have been built during the early to mid-twentieth century. The roof was hipped and clad with concrete interlocking tiles which appeared in reasonable condition and was well-sealed, showing no gaps that would give rise to ingress / egress points or PRFs or ingress points. The soffits were also well-fitted to the masonry showing no gaps.

Photo 1 North elevation

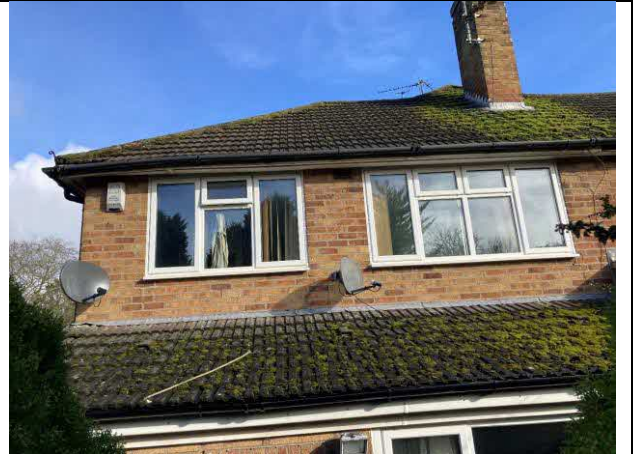
3.1.4 Adjoining the main structure at the south elevation was a single storey section that had a single pitched roof. This was covered with concrete interlocking tiles and was in reasonable condition, although PRFs were visible which were:

Photo 2 South elevation

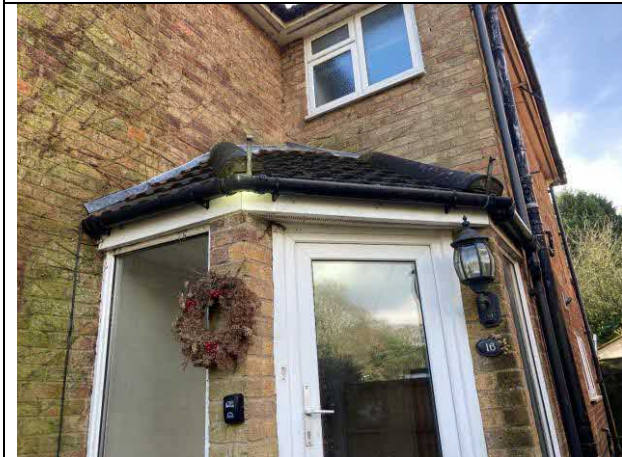
3.1.6 At the north east elevation was a single storey porch with a single pitched hip roof clad with concrete interlocking tiles. This was in good condition and no PRFs or ingress / egress features were identified. The house was considered to show no bat suitability.

Photo 3 Porch north elevation

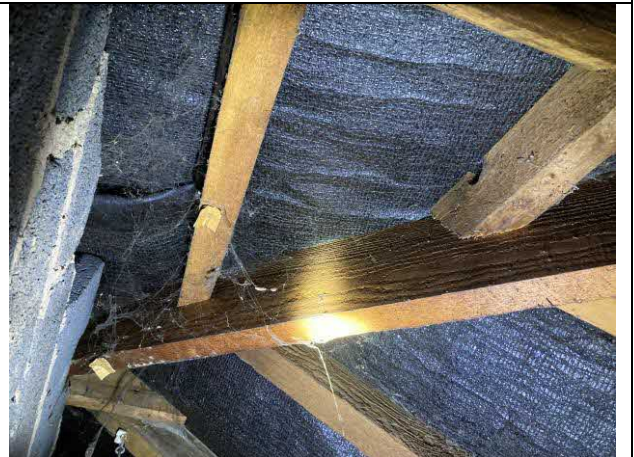
3.1.2 Inside the roof void it could be seen that the roof was lined with traditional bitumen felt which had been retro-covered with white plastic sheeting. This was easily removed to check the felt and roof timbers beneath. Cobwebs were abundant around the roof timbers which suggested no bats or birds had disturbed the area in recent years. The loft floor was boarded and this was also covered in white plastic sheeting which supported a layer of old plant material, although no evidence of bats or breeding birds was encountered.

3.1.3 The ridge supported significant cobwebbing which was considered to provide evidenced that the ridge had not been disturbed by bats or other animals in recent years. The main roof was considered as having no bat suitability.

Photo 4 Cobwebbed roof timbers

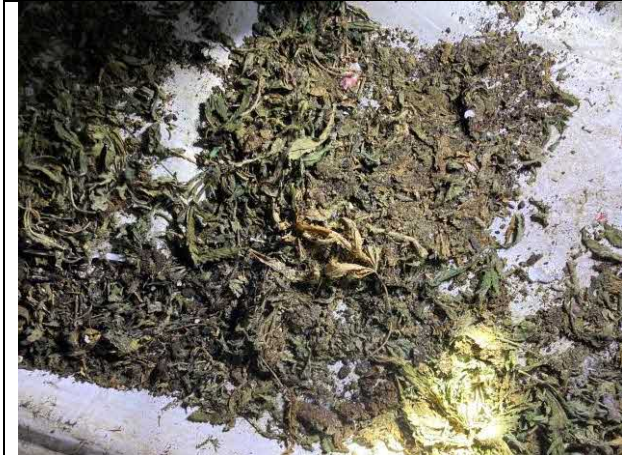
Photo 5 Old plant growth loft floor

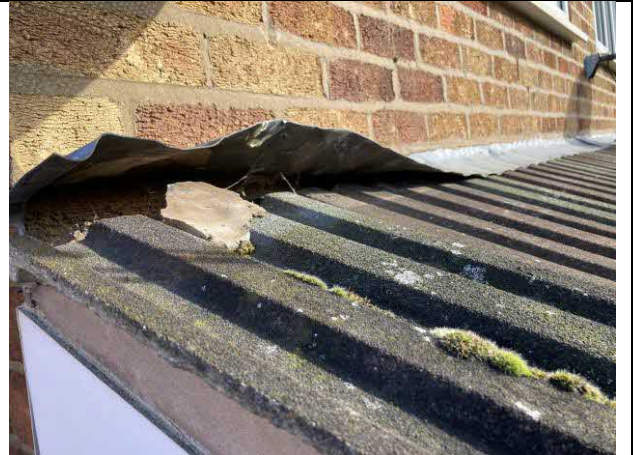
- Beneath the lead flashing where the roof joined the brickwork of the main house
- Where mortar had fallen away from the west verge

3.1.5 These features were thoroughly inspected by hand and no evidence of bats was encountered inside or around the features.

Photo 6 PRF rear single storey section

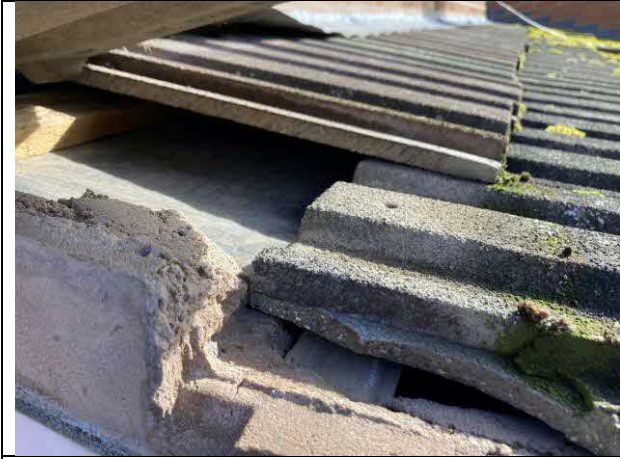
3.1.7 To the rear of the house was a small, single storey, prefabricated concrete garage. This had a pitched roof clad with prefabricated fibrous board panels. Ingress points and minor PRFs were present where small gaps could be seen at the gable ends. No evidence of bats was encountered at the exterior of the building.

Photo 7 PRFs single storey section

4.1 No evidence of bats was encountered either at the exterior or interior of the buildings. It is considered that bats have not been able to ingress the house because it lacks suitable PRFs / ingress points, and that the garage is very limited in its suitability for roosting bats although PRFs / ingress points do exist at the gable ends.

4.2 The house and garage are thought to have negligible bat suitability, and consequently that bats are unlikely to be impacted by the proposals and no further surveys are recommended. It is recommended that the gaps shown in photo 7 are blocked / made good as soon as possible so that these PRFs cannot be used by bats or breeding birds in future.

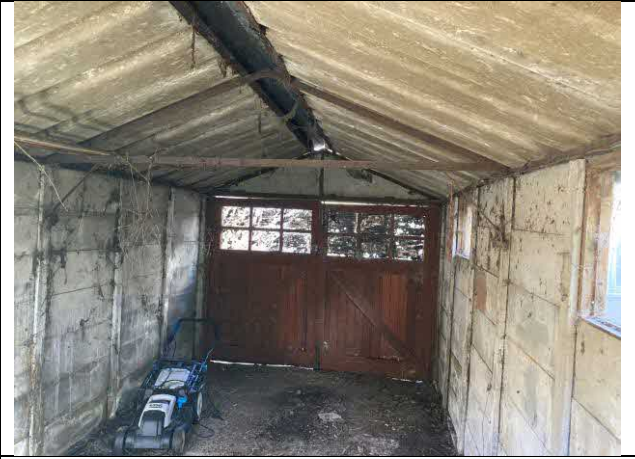
3.1.8 Inside the garage it was apparent that the roof was vaulted and no refuge areas for bats were observed or evidence of bats encountered. The structure was considered as having negligible bat suitability.

Photo 8 Garage interior
