ARBORICULTURAL REPORT
at
Russell Cottage
Bridgnorth Road
Bridgnorth
Shropshire
WV16 6JG

Client:
360Globalnet
on behalf of LV=Insurance

JCA Ref:
19927-A/AJB

Appendix 2: Site Plan

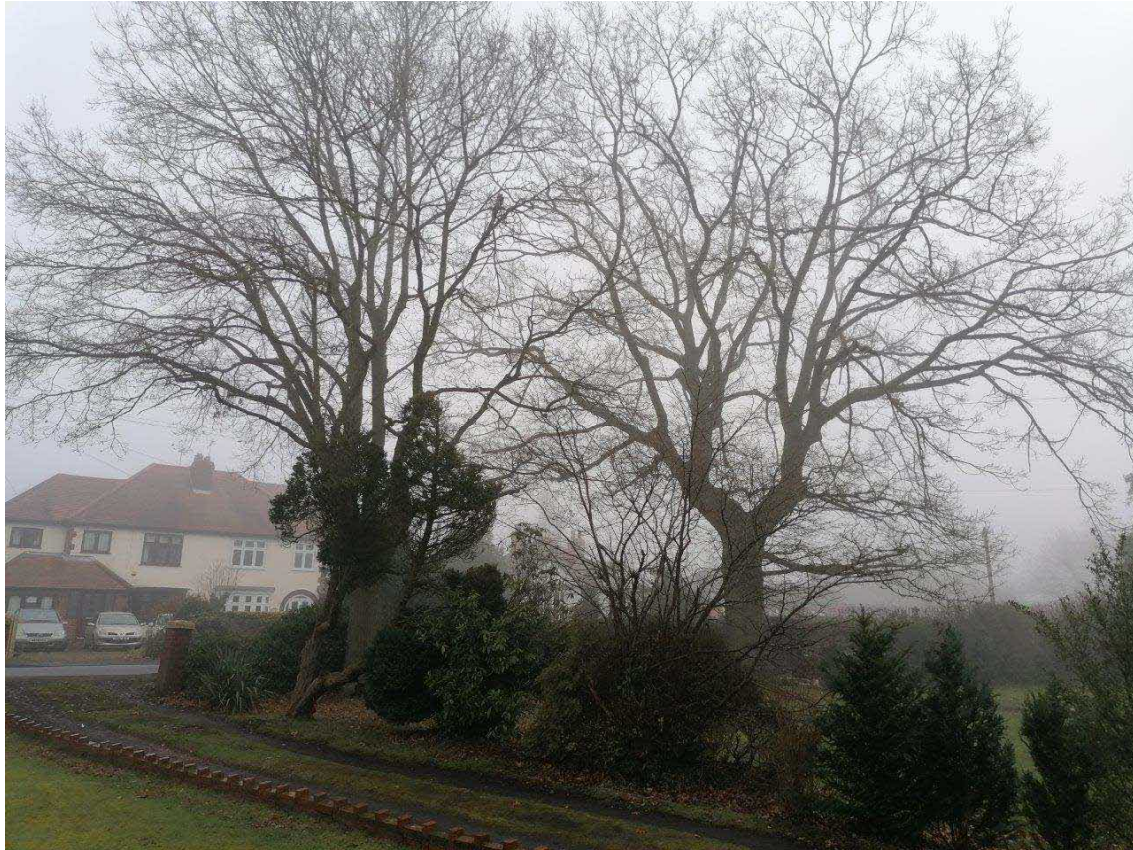
Appendix 4: Photo

- 3.4.7 The root identification is a match to the vegetation identified as **T1** and **T2** in this report.

- 6.1 We have been informed by our client that the damage observed at the property is due to clay shrinkage caused by vegetation.
- 6.2 Following our survey and study of the available facts, we are of the opinion that **T1** and **T2** are contributing to the subsidence damage at the subject property, and as such, it is recommended that both trees are removed, and their stumps treated to prevent regrowth. As third party, protected trees, their owner and the Local Authority will require sufficient proof that the trees are contributing to the damage. In this case we have evidence of:

A photograph showing T1 and T2.

Item	Species	Recommended Action	Location/ Ownership	Planning Restriction
T1	English Oak	Remove to ground level and treat the stump to prevent regrowth.	Oakland	Tree Preservation Order
T2	English Oak	Remove to ground level and treat the stump to prevent regrowth.	Oakland	Tree Preservation Order
