# Sidmouth Tyres & Exhausts

# **Arboricultural Impact Assessment**

# **Arb Impact Assessment and Tree Protection Statement**

Project Reference: 29.03.2023 JG/B612/0323 1.0

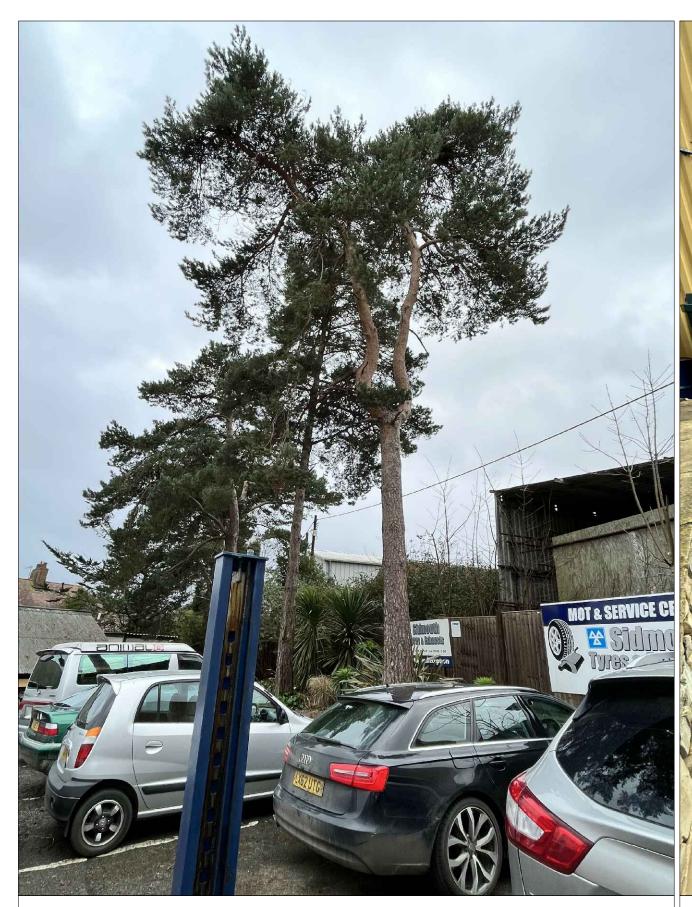
Photograph 2: Example of the hard surfacing with dwarf retaining wall, indicating likely offset of rooting area. Area of tarmac may host some rooting, albeit in unfavorable, compacted ground conditions.

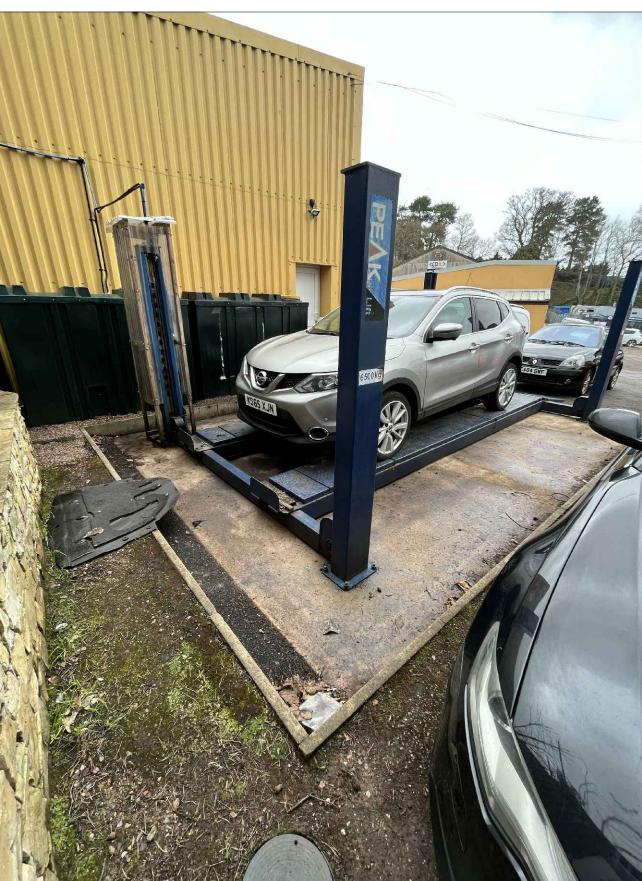
Photograph 2: Vehicle ramp to be covered with structure

The proposals for this site include the installation of a canopy above the existing outdoor mechanical vehicle ramp, to ensure a usable facility year round.

To enable this structure, two steel I beams are required within the nominally circular rooting area of this tree; as previously discussed, the rooting is likely significantly laterally impeded within this area. The beam dimensions are anticipated to be comparable to those within the existing structure to the north-west - 250mm x 140mm. Engineering input is required to calculate the exact size of excavation required to ensure structural stability of the installation, however it will be within the secondary hard surface area which already hosts the ramp itself.

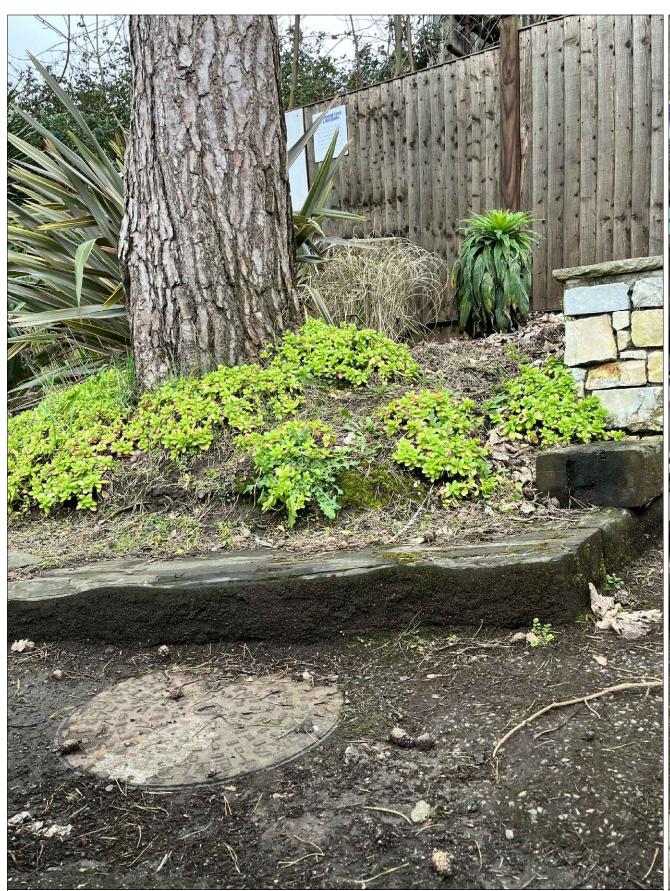
Photograph 1: Location of drain cover suggests utilities excavation within this surfaced area

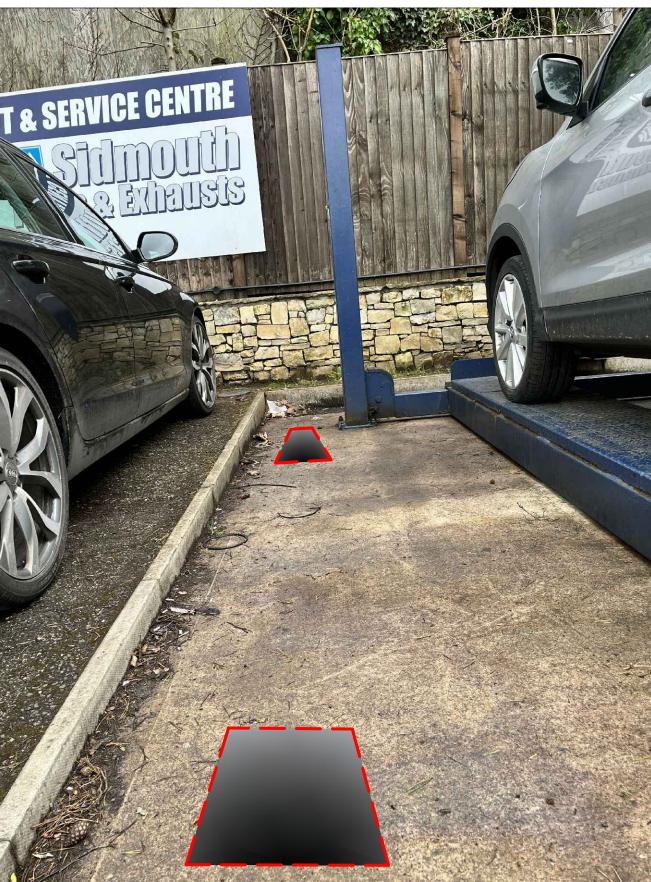
Photograph 2: Secondary hard surfaced area, hosting external ramp with very low likelihood of any rooting from Scots Pine T1 beneath. New pillars to be installed within this locatio, identified indicatively with red squares. Beams to be installed are 250 x 140mm I beams, as per adjacent existing building structure.

T1 to eastern pillar - 7.0m

T1 to western pillar - 5.0m

A canopy height of 4.0m gives significant clearance between the proposed structure and the crown of the tree.
