# 10 Monks Walk, Dibden Purlieu Hampshire, SO454QH.

Vesper Conservation & Ecology Limited 10/02/2024

Phase 1 bat survey (PRA)

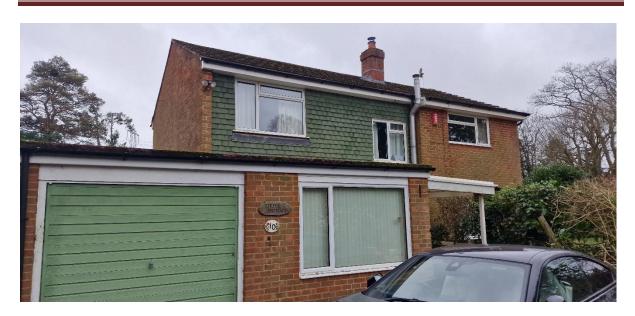
- 2.4 The roof is covered in tight fitting slate tiles there are no lose, missing or broken tiles that would allow ingress into the building.
- 2.5 The ridge is made form the same material there are no gaps or missing cement that would allow bats to ingress.

- 2.7 The building has small area of hanging tiles at the front of the property, these tiles are machine made clay/cement, there are no gaps or holes that would allow ingress into the building structures.

Picture 1: The front elevation

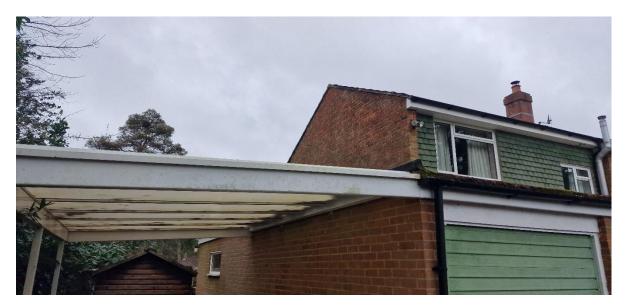
- 2.6 The tile verges are tight fitting with no obvious gaps or holes, the eaves and soffits are tight with no gaps or holes that would allow ingress into eh building.

Picture 2: Showing the side elevation

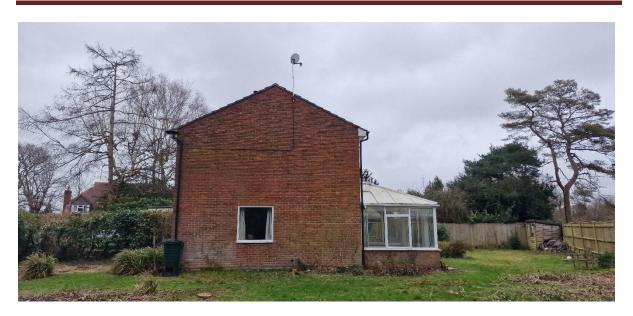
Picture 3: Showing the other side of the building.

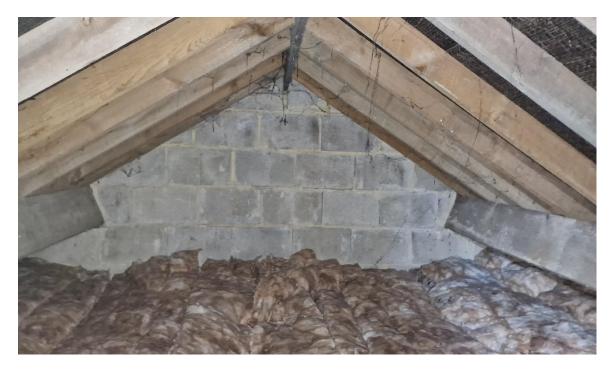
- 2.9 There is a single roof space that cover the whole of the main house, access to the loft space was good throughout.
- 2.10 The roof has a ridge height of about 2m, the ridge has clear of any cobwebbing and the roof space had limited cobwebs throughout.
- 2.11 The roof floor is covered with a thick layer of insulation which goes right into the eaves. There are no obvious gaps or holes that allow light into the roof space.
- 2.12 The tiles are backed with bitumen felt, this is in good condition with no gaps or holes that would allow bats to ingress into the roof void.
- 2.13 There is no light or breeze coming in from the eaves, and no obvious gaps or holes where recorded.
- 2.14 There were no physical signs of bats within the roof, there were also no other signs of rodents or birds in the roof void. There were no signs of other species in the roof

**Picture 4:** Showing the internal roof structure of the main house.
