**Our Ref:** MGeo 2103 BD17 5BN

**RE: Soakaway Test on Land at 2 Prod Lane Baildon BD17 5BN**

This letter report provides a summary of a 'soakaway' test undertaken at the above site as part of a new residential building.

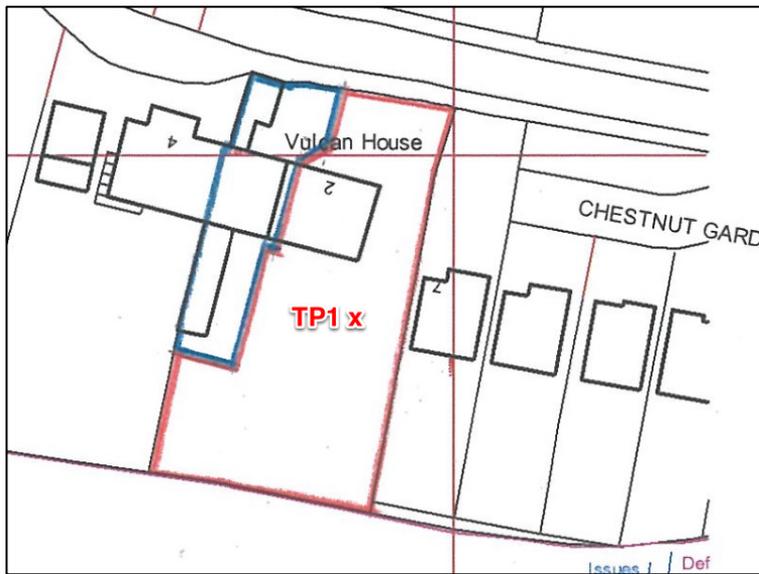
Figure 2 – Trial pit location plan

The investigation works were undertaken by the client's tracked excavator. One trial pit was excavated for soakaway testing relevant to the planned development and where it was safe to do so.

The trial pit was excavated to approximately 1.

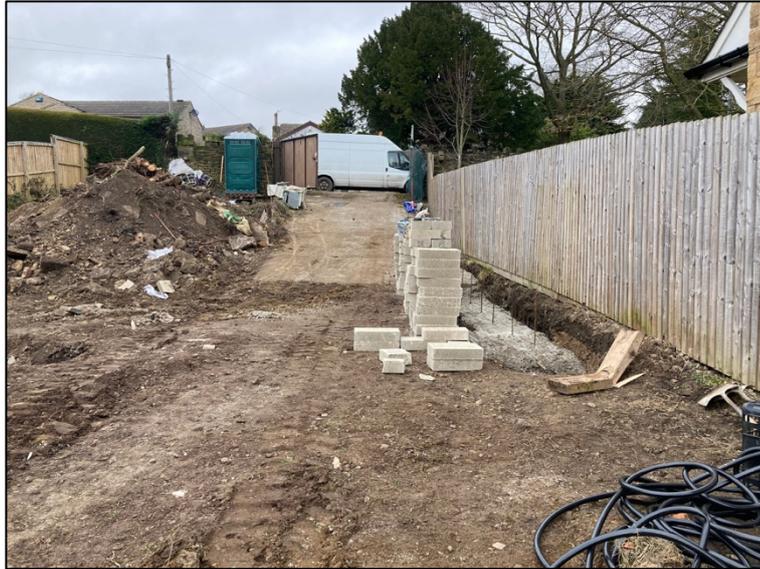
The site was located on sloping land at 2 Prod Lane within an upper moorland setting. As seen in the site photos the initial excavations and site clearance have exposed sandstone bedrock at formation level and quarry backfill in the north and extending to the fields north of the site.

General view to the north looking up towards Prod Lne

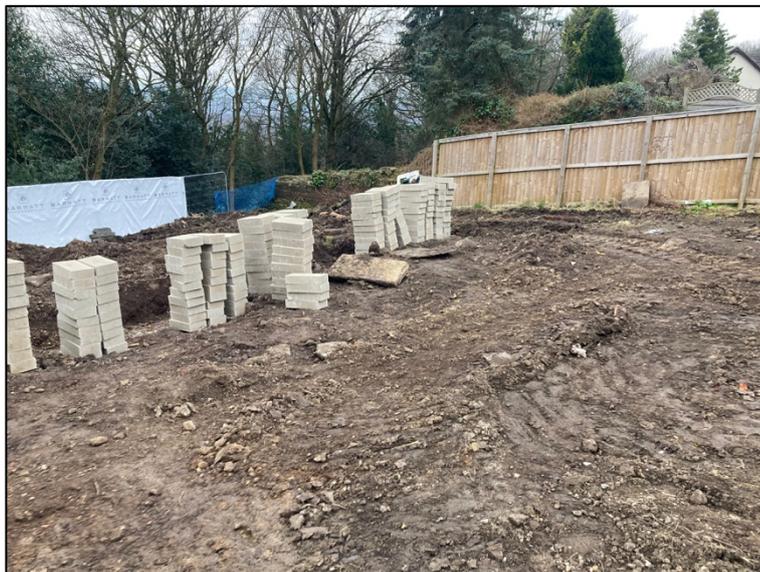
General view to the south west across the site down towards woodland

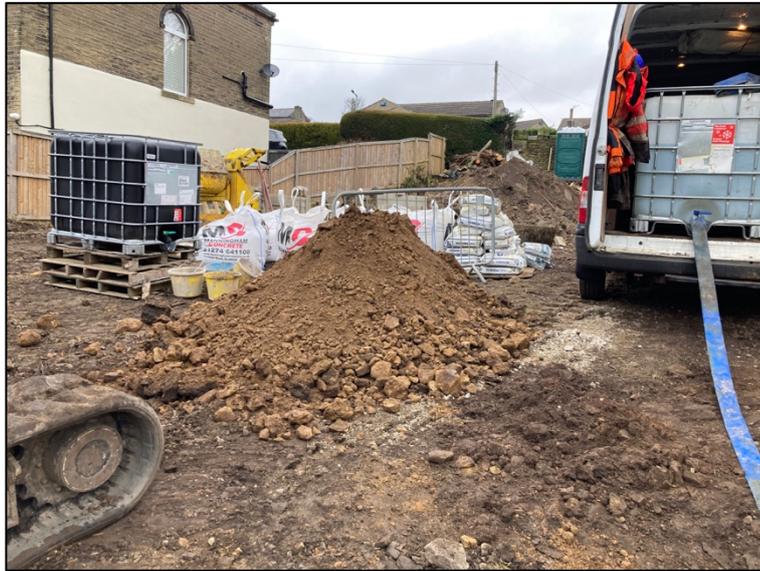
The Rough Rock sandstone is a coarse-grained feldspathic sandstone, cross-bedded. The weathered profile that develops is normally found to comprise sandy gravelly clay and clayey sand and gravel in the near surface.

View of soil arisings from TP1 – note weathered sandstone gravel and cobbles

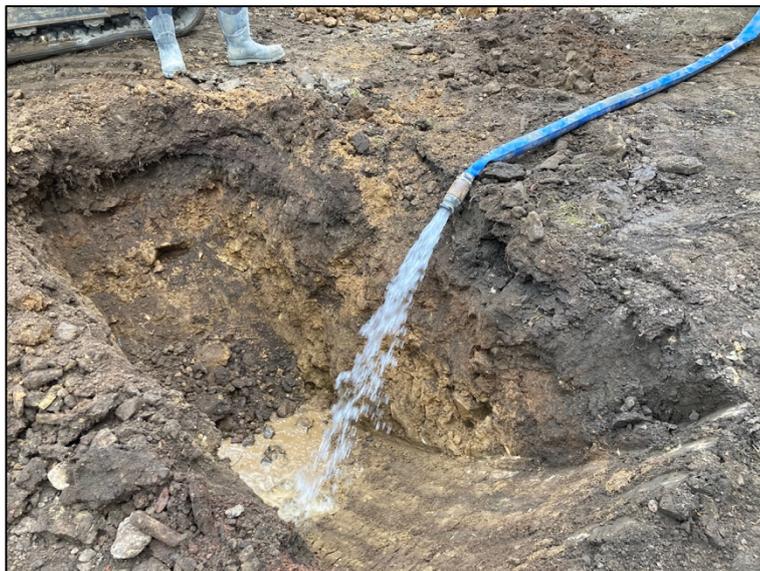
View of TP1 pit

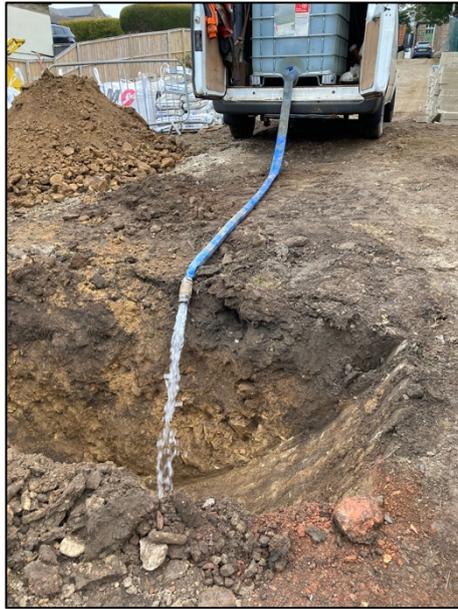
A water bowser had been filled with water and this was discharged to the pit. The water initially drained away faster than the pit could be filled and could not be filled higher than 0.5m above the base of the pit. Upon shutting the water off (after discharging 500L of water) the remaining water in the pit drained away completely within approximately 9 minutes. A selection of photos showing the site condition is included as appendix A.

Initial filling operations

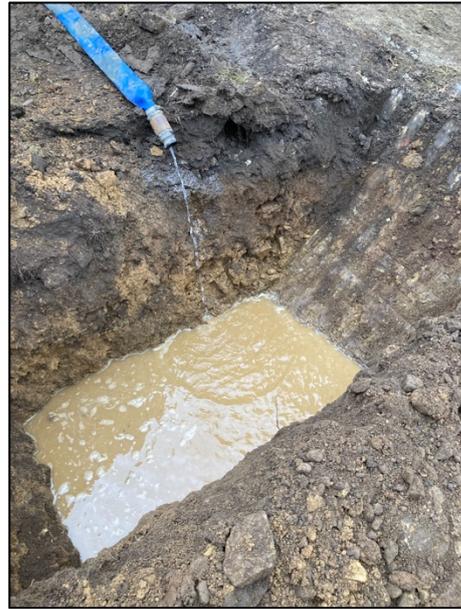
Soakaway test

It is considered the investigations have been able to confirm that the geology of the site is such that constructed soakaways should be suitable as positioned when excavated into the encountered weathered sandstone strata.

The soakaway test undertaken was not entirely compliant with Soakaway Design BRE Digest 365 (BRE 365) which provides the most recognised guidance and recommendations for testing methods. This was due to a number of site constraints, however, the inspection was considered sufficient to confirm, with consideration of the overall site setting, that the infiltration rate within the underlying sandstone strata is more than adequate.

A soil infiltration rate ( $f$ ) has not been calculated, however, for design purposes a conservative infiltration rate can be assumed as  $1 \times 10^{-4}$  m/s although in practice the secondary permeability controlled by fracture flow is likely to be closer to  $1 \times 10^{-3}$  m/s within sandstone strata. It is considered that further investigation is not necessary or cost effective. It is understood that the soakaway will be constructed at the rear of the property and is likely to be excavated at least 1.2m below formation level. It is recommended that the soakaway is extended parallel to the slope and set back from the site boundary with the woodland to avoid creating any slope instability (it is noted that existing land drainage discharged via a pipe into the wood previously).

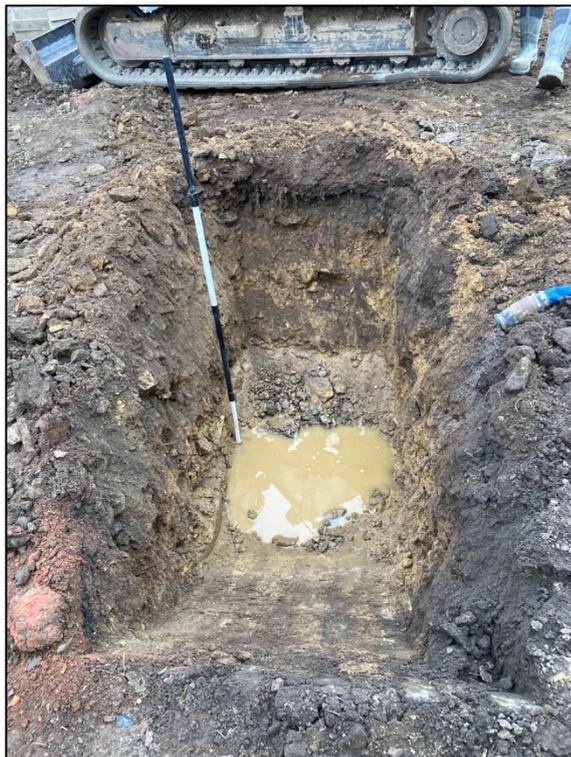
Test after approximately 8 minutes

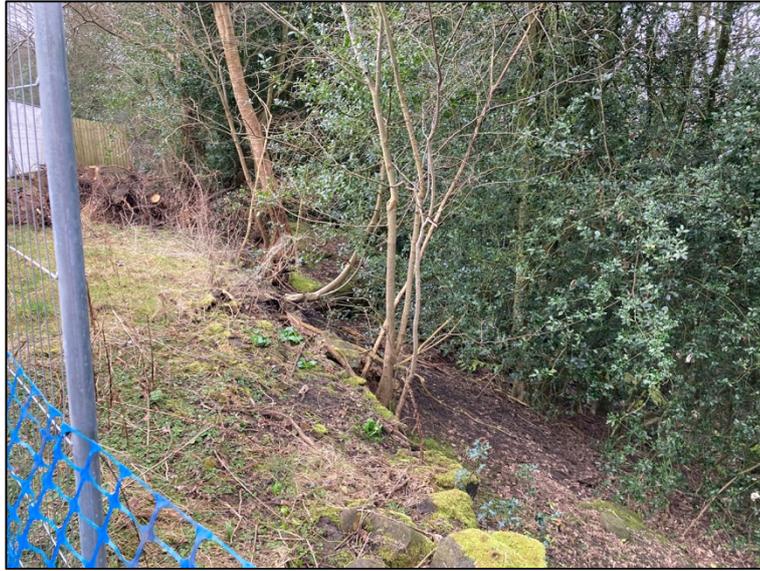
View of southern boundary showing slope condition

The quality of soakaway system and drainage construction will have a significant bearing on the systems performance. Adequate gradients should be provided for all drains so as not to create backfalls should any future ground movements take place.
