STRUCTURAL REPORT

PEARCES YARD

NEWTON POPPLEFORD, DEVON

PLANNING REPORT

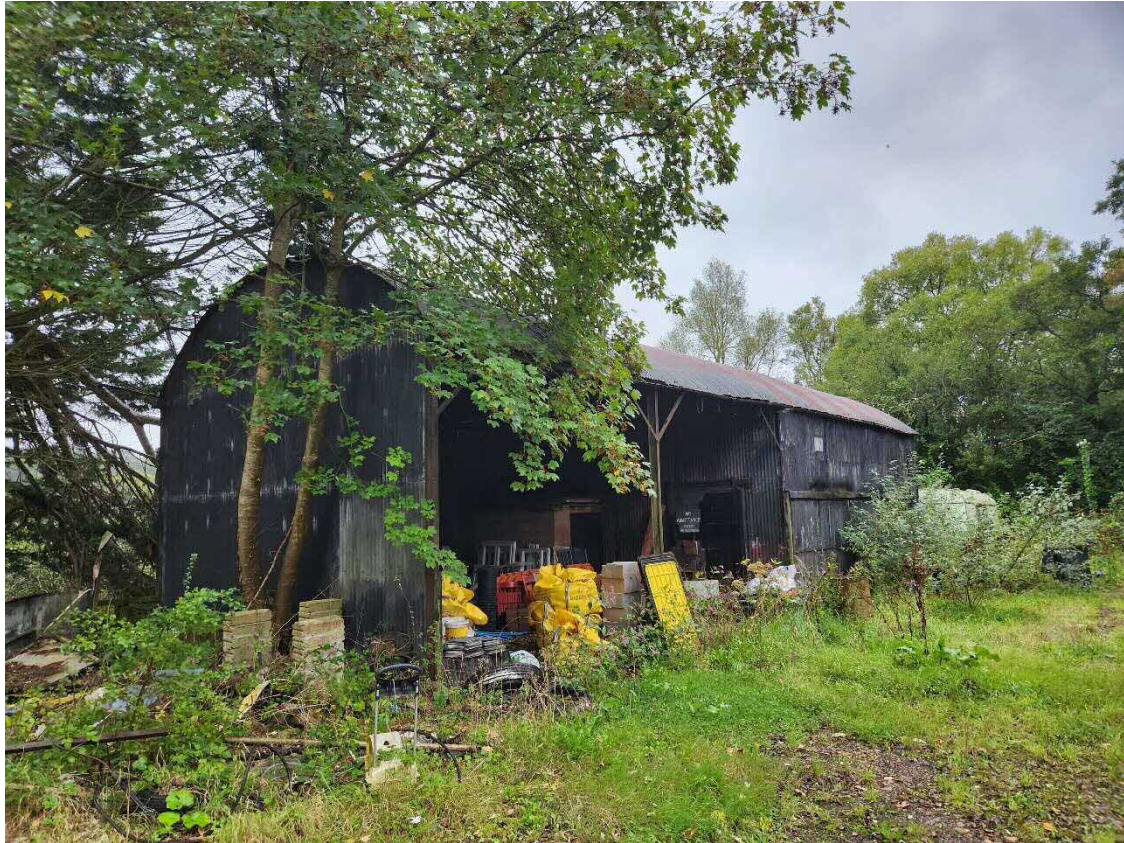
Above: North east gable elevation/north west side elevation.

The barn is rectangular; measuring approximately 18.5m x 7.5m on plan and 4.3m/5.8m to eaves and 'ridge' height respectively. The primary structure comprises of steel columns/trusses with corrugated profile fibre cement sheet walls supported on a series of angle section side rails. Similar angle section purlins support a corrugated profile single skin metal sheet roof, onto a 'scissor' truss type arrangement. It is configured in 4 equal bays, with 2 bays open on north western side. There is an internal gable that closes off half the building. Within the open covered area there is a small single storey single blockwork skin store and to the south west gable there appears to be single storey wooden enclosure. Note: Access to the south eastern/south western elevations of the building were restricted due to it being overgrown and the enclosed section of the building was locked and inaccessible.

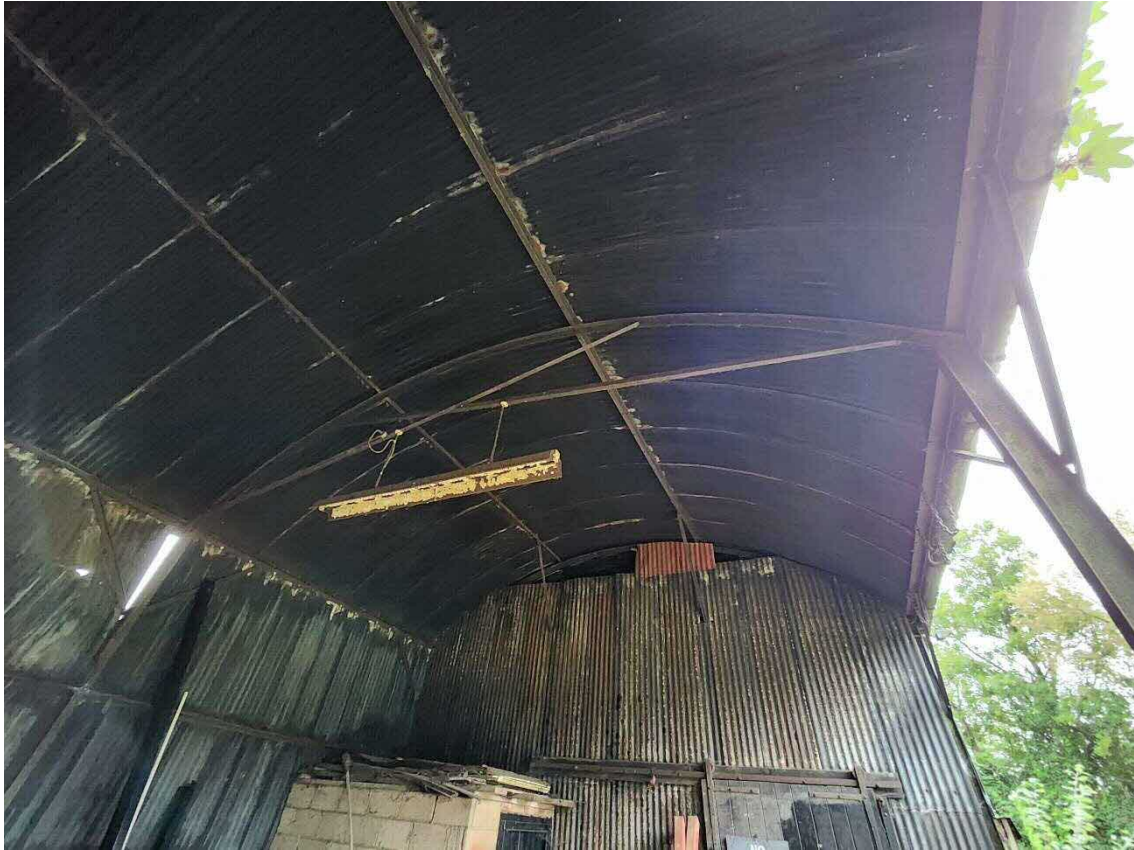
The current roof is a single skin corrugated profile metal sheet cladding. This is supported on angle section steel purlins, picked up onto truss/gable locations.

Above: Single skin corrugated profile metal sheeting roof supported on purlins/trusses/internal gable.

- The external roof covering appears at a point in its lifespan where maintenance is required. Suitable patch repairs should be undertaken where required and generally wire-brushed and treated to relevant specialist specification.
- The steelwork framing would be suitable to take vertical roof/wall loading, a further corrosion survey should be undertaken once the site is clear and steelwork remediated as required.
- The ground floor concrete slab will need further investigation to see if levels and make-up will be suitable for proposed conversion. Similar for existing pad foundations.

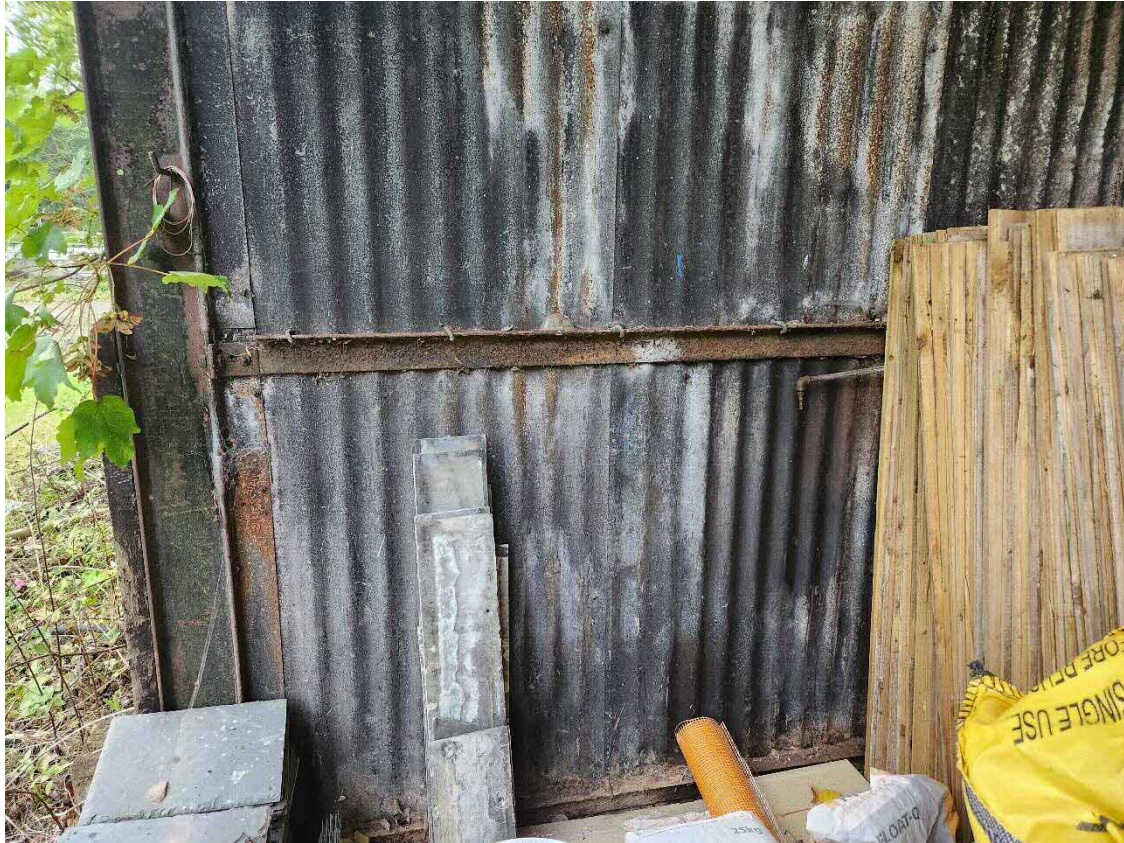
All elevations are constructed from corrugated profile fibre cement sheeting, fixed with hook-bolts to side rail metal angle sections sections. Similar to internal gable wall.

Above: Fibre cement corrugated profile sheeting fixed to angle section side rails.
