**Bridge End, Newton Poppleford**

**British Standard 5837:2012 Arboricultural Report**

20<sup>th</sup> February 2024

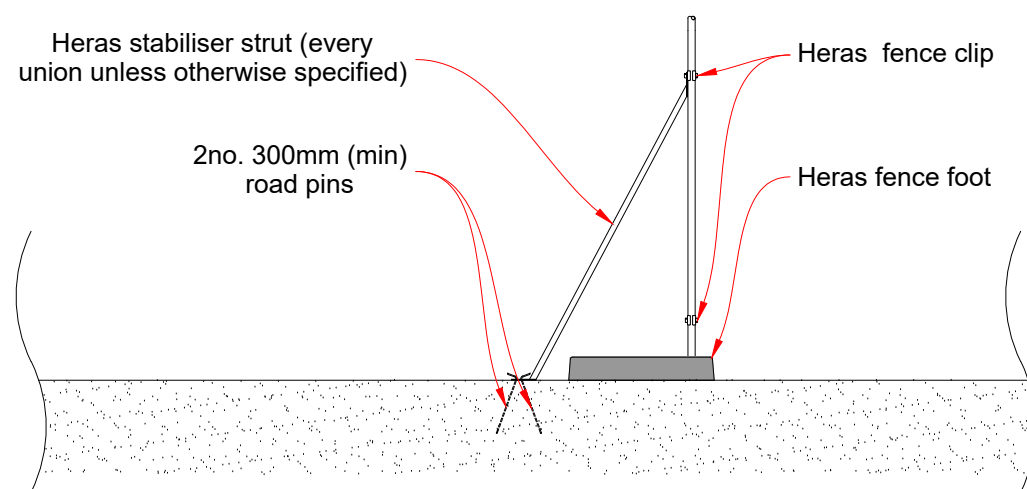
**Back Bracing Cross Section (for use where road pins may be driven into the ground)**

- Where it is not possible to use road pins due to hard surfacing or the presence of underground services, a Heras block tray may be used with a minimum of 10kg of ballast (concrete blocks, metal weights or sandbags).

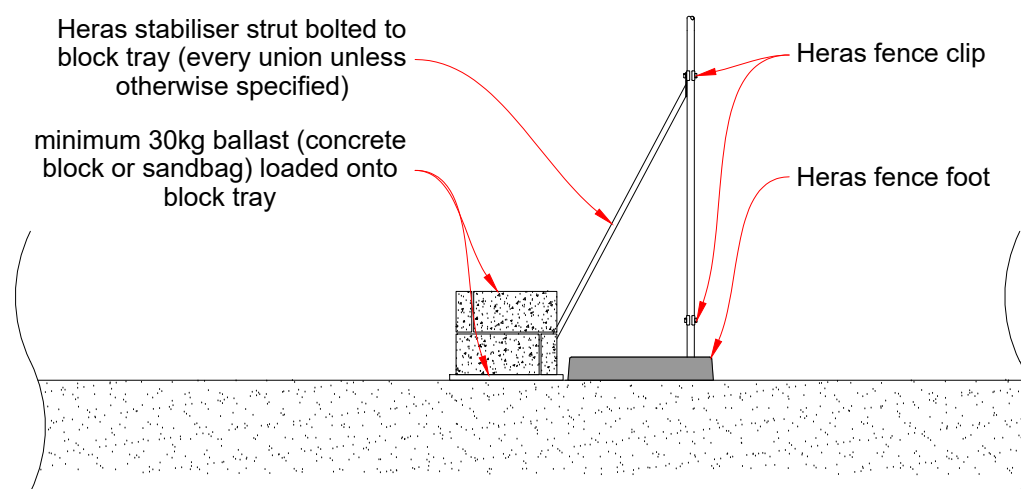
**Back Bracing Cross Section (for use where road pins cannot be driven into the ground)**

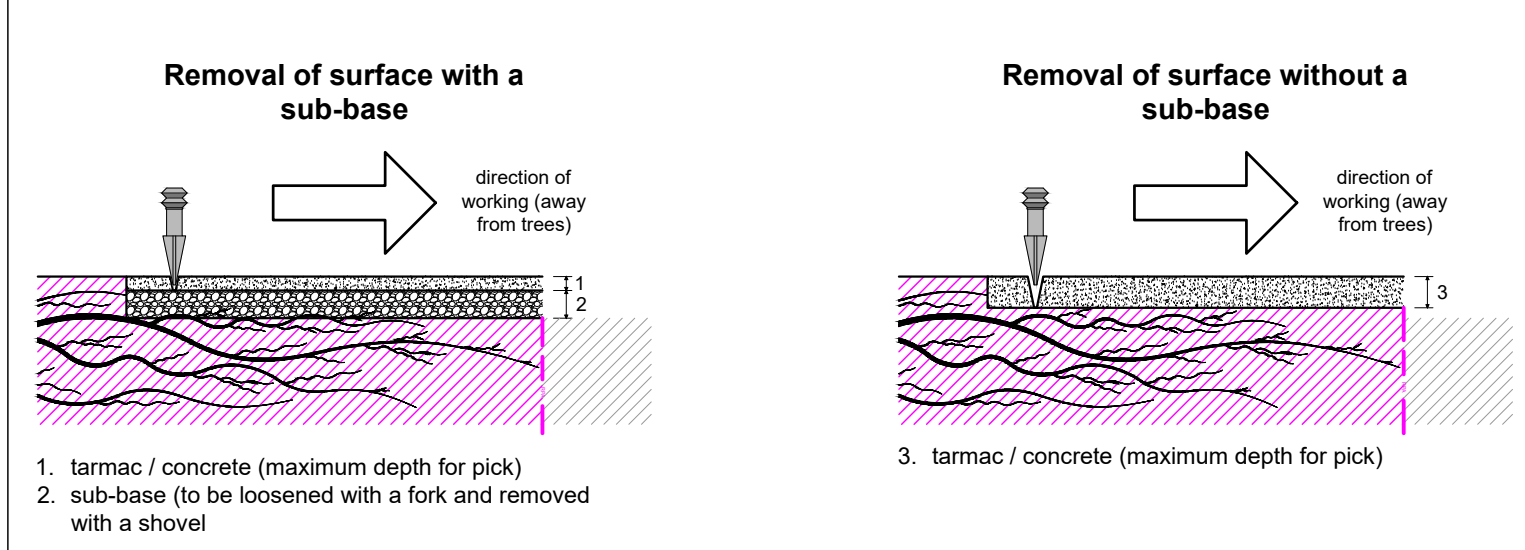
# Removal of Hard Surfaces Near Trees

1. tarmac / concrete (maximum depth for pick)
2. sub-base (to be loosened with a fork and removed with a shovel)

3. tarmac / concrete (maximum depth for pick)
