Outbuildings at Bec House, Ampport Road, Monxton, Andover, Hampshire SP11 8AH

A Heritage Statement

Project No: RHC 2023-23/01

Date: 19/02/2024

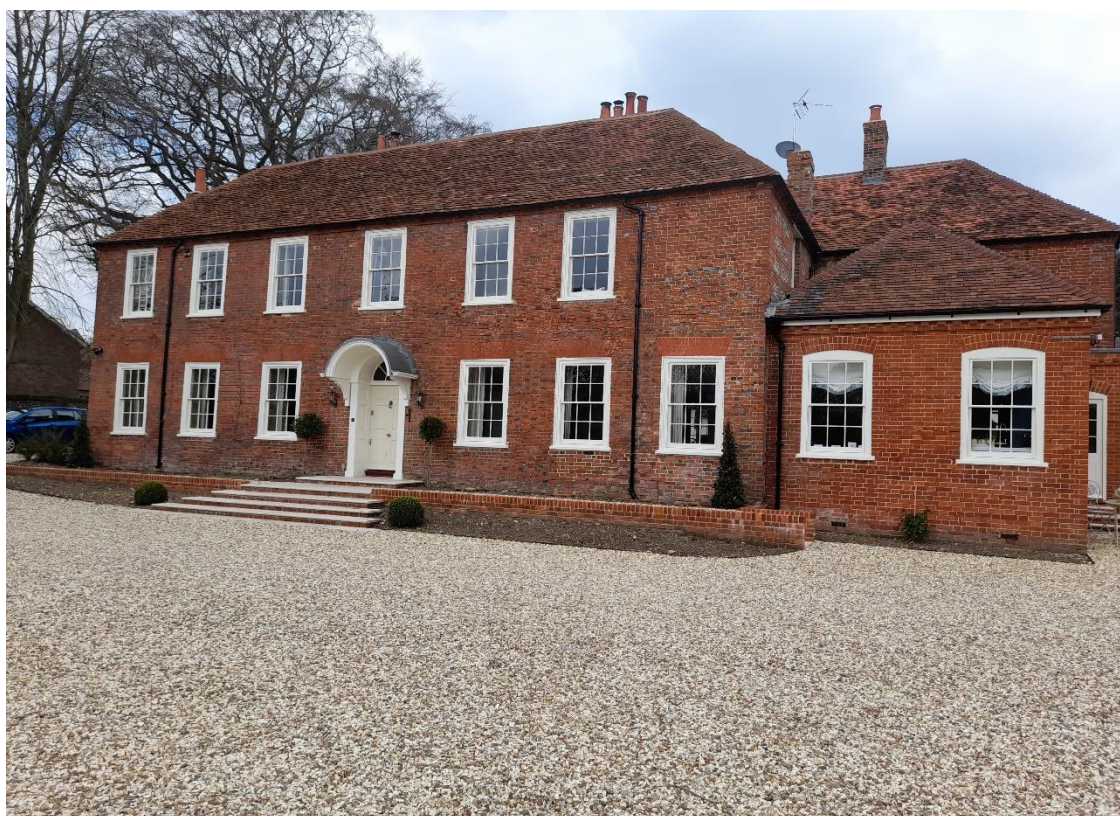
Fig. 5: The south, front elevation of Bec House, looking north-west.

4.2 The precise symmetry, regular fenestration and hipped roof of the front elevation all suggest a date not much later than 1750 (Fig. 5). The symmetry is partly disturbed by a small, single-storey addition to the right, which appears to be of modern date, and a projecting element of the rear range. The formal, polite character of the front elevation faces gardens and sloping ground running down to the Pilhill Brook. The rear elevation, by contrast, is of

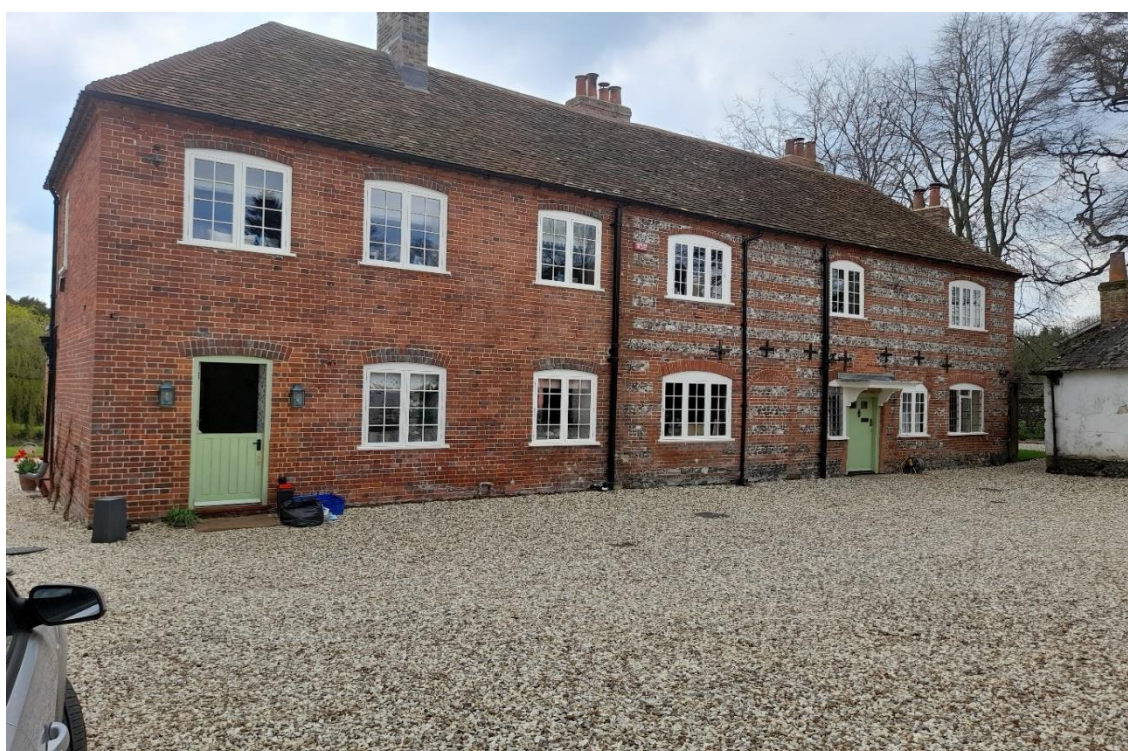
Fig. 6: The north, rear elevation of Bec House, looking south-west.

plainer, more domestic character, with camber-headed casements rather than sashes, and appears to comprise two distinct phases of construction (Fig. 6). The right-hand half of this elevation incorporates flint bands with brick dressings, while to the left, construction is of plain brick, laid in Flemish bond. There is a blocked round-headed opening to the right, possibly representing a former doorway. To the left, casement windows are of simpler form, and more closely spaced than those to the right (Fig. 6). The evidence suggests two principal phases of construction, with the flint-banded section to the right the earlier of the two. The plain brick phase to the left may be contemporary with the front elevation, and thus represent a major phase of expansion or reconstruction of the house, in *c.* 1750.

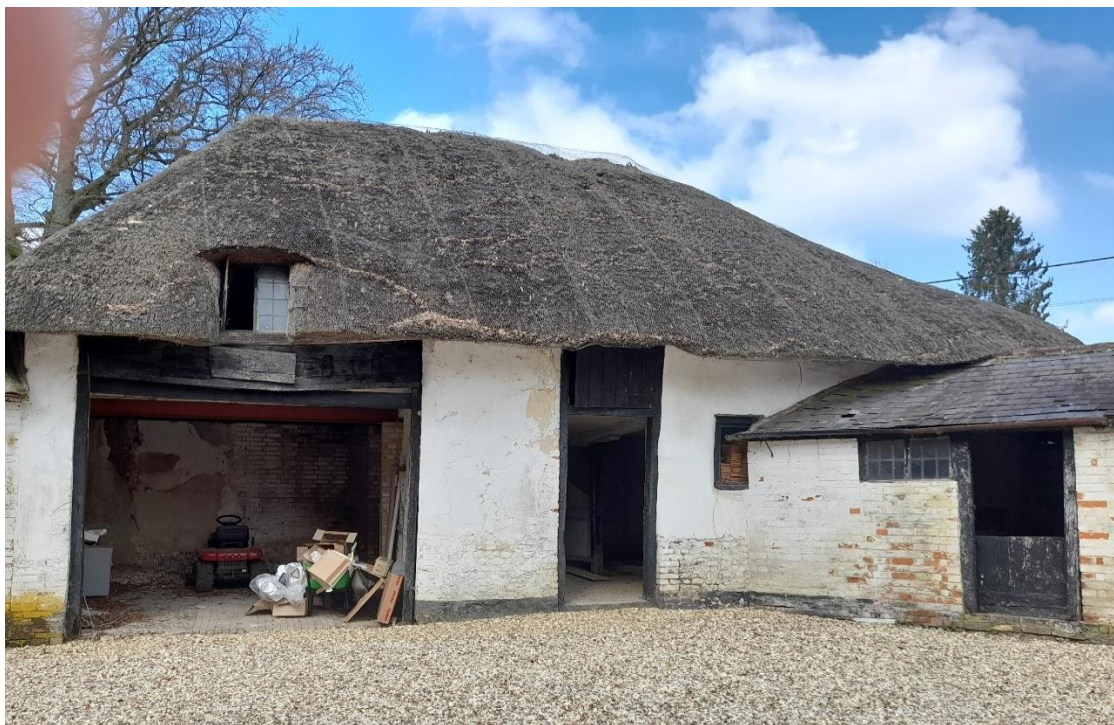
Fig. 11: The front elevation of the central coach house and stables, looking west.

4.8 To the right of the wide carriage entrance is a doorway to the adjoining low, ground-floor accommodation, with a loft above (Fig. 11). There is a two-leaf stable door, with an opening above, providing access to the loft. The intervening, timber-framed wall between the Coach House and adjoining stables was probably once external, as this comprises lapped boarding and extends up to the roof ridge. The roof over the stables is of common rafters, supported on surrounding cob walling. External walls are of white-painted cob, with areas of brick infill. Internally, an original timber partition survives, and partly supports a chamfered timber cross-beam, which is also supported at both ends by wall-posts of similar character (Figs. 14 and 15). The rear cob wall to the right retains an original covering of lime plaster. The original external walling of this building which is exposed within the interior of the later adjoining single-storey range displays flint-rubble construction which incorporates early brick (Fig. 16D). This suggests that elements of this building are considerably earlier than the nineteenth-century date offered by the listing description, and that a sixteenth or seventeenth-century origin is plausible (Fig. 28).

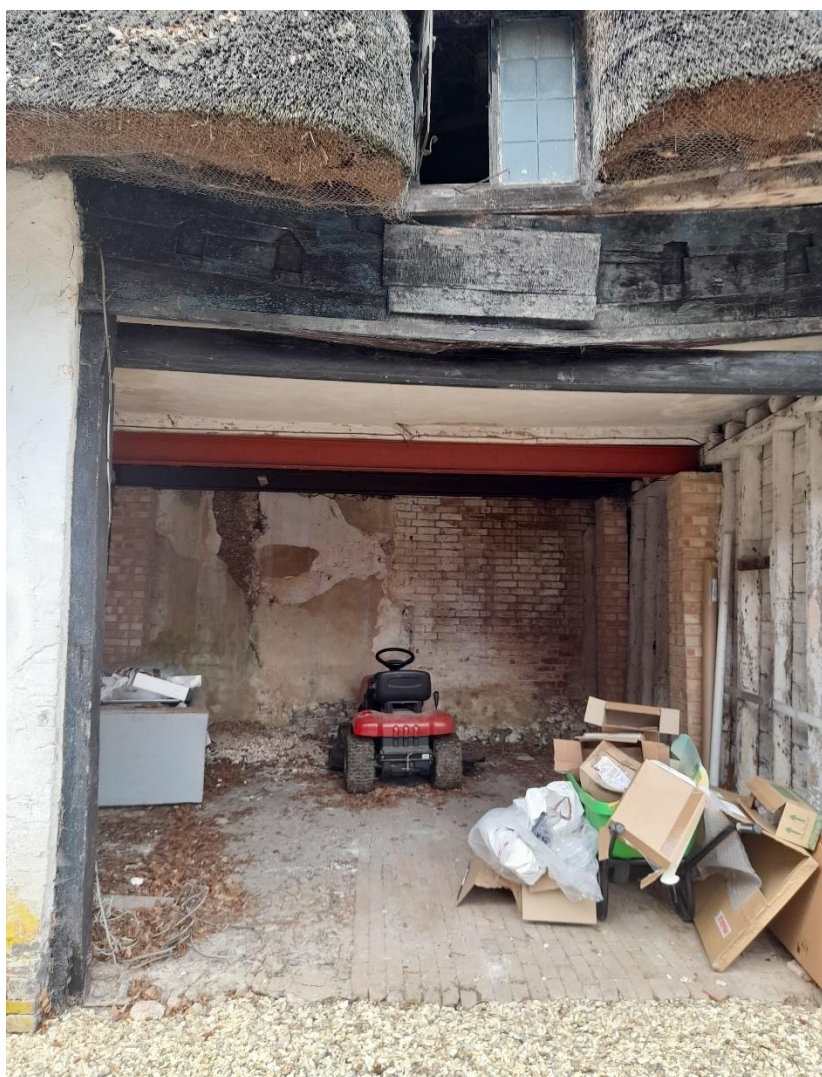
- 4.7 The full-height wooden doors which would have served this entrance have not survived. There is an original floor of brick. Timber wall studs, supporting horizontal boarding, are visible on the interior wall to the right (Fig. 16A), with timber box-framing with brick infill on the left-hand side (Fig. 16C). The rear wall retains decayed areas of original cob construction, much of which has been rebuilt in brick (Fig. 16B). The highly unstable ceiling and roof are now supported within the centre of the coach house by a steel beam, supported on modern brick piers (Fig. 13). The original roof-structure was without purlins or struts,

which were inserted later, to support a sagging roof structure. There is also no ceiling-tie to the rafters. The roof is pushing the cob walls outwards at eaves-level, resulting in an outward lean of walls and serious structural cracking. A number of later purlins and rafters have failed, due to increased load and decay due to water ingress.

Fig. 13: View, looking west, of the coach house entrance, with details of internal construction and recent repair.

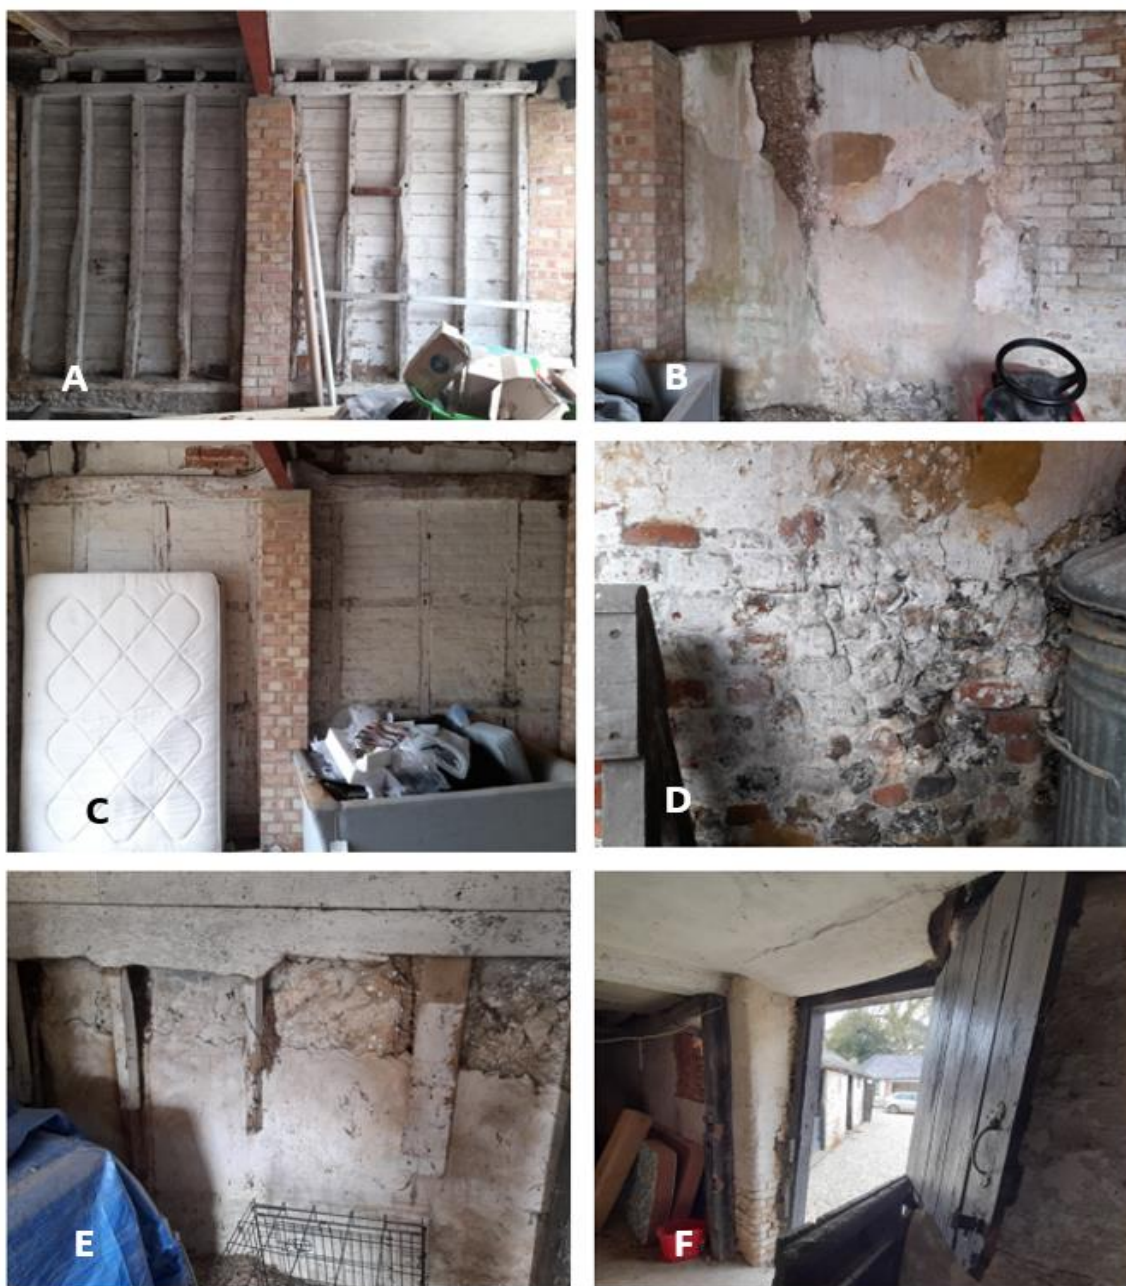
Fig. 16 A-F: Details of original fabric and construction within the central coach house.

5.2 The structural survey of the central Coach House has confirmed its unstable condition, and has recommended removal of its defective thatched roof to forestall the imminent collapse of the building (Nigel Challis Ltd 2024; Figs. 16 and 29). It has therefore been proposed to provide waterproof sheeting to prevent further water ingress, before removing the thatch and undertaking an inspection of decayed and defective elements of timber framing. It is proposed to repair and convert the central Coach House as residential accommodation (Figs. 32-35). This will require substantial initial repairs to the roof, and to the supporting cob wall to the rear. This would be repainted, where necessary, to match the existing.

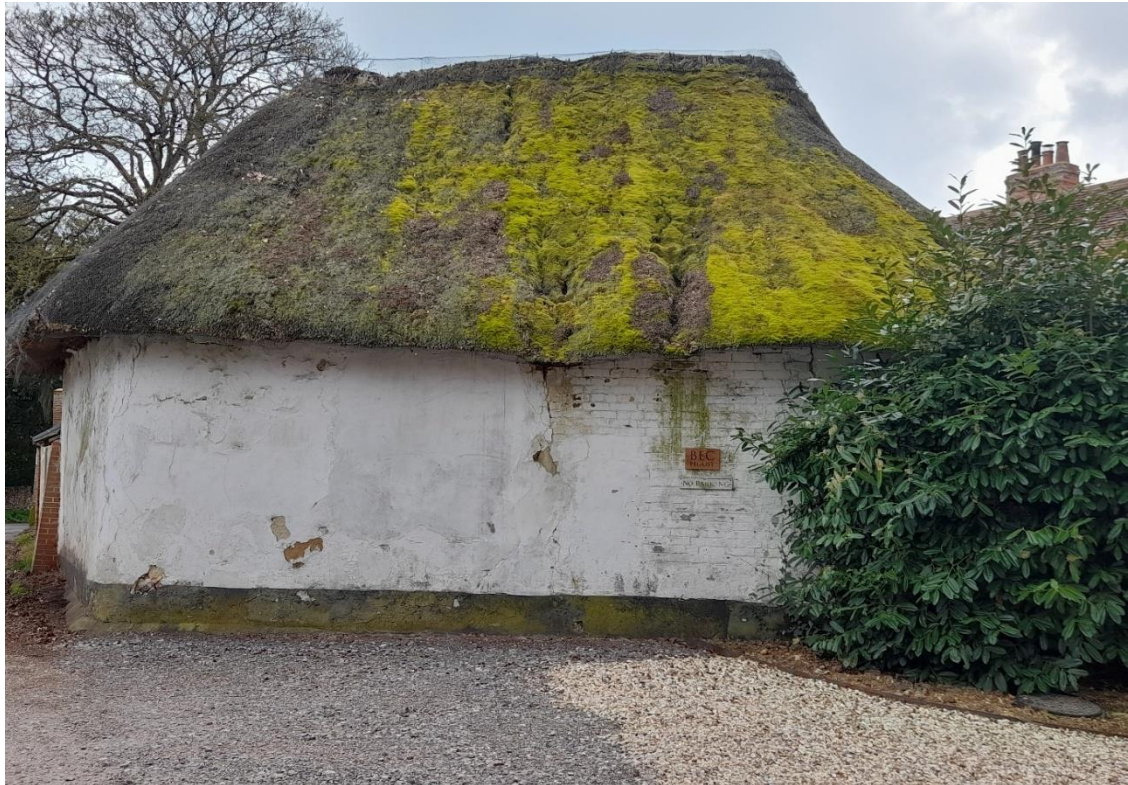
- 4.9 To the rear, the central coach house building presents a blank wall of painted cob construction, with areas of brick infill (Figs. 12 and 17). This immediately faces the entrance to Bec House, and it is evident that this building has been integral to the northern boundary of the property and to its principal entrance, from an early date. The thatched roof has deteriorated badly on this side, permitting water ingress to wall-tops and exposed fabric, and thus hastening the deterioration of underlying areas of cob construction (Fig. 17). Much of the observed internal instability of the coach house may result directly from this problem.

Fig. 17: View, looking east, of the rear elevation of the central coach house.

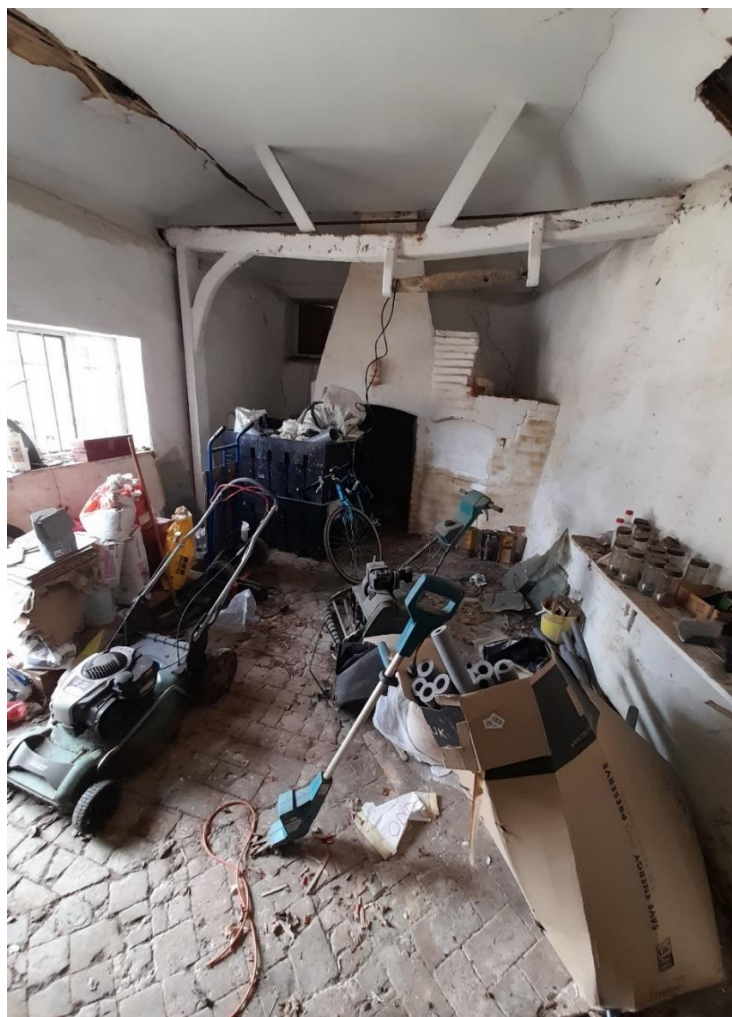
4.13 This small building also displays evidence of structural instability, particularly towards its northern end and its junction with the cob construction of the adjoining coach house. Here, there is clear evidence of structural movement and cracking of the lath and plaster ceiling (Figs. 19, 21A and 29). The building is of contrasting fabric to that of the adjoining Coach House, and appears to have been built as a modest lean-to construction against the earlier building to the right, and the pre-existing cob wall to the rear (Fig. 27A). There is evidence of sagging of trusses and dropping of roof purlins, with consequent outward movement of walls, particularly on the outer, north-western side, where the instability of the cob wall is exacerbated by that of the adjoining Coach House. An iron tie-rod has been inserted at some stage, to arrest roof-spread. This is a small, functional building, which otherwise displays remarkable levels of internal and external preservation, including a number of unusual features such as the forge/bread oven. It represents an addition of probable mid to late eighteenth-century date, which is of considerable historic interest.

Fig. 20: Looking south within the small, single-storey building, with details of internal construction, and the brick forge/bread oven to the rear.

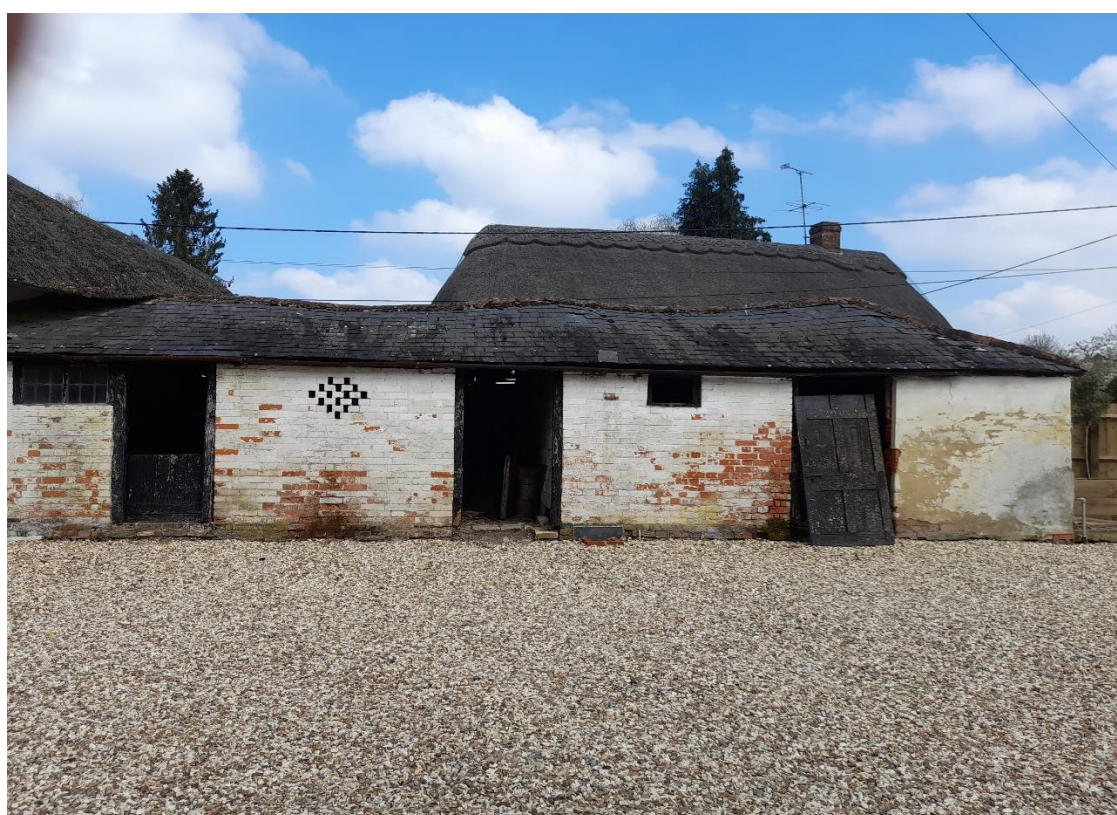
Fig. 23: View, looking north, of the eastern single-storey range, comprising stabling.

4.14 Like the small, single-storey building on the south side, the eastern range comprises a later addition to the central coach house and stables (Front cover and Figs. 10, 12, 23 and 28). This is a low, single-storey building, with a hipped slate roof, and of painted brick construction, laid in Flemish bond, on its southern, courtyard side. This side has three wooden doors of identical pattern, which provide entry to individual spaces defined by internal wooden partitions. This building was evidently intended to provide further stabling accommodation. The central door has an adjoining small timber-framed casement window, and there is another small window at eaves-level between the middle and eastern doors (Figs. 12 and 23).

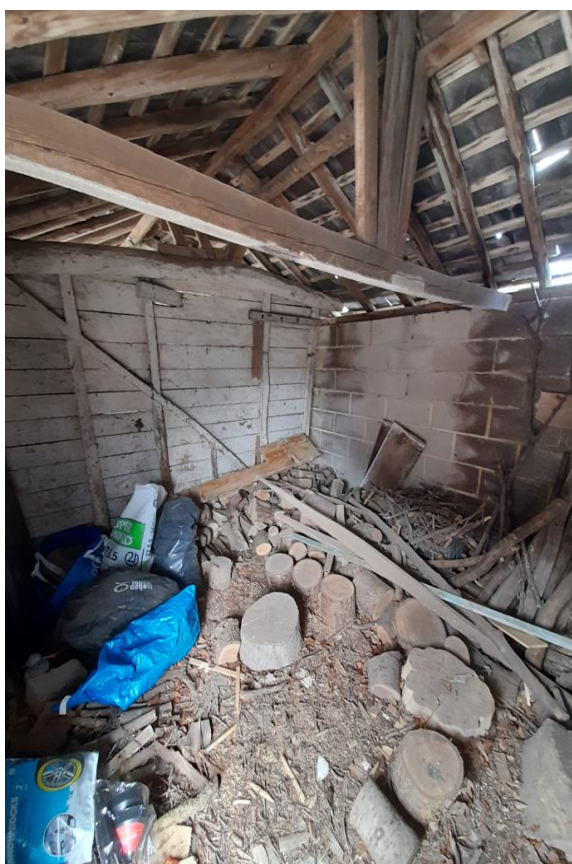
Fig. 24: Looking north-west within an interior space within the eastern single-storey range, with details of roof construction and timber partition.

4.15 Internally, the slate roof is supported by small-quarter queen-post trusses, with steeply-angled struts supporting purlins and ridge-beam (Fig. 24). These support half-round pole rafters, some of which are badly affected by woodworm. It would appear that sawn ridge-boards and purlins have been inserted at a later date. The well-preserved internal partitions comprise horizontal boarding, supported by wall studs (Figs. 24 and 25). The rear wall

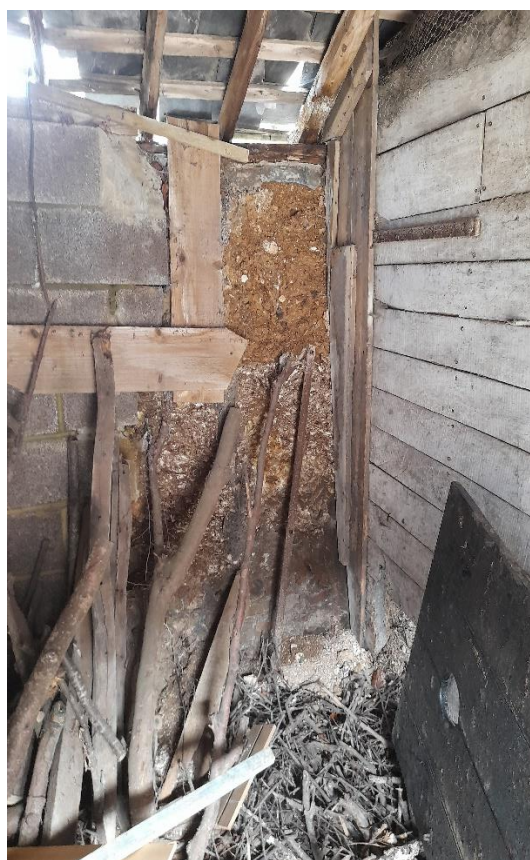
Fig. 25: Looking north within the interior of the eastern range, with cob and concrete block construction of the rear wall.

includes areas of cob construction, which presumably originally formed the roadside boundary wall of the property. This has been replaced in a number of places by modern concrete block and brick construction, and has clearly been subject to long-term decay (Fig. 25). The floor of this range comprises flint cobbles, with inset clunch or limestone slabs at door thresholds (Fig. 26). The character of this flooring suggests that it may predate the building itself, and that this may therefore have been constructed within an earlier footprint.

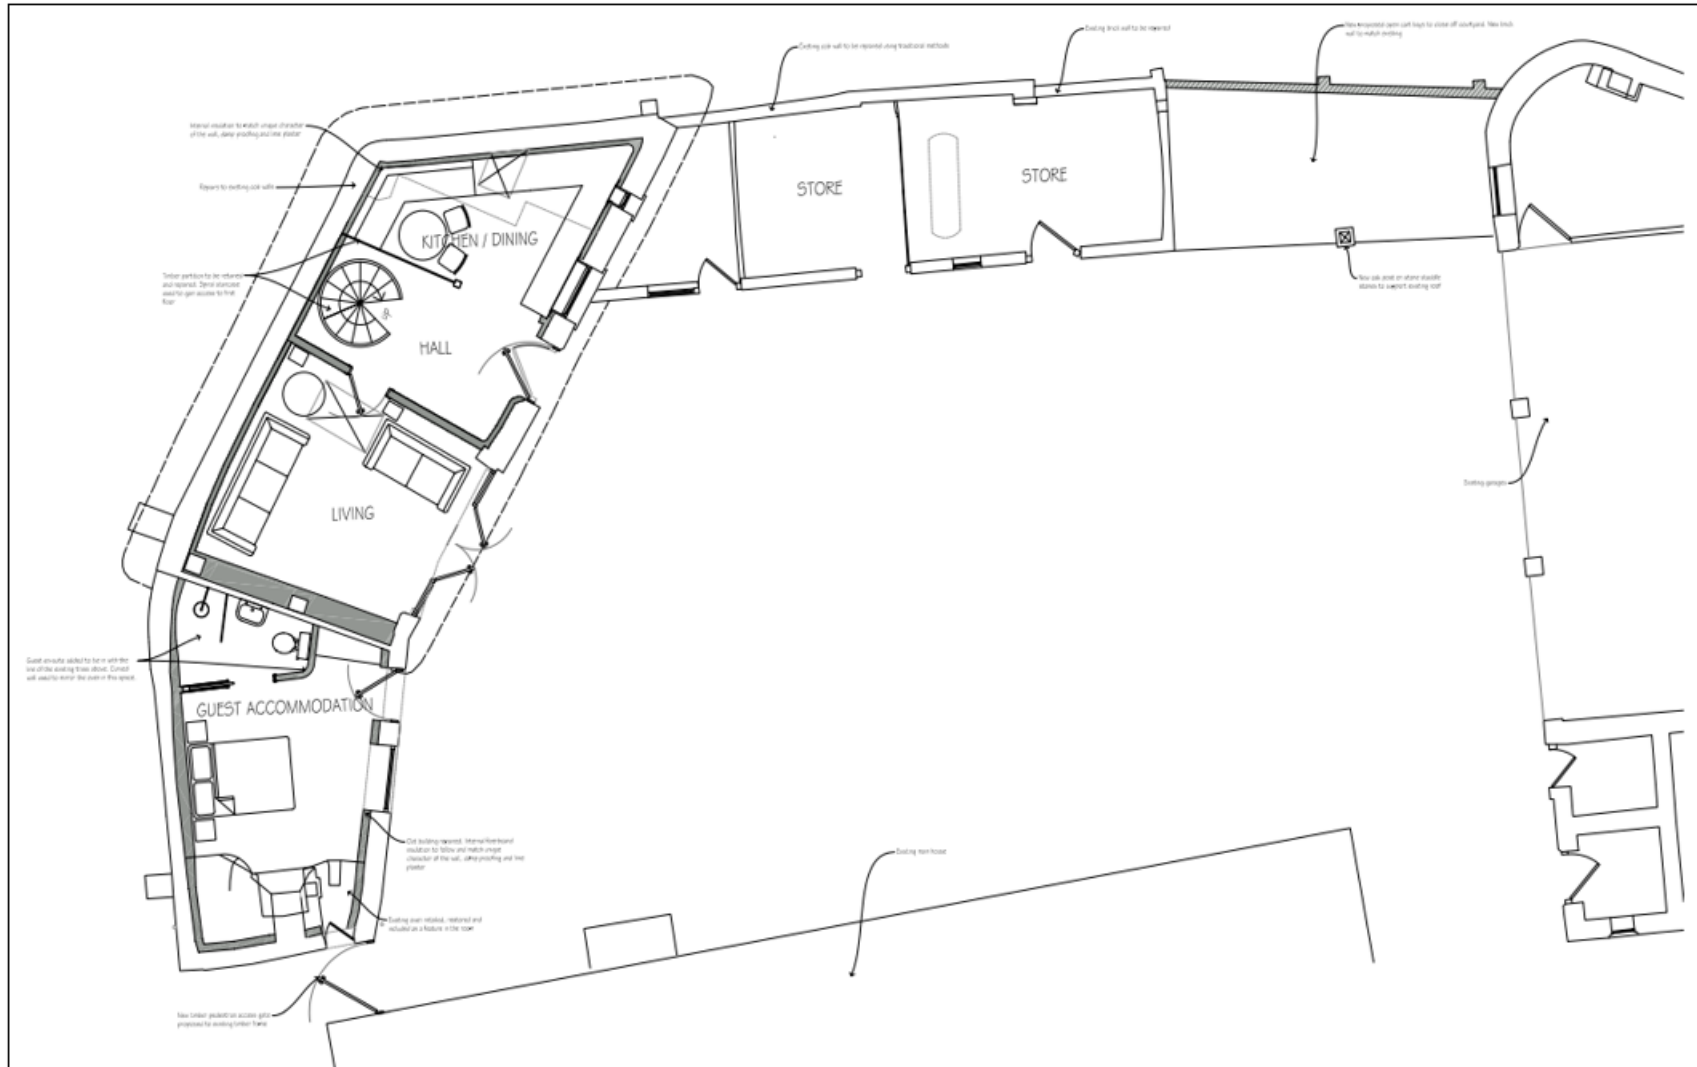
Fig. 32: Proposed ground-floor plan of the outbuildings at Bec House (Fowler Architecture and Planning).

5.3 The ground-floor of the Coach House would be converted to a living-room space, with the wide carriage entrance on the south-eastern side infilled with Crittall-type, metal-framed fully glazed double doors, with glazed side-lights (Fig. 34). The adjoining ground-floor accommodation with stable partition, on the north-eastern side, would be converted to a hallway and an adjoining kitchen/dining space. This arrangement would enable the retention and repair of existing historic timber partitions in this space. The hallway, to be accessed through an existing doorway opening on the south-eastern side, would incorporate a spiral staircase, providing access to the first-floor (Fig. 32). A new internal doorway opening would be created between the former Coach House and the adjoining ground-floor accommodation with stable partition, immediately to the north-east. All internal walls within the central Coach House building would be lined with insulation and damp-proofing, with a surface of lime plaster to match the existing character of the walls.

- 5.4 At first-floor level, the central Coach House building would be converted to a bathroom on the north-eastern side, with a guest bedroom on the south-western, each room to be accessed off a small central landing leading off the spiral staircase (Fig. 33). A new dormer, with timber-framed casement, would be inserted towards the northern end of the south-east elevation, which would serve the proposed bathroom, and match the existing dormer to the left (Figs. 33 and 34). The existing dormer on this elevation would be retained, and a new timber casement window installed, to match the existing. A new timber door, of appropriate historic pattern would replace the existing stables door on the south-east elevation (Figs. 32 and 34).
