### Geotechnical Testing Analysis Report

# Site Investigation Report

## Job Information

Auger were commissioned by Crawford & Co to undertake a site investigation and CCTV inspection of the underground drainage within the area of concern (AOC) at the property.

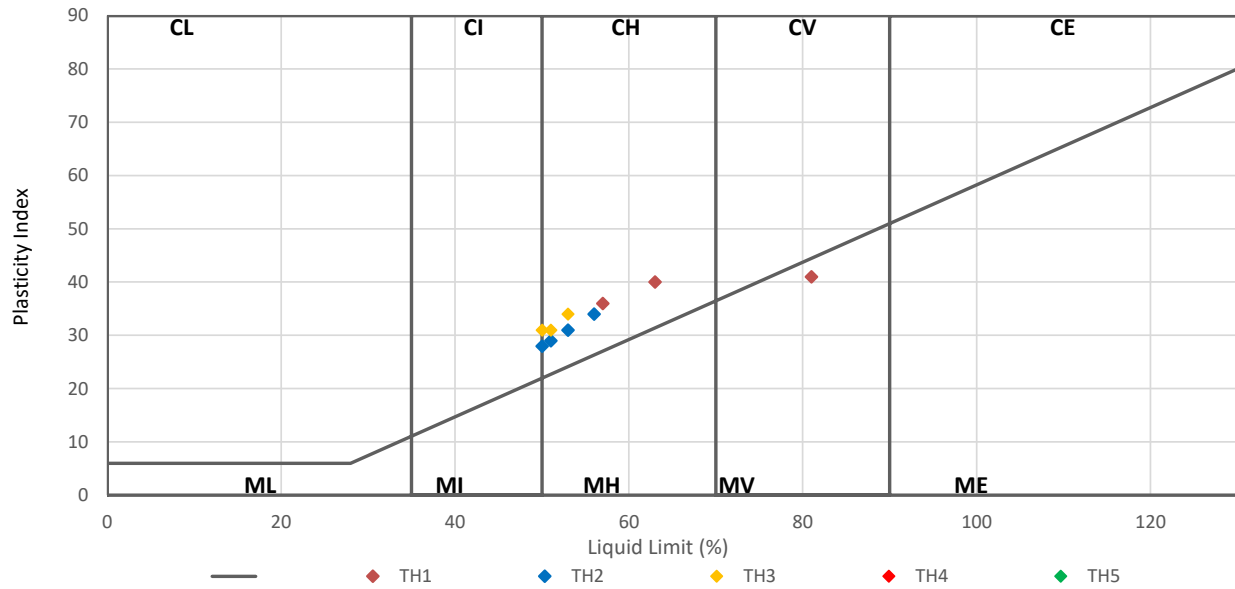
PLASTICITY CHART FOR CASAGRANDE CLASSIFICATION  
BS 5930:1999+A2:2010

TH Trial Hole	Sample Type	Depth (m)	Moisture Content %	Liquid Limit %	Plastic Limit %	Plasticity index %	Passing .425mm %	NHBC Chapter 4.2	Remarks
TH1	D	0.80	61	81	40	41	92	HIGH VCP	MV Very High Plasticity
TH1	D	1.30	35						
TH1	D	1.80	33	63	23	40	93	MEDIUM VCP	CH High Plasticity
TH1	D	2.30	26						
TH1	D	2.80	30	57	21	36	90	MEDIUM VCP	CH High Plasticity
TH2	D	0.40	22	56	22	34	90	MEDIUM VCP	CH High Plasticity
TH2	D	0.90	24						
TH2	D	1.40	23	51	22	29	94	MEDIUM VCP	CH High Plasticity
TH2	D	1.90	22						
TH2	D	2.40	23	50	22	28	94	MEDIUM VCP	Cl/H Inter/High Plasticity
TH2	D	2.90	25	53	22	31	90	MEDIUM VCP	CH High Plasticity
TH3	D	1.20	22	51	20	31	86	MEDIUM VCP	CH High Plasticity
TH3	D	1.70	23						
TH3	D	2.20	20	53	19	34	82	MEDIUM VCP	CH High Plasticity
TH3	D	2.70	21	50	19	31	82	MEDIUM VCP	Cl/H Inter/High Plasticity

Modified Plasticity Index (PI) <10 : Non Classified  
 Modified PI = 10 to <20 : Low volume change potential (LOW VCP)  
 Modified PI = 20 to <40 : Medium volume change potential (Med VCP)  
 Modified PI = 40 or greater : High volume change potential (HIGH VCP)

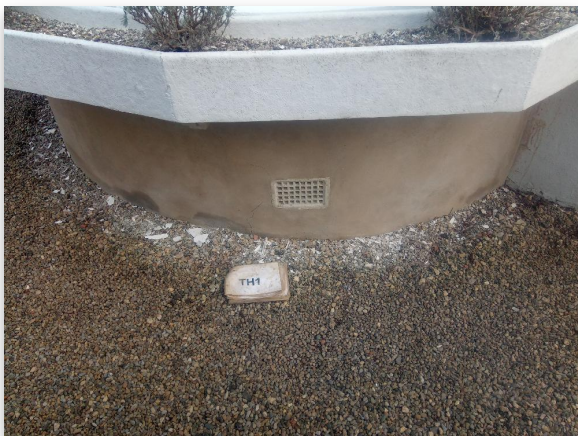
Fig 1.1: Trial Hole 1 Location

TH1 and TH2 were all completed in the proposed location and revealed the footing. Soil and root samples were taken.

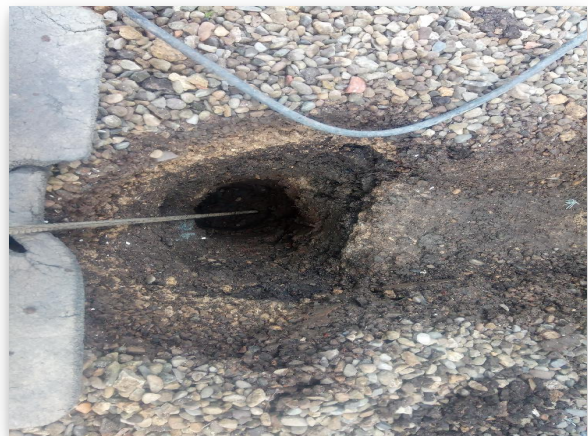
Fig 1.2: Trial Hole 1 Footing

Depth (m)	Symbolic Log	Strata Description	Insitu Tests		Soil Sample	Root Sample
			SV(19)			
0.0	<p>800mm</p> <p>Ground Level</p> <p>Gravel</p> <p>Brickwork</p> <p>Concrete</p>					
0.5						
1.0		Moist very stiff Brown (organic) fine to medium gravelly clayey SILT	82kpa		Soil @ 0.8m	Root @ 0.8m
1.5		Moist Very Stiff Brown fine to medium gravelly silty CLAY	96kpa		Soil @ 1.3m	Root @ 1.3m
2.0			110kpa		Soil @ 1.8m	
2.5			108kpa		Soil @ 2.3m	
3.0			90kpa		Soil @ 2.8m	
3.5		TRIAL HOLE TERMINATED	90kpa

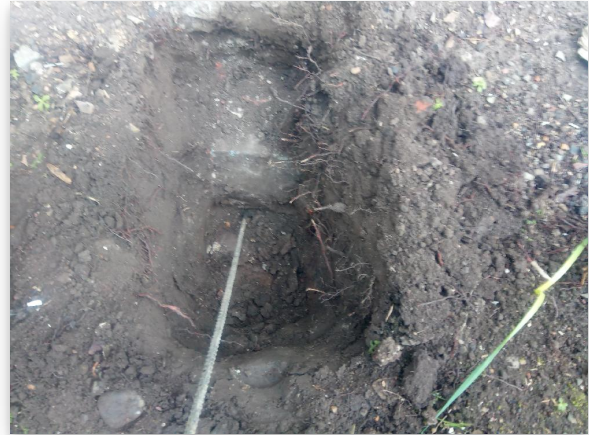
Fig 2.2: Trial Hole 2 Footing

Depth (m)	Symbolic Log	Strata Description	Insitu Tests		Soil Sample	Root Sample	
			SV(19)				
0.0		Ground Level Rendered Masonry Soil (Border) Concrete Moist very stiff Brown fine to medium gravelly silty CLAY					
0.5			104kpa		Soil @ 0.4m	Root @ 0.4m	
1.0			110kpa		Soil @ 0.9m	Root @ 0.9m	
1.5			122kpa		Soil @ 1.4m	Root @ 1.4m	
2.0			118kpa		Soil @ 1.9m		
2.5			104kpa		Soil @ 2.4m		
3.0			100kpa		Soil @ 2.9m		
3.5			100kpa	TRIAL HOLE TERMINATED

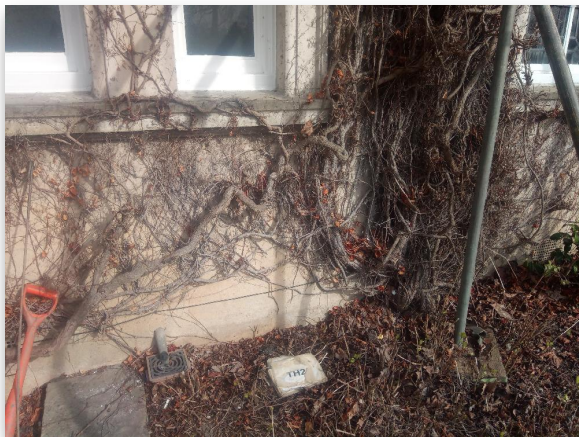
Fig 3.1: Trial Hole 3 Location

The underside of TH3s footing could not be determined. The footing was probed to 1.2m and is believed to continue past this point. Soil and root samples were taken from 1.2m. If deemed necessary Auger may return with 2 men for a full day to attempt a deep trial hole to fully expose the footings.

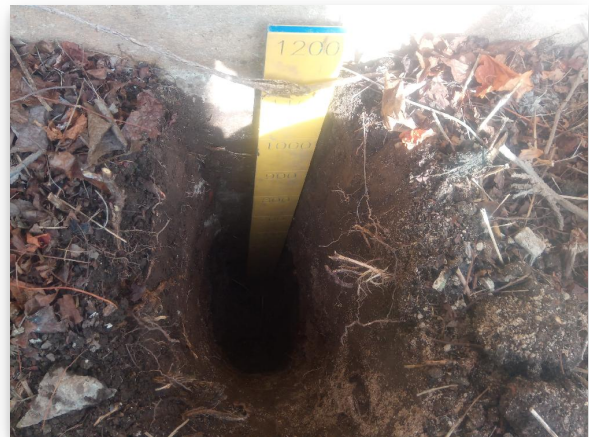
Fig 3.2: Trial Hole 3 Footing

Depth (m)	Symbolic Log	Strata Description	Insitu Tests		Soil Sample	Root Sample		
			SV(19)					
0.0		Moist stiff Brown slightly sandy fine to medium gravelly silty CLAY	58kpa		Soil @ 1.2m	Root @ 1.2m		
0.5								
1.0								
1.5					60kpa		Soil @ 1.7m	
2.0					54kpa		Soil @ 2.2m	
2.5					52kpa		Soil @ 2.7m	
3.0								
3.5				TRIAL HOLE TERMINATED	52kpa

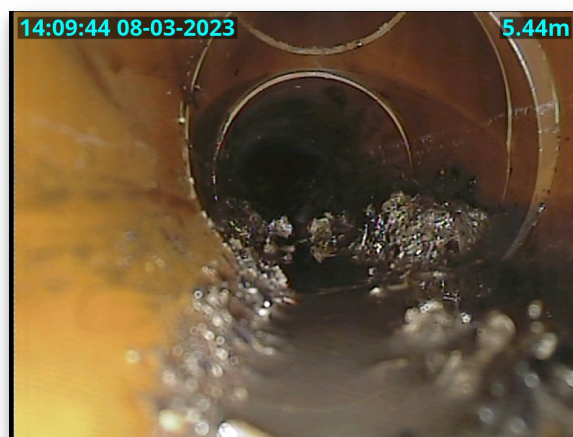
Fig 4.1: Plastic Pipework

Our survey of lines 1-7 revealed no significant defects that could lead to an escape of water within the area of concern. All pipework was noted to be PVC.

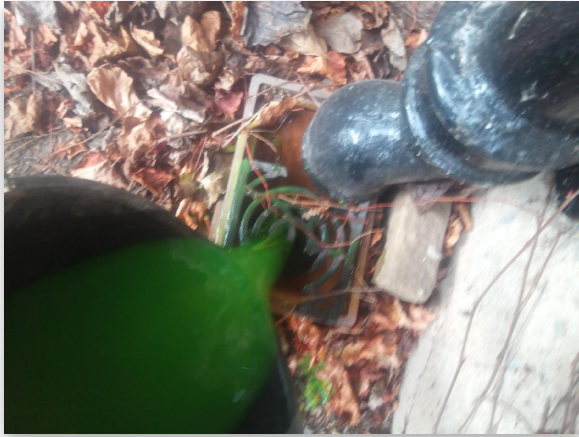
Fig 5.1: Dye Testing

Dye testing was undertaken with green dye, this did not reveal an escape of water.

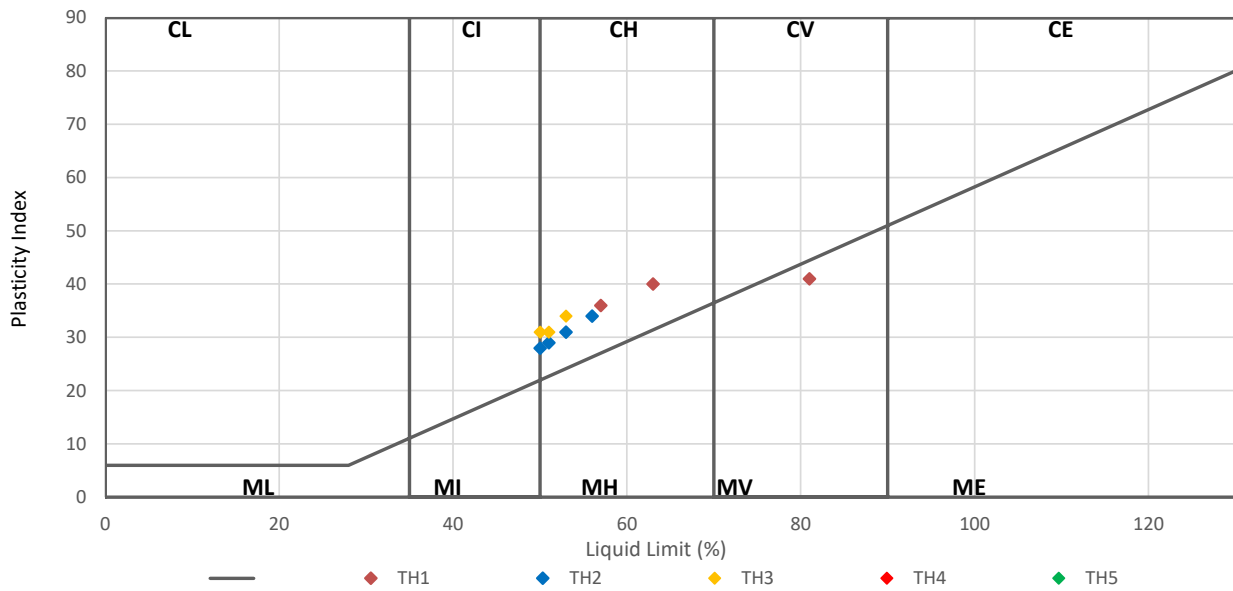
PLASTICITY CHART FOR CASAGRANDE CLASSIFICATION  
BS 5930:1999+A2:2010

TH Trial Hole	Sample Type	Depth (m)	Moisture Content %	Liquid Limit %	Plastic Limit %	Plasticity index %	Passing .425mm %	NHBC Chapter 4.2	Remarks
TH1	D	0.80	61	81	40	41	92	HIGH VCP	MV Very High Plasticity
TH1	D	1.30	35						
TH1	D	1.80	33	63	23	40	93	MEDIUM VCP	CH High Plasticity
TH1	D	2.30	26						
TH1	D	2.80	30	57	21	36	90	MEDIUM VCP	CH High Plasticity
TH2	D	0.40	22	56	22	34	90	MEDIUM VCP	CH High Plasticity
TH2	D	0.90	24						
TH2	D	1.40	23	51	22	29	94	MEDIUM VCP	CH High Plasticity
TH2	D	1.90	22						
TH2	D	2.40	23	50	22	28	94	MEDIUM VCP	CI/H Inter/High Plasticity
TH2	D	2.90	25	53	22	31	90	MEDIUM VCP	CH High Plasticity
TH3	D	1.20	22	51	20	31	86	MEDIUM VCP	CH High Plasticity
TH3	D	1.70	23						
TH3	D	2.20	20	53	19	34	82	MEDIUM VCP	CH High Plasticity
TH3	D	2.70	21	50	19	31	82	MEDIUM VCP	CI/H Inter/High Plasticity

Modified Plasticity Index (PI) <10	: Non Classified
Modified PI = 10 to <20	: Low volume change potential (LOW VCP)
Modified PI = 20 to <40	: Medium volume change potential (Med VCP)
Modified PI = 40 or greater	: High volume change potential (HIGH VCP)
