PHASE 2 REPORT ON A SITE INVESTIGATION

**FRIARS GARTH,
THE PARADE, EPSOM,
SURREY KT18 5DH**

WELDIN BUILDERS LTD

22/12385/KJC REV 1

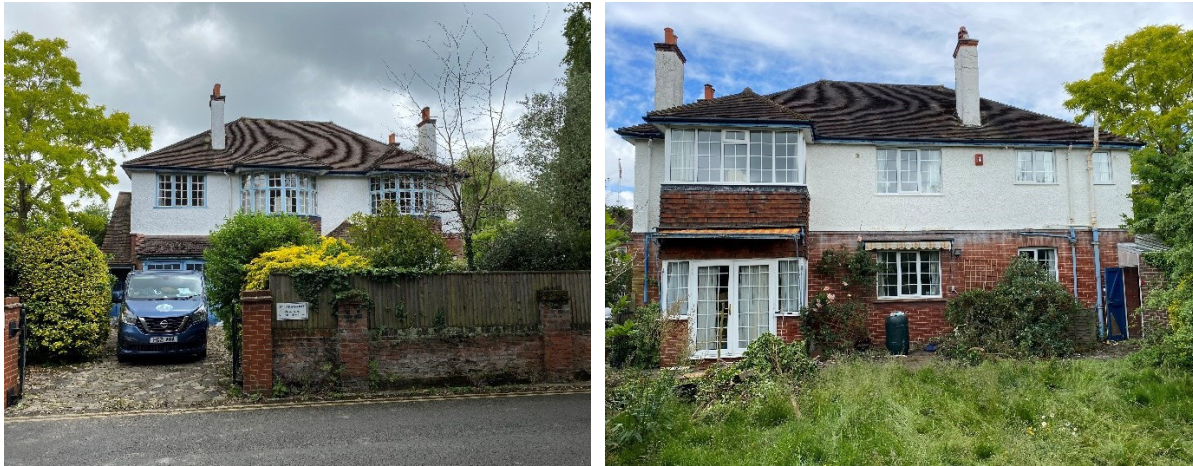
Photographs which give a general impression of the site at the time of the fieldworks are included below.

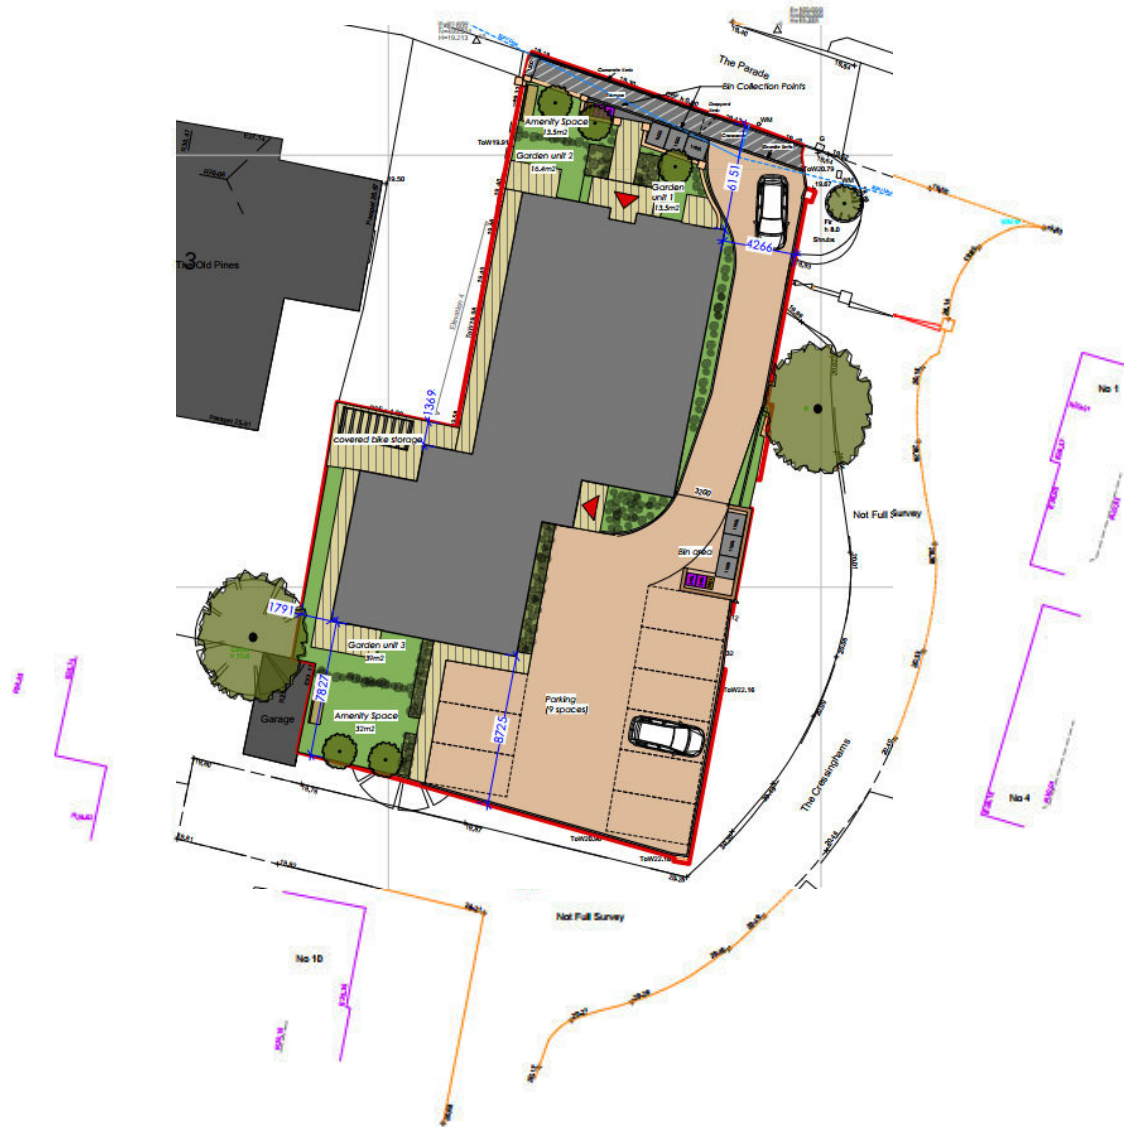
FIGURE 2

PROPOSED LAYOUT

Dwg No: 22/12385/2

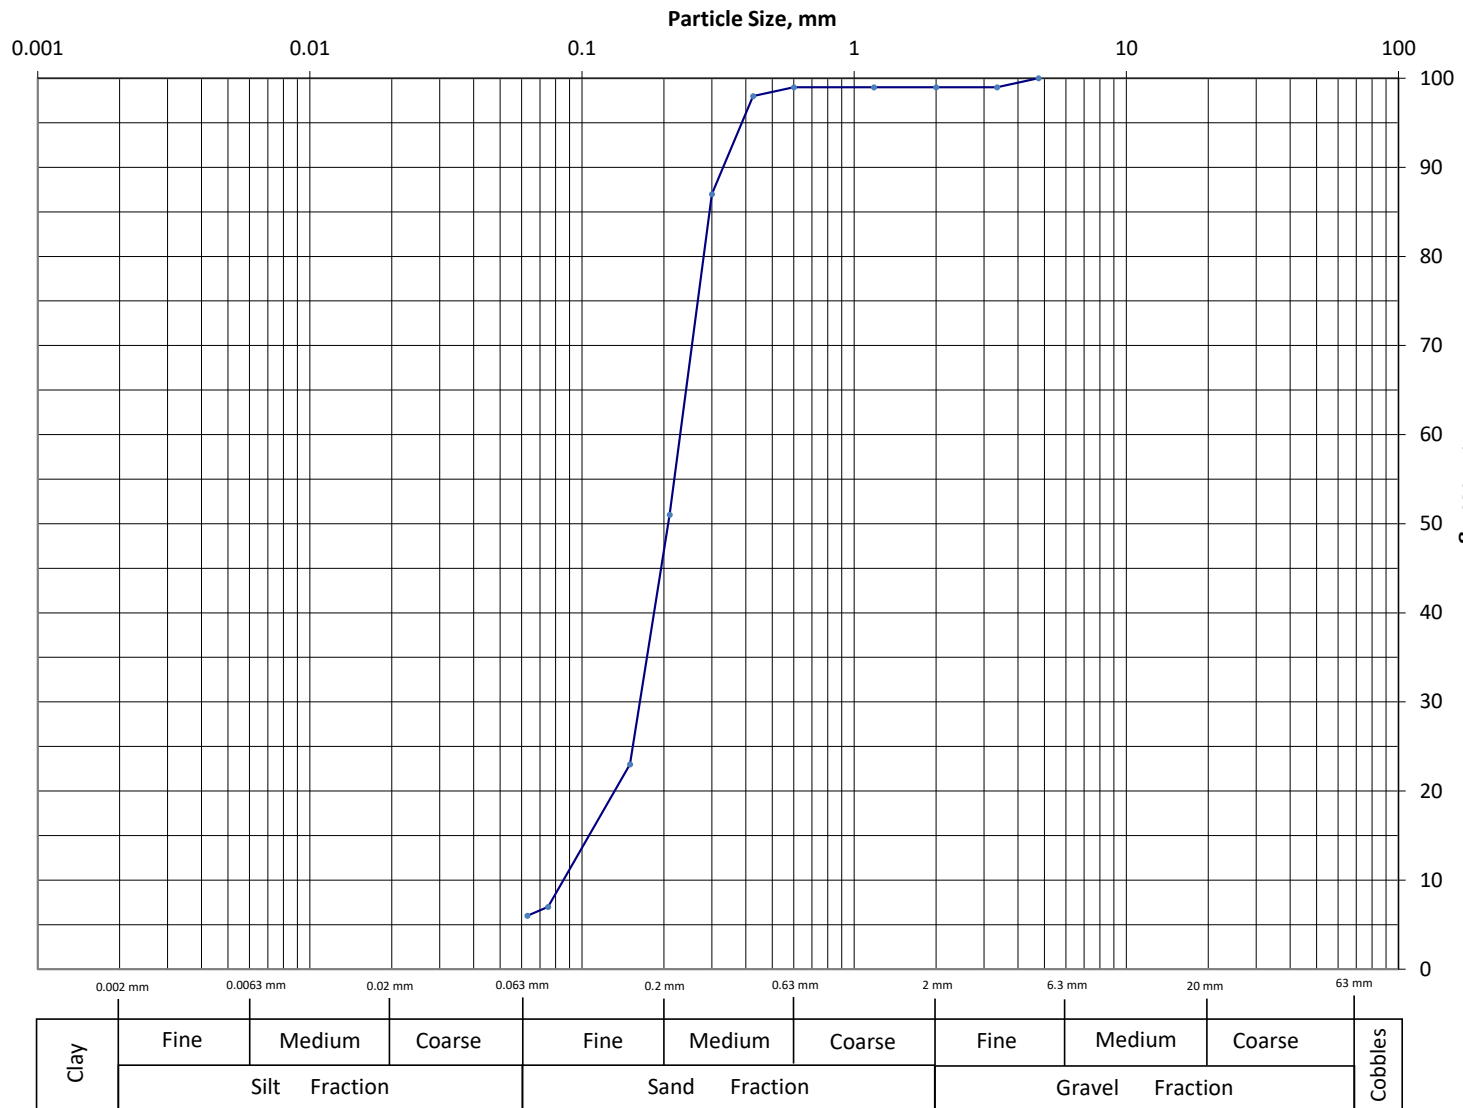
PARTICLE SIZE DISTRIBUTION TEST

BS 1377 : Part 2 : Clauses 9.2, 9.3 : 1990 Particle Size Distribution by Wet/Dry Sieving Method

Particle Proportions (%)	
Cobbles	0
Gravel	1
Sand	93
Silt & Clay	6

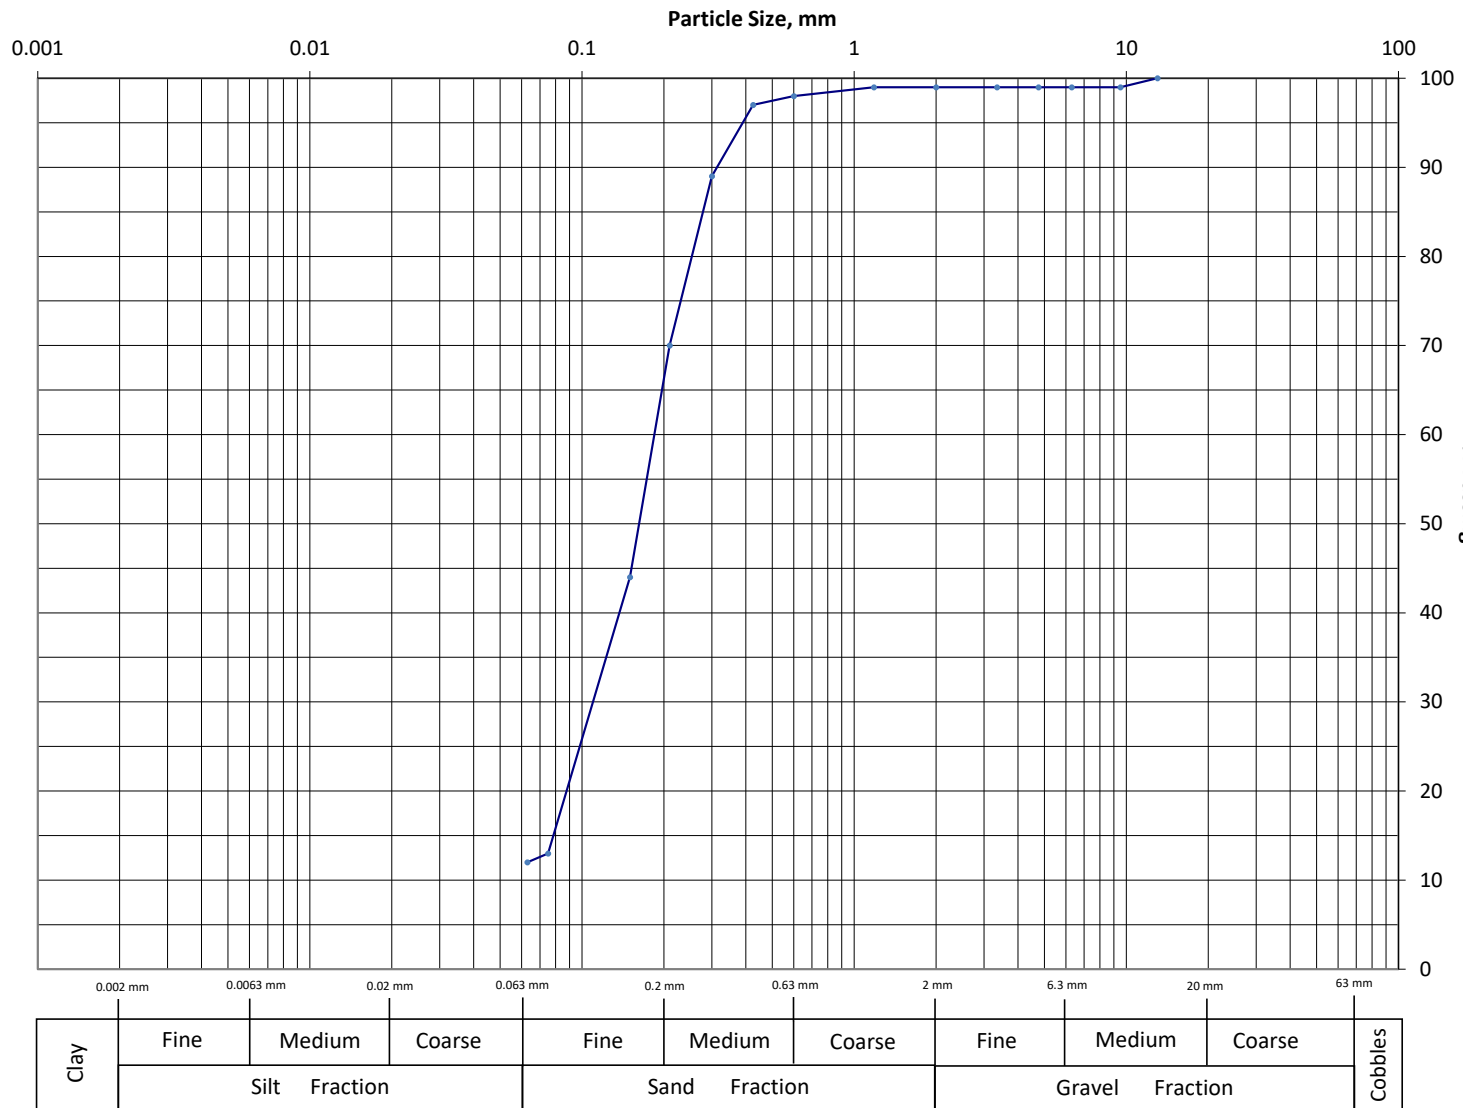
PARTICLE SIZE DISTRIBUTION TEST

BS 1377 : Part 2 : Clauses 9.2, 9.3 : 1990 Particle Size Distribution by Wet/Dry Sieving Method

Particle Proportions (%)	
Cobbles	0
Gravel	1
Sand	87
Silt & Clay	12
