## PRELIMINARY SITE RISK ASSESSMENT TIER 1

SITE: GREAT LANHARGY FARM  
BRAY SHOP  
CALLINGTON  
CORNWALL  
PL17 8QJ

Our Ref: A2298/PSRA/JW

**End-use:** Conversion of existing barn to form a single residential dwelling and associated works.

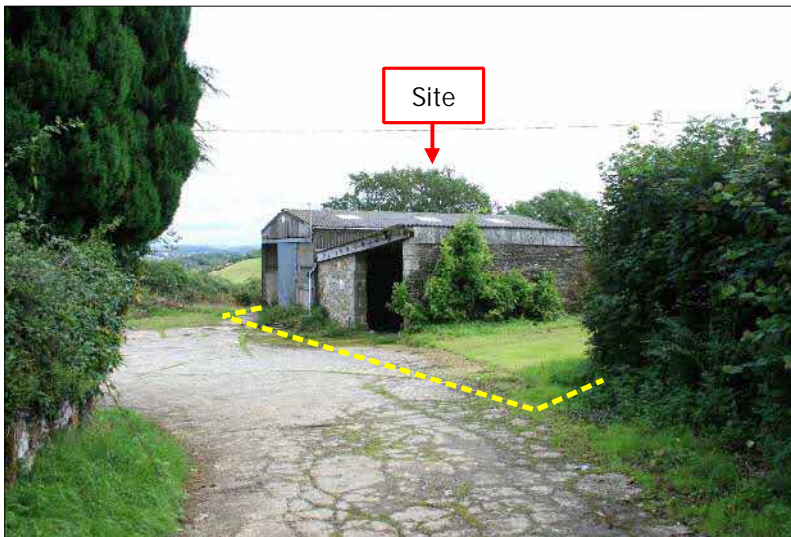
Photograph 1.

View: northeast

Looking towards the site and the existing barn, as viewed from the current access track shared with the neighbouring farm.

The yellow dashed line indicates the approximate site boundaries.

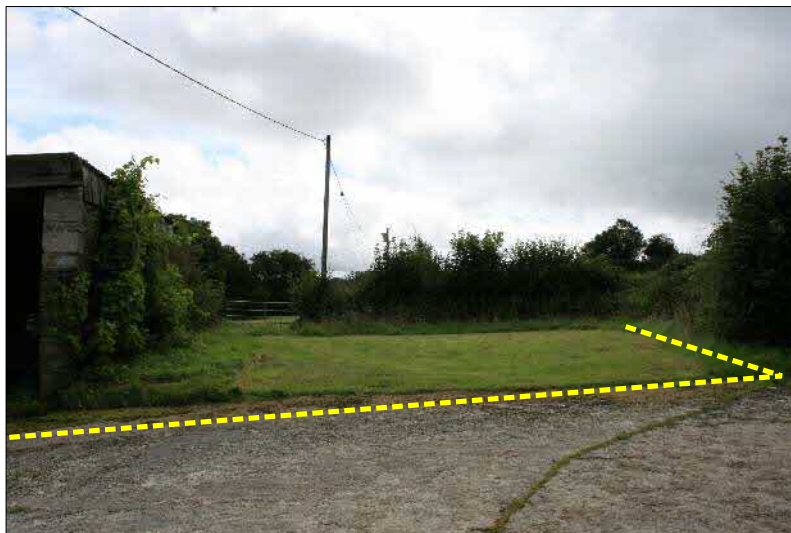
Photograph 2.

View: southeast

Looking across the south-western extent of the site.

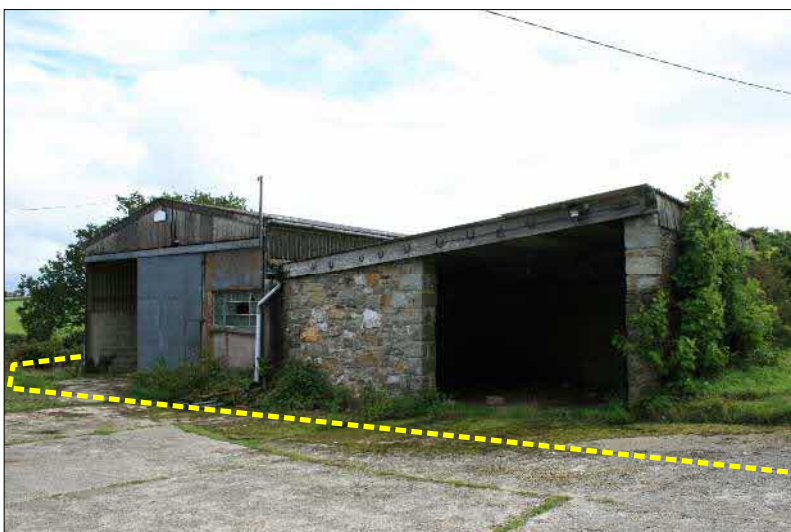
Photograph 3.

View: east-northeast

View of the north-western elevation of the barn, with the original site barn to the right of image and the later stage extension(s) to the left.

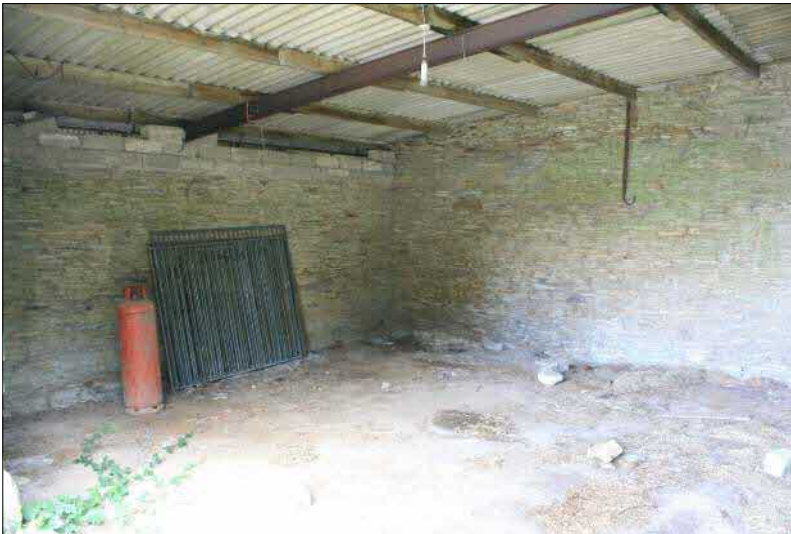
Photograph 4.

View: east

Interior view of the south-western section of the barn (original barn).

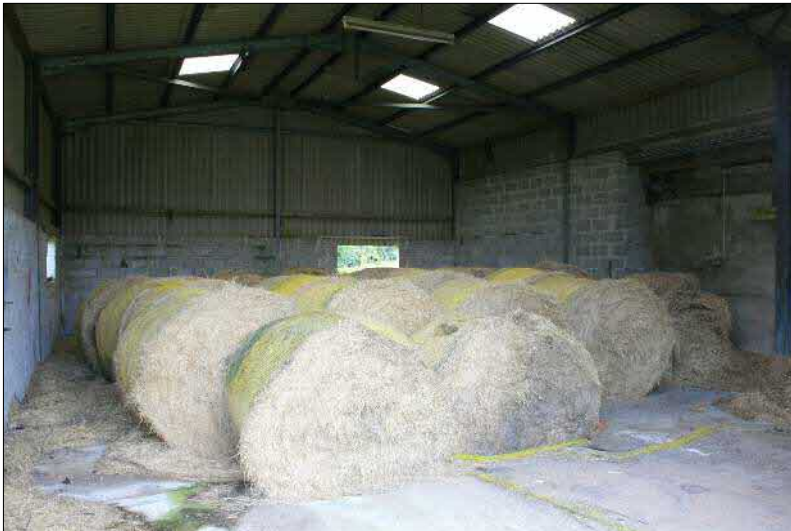
Photograph 5.

View: east

Interior view of the north-eastern section of the barn (extended area).

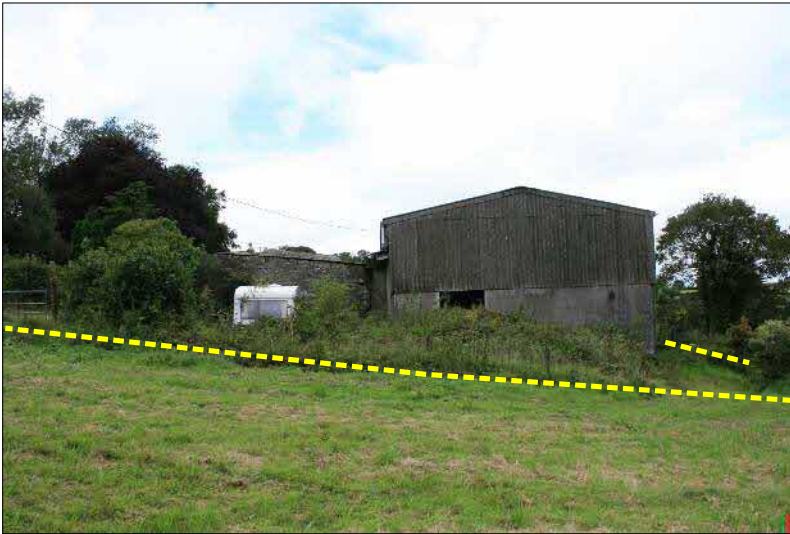
Photograph 7.

View: northwest

View of the south-eastern elevation of the barn as observed from the neighbouring field.

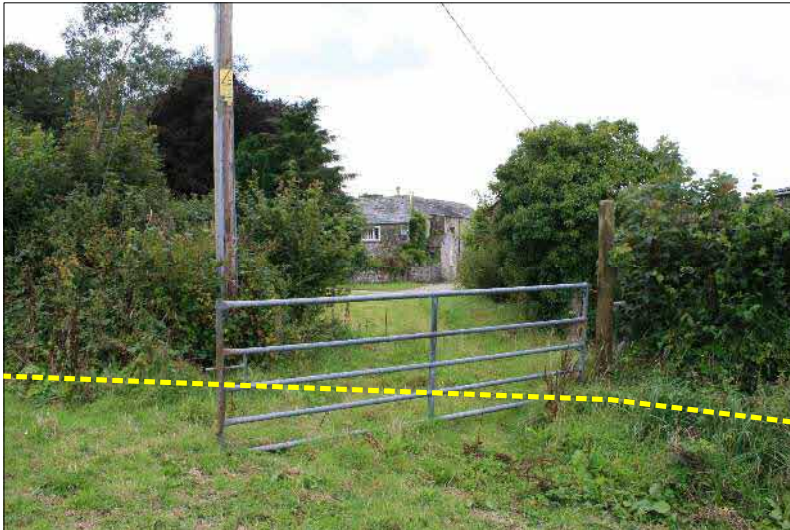
Photograph 8.

View: northwest

Gateway between neighbouring field and the grass area located at the south-western extent of the site.

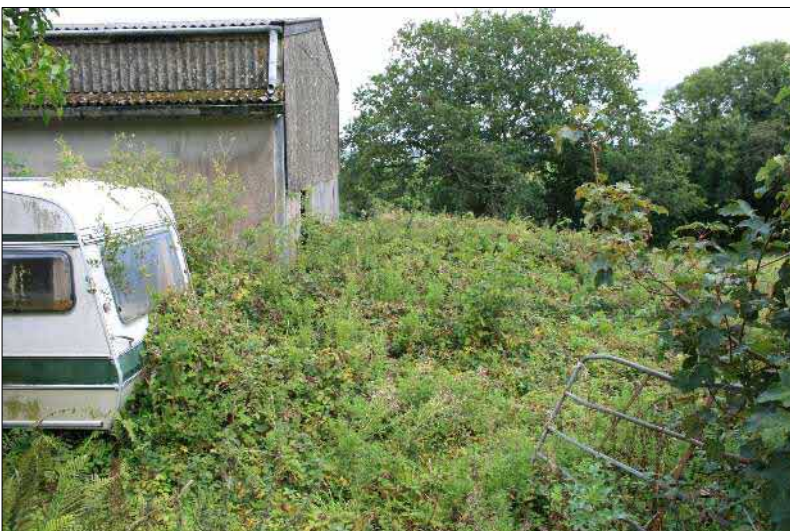
Photograph 9.

View: northeast

Closer view of the caravan and toward the south-eastern elevation of the barn.
