Project Name:
**The Grade II* Listed Poole Barton,
Barton Close,
Cheriton Fitzpaine
EX17 4JB**

Drawing Title:
**As Existing
Ground Floor Layout**

Number:
P01-0065-ISC-XX-00-DR-AR-001

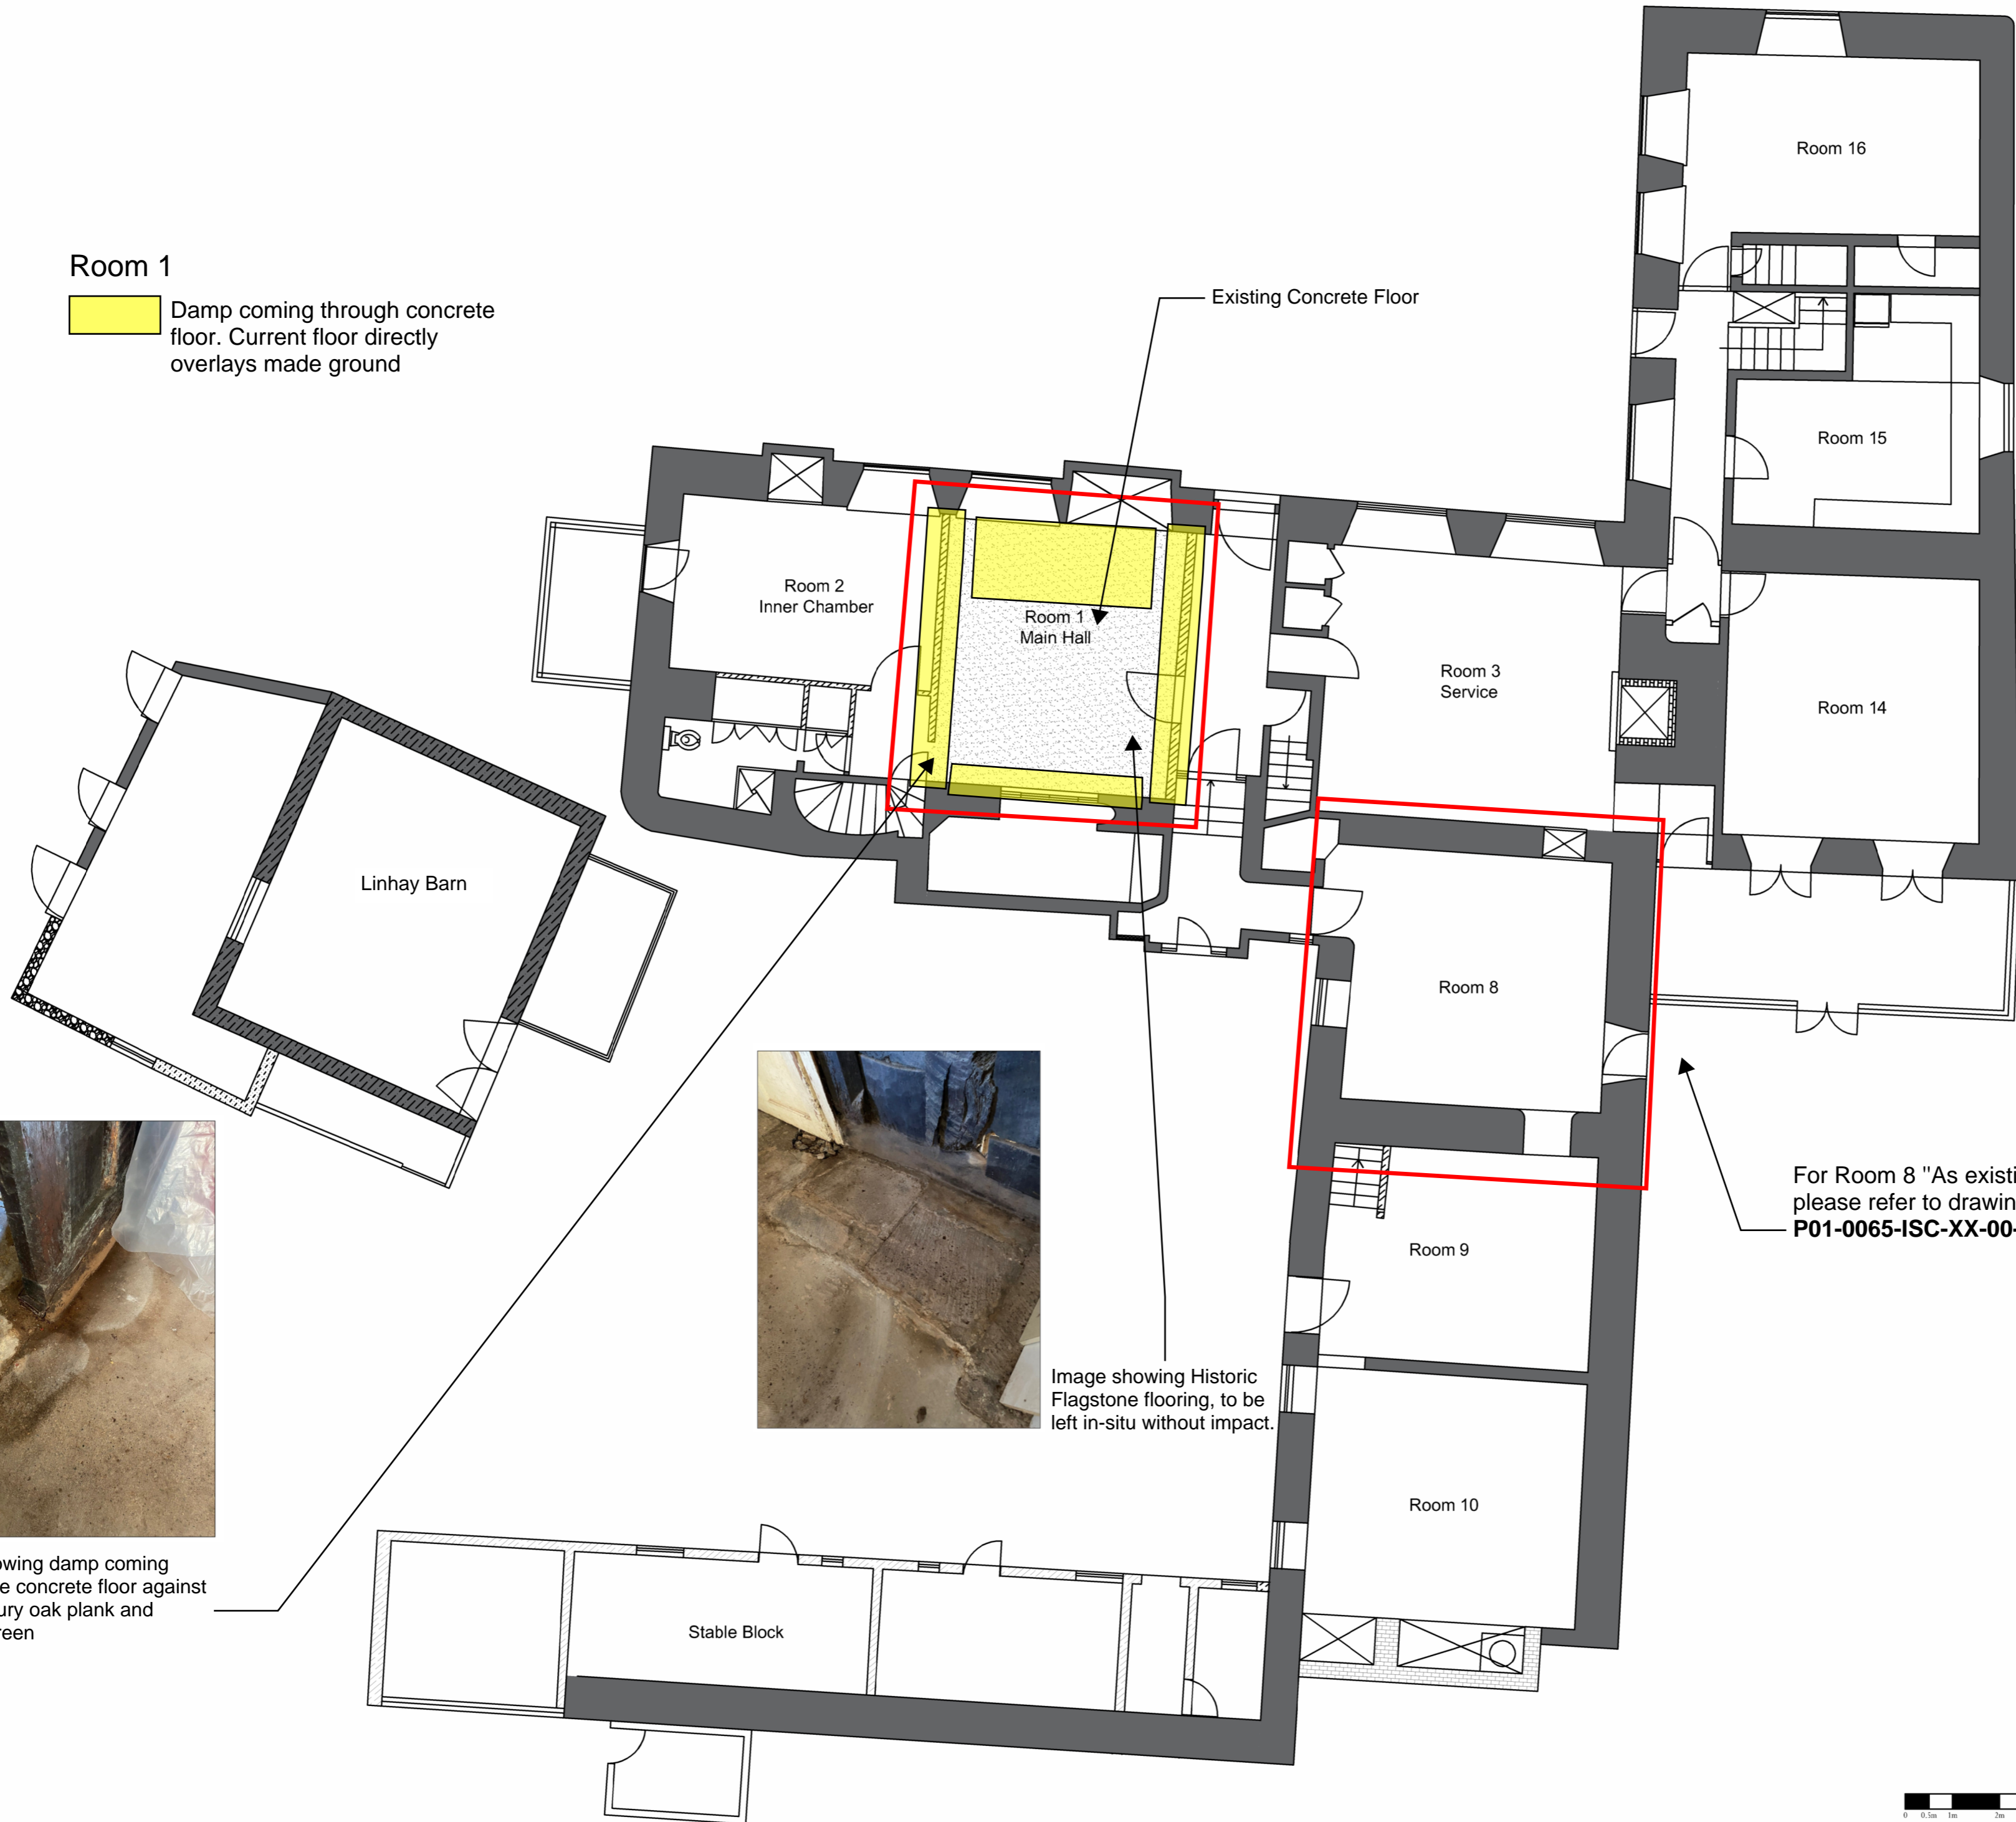
Room 1

Damp coming through concrete floor. Current floor directly overlays made ground

Image showing damp coming through the concrete floor against 15th Century oak plank and muntin screen

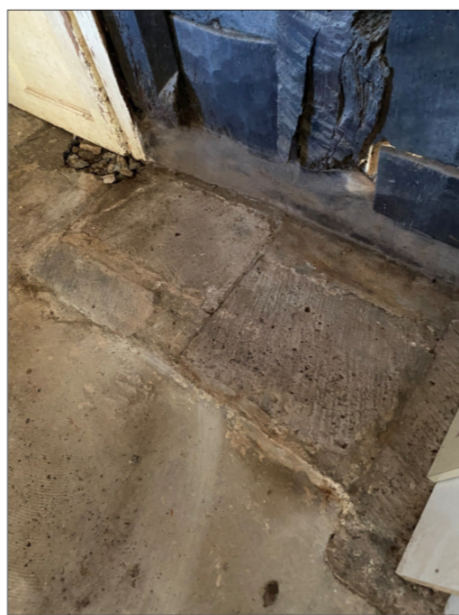
Image showing Historic Flagstone flooring, to be left in-situ without impact.
