Chains Cottage, Sampford Peverell, Devon

Ecological Impact Assessment

Type of document (Version)	-
Revisions	
Report reference	24-623-EcIA-CT
Issue date	5 March 2024
Document prepared by	Chris Turner BSc MCIEEM
Quality control/ checked by	Ruth Testa MSc MCIEEM
Information Valid for	One year from the date of the report

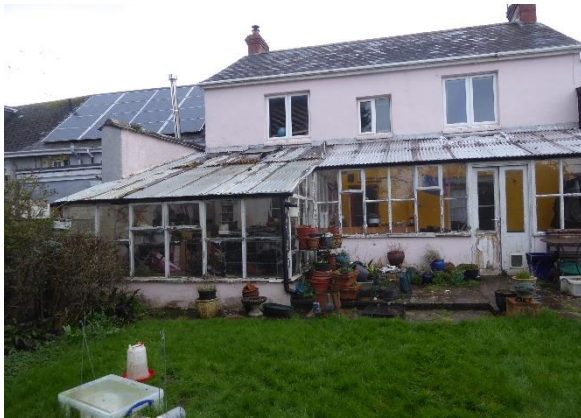
Photograph 3

Overall, the area to be affected by proposals presented **negligible** bat roosting potential, with **no** bat roosting potential noted in/ on the conservatory (**Photograph 3**), the adjoining metal roofed 'lean-to' (**Photograph 4**) and no bat roosting potential in/ around the timber dormer and timber clad section (**Photograph 5 & 6**).

The conservatory lacked dark, sheltered areas sought out by roosting bats, being constructed mostly from timber framed, glazed panels, with a degrading, clear corrugated plastic roof. There were no crevices where the conservatory met the main house wall, and no open timber junctions which could provide close cover for roosting bats.

It is considered that no bat roosts are present within the area to be affected by proposals and no adverse effects are predicted. The timber dormer, conservatory, rear lean-to and timber gable of the garage presented no bat roosting potential. Whilst the fascia on the north-eastern elevation of the garage lean to provided some limited potential for individual crevice dwelling bats, between fascia and stonework, no evidence of bats was found and this area will remain unaffected. As such, bats would be able to roost, should they find the feature in future. No further survey is needed and a licence from Natural England **will not** be required prior to commencement of works.

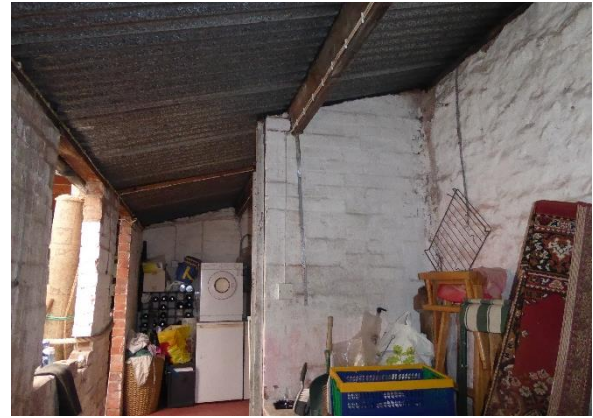
Photograph 4

Similarly, the adjoining 'lean-to' in the rear garden presented negligible potential for roosting bats, with the building being in regular use as a utility/ store/ WC, thus suffering high levels of disturbance. There were no suitable crevices at wall tops, with the unlined metal roof straight onto block/ stonework. No evidence of bats was found and these two buildings presented no bat roosting potential.

An old bird nest was found at the wall top of the north elevation of the rear lean to. Works therefore have the potential to kill/ injure nesting birds and to destroy active nests, which would be an offence under current legislation. Demolition works should be timed to avoid the bird breeding season (**March – August inclusive**). Alternatively, if this cannot be achieved, a check for active birds' nests must be undertaken immediately prior to commencement of works. Any active nests and access points will need to be retained and buffered until all chicks have fledged.

To compensate for the loss of nesting opportunities, a sparrow terrace should be installed within the north-eastern wall, as close to the location of the existing nesting site as possible.

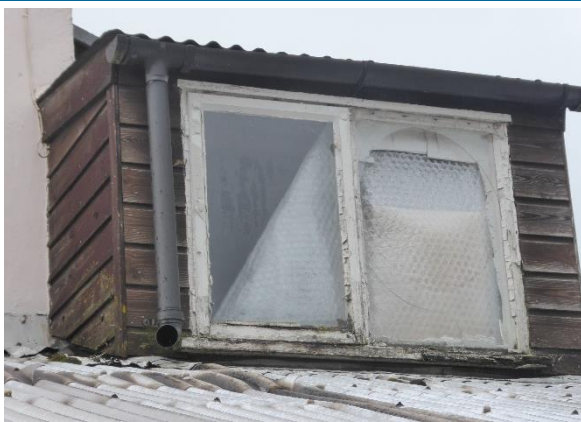
Photograph 5

It was possible to get a close view of the dormer structure internally and externally, both using close-focussing binoculars and by leaning out of the window in the dormer, to inspect the roof covering (**Photograph 7**), timber cladding and the areas where the dormer met the main house and adjacent timber clad wall (**Photograph 8**). The roof structure presented no potential for roosting bats, with corrugations blocked, preventing ingress (checked with an endoscope). Timber cladding on the dormer cheeks, and adjacent wall is tongue-and-groove, with no degraded areas and thus no gaps larger than 3mm; insufficient for a bat to gain access. Timber fascias at the roof verges were tight to the cladding below and slates were enclosed with a plastic trim, with no suitable gaps in which a bat could shelter (**Photograph 8, 9 & 10**) and therefore this section of the building presented negligible bat roosting potential.

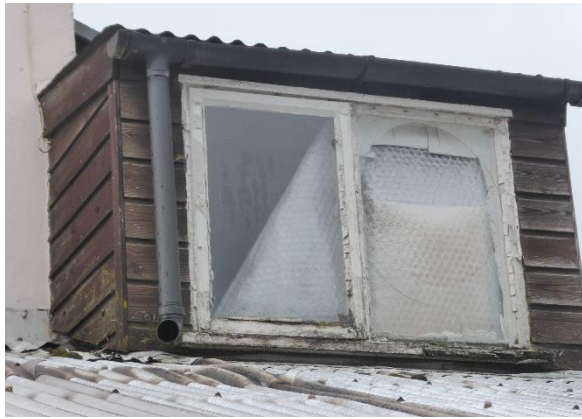
Photograph 9

The remainder of the garage on the north-eastern, side elevation of the property, beyond the timber cladding shown above presented negligible bat roosting potential. This had previously been assessed as having moderate potential for bats. The garage is in regular use, with minimal potential for bats to be present inside the building; gaps around the garage doors were considered unsuitable for bat access.

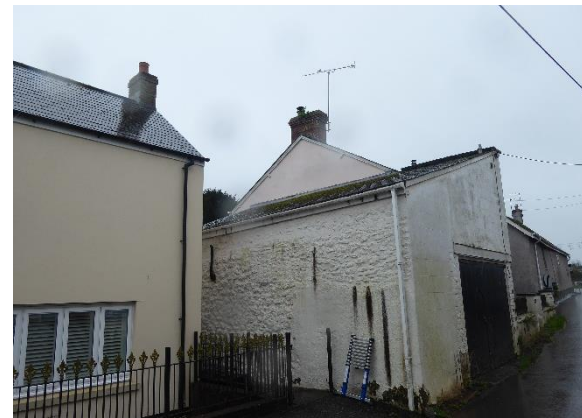
Photograph 11

Externally, the slate is in sound condition, with no lifted areas where bats could access the roof structure. Minor gaps do occur along the northern fascia, where it does not sit flush to the stonework (**Photograph 11 & 12**), but close inspection with an endoscope revealed that the wall-plate overhangs the wall, with fascia attached directly to the wall-plate, thus blocking access to the roof structure. All of the gaps behind the fascia were heavily cobwebbed, indicating that this area has been undisturbed for some time and whilst the narrow void behind the fascia did extend approximately 10cm; sufficient depth for a bat to shelter, there was no evidence of roosting bats.

In any case, this part of the building will not be affected by proposals.

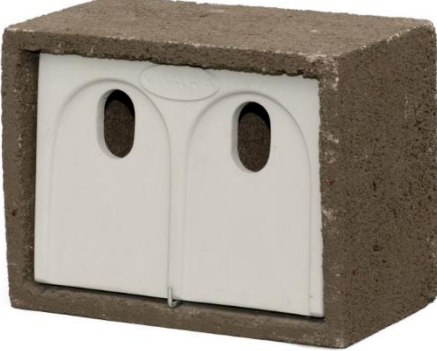
Type (examples – other manufacturers may have slightly different designs)	Location and description
<p>House Sparrow terrace</p>

<p>Installed as high as possible above ground (ideally at least 4m), ensuring that there is unobstructed access for birds entering and leaving.</p> <p>Boxes should be sited under the shelter of eaves or overhanging roofs.</p> <p>Entrance out of direct sun, preferably north or east-facing.</p>
<p>Vivarapro Woodstone bat box</p>

- One additional sparrow terrace is installed in the north-eastern wall of the new extension.
- Two crevice bat boxes are built behind cladding on the east facing wall (near where the dormer is to be removed)

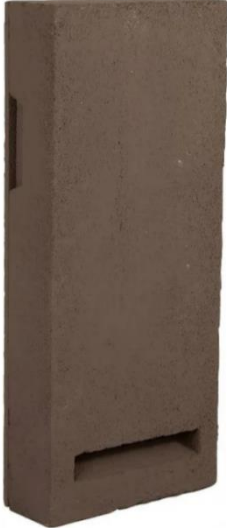
<p>Installed as high as possible, directly beneath the eaves, away from exterior lighting and windows.</p> <p>Boxes can be built into masonry, or installed behind cladding, with only the access slot exposed.</p> <p>Bat boxes should ideally face a range of directions to allow bats to select their environmental conditions depending upon the time of year/ amount of thermal gain from the sun.</p>
<p>Beaumaris woodstone bat box</p>

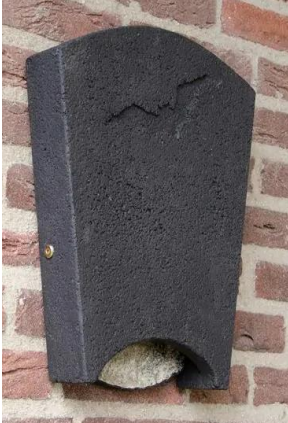
<p>If it is not possible to build in bat boxes, a suitable alternative is to surface mount a box.</p> <p>Installed as high as possible, directly beneath the eaves, away from exterior lighting and windows.</p> <p>Bat boxes should ideally face a range of directions to allow bats to select their environmental conditions depending upon the time of year/ amount of thermal gain from the sun.</p>
