Design & Access Statement

62 Albion Hill, Brighton

February
2024

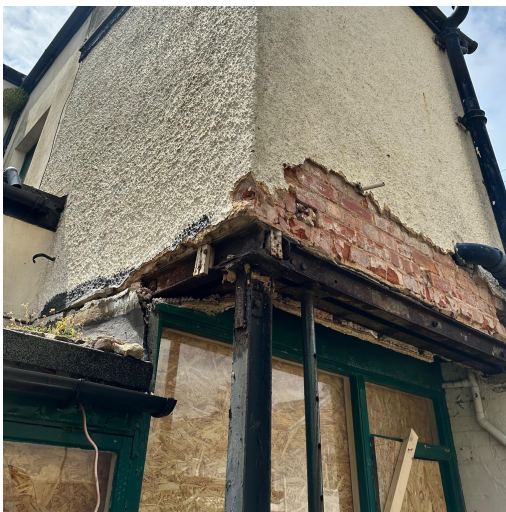
Rear Extension

A key area of structural concern is the building's rear extension. This view is shared by the Senior Building Control Surveyor, Brighton & Hove City Council:

"The rear extension part where an acro prop has been provided this is showing signs of deterioration and I would agree that this is an area of the building that should be addressed."

"Any delay in making repairs in the medium to longer term may result in the building representing as a potential Dangerous structure."

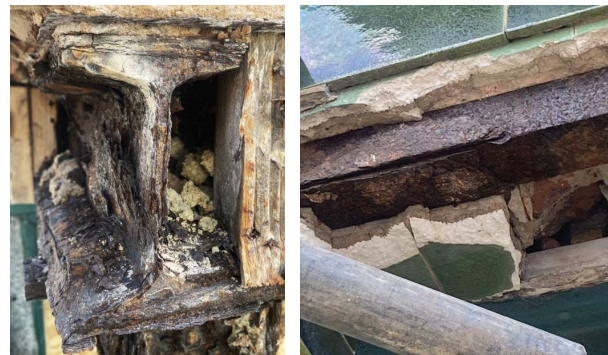
Severe Rusting & Corrosion

There is evidence of severe rust and corrosion to weight-bearing beams throughout the property.

"All structural steels, particularly the RSJ beams to the rear extension, are experiencing severe corrosion. These elements, crucial for the building's support, are embedded within the structural fabric and have deteriorated to a point where replacement is unavoidable. Localized demolition will be necessary to excavate and replace these failing steels.

Similarly, the RSA steel lintels embedded within the building's fabric are severely corroded. This has compromised their structural integrity, necessitating their removal and replacement. The process will involve the removal of some of the decorative tiled cladding on the building's façade, this needs to be undertaken to ensure the ongoing safety and stability of the structure."

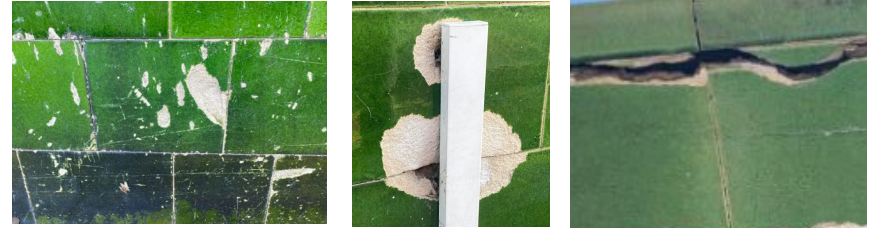
Upon acquisition of the building in 2022, the condition of the tiles was notably poor. Expansion of corroded lintels has caused the tiles covering these lintels to fracture and crack significantly.

Damage attributable to previous owners includes installation of wooden paneling, signage, and broadband, resulting in sections of tiles being chipped away, cut with an angle grinder, or affixed with nails. Previous repair attempts involved the removal of large tile sections, subsequently patched over with plaster without replacement.

Over the years, natural wear and tear has further weathered and chipped the tiles adorning the facade.

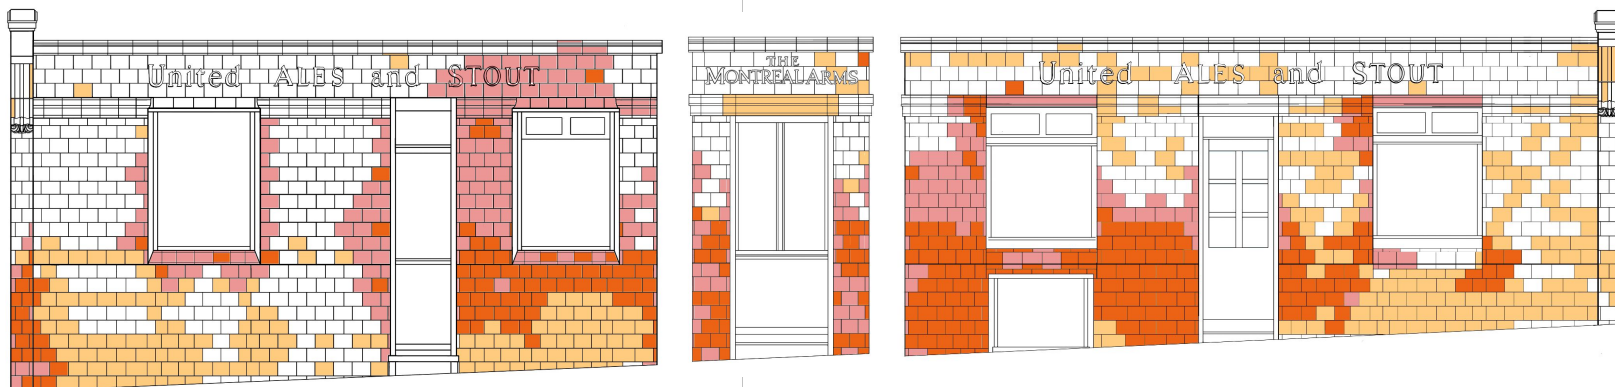
Tile Damage: Visualisation of Current Damage

Damage from Tile Removal

Pre-existing Tile Damage

Damage Overlap

Drawings represent the building in its current state: tiles highlighted in yellow represent tiles with existing damage, prior to tile removal in 2022. Tiles highlighted in pink represent tiles damaged or removed in 2022. Orange tiles represent overlap in the existing damage and in tile removal.

The visual representations on pages 7 and 8 illustrate the extensive existing and predicted damage to the tiled facade. The replacement of lintels across all 7 window and door apertures inevitably requires more tile removal, resulting in a situation where the majority of tiles must be replaced.

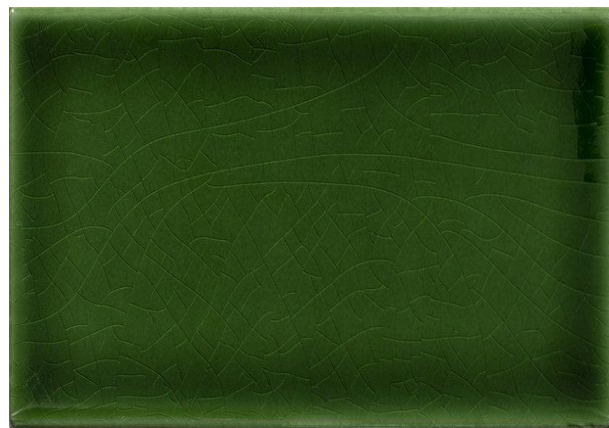
15.5cm

22.5cm

The existing tiles will be laser scanned and replicated by specialists at Craven Dunnill.

Replica tiles will be all glazed by hand, in true Victorian size and coloured 'crazing' glaze.

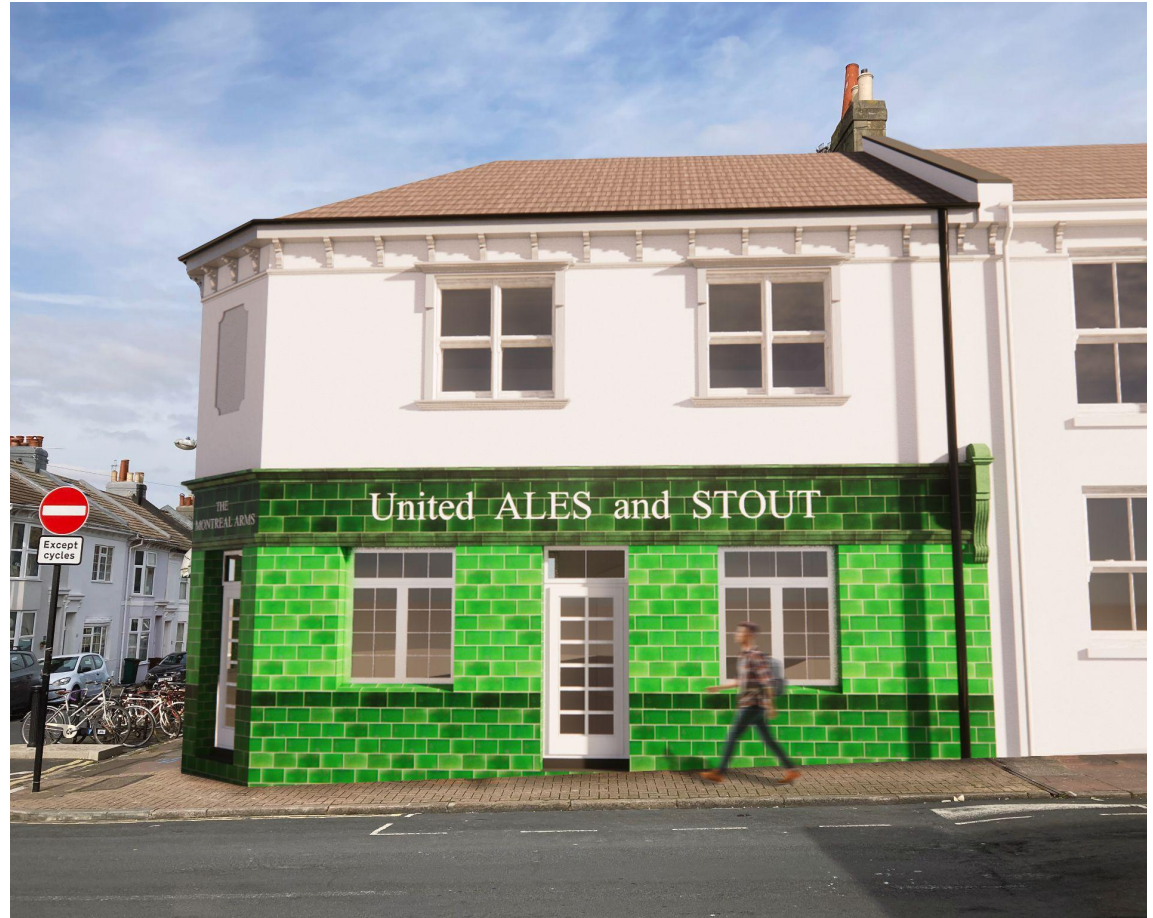
The building comprises a commercial unit on the ground floor and a residential unit above, mirroring the existing structure.

We will work to maintain as many parts of the existing structure as possible, whilst being mindful of the challenges with regard to structural integrity and safety outlined in this document.

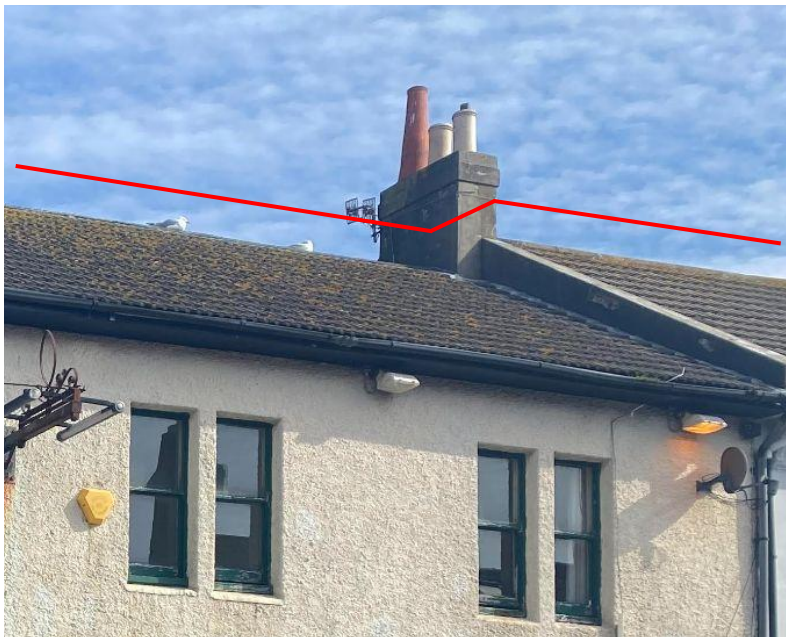
Existing Roofline

The existing roofline exhibits an unappealing tapering effect at the boundary firewall - creating an uneven, asymmetrical silhouette.

A significant aspect of the proposed architectural enhancements includes a subtle yet impactful modification to the roofline. By slightly raising the ridge-line, the proposal aims to eliminate the unsightly tapering present at the boundary firewall. This minor adjustment ensures a consistent and aesthetically pleasing roofline, respecting the building's heritage while improving its external appearance.

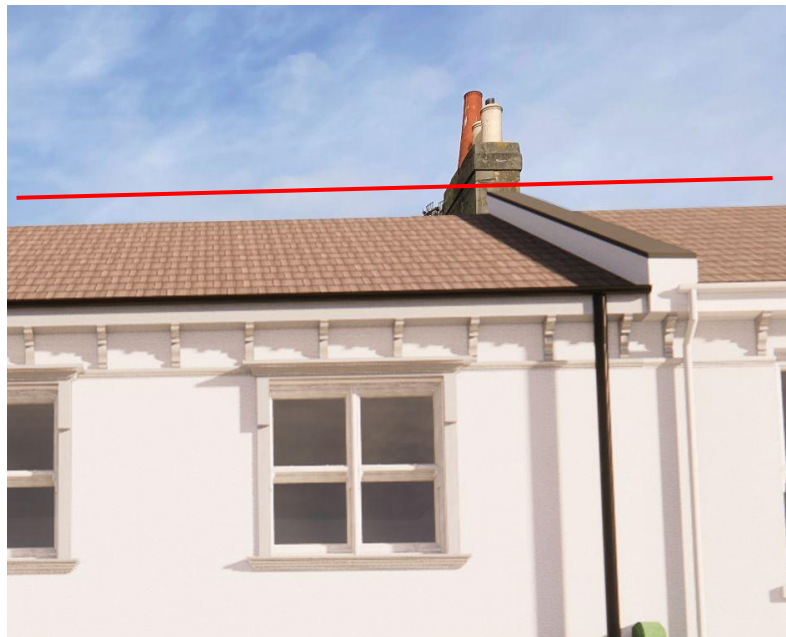
Proposed Design

The proposed design features a subtly elevated ridgeline, aiming for coherence with the neighbouring property

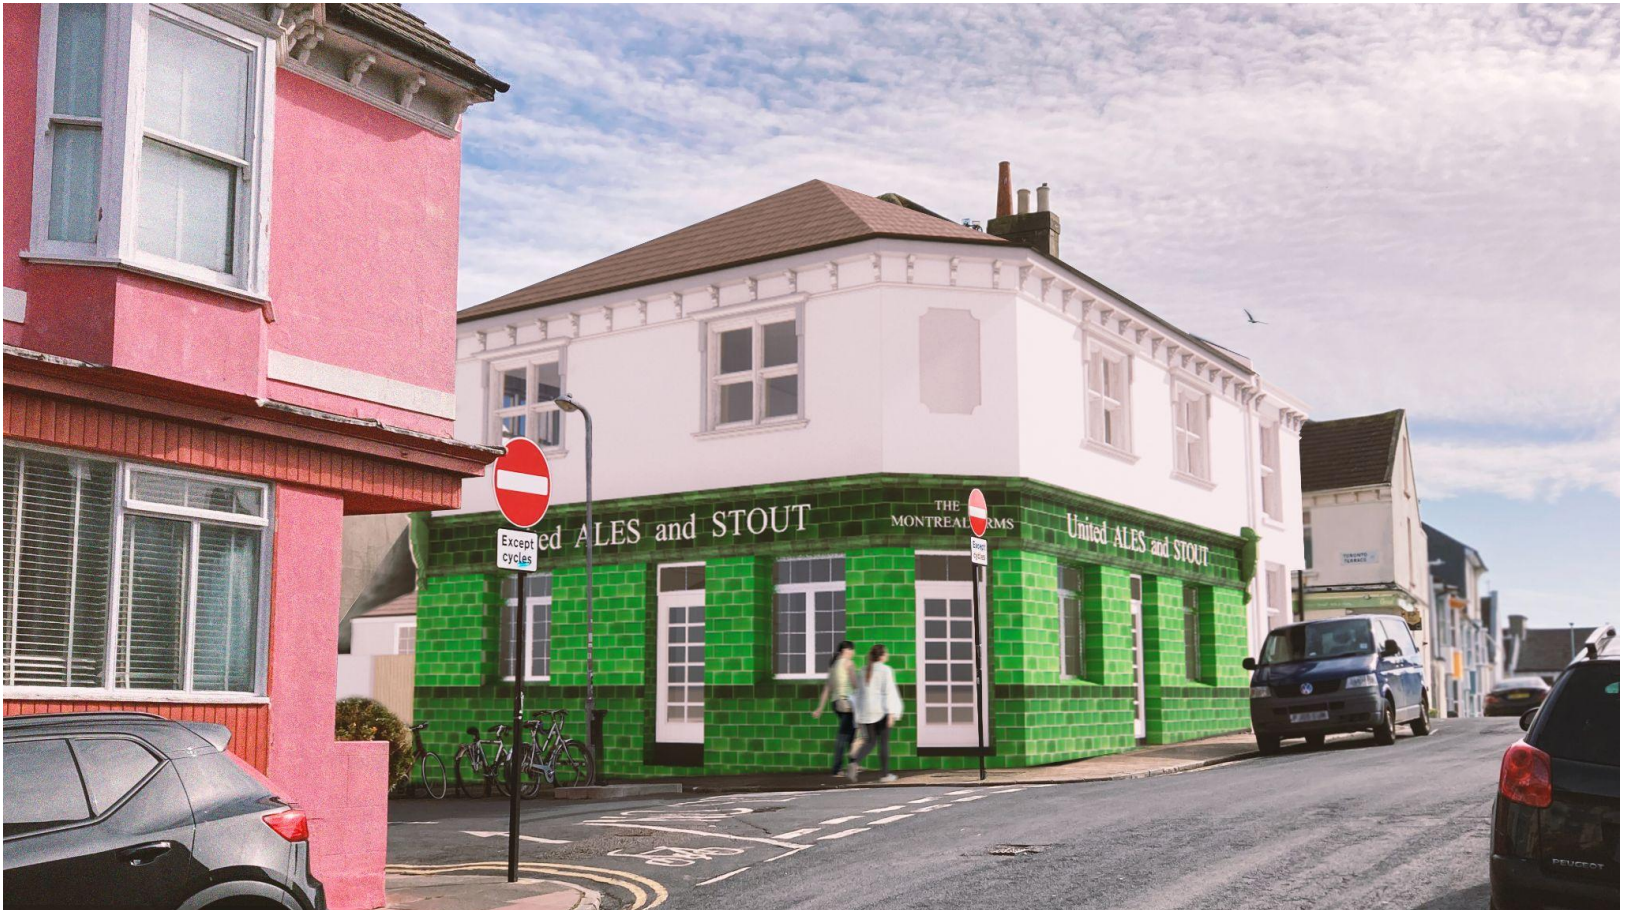
Timber Sash Windows:

A key element of this proposal is the reintroduction of heritage timber sash windows. These are an original feature which were lost during previous redevelopment.

A cornerstone of the proposal is the reinstatement of heritage timber sash windows, an original feature lost to previous redevelopment efforts. This restoration is respectful of the building's historical significance, aiming to reintroduce lost character and charm; bridging the gap between past and present architectural features.

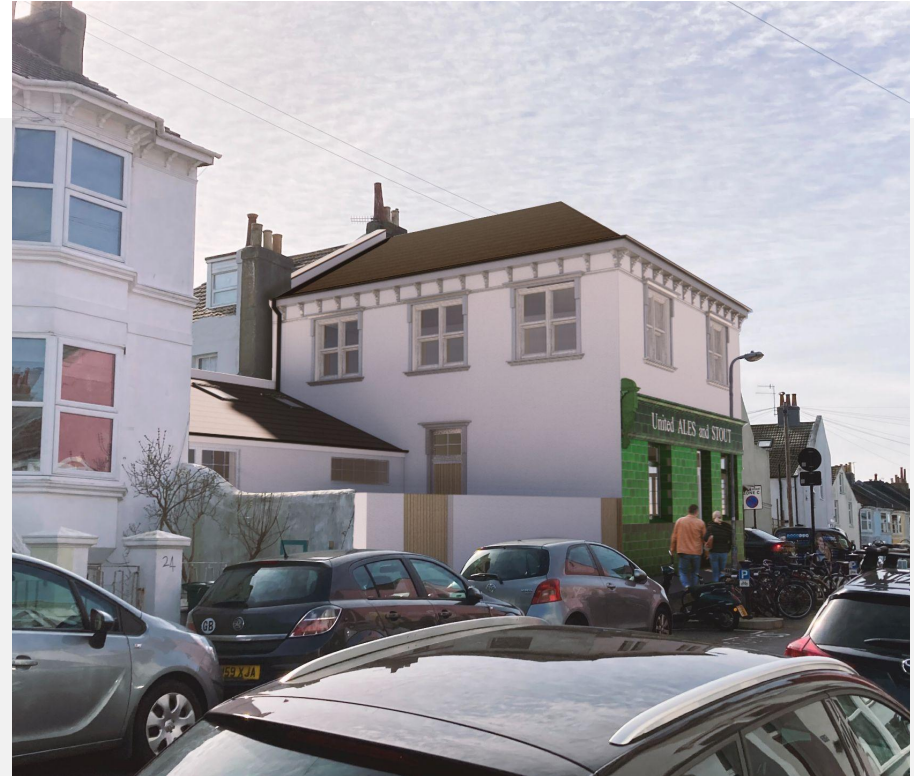
Proposed Design

The proposal includes expanding the outbuilding rear wing for improved commercial functionality while preserving the property's historical architectural value. Additionally, the redesign of the courtyard aims to create a more practical and visually appealing outdoor space, with private flat access and efficient waste management areas. This transformation also involves removing an unattractive modern lean-to, refining the architectural quality of the building.

The proposal envisions a slight expansion of the outbuilding rear wing, offering a more functional commercial space. This thoughtful enhancement is designed to meet contemporary commercial needs while maintaining the architectural essence of the property.

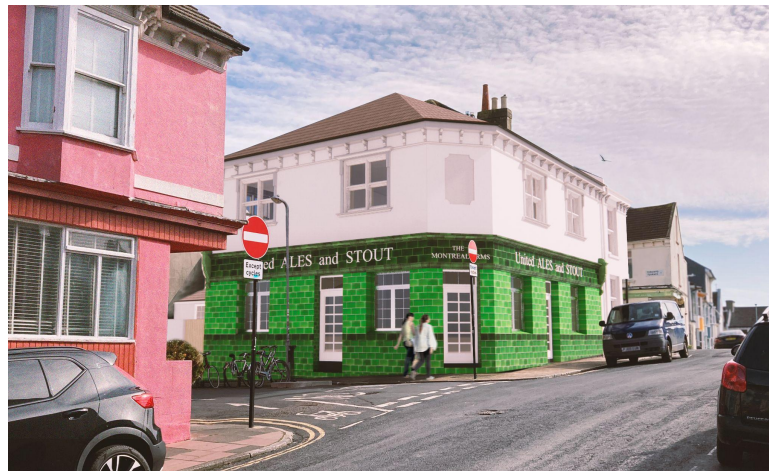
The proposed changes offer a heritage benefit in restoring the tiled frontage to a pristine condition, which will be reinstated within new high-quality development.

Acknowledgement:

We recognise the importance of repairing the green tiled frontage on the property and honoring the heritage of the site.
