# Design & Access Statement

62 Albion Hill, Brighton

February  
**2024**

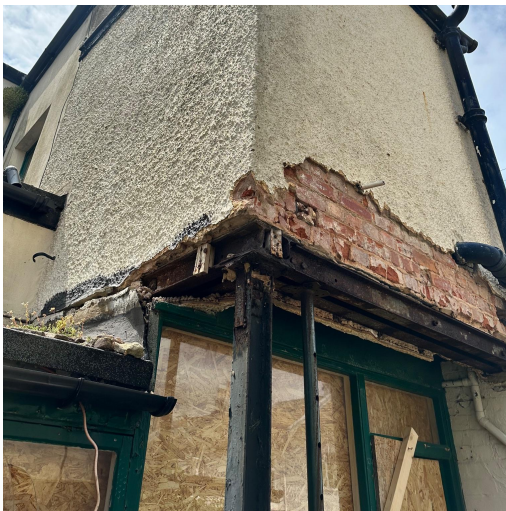
### Rear Extension

A key area of structural concern is the building's rear extension. This view is shared by the Senior Building Control Surveyor, Brighton & Hove City Council:

*"The rear extension part where an acro prop has been provided this is showing signs of deterioration and I would agree that this is an area of the building that should be addressed."*

*"Any delay in making repairs in the medium to longer term may result in the building representing as a potential Dangerous structure."*

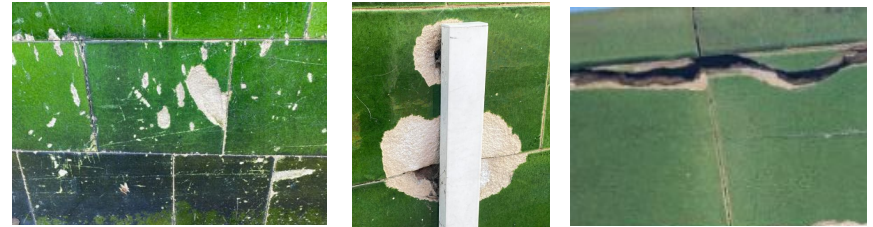
[Annex H: Detailed Report of Tile Condition](#)

Upon acquisition of the building in 2022, the condition of the tiles was notably poor. Expansion of corroded lintels has caused the tiles covering these lintels to fracture and crack significantly.

Damage attributable to previous owners includes installation of wooden paneling, signage, and broadband, resulting in sections of tiles being chipped away, cut with an angle grinder, or affixed with nails. Previous repair attempts involved the removal of large tile sections, subsequently patched over with plaster without replacement.

Over the years, natural wear and tear has further weathered and chipped the tiles adorning the facade.

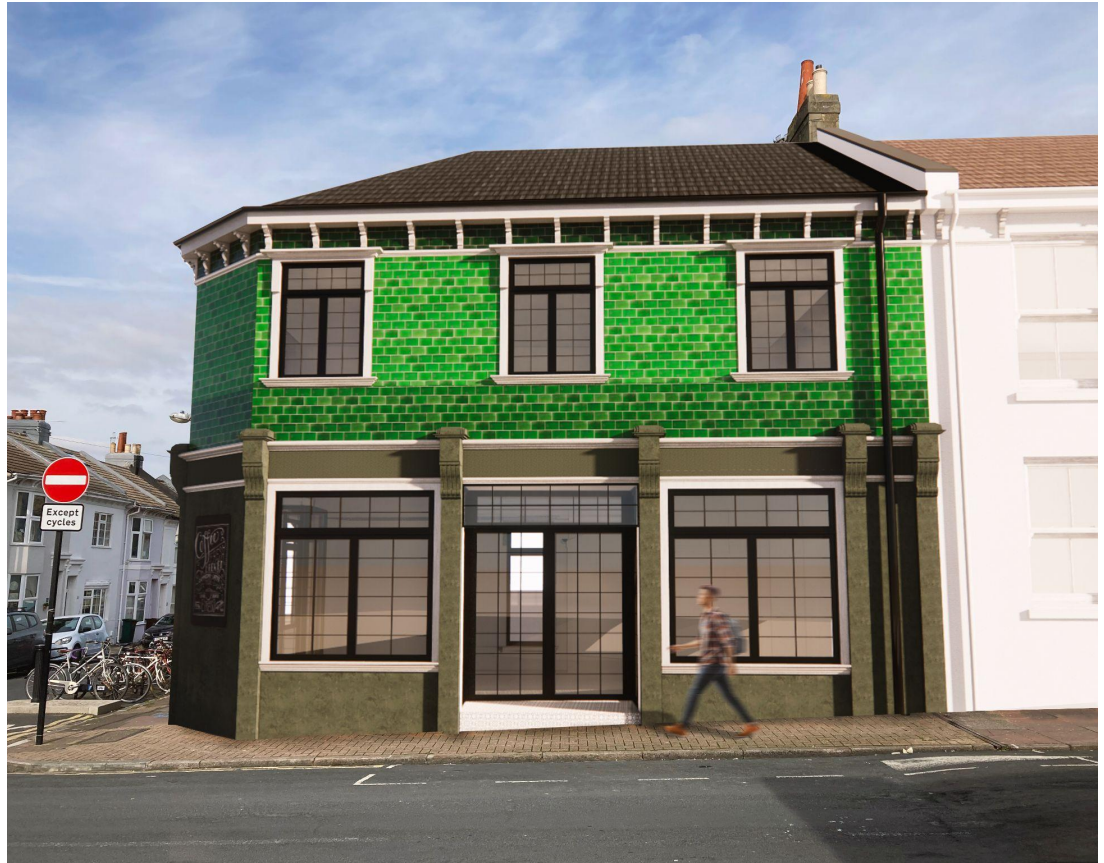
**Updated Facade:** The facade will be adapted to pay homage to the building's heritage, whilst ensuring longevity. This will involve repositioning the green tiles to higher levels, safeguarding them against street-level wear and tear, as observed in the previous facade. This adjustment will also improve sightlines and capitalise on sunlight reflections on the glazed surfaces.

**Dark Green Render:** A dark green render on the lower portion will nod to the existing frontage. This choice not only maintains continuity with the building's heritage but also offers a resilient surface capable of withstanding wear and tear.

**Heritage Preservation:** Elements such as bands of color from the previous design, column features, and decorative end corbels (created using casts of the originals) will be retained to honor the building's heritage.

**Sympathetic Design:** Cornices at the top of the building have been designed to complement those of neighboring structures, ensuring architectural coherence within the neighbouring property.

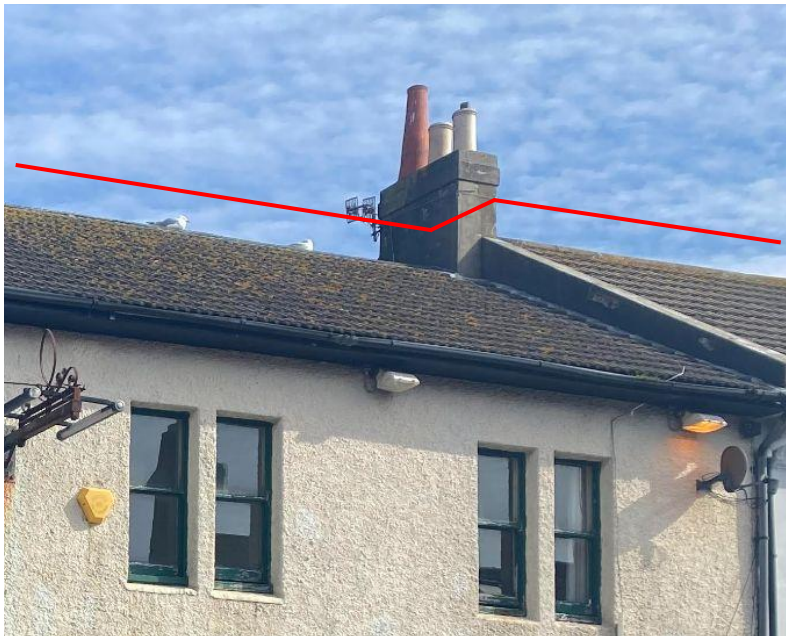
*Existing Roofline*

The existing roofline exhibits an unappealing tapering effect at the boundary firewall - creating an uneven, asymmetrical silhouette.

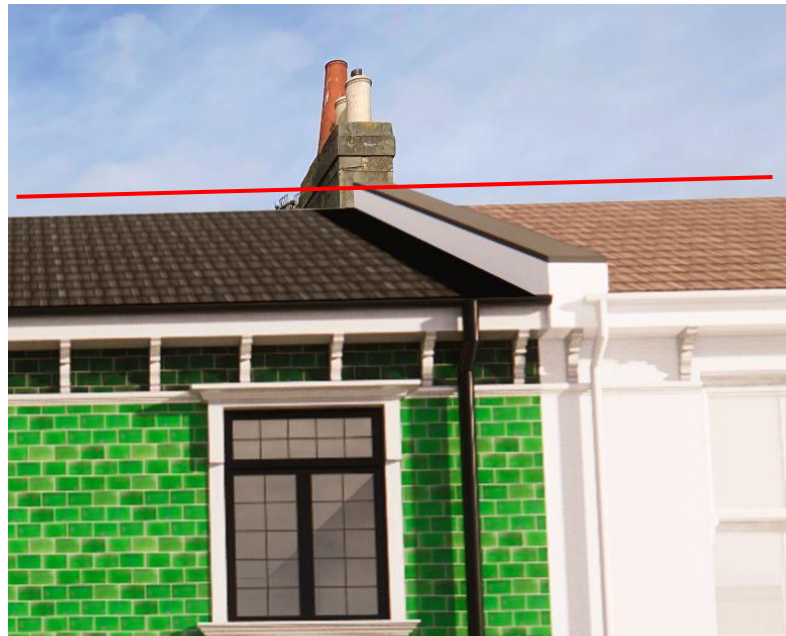
*Proposed Design*

The proposed design features a subtly elevated ridgeline, aiming for coherence with the neighbouring property

A significant aspect of the proposed architectural enhancements includes a subtle yet impactful modification to the roofline. By slightly raising the ridgeline, the proposal aims to eliminate the unsightly tapering present at the boundary firewall. This minor adjustment ensures a consistent and aesthetically pleasing roofline, respecting the building's heritage while improving its external appearance.

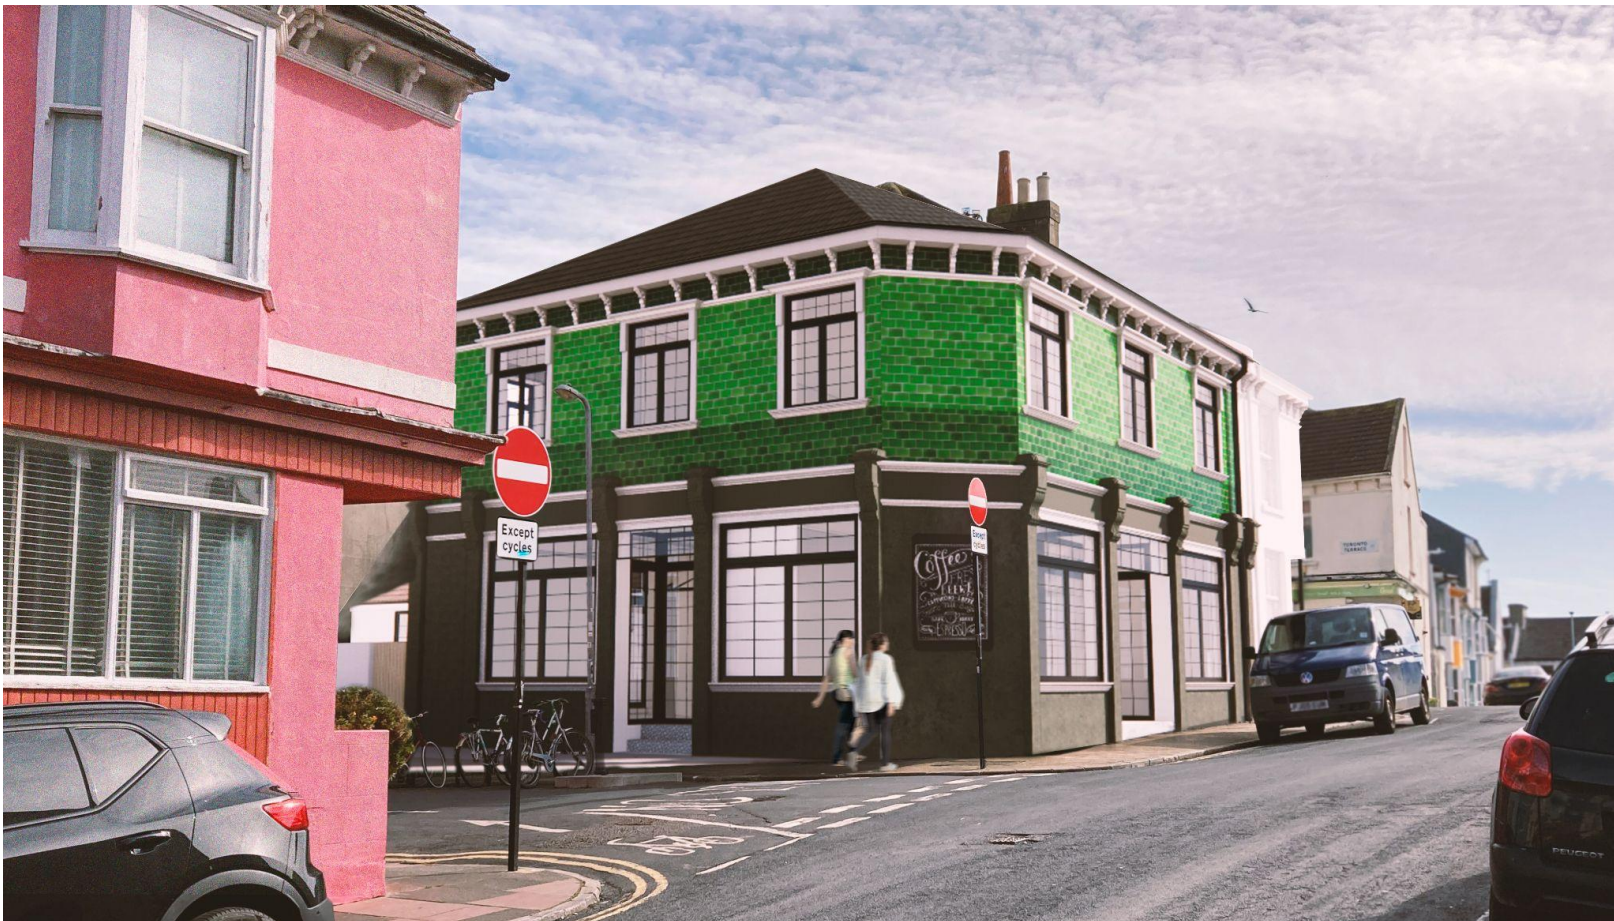
*Street View: Visualisation of proposed building from Albion Hill*

The design also includes traditional cast cornices, soffits and trimming details, typical of the surrounding architecture.

Replica Emerald Green tiles to be produced by Craven Dunhill, using historically accurate production techniques. The design emulates the striped layout from the former facade as a homage to the original design.

Replica corbels, cast from the originals in order to preserve key building heritage features

Leading Heritage Glassing in windows, improving upon the modern replacements presently installed in the building.

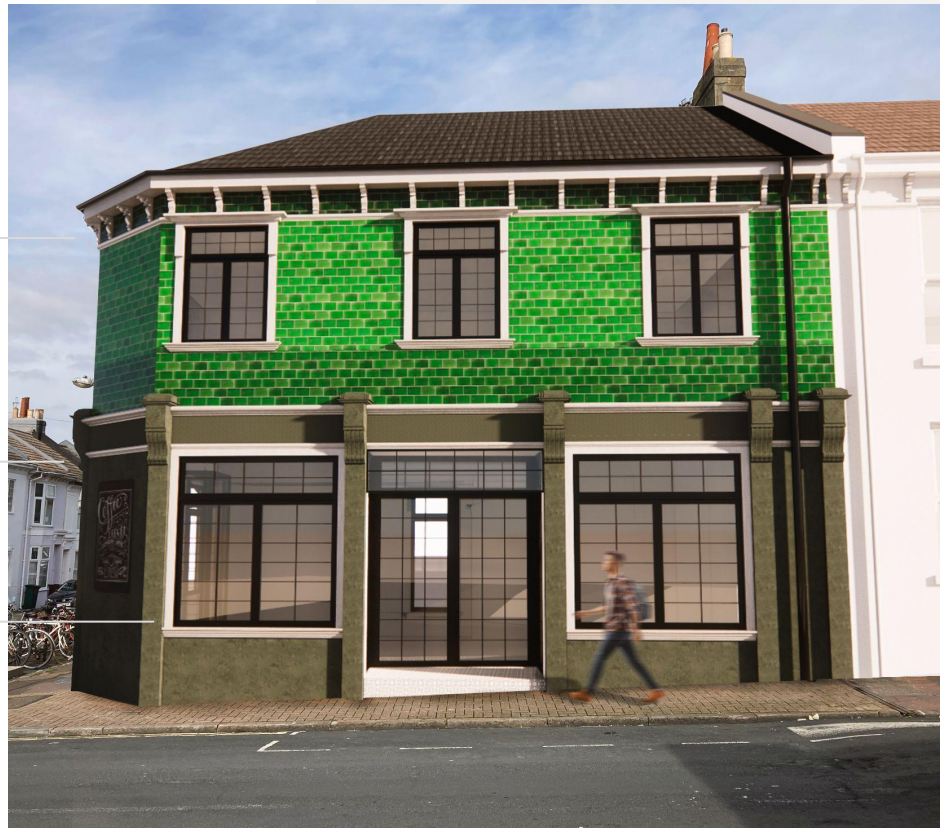
## Key Features

## Tiled Facade:

We plan to re-clad the exterior facade in ceramic tiles on the facade to match the originals, however reconfigure them into a new design that honors the building's heritage.

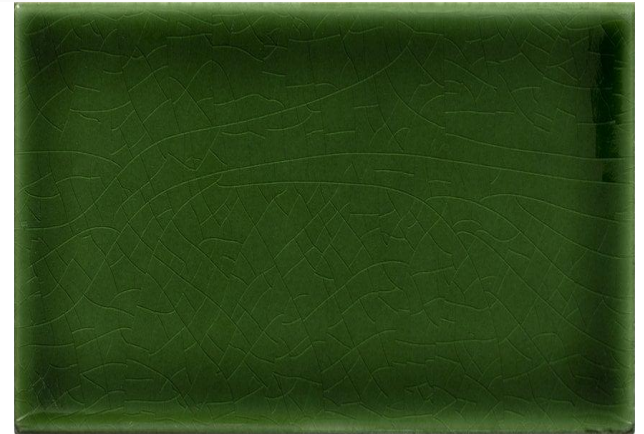
Replica tiles will match originals in size, colour and finish. They will be all glazed by hand, in true Victorian size and colour, with a 'crazing' glaze.

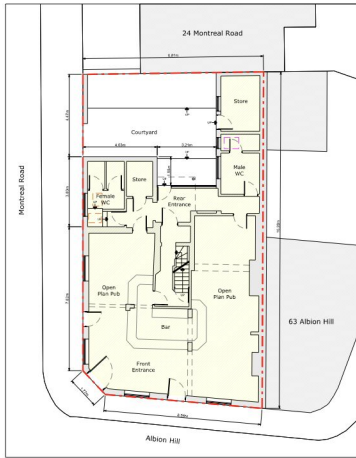
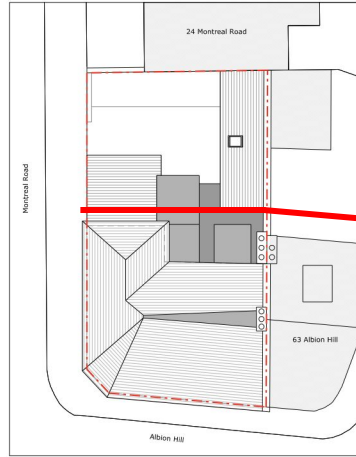
*Existing Floorplan*

Red line highlights line of property back wall

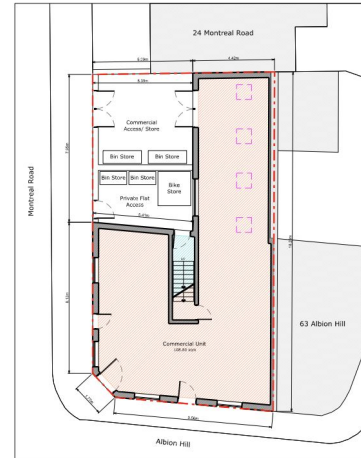
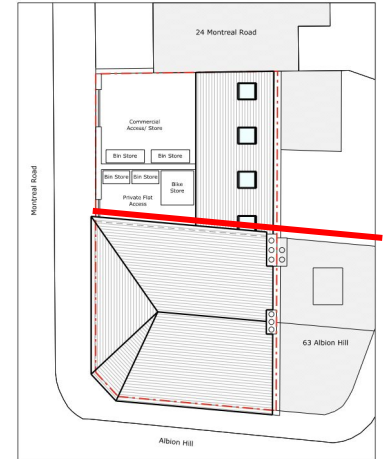
*Proposed Design*

In a bid to achieve visual harmony within the streetscape, the proposed changes include aligning the building with the adjoining property at number 63. This decision aims to contribute to a more cohesive architectural narrative along the street.

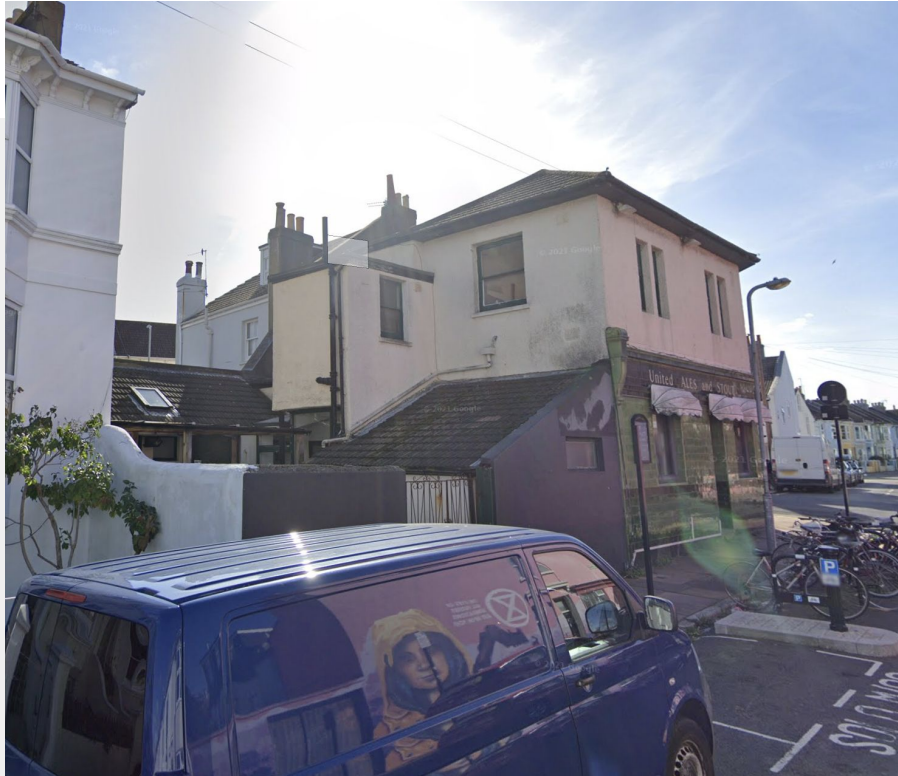
*Current view from Montreal Road*

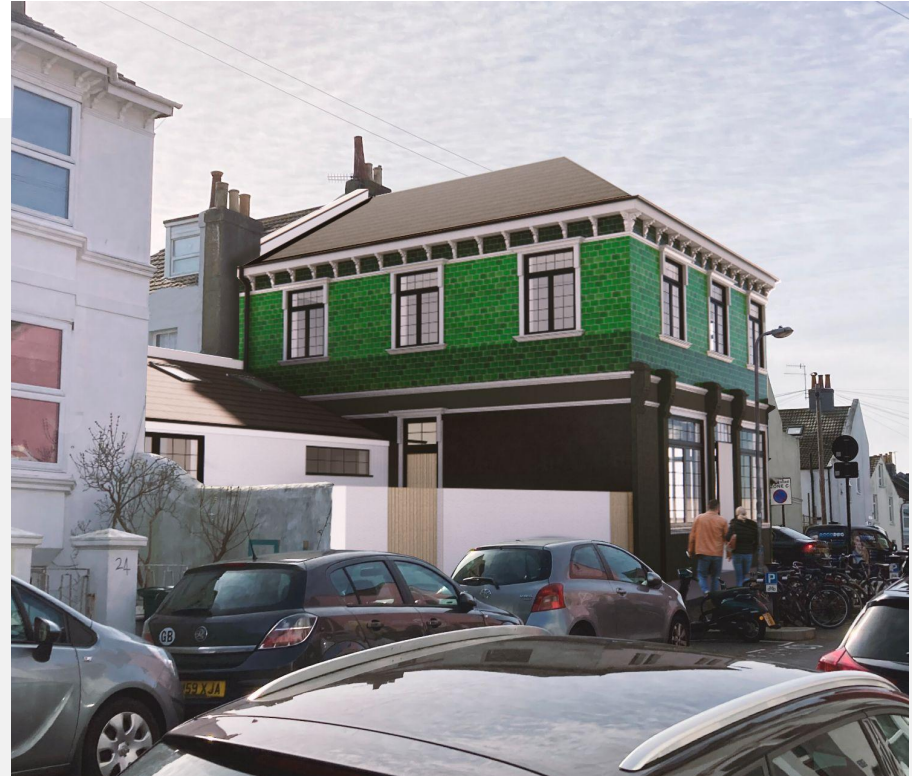
*Proposed Design*

The back extension will be reconstructed in a similar fashion to current structure, featuring a pitched roof and including a private door for deliveries and access, along with bin storage. The redesign of the rear is intended to create a more cohesive aesthetic compared to the current mishmash of poorly executed modern extensions added over time.
