**Bat Survey Report for
9 Oxford Street, Leamington Spa,
CV32 4RA**

2nd March 2024

9 Oxford Street, Leamington Spa – Bat Survey Report

Report Number: 4685-CWS-01

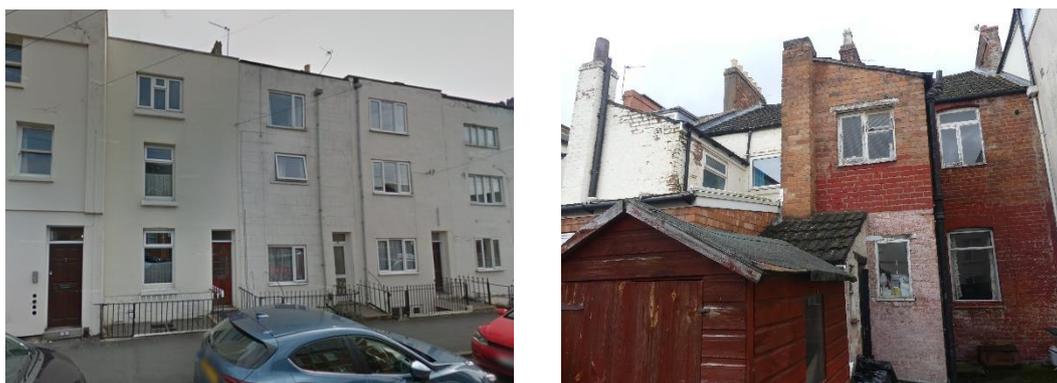
Figs. 1 & 2 Front and rear views of the house

The survey site comprised a terraced three storey town house with rear extensions (Figs. 1 and 2).

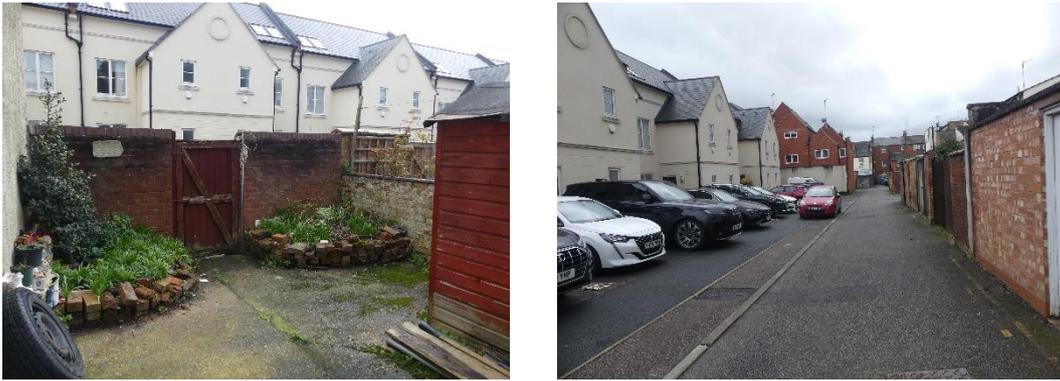
Figs. 3 & 4 Rear yard (L) and Oxford Place (R)

The front of the house opened onto Oxford Street, but to the rear there was a small yard with raised flower and shrub beds (Fig. 3).

The house was surrounded on all sides by an extensive residential area with very little vegetation and no trees in any of the neighbouring gardens (Fig. 4).

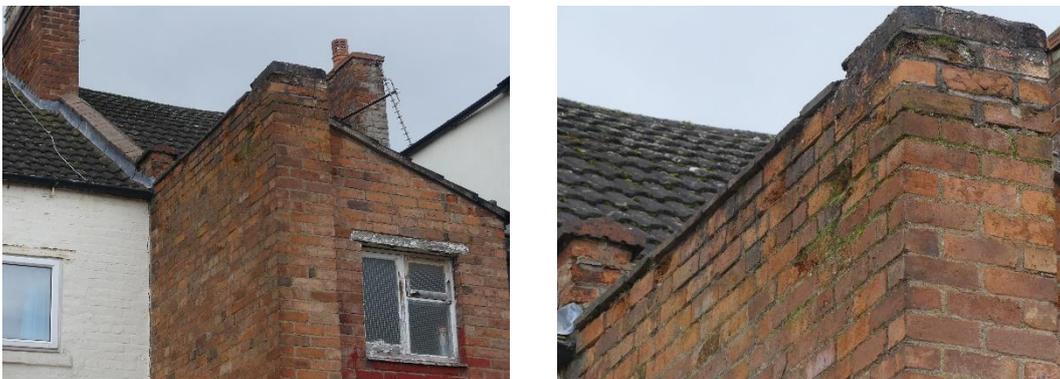
Figs. 5 & 6 Ridge, roof tiles and parapet to rear

The roof of the main part of the house was intact and sealed, with all the roof tiles tightly overlapping and none raised, broken, dislodged or missing (Figs. 5 and 6).

A brick parapet formed the side wall of the two storey rear extension, off which there was a small section of sloping tiled roof, this also tight.

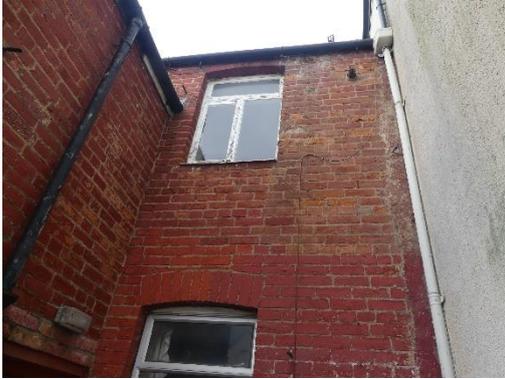
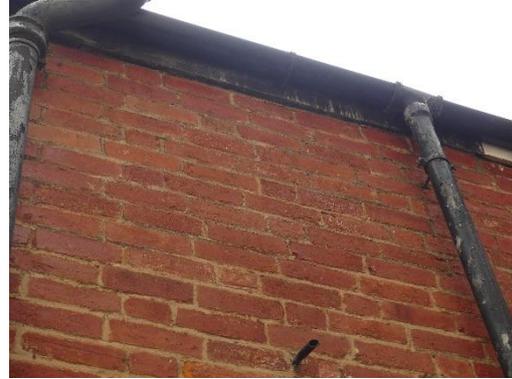
Figs. 7 & 8 Clipped eaves with fascia boards tight

The eaves were clipped, with guttering attached to timber fascia boards, the latter tight against the walls (Figs. 7 and 8). There was a small gap behind a replaced section of fascia, but this was heavily cobwebbed behind and clearly not in use by roosting bats. The verge of the two storey extension roof was fully pointed (Fig. 9).

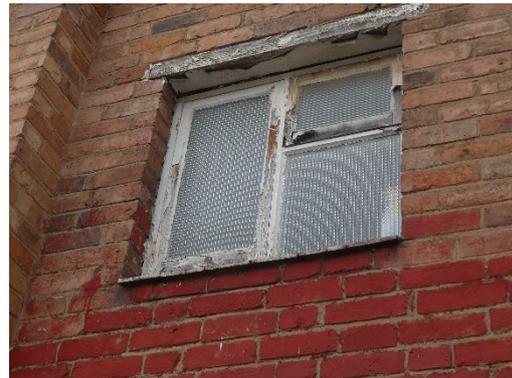
Figs. 9 & 10 Verge fully pointed (L) and bathroom window (R)

The walls were sound throughout, and the window casements and door frames were tightly fitting. A gap was noted behind the bathroom window lintel, but this was thickly cobwebbed inside and was not identified as a suitable bat roost (Fig. 10).

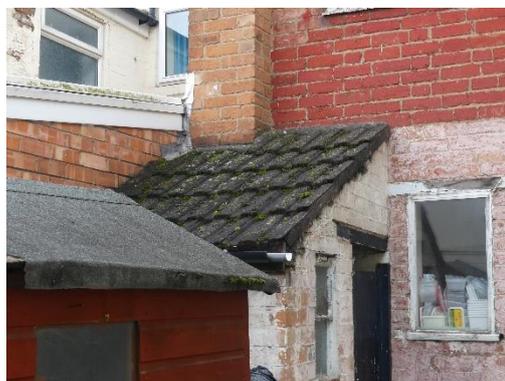
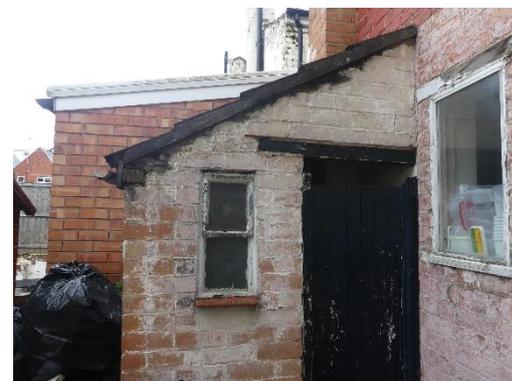
Figs. 11 & 12 Outside toilet

The small outside toilet had a sloping pantiled roof, this tight, with the verge fully pointed (Figs. 11 and 12).

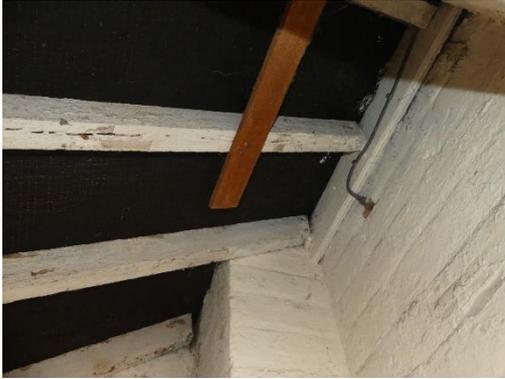
Figs. 13 & 14 Outside toilet roof lining (L) and bathroom (R)

Internally the toilet had no roof void. The roof was lined with tarred felt, and the whole structure was lightly cobwebbed (Fig. 13).

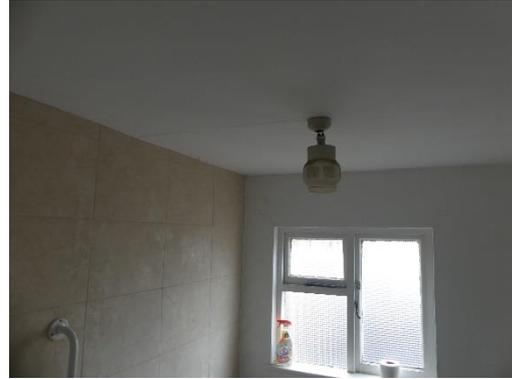
There was no access to the tiny void above the bathroom (Fig. 14), but this measured less than 30 cm high was obviously inaccessible to bats.

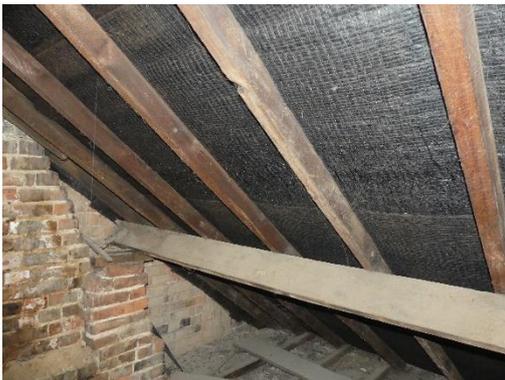
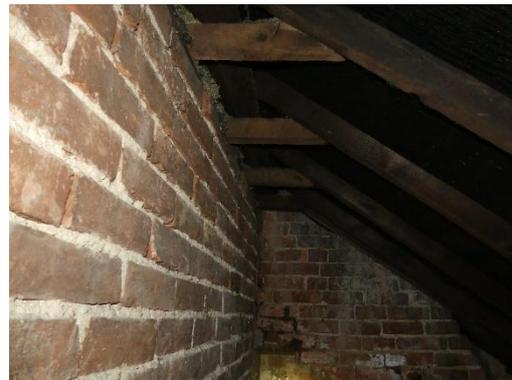
Figs. 15 & 16 Main roof void

The main house roof void was lined with tarred felt and only occupied half of the roof space, as the front half of the void was a bedroom (Fig. 15 and 16). There was no light penetration and the void was considered inaccessible to bats.
