Orchard House, Orchard
Lane, Itchenor,
Chichester, West Sussex,
PO20 7AD

Ecological Appraisal Report

February 2022

Ecological Appraisal Report
Orchard House, Orchard Lane, Itchenor, Chichester, West Sussex, PO20 7AD
for
Marc Boughton

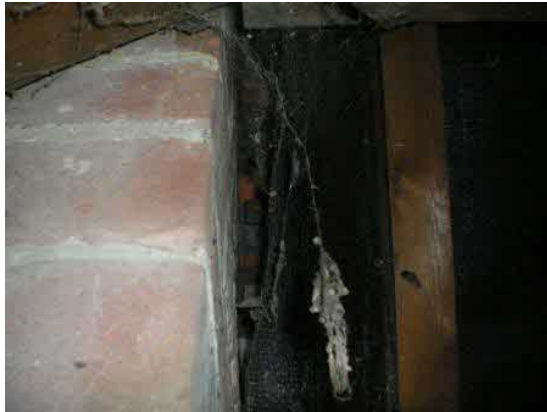
Against the ridge beam

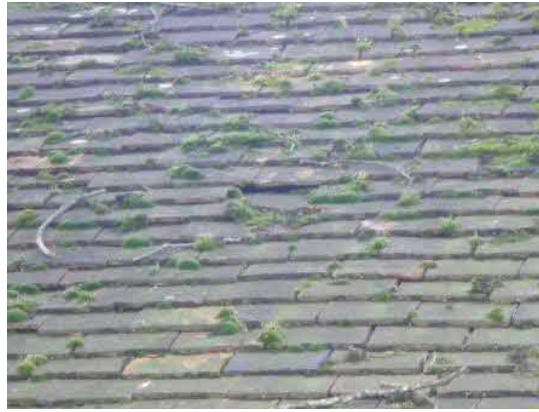
Under roof tiles

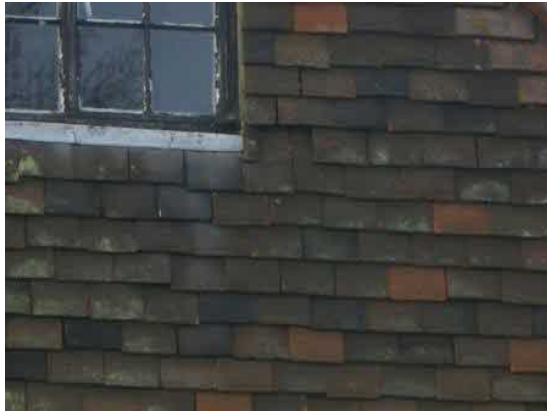
Under hanging tiles

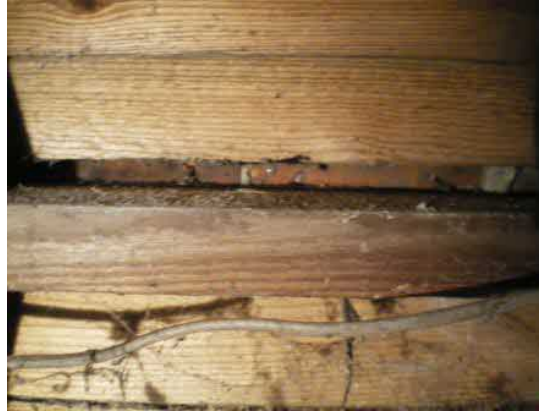
Under wooden cladding and sarking boards

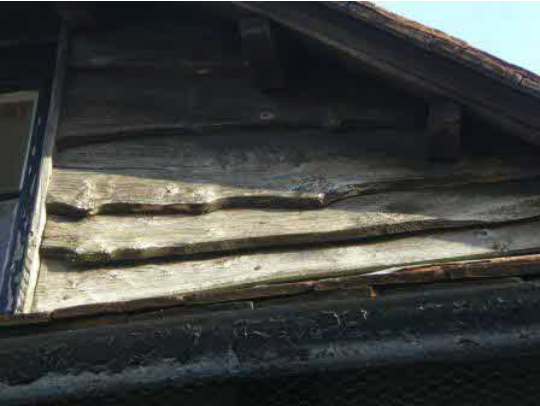
<p>Potential roosting locations</p>	<p>Under wooden cladding</p>

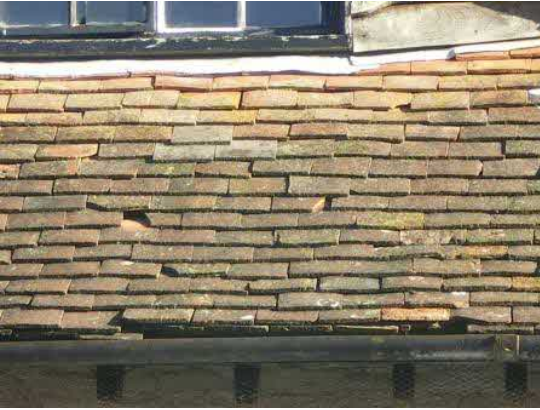
<p>Between roof tiles and roof lining</p>

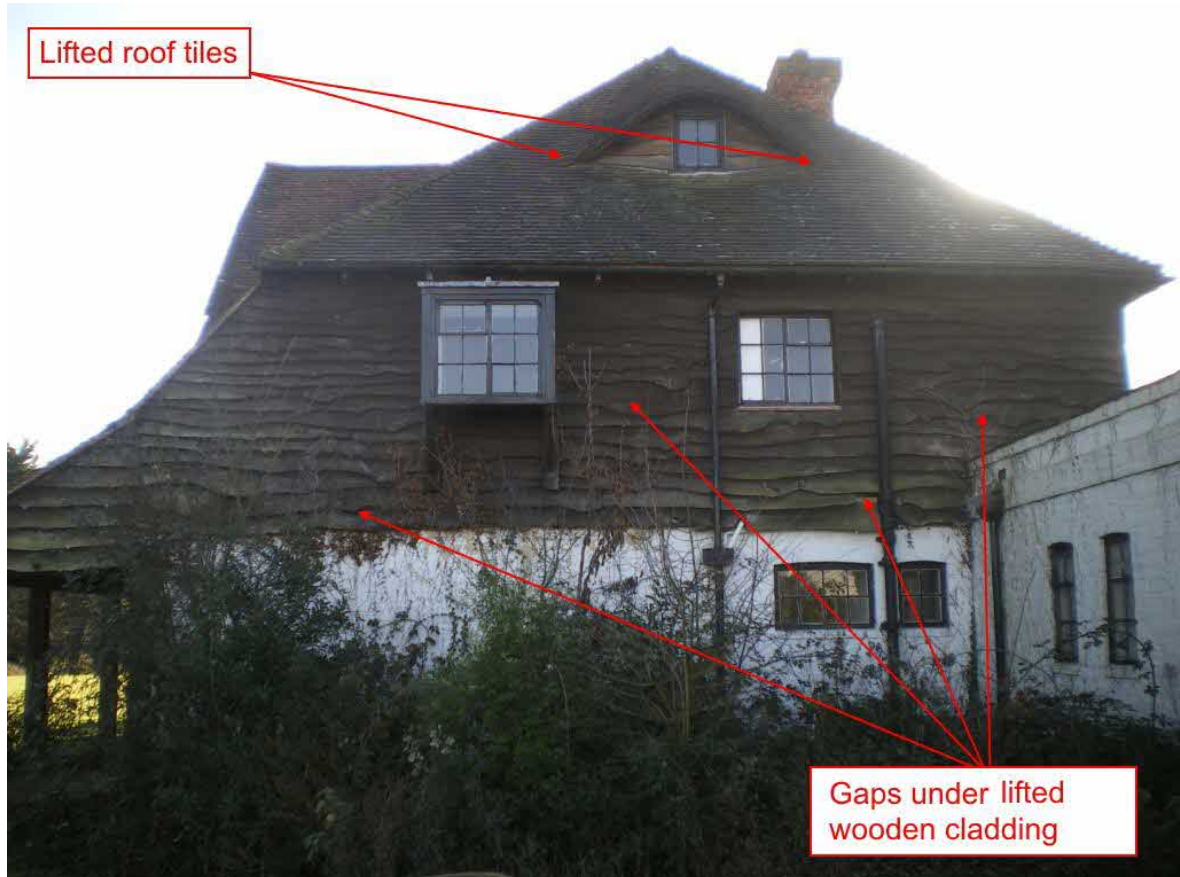
Image 4.3.1.1. Location of potential bat access points and potential exterior roof features on the north elevation of the house.

Most of the roof of the house appears well-sealed and in good condition. However, there are potential bat access points into the roof void as well as exterior features that also provide potential roosting locations for bats. The locations and details of potential bat access points on the house are illustrated in *Images 4.3.1.1 – 4.3.1.4*.

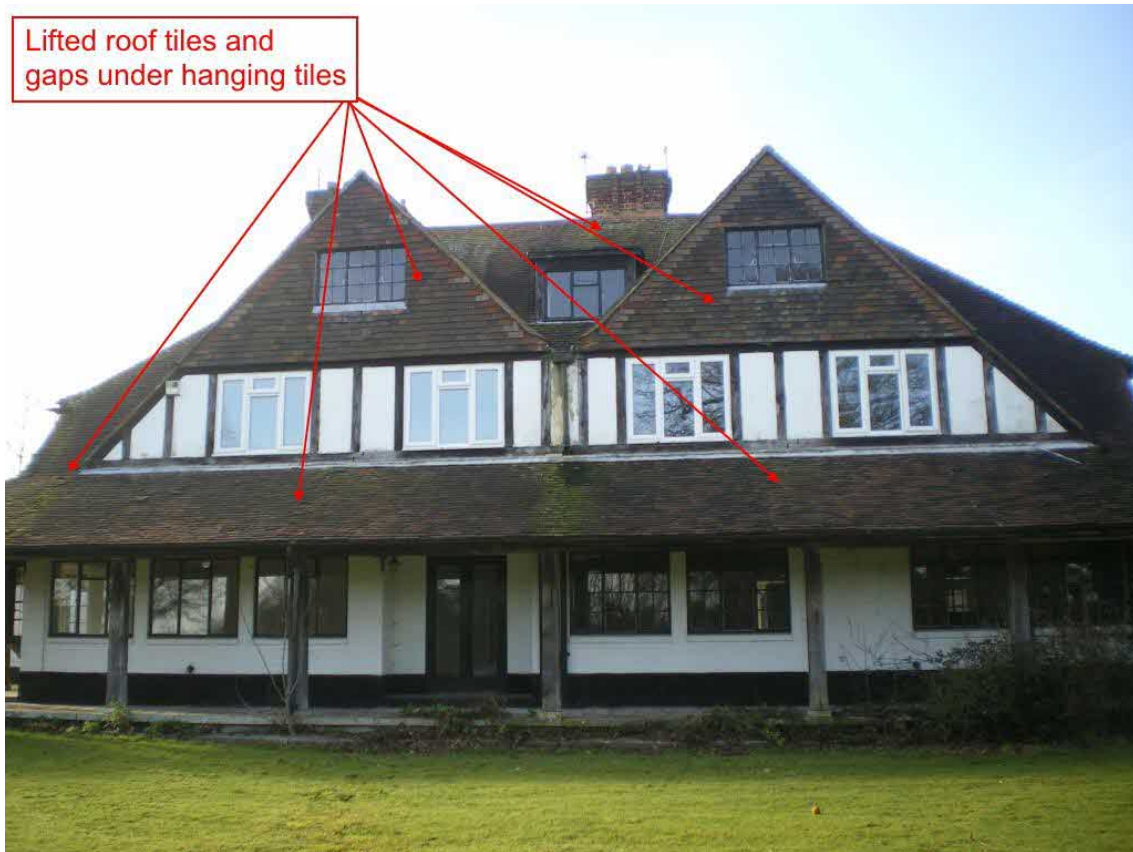
Image 4.3.1.2. Location of potential bat access points and potential exterior roof features on the east elevation of the house.

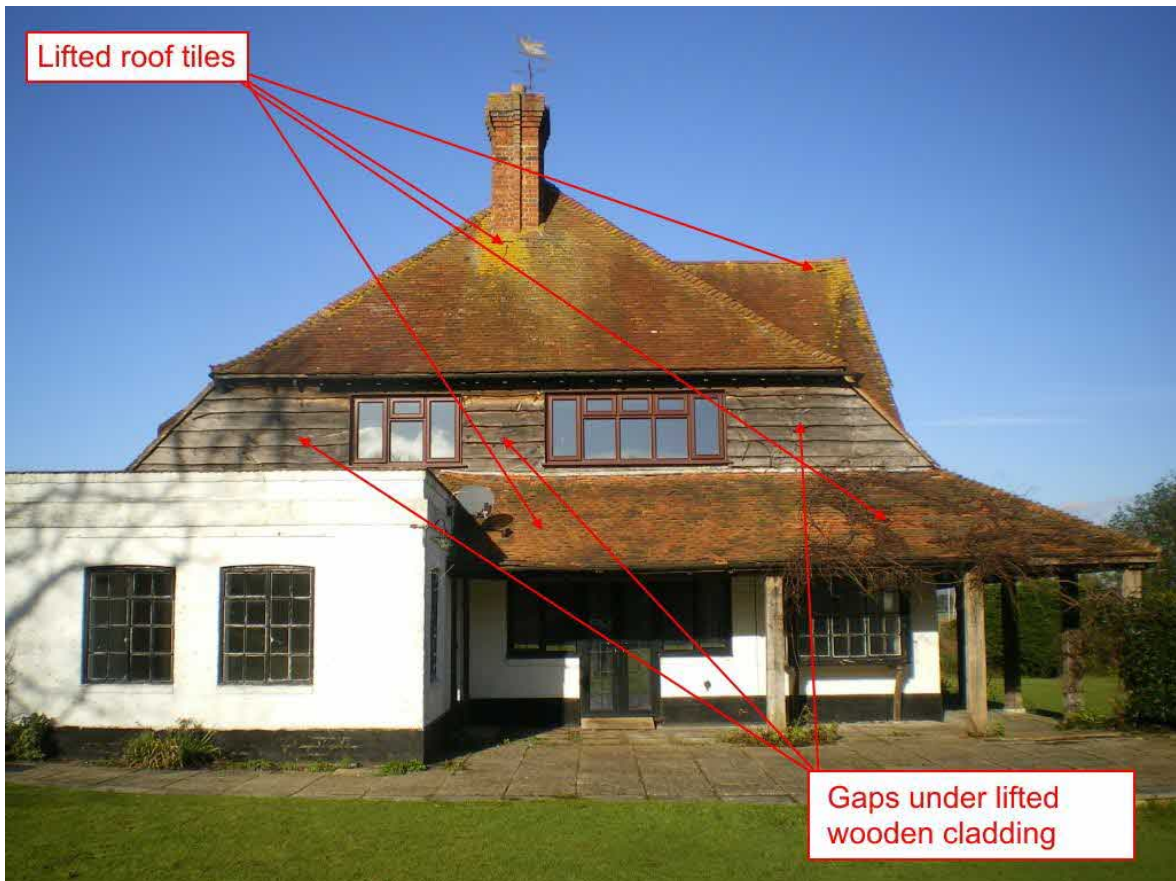
Image 4.3.1.3. Location of potential bat access points and potential exterior roof features on the south elevation of the house.

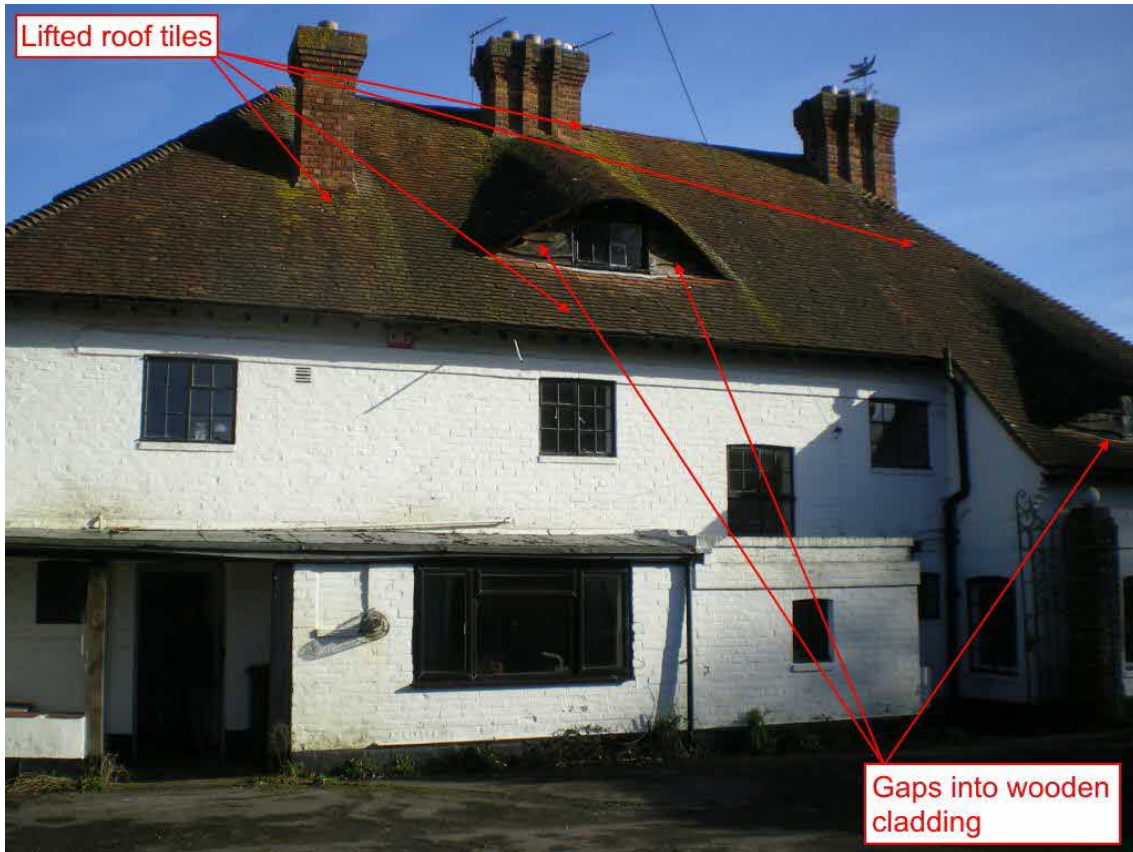
Image 4.3.1.4. Location of potential bat access points and potential exterior roof features on the west elevation of the house.

Due to the presence of these potential access points, and suitable roosting locations, the house is classed as having high suitability to be used by roosting bats, following the criteria in *Table 3.2.4.1*.

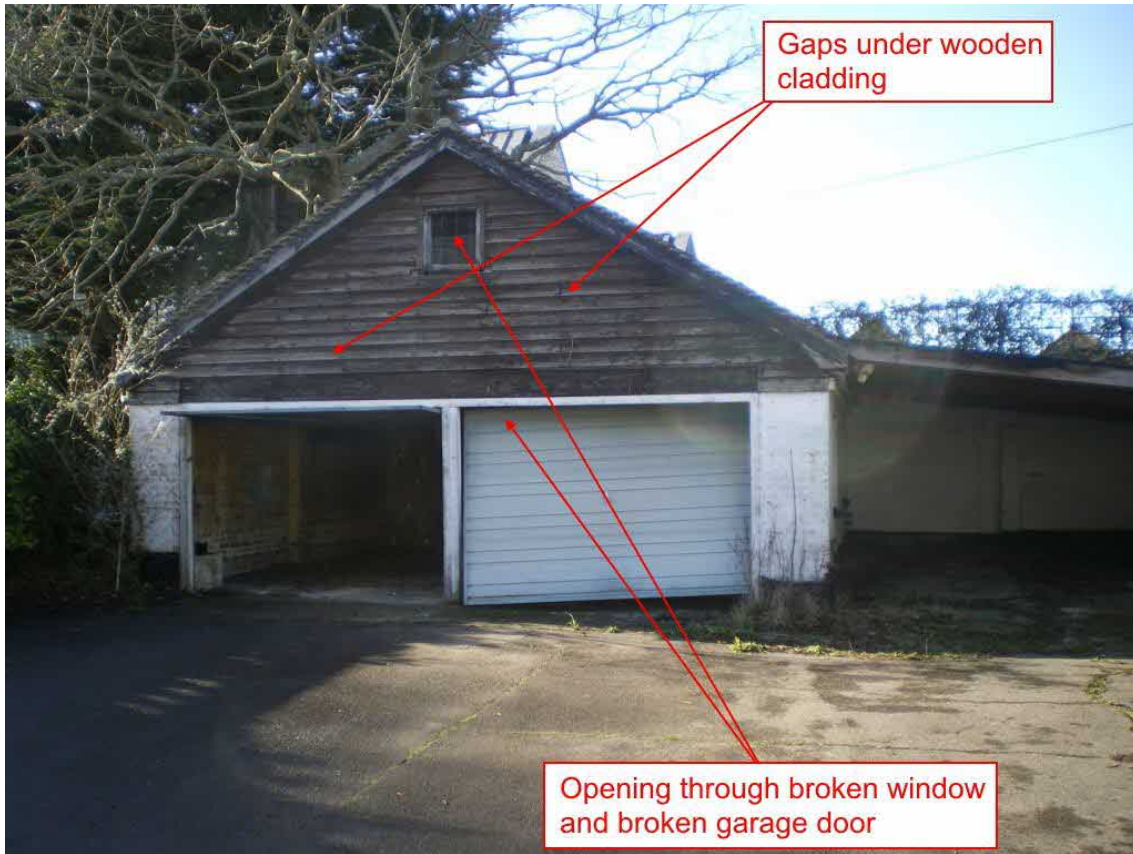
Image 4.3.1.5. Location of potential bat access points and potential exterior roof features on the east elevation of the garage.

Most of the roof of the garage appears well-sealed and in good condition. However, there are potential bat access points into the first-floor space as well as exterior features that also provide potential roosting locations for bats. The locations and details of potential bat access points are illustrated in *Images 4.3.1.5 – 4.3.1.6*

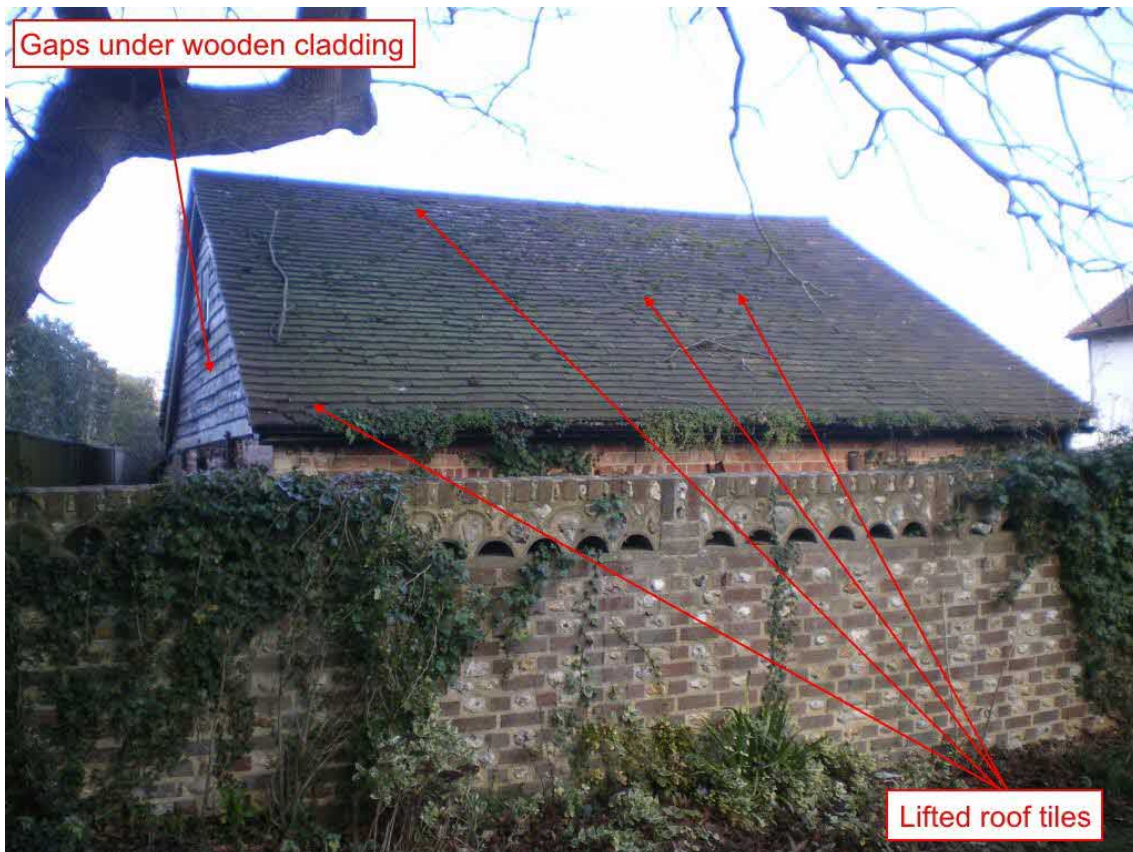
Image 4.3.1.6. Location of potential bat access points and potential exterior roof features on the south and west elevations of the garage.

Due to the presence of these potential access points, and suitable roosting locations, the garage is classed as having high suitability to be used by roosting bats, following the criteria in *Table 3.2.4.1*.

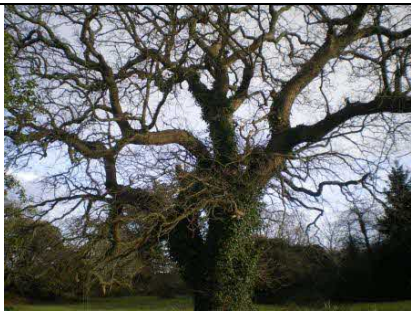
At least three rot holes.

It has high bat roost suitability .
11	<i>Tilia × europaea</i> (Common Lime)

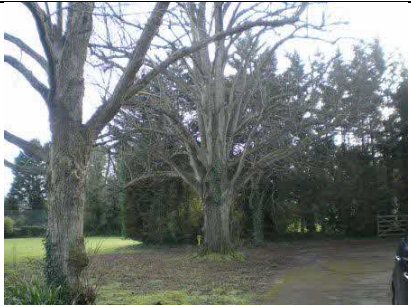
At least one rot hole

It has moderate bat roost suitability .
12	<i>Tilia × europaea</i> (Common Lime)

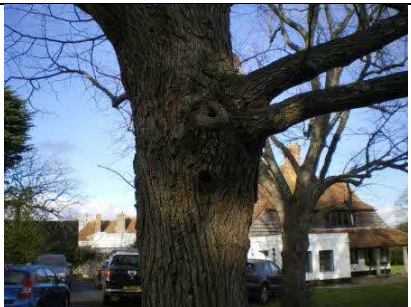
At least two rot holes and two woodpecker holes.

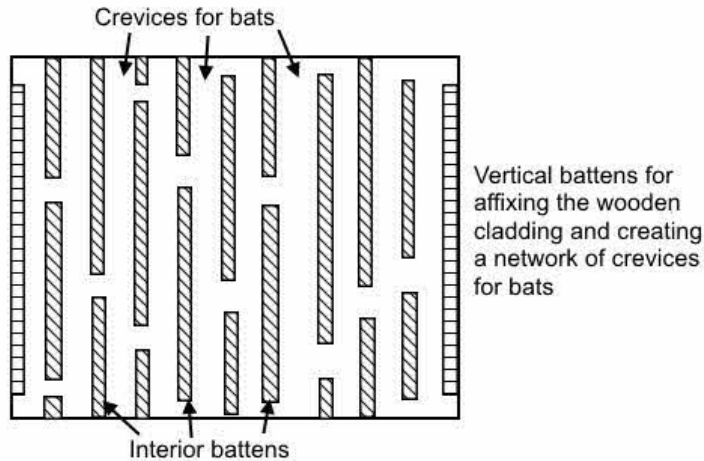
Image 5.6.4.1. Examples of the battens behind the cladding.

The walls will be blockwork with wooden cladding over the top (ideally featherboarding to provide natural gaps as it warps over time). Access will be provided behind the top edge of the wooden cladding on all elevations. The wooden cladding will be mounted on offset battens to allow bats to access the entirety of the area behind the cladding. An example of the offset of battens behind the cladding and access points into the cladding and are given in *Images 5.6.4.1 & 5.6.4.2* below.

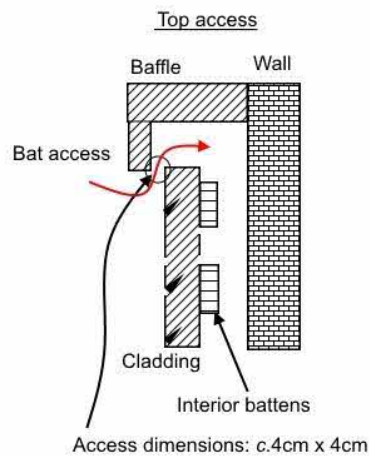
Image 5.6.4.2. Example of access at the top of the wooden cladding.

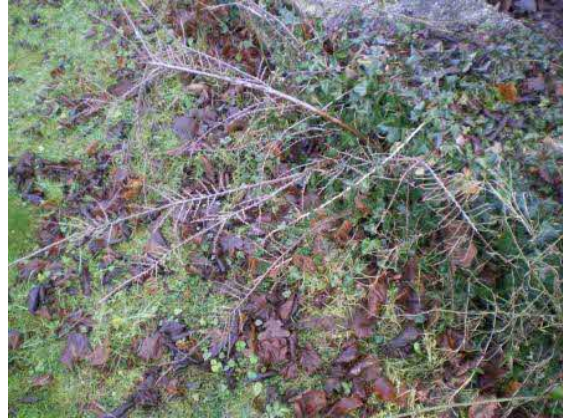
Photo 2. Cotoneaster horizontalis (Wall Cotoneaster) a Schedule 9 species located at Target Note 10 on Figure 3 (taken 22/01/2021).

27. To comply with the law, the *Schedule 9* species *Cotoneaster horizontalis* (Wall Cotoneaster) should be controlled and eradicated so not to cause the plant to spread on this or other sites as a result of earth moving, soil/rubble removal or other operations. However, if in an area unaffected by the works, the plant can remain in situ with the areas fenced off for the duration of the works. This will prevent machinery, tools or boots accidentally carrying it off site. Further information on the methods of removal is given in *Section 5.6.3*.
