## Phase 1 GeoEnvironmental Desk Study

Higher Gibfield Barn

Burnley

**Report No. A5910/24/FDS**

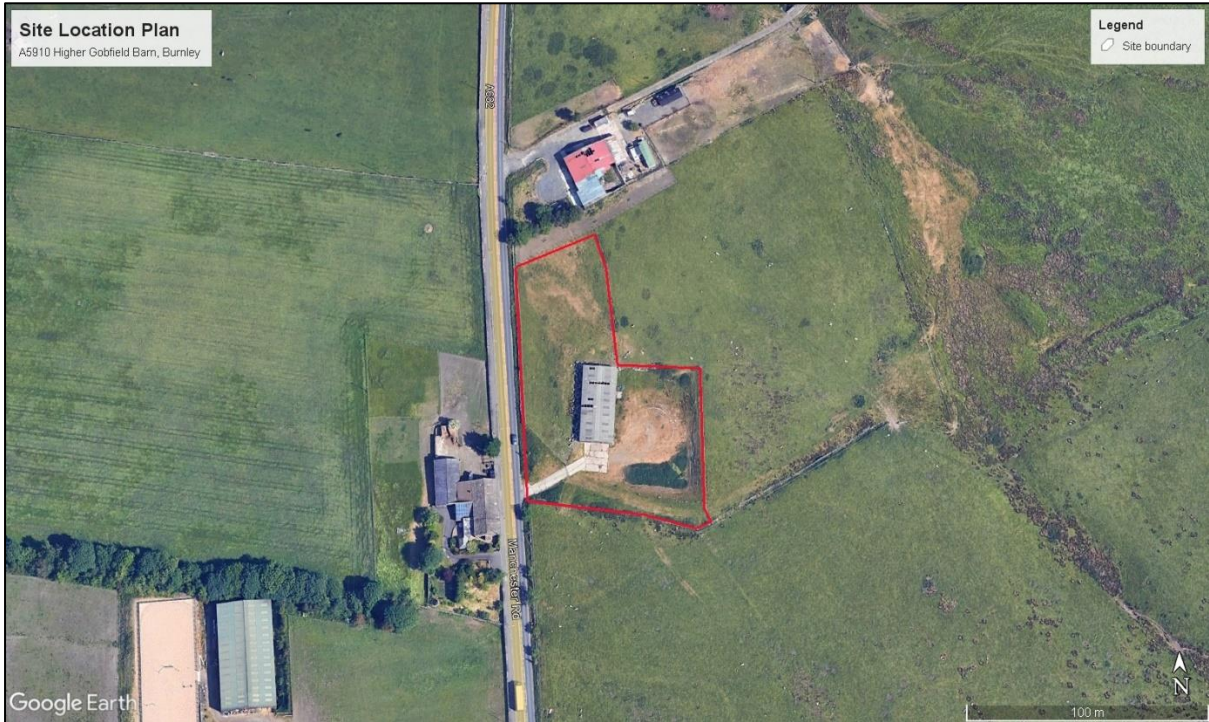
**Figure 2 Site Location Plan**

- 2.6 The general surrounding area comprises of agricultural land and farmhouses. Manchester Road is adjacent to the western boundary of the site.
- 2.7 A location plan is shown below as Figure 2, together with a recent site photograph as Figure 3 (overleaf).

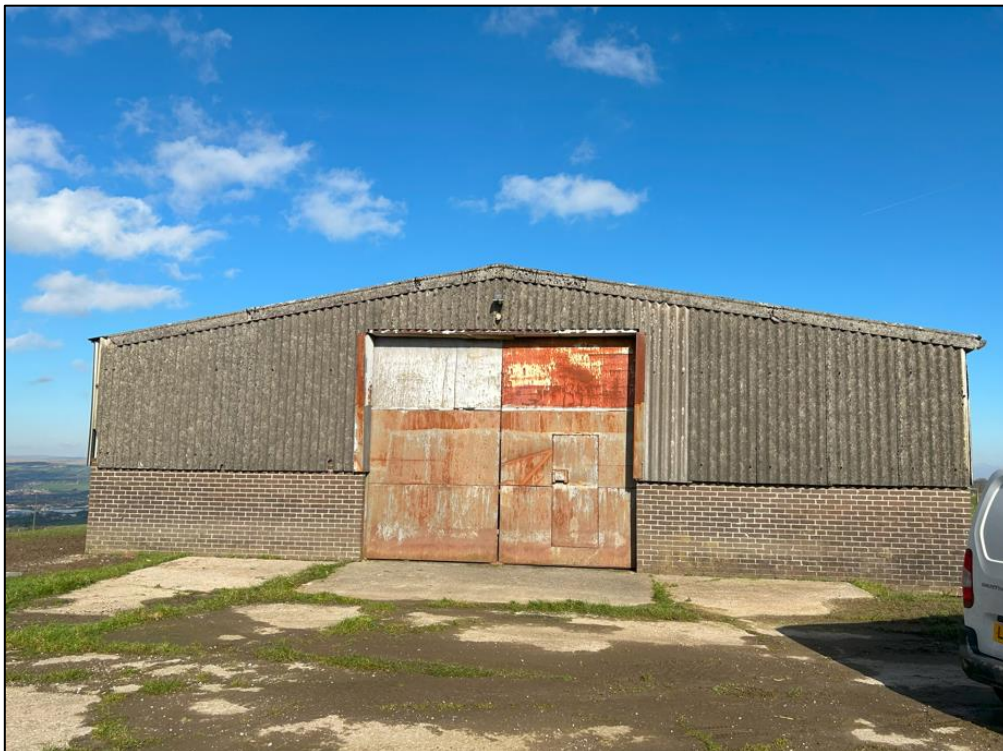
**Figure 3 Site Photograph**

- 2.5.2 The barn is currently derelict with an entrance to the south and east.
- 2.5.3 The only hardstanding on site at the time of the walkover was the road leading to the barn.

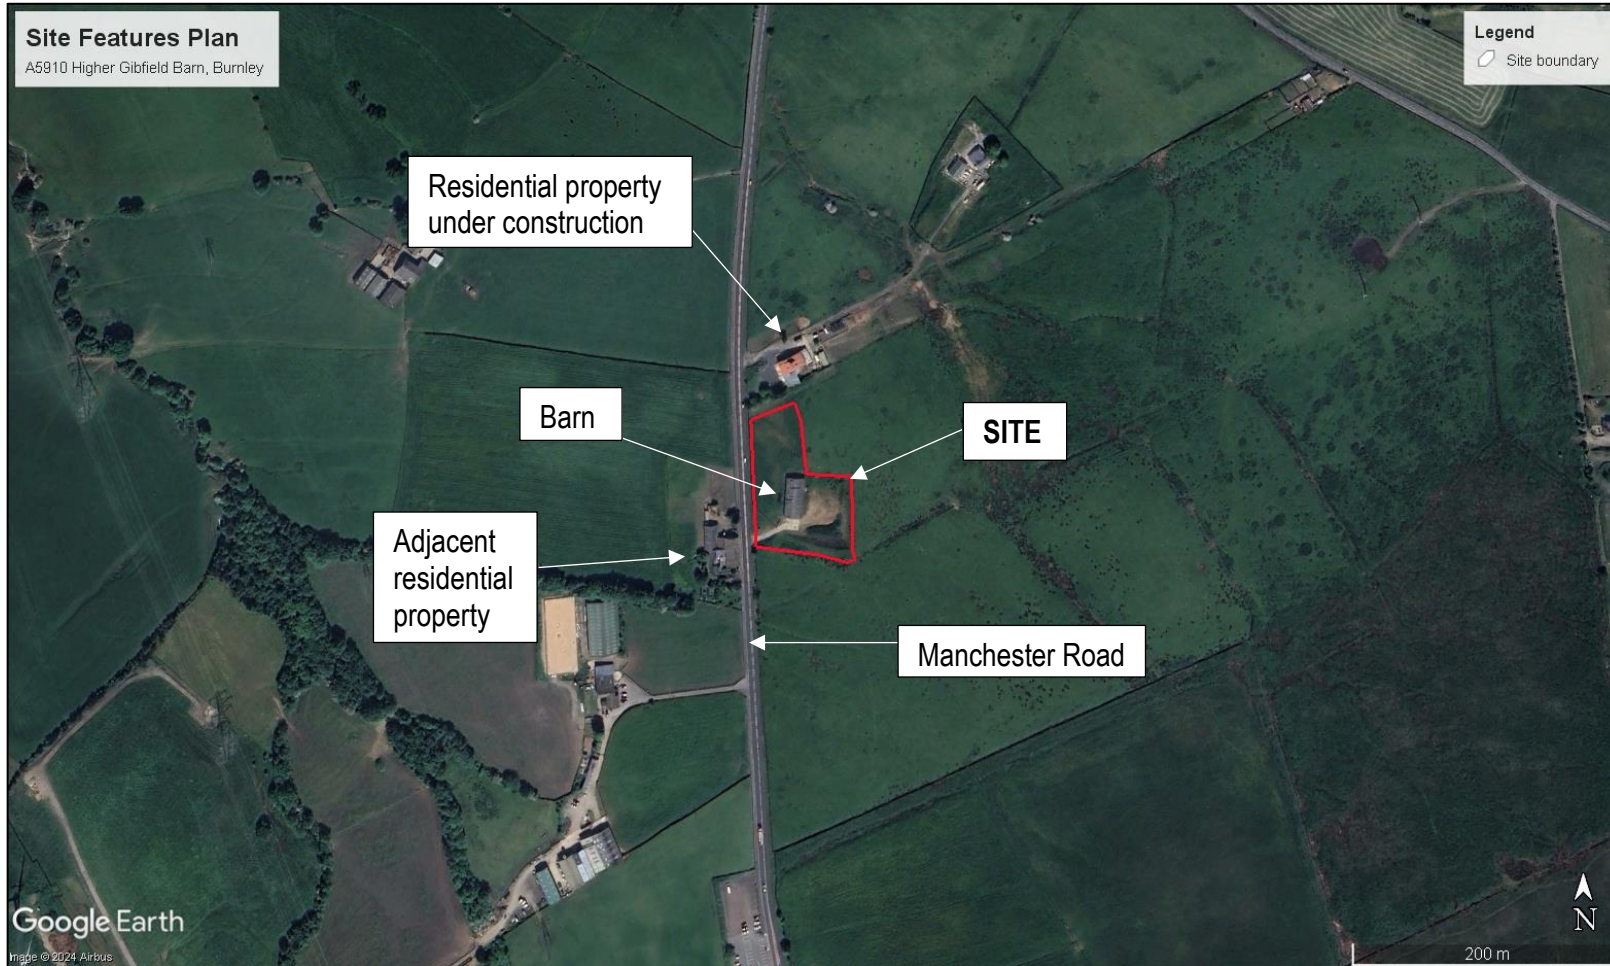
Figure 10 Site Features Plan

- 5.4 The barn is derelict with broken and missing metal sheet padding to the walls and roof.
- 5.5 The site is demarcated by a residential property to the north of the site, which is under construction. Rolling hills to the east and south. Manchester Road and another residential property to the west.

- 5.6 There are no manhole covers or overhead telephone cables present on site.
- 5.7 Generally, the immediate surrounding area is comprised of rolling hills and farmhouses.

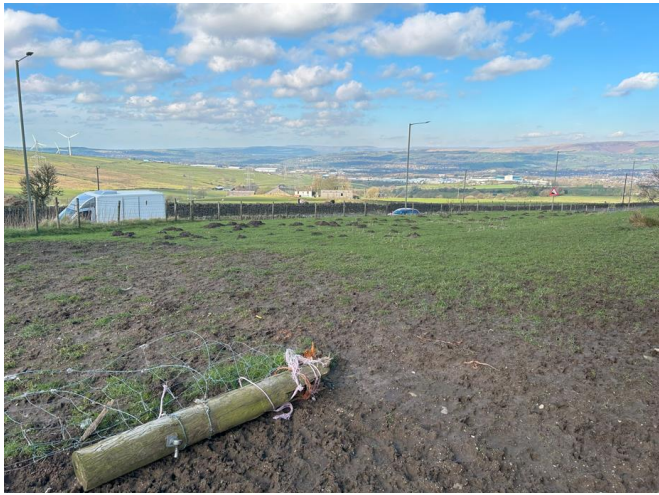
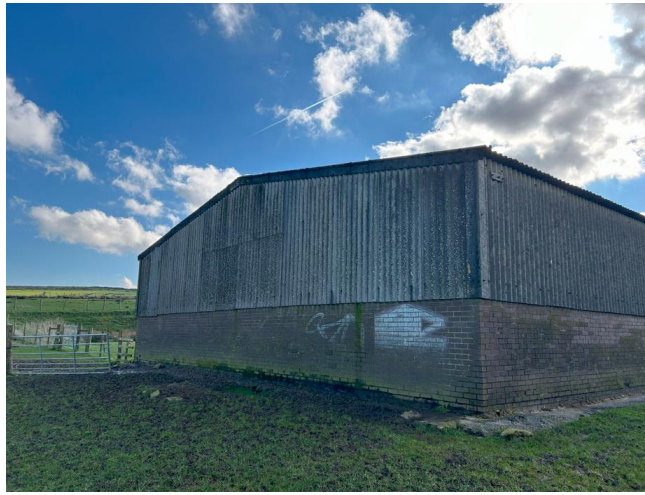
<p><b>Job No.:</b> A5910/24/FDS</p>	<p><b>Site:</b> Higher Gibfield Farm, Burnley</p>
<p><b>Plate 5 Viewing northwest showing Manchester Road and the west of the site</b></p>	<p><b>Plate 6 Viewing southeast showing the back of the barn</b></p>
