RE: Preliminary Bat Roost Assessment. Little Copse, Long Sutton, RG29 1SR

This letter outlines the results of a preliminary bat roost assessment of the Little Copse dwelling located off The Street, Long Sutton, RG29 1SR (located at OS grid reference SU 740 473 (Fig 1)). This was requested by the Local Planning Authority (LPA) following proposals for renovations and modest extensions to the existing property on-site.

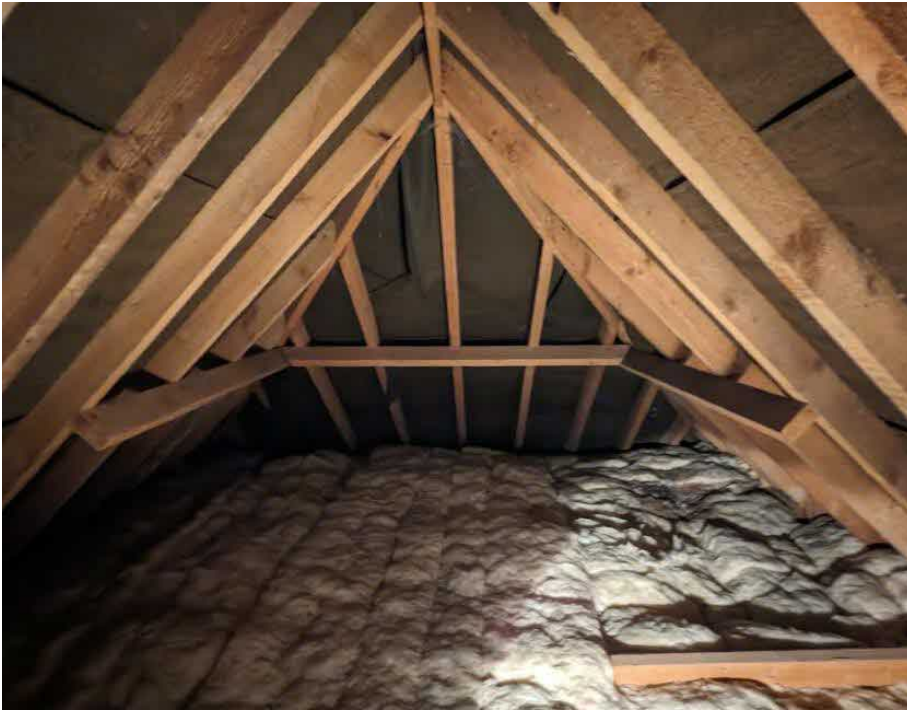
The main focus of this assessment was on the rear of the property as this is the area where there will be impacts to the roof from extensions (although the loft inspection covered the whole roof space). Internally, the loft space was large and relatively unobstructed with bitumen felt underling the roofing tiles (this was largely intact, although a few tears were noted) (Fig 2). No evidence of bat occupation was noted.

Figure 2. View of the loft space with this section the area that will be extended slightly (taken March, 2024).

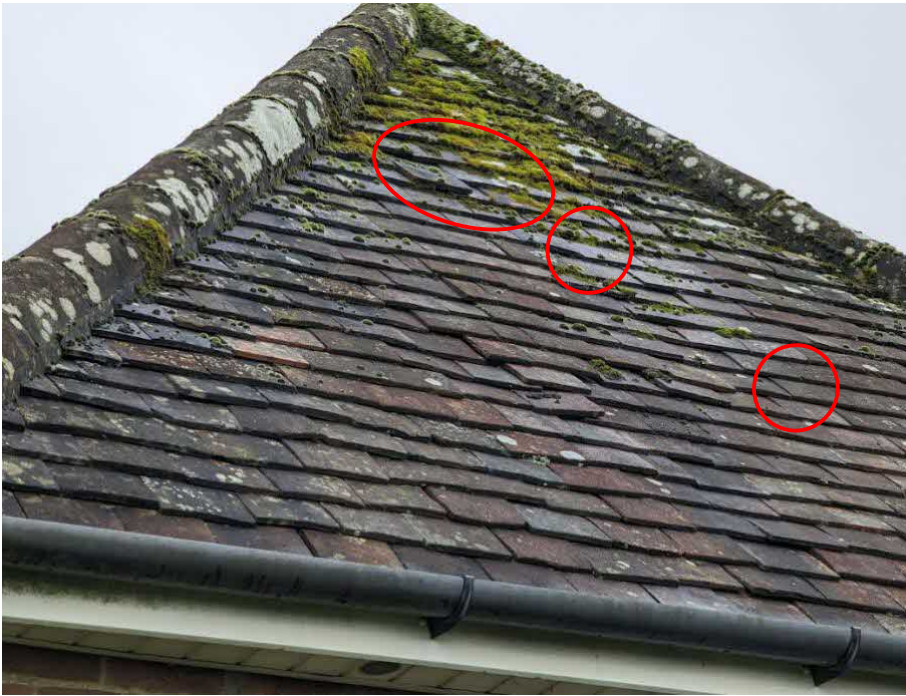
On the externals, the roof was formed from pegged clay tiles and as can be seen in Figs 3 and 4, due to the nature of these tiles, a number of PRFs were noted (the soffit box was uPVC and was well sealed against the external bricks work). The PRFs were all raised or slipped roof tiles including areas where the small flat roof section of the building had been tied into the existing roof tiles.

Figure 3. View of the roof section that will be removed for a new gable end with PRFs highlighted (taken March, 2024).

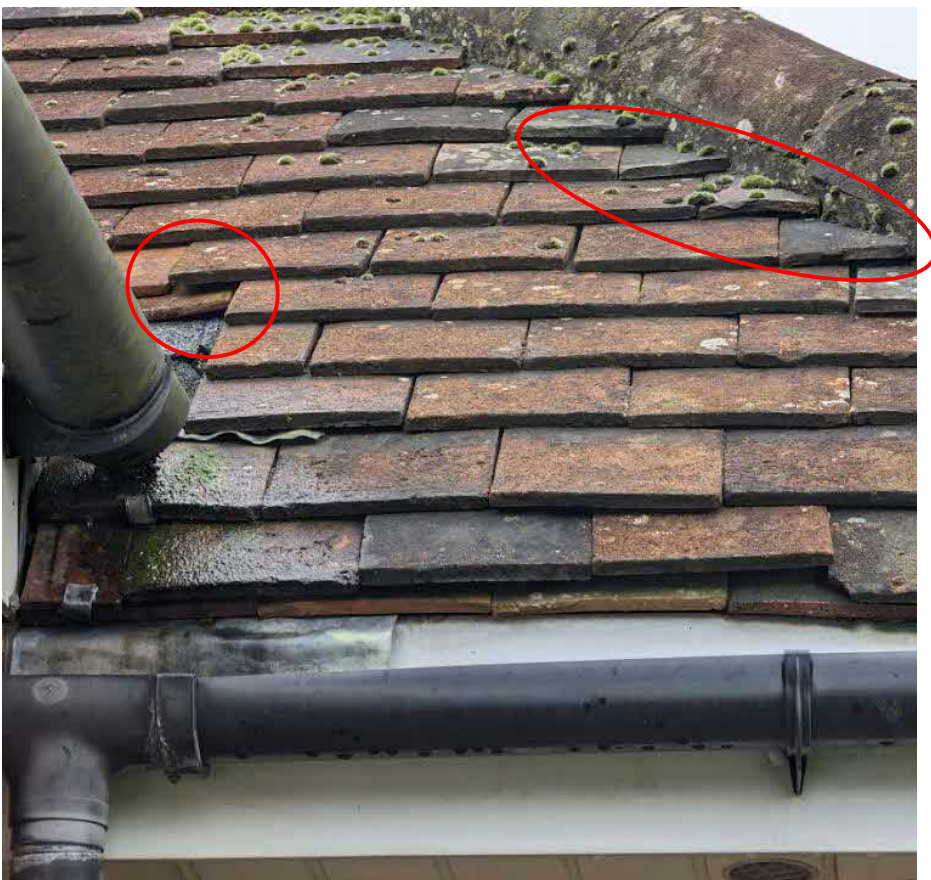
Figure 3. Additional PRFs noted where the existing flat roof section ties into the roof (this area will be impacted upon by the

proposed works)
