Verification of Made Ground Excavation & Topsoil Import

Vale House, Vale Avenue, Horwich

12 March 2024

47800-ECE-XX-XX-RP-C-003

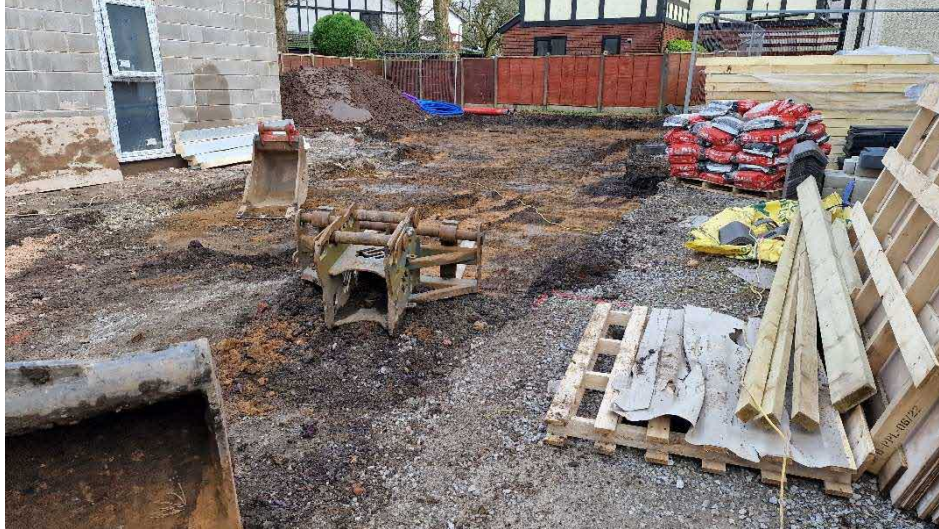
Prepared	JDO	Checked	KE	Job No.	47800	Date	20/02/2024	Photograph No.	1&2
----------	-----	---------	----	---------	-------	------	------------	----------------	-----

Overview of eastern stripped area; topsoil stockpile in distance, which was later removed with underlying made ground excavated. Looking northeast

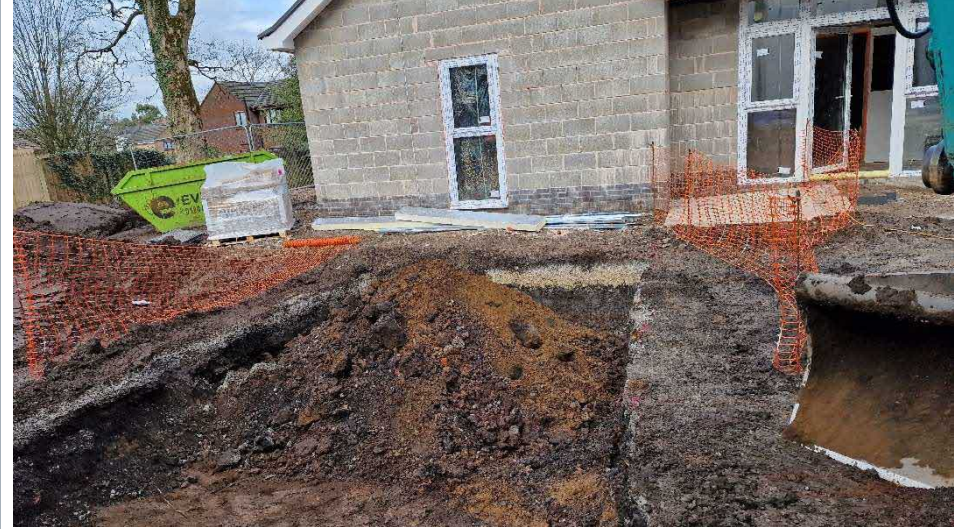
Overview of western stripped area, with spoil heap to be removed. Looking north

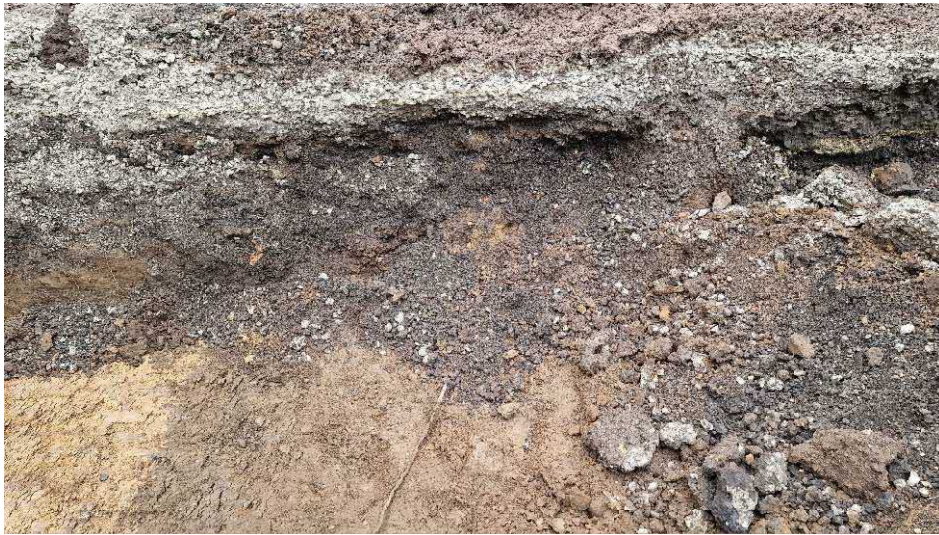
Prepared	JDO	Checked	KE	Job No.	47800	Date	20/02/2024	Photograph No.	3&4
----------	-----	---------	----	---------	-------	------	------------	----------------	-----

Southern wall of the western stripped area showing made ground of gravel and clinker.

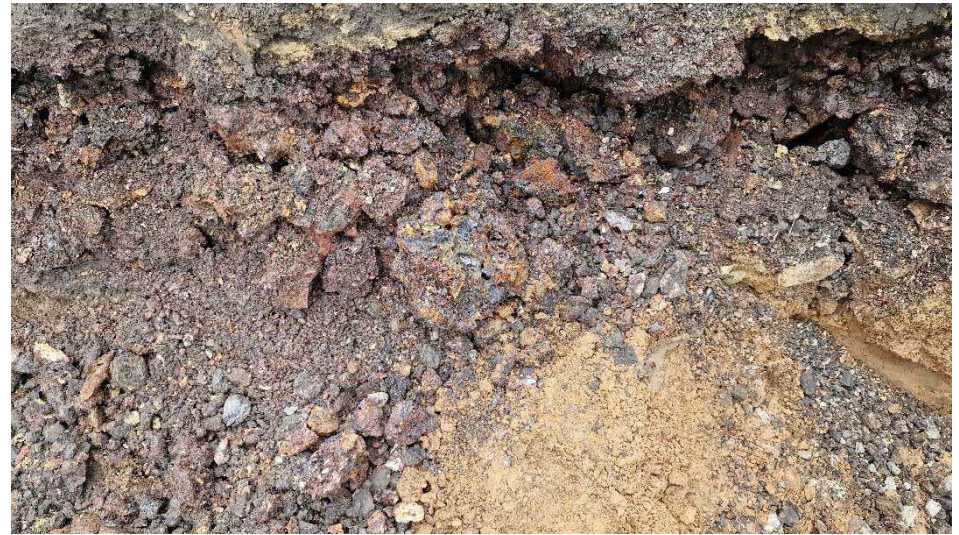
Clinker in eastern wall of the western stripped area.

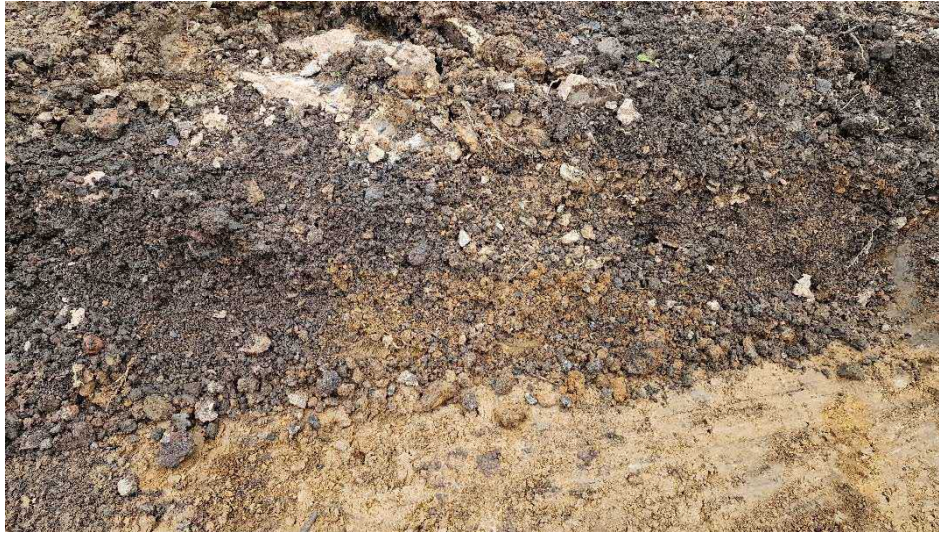
Prepared	JDO	Checked	KE	Job No.	47800	Date	20/02/2024	Photograph No.	5&6
----------	-----	---------	----	---------	-------	------	------------	----------------	-----

Northern side of the western stripped area, south of the existing grassed area. Made ground comprising brick, concrete clinker gravel.

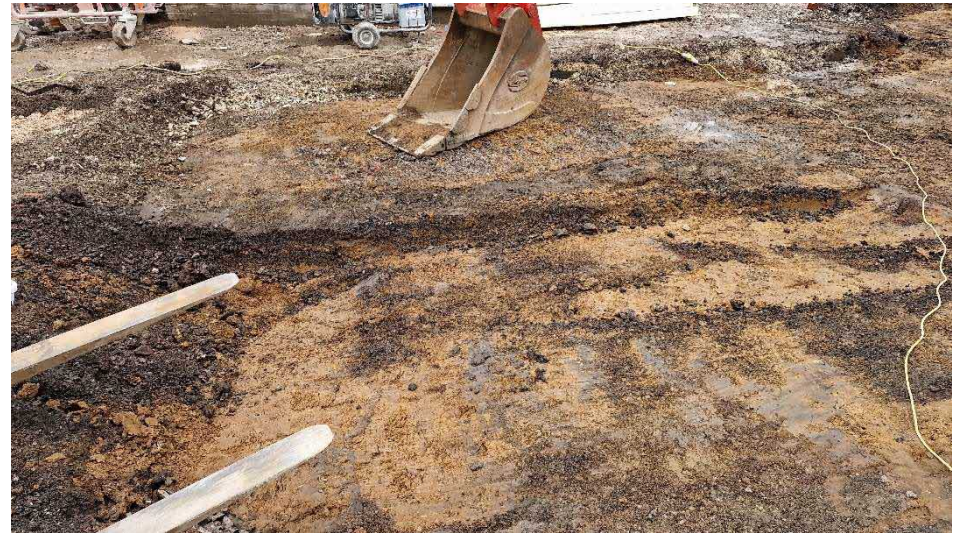
Base of eastern stripped area showing natural ground. Looking north.

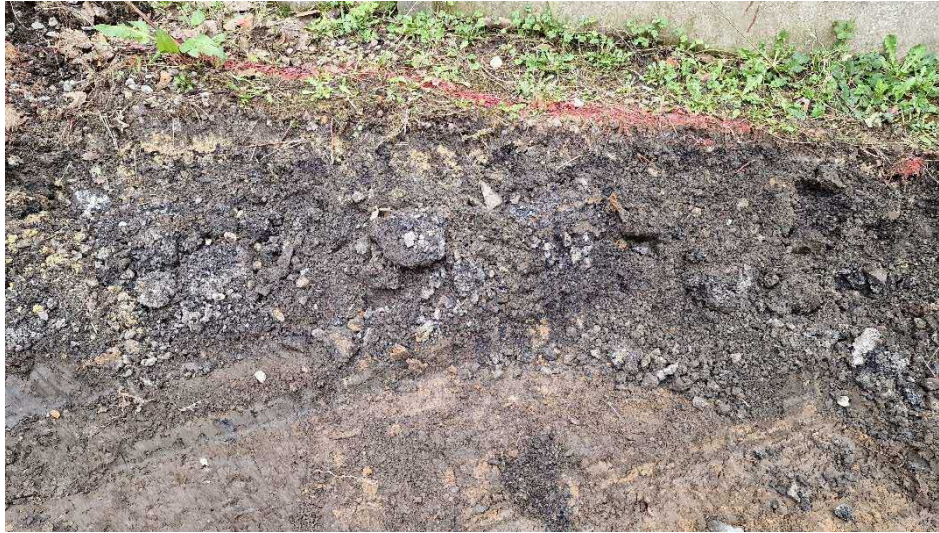
Prepared	JDO	Checked	KE	Job No.	47800	Date	20/02/2024	Photograph No.	7&8
----------	-----	---------	----	---------	-------	------	------------	----------------	-----

Eastern wall of the eastern stripped area showing made ground below thin topsoil on site boundary.

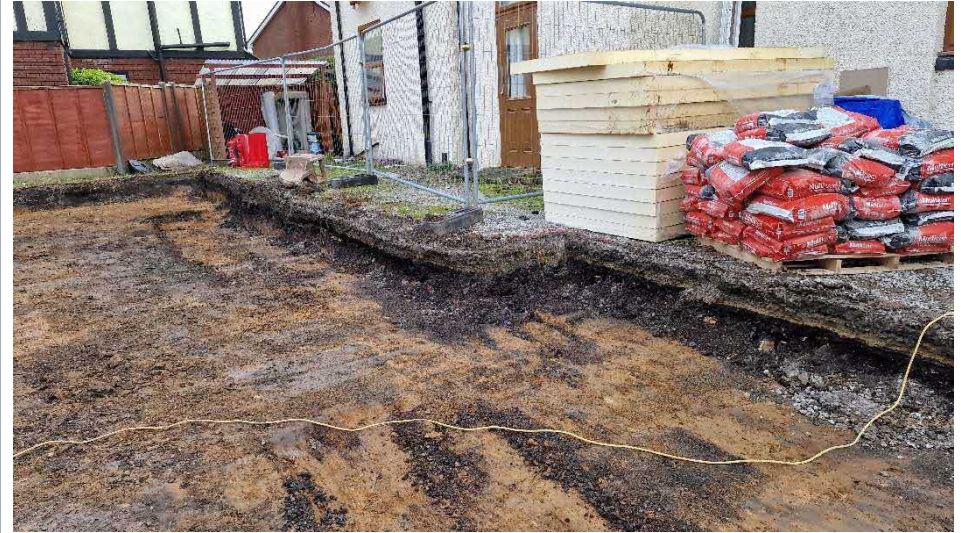
Overview of the southern wall of the eastern stripped area. Looking southeast.

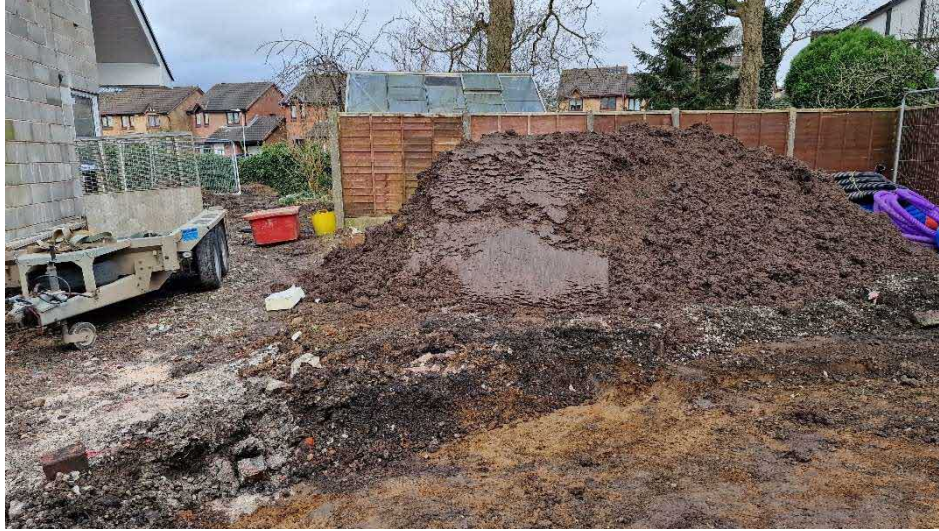
Prepared	JDO	Checked	KE	Job No.	47800	Date	20/02/2024	Photograph No.	9&10
----------	-----	---------	----	---------	-------	------	------------	----------------	------

North eastern area; topsoil stockpile present, which was subsequently moved, and made ground below excavated.

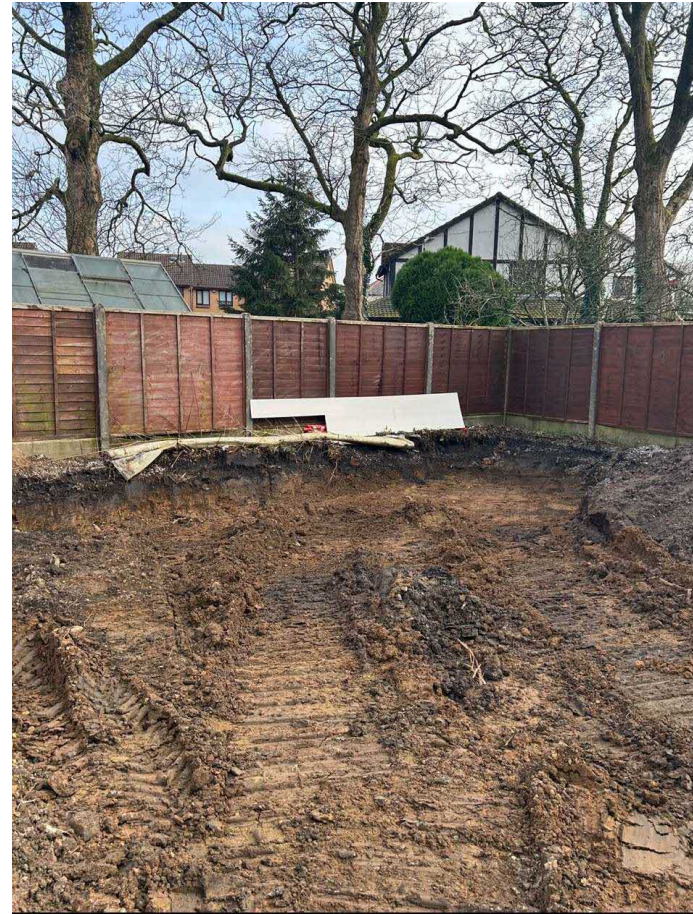
Stripped north eastern area.

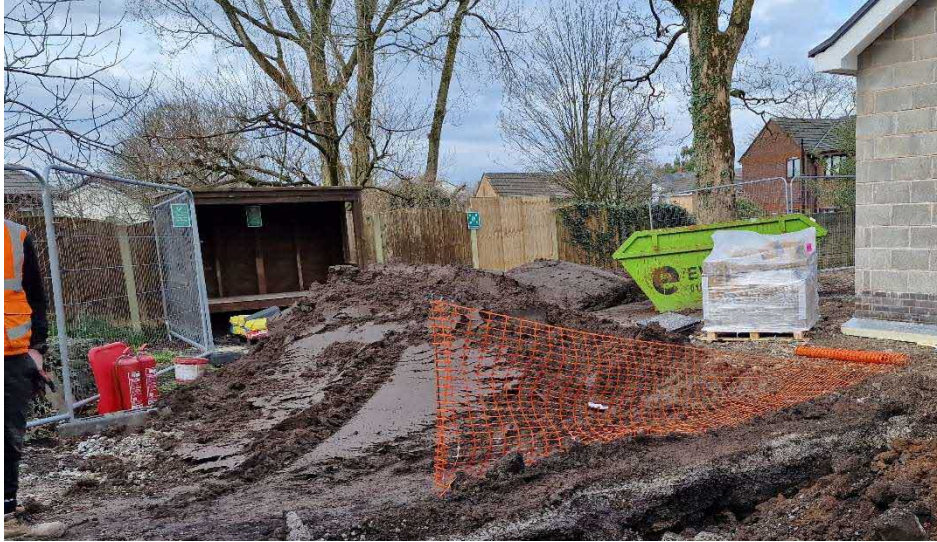
Prepared	JDO	Checked	KE	Job No.	47800	Date	20/02/2024	Photograph No.	11
----------	-----	---------	----	---------	-------	------	------------	----------------	----

Topsoil stockpile in west of the site. Looking west.
