Project Name
LAND SOUTH OF SALISBURY ROAD, TOTTON

Title
SIGNAL JUNCTION TRACKING

Road Safety Audit Stage 1

Land South of Salisbury Road

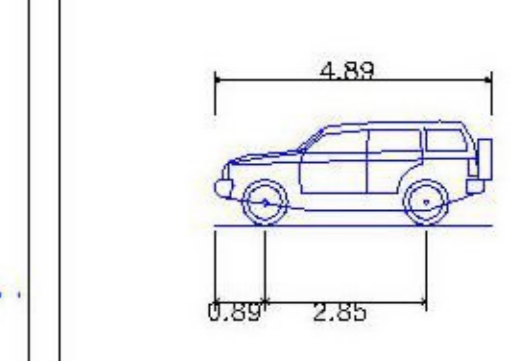
Large Family Car
Overall Length 4.890m
Overall Width 1.940m
Overall Body Height 1.850m
Min Body Ground Clearance 0.258m
Track Width 1.940m
Lock to lock time 4.00s
Kerb to Kerb Turning Radius 5.900m

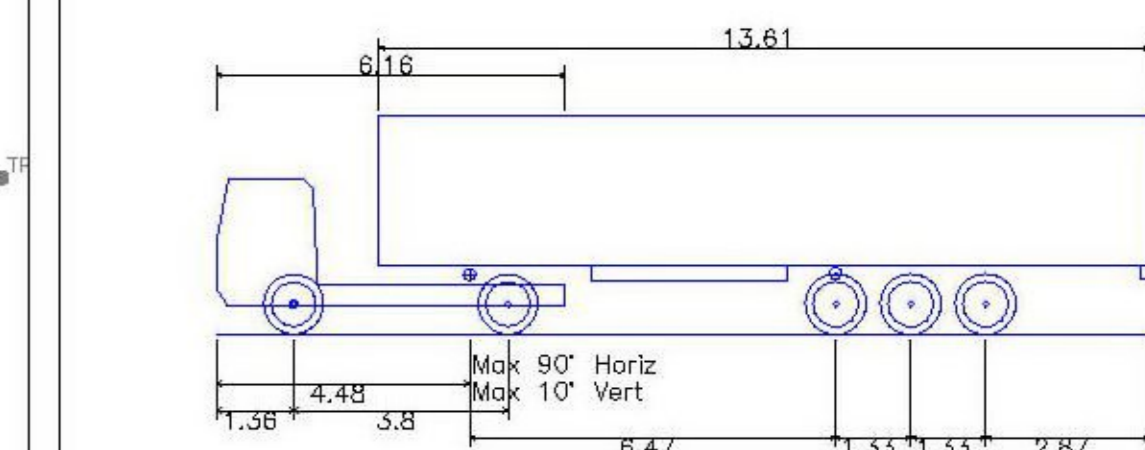
6. ALL TRACKING HAS BEEN COMPLETED WITH A 20MPH DESIGN SPEED, APART FROM THE RIGHT TURN MANOUVRE INTO THE SITE WHICH HAS BEEN DEMONSTRATED AT 15MPH WHICH IS NOT UNREASONABLE IF THE VEHICLE IS WAITING FOR A GAP IN THE TRAFFIC.

FTA Design Articulated Vehicle (2016)
Overall Length 16.490m
Overall Width 3.270m
Overall Body Height 3.000m
Min Body Ground Clearance 2.470m
Lock to lock time 3.00s
Kerb to Kerb Turning Radius 6.600m

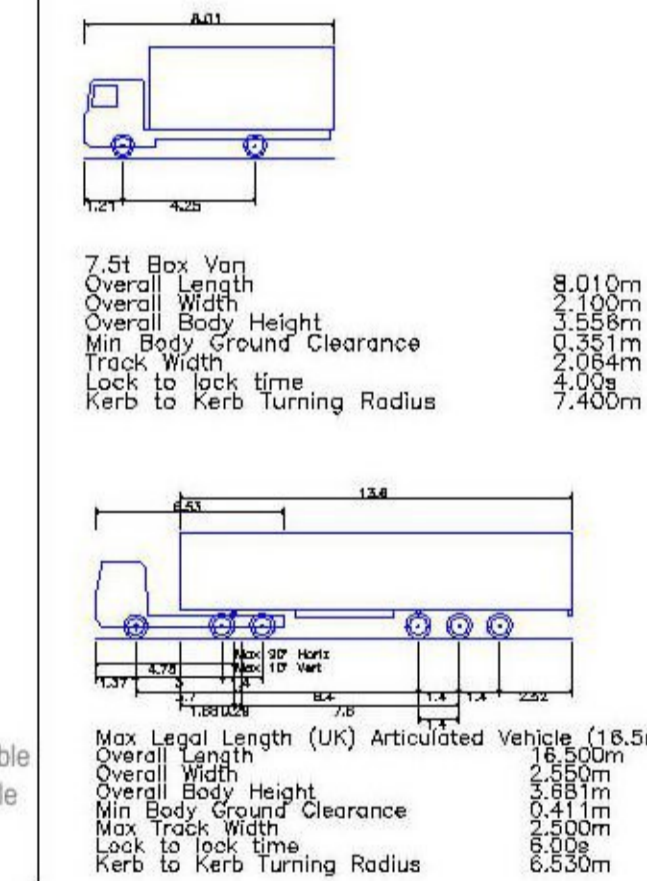
Title
FORWARD VISIBILITY
SPLAYS AND TRACKING OF
INTERNAL BEND

1.5M X 25M FORWARD VISIBILITY SPLAY

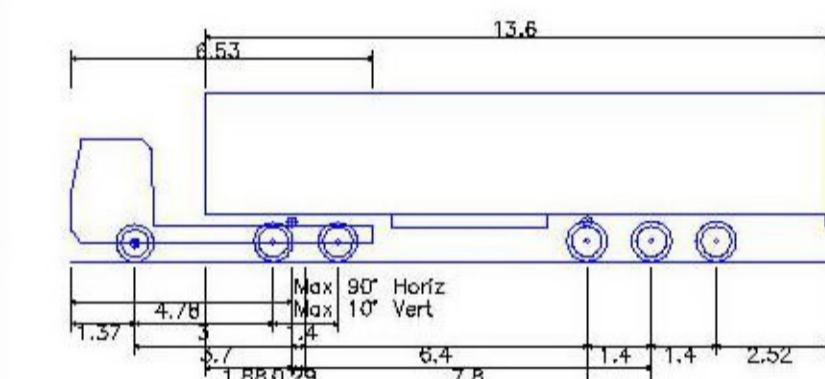
6. VEHICLE TRACKING HAS BEEN UNDERTAKEN TO A 10MPH DESIGN SPEED.

Max Legal Length (UK) Articulated Vehicle (16.5m)
 Overall Length 16.500m
 Overall Width 2.550m
 Overall Body Height 3.561m
 Min Body Ground Clearance 0.411m
 Max Track Width 2.500m
 Lock to lock time 6.00s
 Kerb to Kerb Turning Radius 6.530m

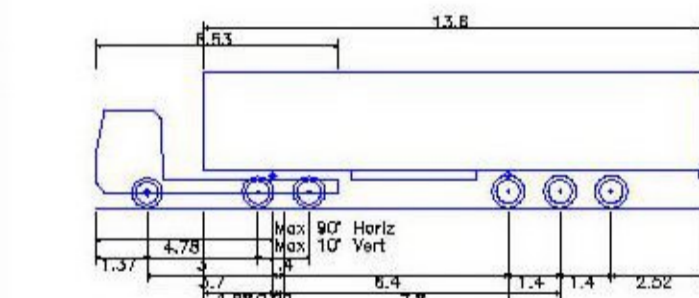
Large Family Car
 Overall Length 4.890m
 Overall Width 1.940m
 Overall Body Height 1.850m
 Min Body Ground Clearance 0.250m
 Track Width 1.940m
 Lock to lock time 4.00s
 Kerb to Kerb Turning Radius 5.900m

Max Legal Length (UK) Articulated Vehicle (16.5m)
 Overall Length 16.500m
 Overall Width 2.500m
 Overall Body Height 3.681m
 Min Body Ground Clearance 0.411m
 Max Track Width 2.500m
 Lock to lock time 6.00s
 Kerb to Kerb Turning Radius 6.530m
