LAND AT CALMORE CROFT FARM, SALISBURY ROAD, CALMORE

Walking, Cycling and Horse-Riding Assessment &
Review

February 2024

Document No:	135.0041/WCHAR/3	
Status:	Original	
	Name	Date
Prepared by:	Oliver Samuel - Camps	November 2023
Checked by:	Shannon Betteridge	November 2023
Approved by:	Kim Hammonds	November 2023

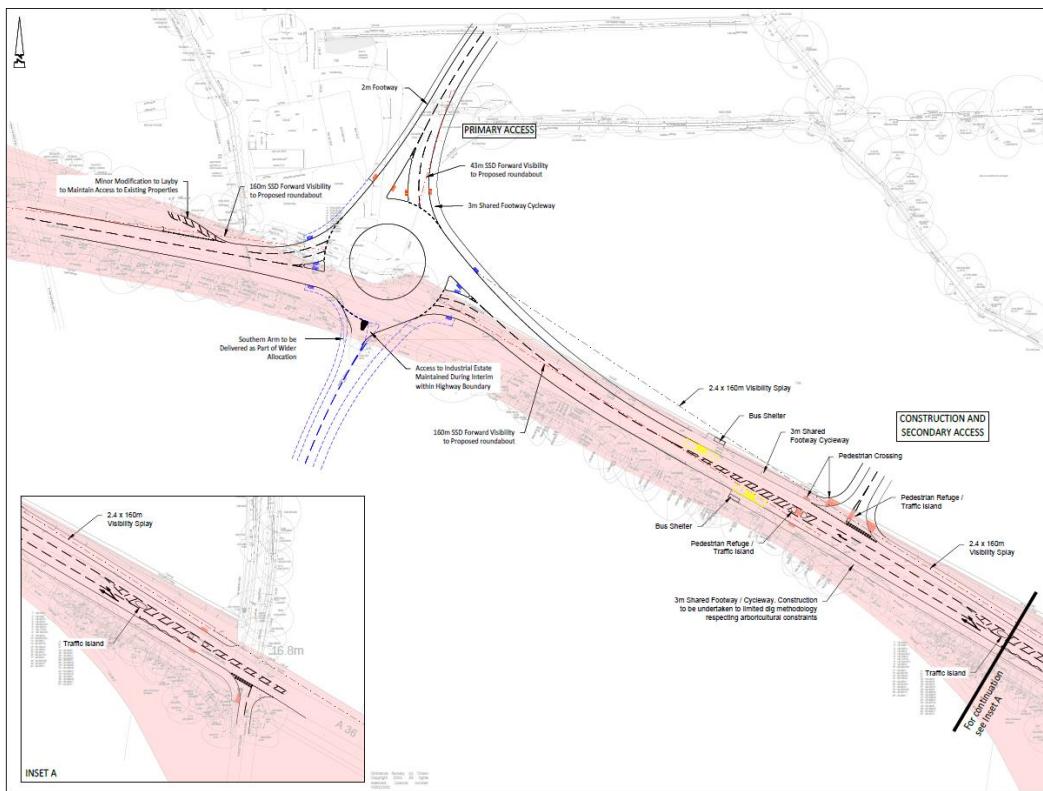
Figure 2: Bloor Homes Improvements

- 1.7 As part of the land north of Salisbury Road development for Bloor Homes, a new 2m wide footway/cycleway is to be provided flanking the western side of the access arm from the roundabout into the Bloor Homes site, with the provision then continuing across the A36 (eastbound) arm of the roundabout and south towards the existing industrial estate (and what is anticipated to provide the access for the southern parts of the SS1: North Totton allocation land).

- 1.8 The Bloor Homes application (ref: 20/10997) also includes a new 3m wide shared footway/cycleway on the eastern side of the new roundabout continuing both eastbound along the A36, before a new crossing facility is provided outside the sites’ secondary access, facilitating the movement of pedestrians and cyclists onto a new 3m wide shared footway/cycleway on the southern side of the A36.

- 1.9 Crossing facilities are also proposed across each arm of the roundabout junction, where appropriate. The proposed access arrangements and associated improvements submitted as part of the Bloor Homes application (ref: 20/10997) are demonstrated in **Figure 2**, and attached as **Appendix B**.

- 2.10 It should also be noted that as part of the Bloor Homes application (reference: 20/10997), a new set of bus stops (complete with shelters and bus cage road markings) are proposed circa 70m east of the new roundabout (circa 400m from the proposed site access) thus reducing the distance between the proposed development site and bus stop provision. This is demonstrated on the drawing included in **Figure 2**.

- 3.3 For access to the westbound bus stops, a refuge island is proposed within the hatching of the secondary site access to the Bloor Homes site, as shown in **Figure 2**. The refuge island would be located to the west of this secondary access.

- 4.2 As already detailed, a new 3m wide shared footway/cycleway is to flank the southern side of the A36 between the new bus stops/secondary site access to the Bloor Homes site and Pauletts Lane. This footway/cycleway is demonstrated to terminate at the Pauletts Lane/A36 junction, as shown in **Figure 2**.

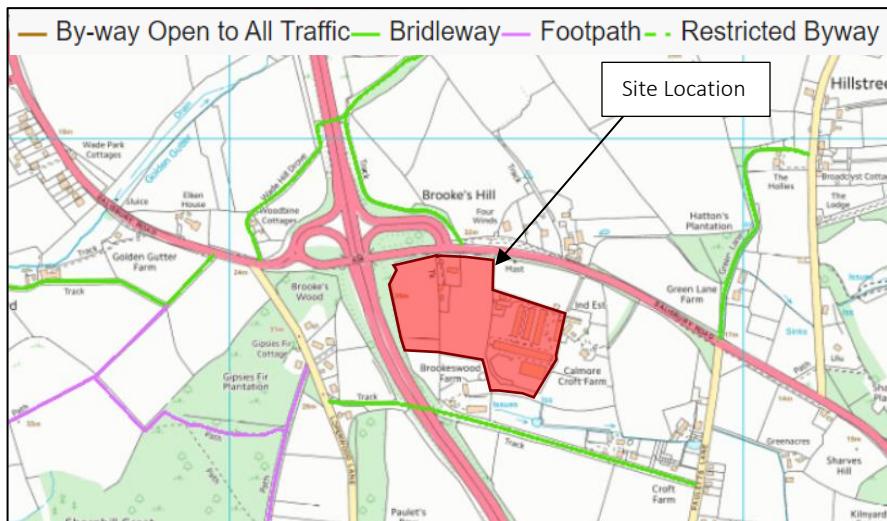
Figure 3: Public Rights of Way (PROW) in the vicinity of the site (Source: HCC)

- 1.12 Whilst there is limited pedestrian infrastructure at present in the vicinity of the site, several Public Rights of Way (PRoW) routes are present. The closest footpath is located circa 350m west of the site (route number 166/5/1) which connects Loperwood Lane with Loperwood. In addition, a bridleway is situated south of the site, connecting Pauletts Lane and Loperwood Lane. The PRoW routes in the vicinity of the site are demonstrated in **Figure 3**.

- 1.13 The location of the PRoW does not typically provide a route between the site and the local facilities and amenities, but do provide suitable options for leisurely walks.

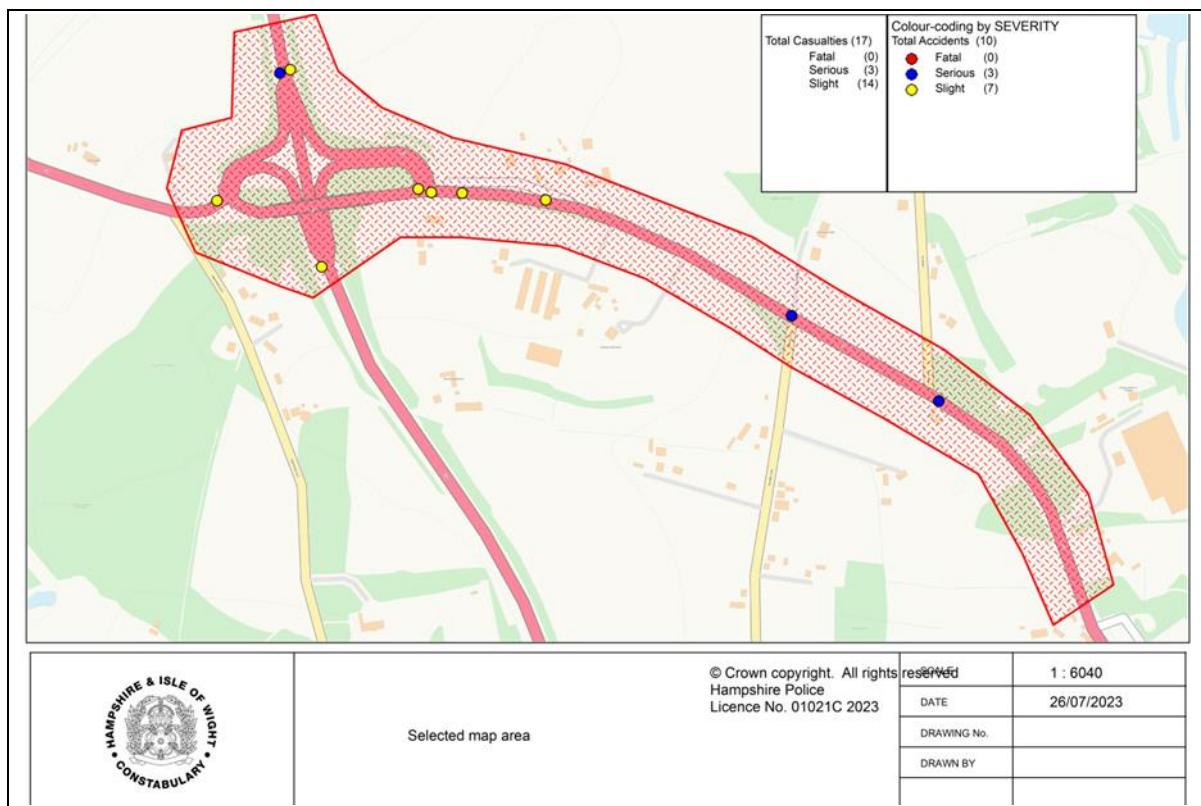
Figure 4: PIA Data

2.2 Personal Injury Accident (PIA) data has been obtained from Hampshire Constabulary for the latest available 5-year period. The data assessed is for the period between the 1st March 2018 and the 28th February 2023, and has considered the same scope required as part of the Bloor Homes application. The PIA investigation is demonstrated in **Figure 4**, with the full data included in **Appendix C**.

2.3 The data demonstrates 10 incidents were recorded throughout the assessment area, of which only 4 incidents were recorded in the vicinity of the proposed site. A summary of the data is provided in **Table 1**.

- 2.4 Of the 10 recorded PIAs in the vicinity of the site, 2 involved cyclists. Of these, 1no. was classified as slight in nature and 1no. was classified as serious.
- 2.5 Whilst any PIA is regrettable, there does not appear to be any significant pattern in the data, other than that accidents tend to occur at junctions (as expected). Of the 3no. serious accidents, 2no. were attributed to drivers' attempting a poor turn/manoeuvre, with the other incident being attributed to the driver traveling too fast for the conditions/exceeding the speed limit. There were no recorded accidents attributed to the road layout.
- 2.6 Overall, the distribution, frequency and severity of incidents does not suggest a trend in the PIAs, and the investigation does not indicate any specific highways concern that would worsen as a result of the development or pose a highways safety concern for future site users.

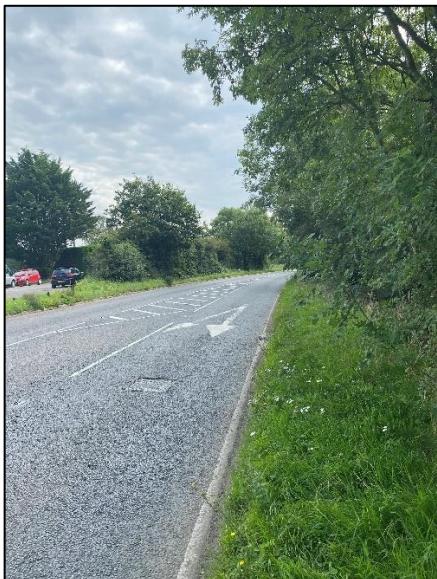
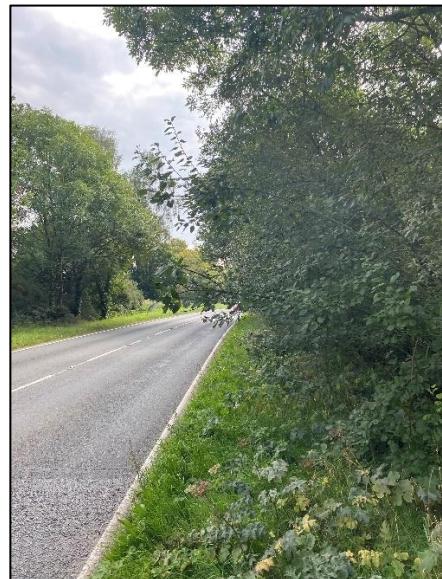
- 3.1 As aforementioned, the closest bus stops to the site are situated circa 750m east along Salisbury Road, but there is currently no provision to encourage pedestrians to use this route. Presently, pedestrians have to walk along the grass verge flanking the southern side of the carriageway, which, given the existing speed of the road, and the overhanging vegetation, is not a safe route. This is demonstrated in **Photographs 1 & 2**.

Photograph 1: Existing conditions along Salisbury Road (A36)

Photograph 2: Existing conditions along Salisbury Road (A36)

- 3.2 Whilst not yet implemented, the Bloor Homes planning approval (Ref: 20/10997) includes, a 2m wide footway on the southern side of the A36, circa 60m east of the existing layby (on the northern side of Salisbury Road). A new pedestrian refuge island will be provided, facilitating the movement of pedestrians to the northern footway (west of the new roundabout to the Bloor Homes site), and subsequently enabling the use of a second refuge island across the northern access arm of this new roundabout. This would then enable pedestrians/cyclists to continue on the northern side of the A36 heading east towards the new bus stops also delivered by Bloor Home and Pauletts Lane.

- 3.4 Given that the Bloor Homes development will be providing new bus stop facilities between the new roundabout and Pauletts Lane, the remainder of the route east to the existing bus stops has not been assessed further, as these bus stops will not be the closest to our development, at the anticipated time of occupation.

- 3.5 With the improvements to be delivered by Bloor Homes, no further improvements have been identified and required to be delivered through the proposed development (aside from ensuring suitable connectivity to the roundabout).

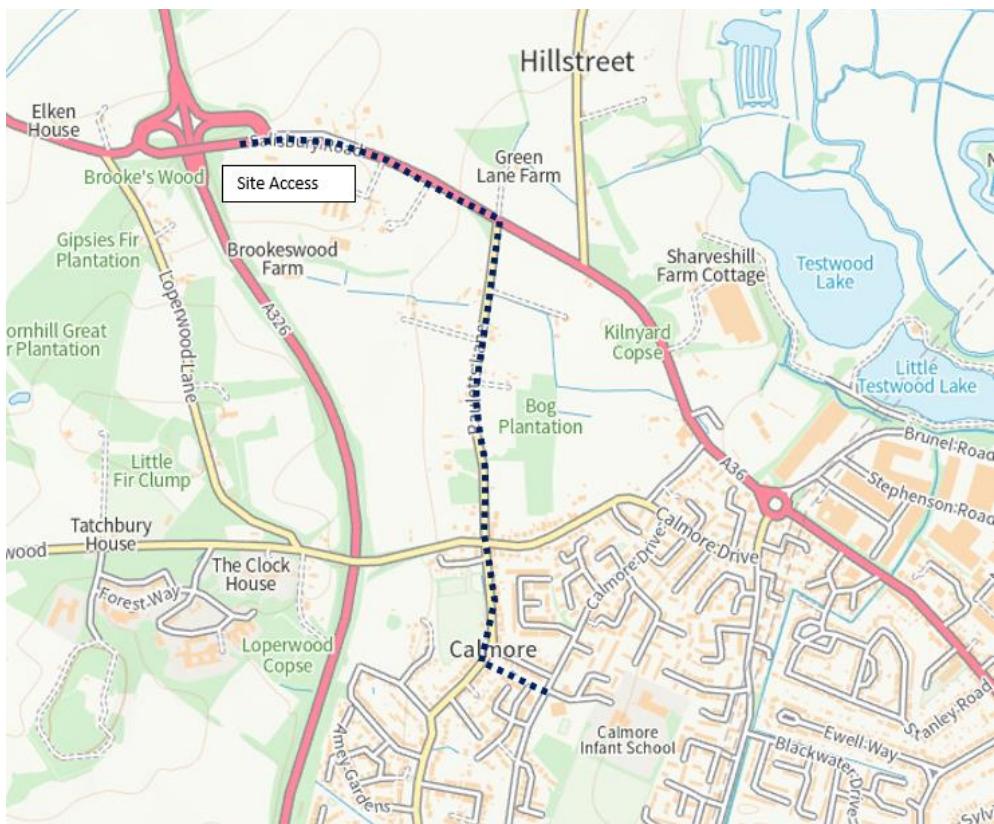
Figure 6: Route to Calmore Facilities

- 4.1 The existing route to the Calmore facilities involves the use of the route as outlined in Section 3, with the remainder of the route assessed within this section. The route this section assesses is demonstrated in **Figure 6**.

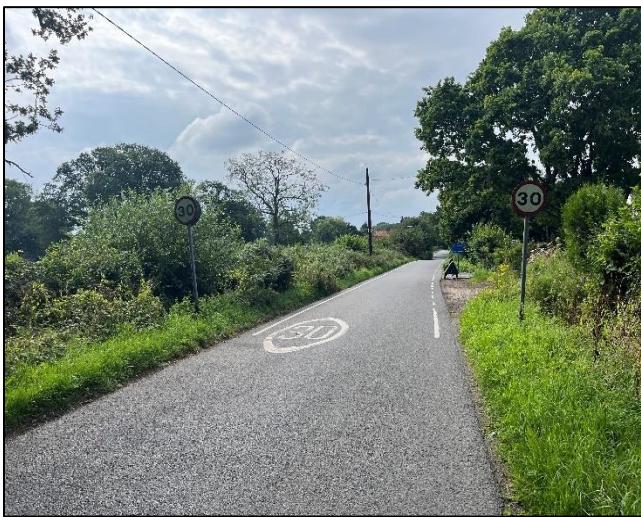
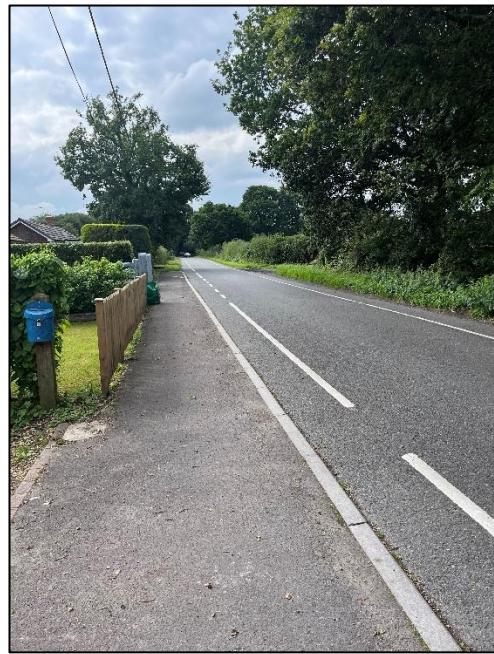
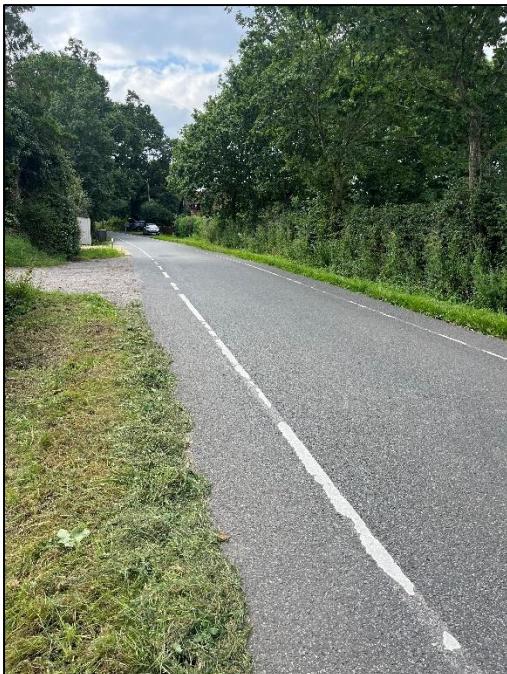
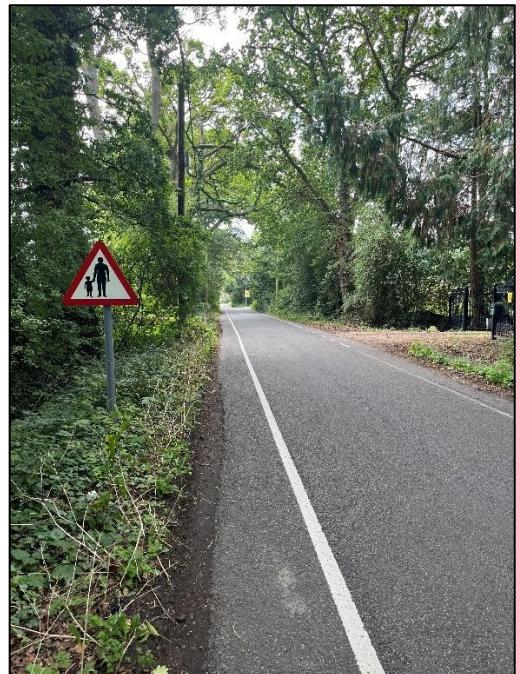
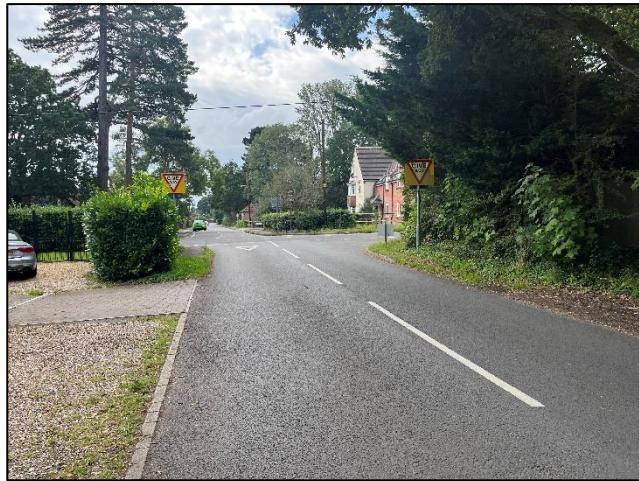
- 4.3 At present, Pauletts Lane provides the optimal route towards the facilities in Calmore. Whilst Pauletts Lane does not have formal pedestrian infrastructure, advisory signage was observed whilst on site highlighting that pedestrians do walk within the carriageway. The environment for vehicles along Pauletts Lane enhances the provision for pedestrians, with a 30mph speed limit and white lining demarcating a narrow carriageway width which was observed, whilst on site, to be only wide enough for one vehicle at a time.

- 4.4 The existing conditions along Pauletts Lane are demonstrated in **Photographs 3 – 7**.

Photograph 3: Existing conditions along Pauletts Lane

Photograph 4: Existing conditions along Pauletts Lane

Photograph 5: Existing conditions along Pauletts Lane

Photograph 6: Existing conditions along Pauletts Lane

Photograph 7: Existing conditions along Pauletts Lane

- 4.8 Whilst it is noted that the existing environment along Pauletts Lane is not suitable for high footfall of pedestrians, the proposed development is not anticipated to generate significant pedestrian movements given the distance of the facilities from the site. Moreover, if pedestrian movements were to occur along Pauletts Lane, these would most frequently be in daylight hours when visibility for pedestrians and vehicles is good.

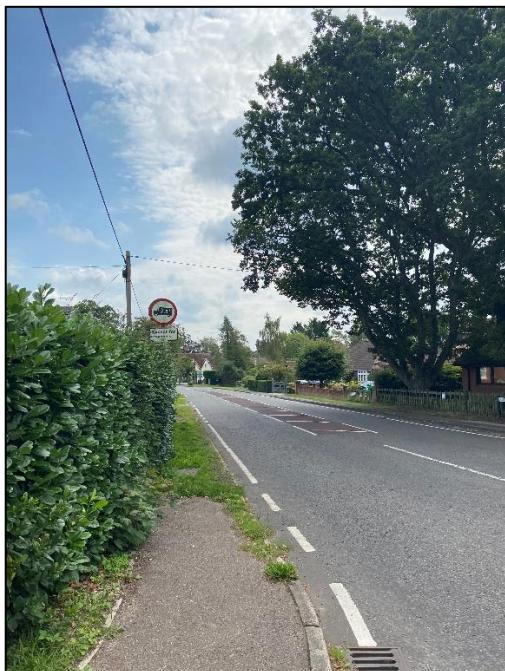
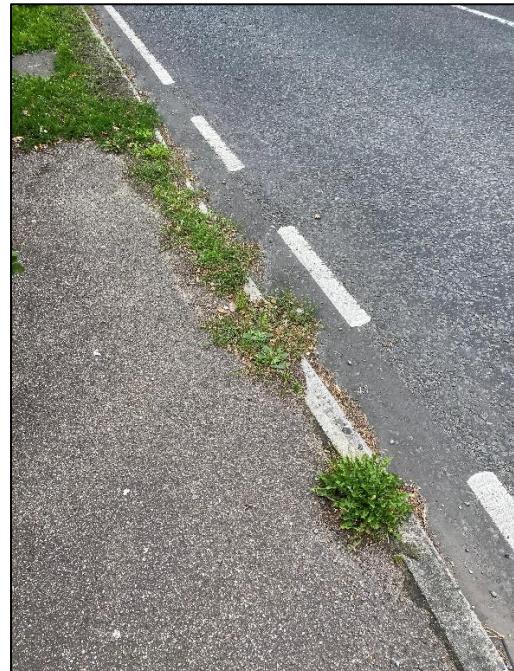
4.5 At the southern extent of Pauletts Lane, there is a dropped kerb crossing at the junction of Pauletts Lane/Cook Lane/Calmore Road. This enables a safe and continuous route to be provided between Pauletts Lane and the existing infrastructure along Calmore Road. This is demonstrated in **Photographs 8 and 9**.

Photograph 8: Dropped kerb crossing at Calmore Road

Photograph 9: Dropped kerb crossing at Calmore Road

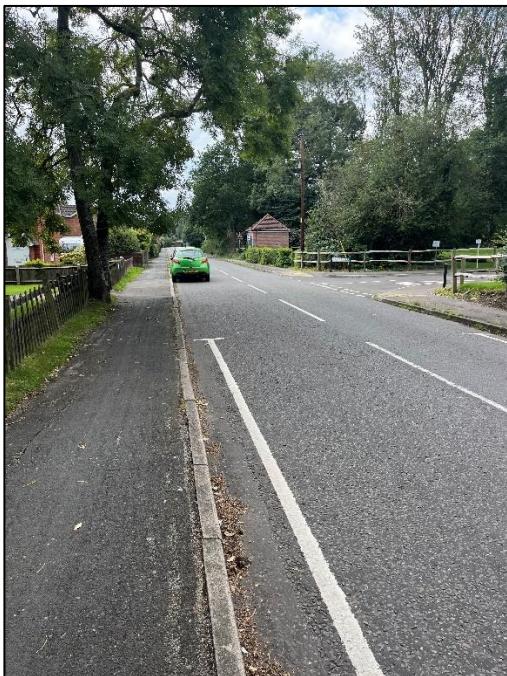
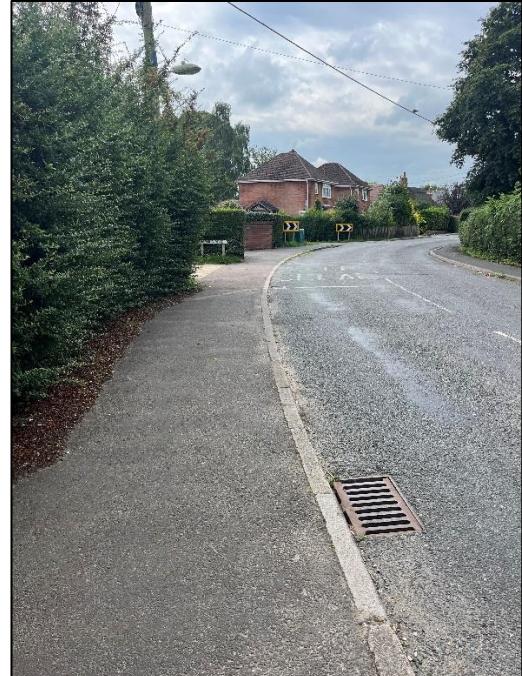
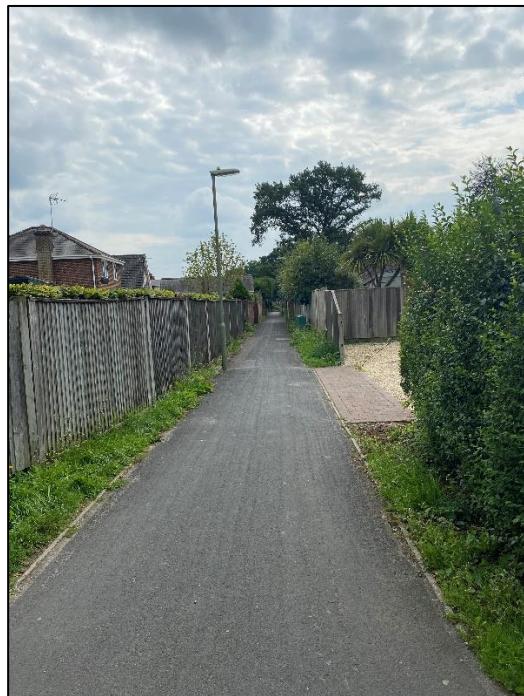
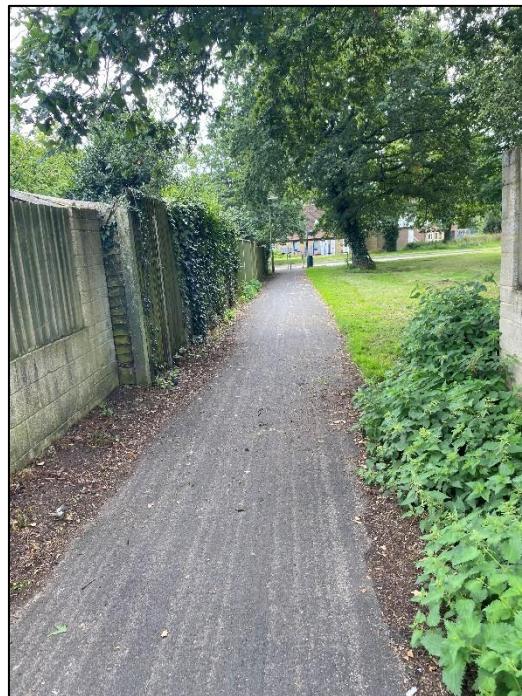
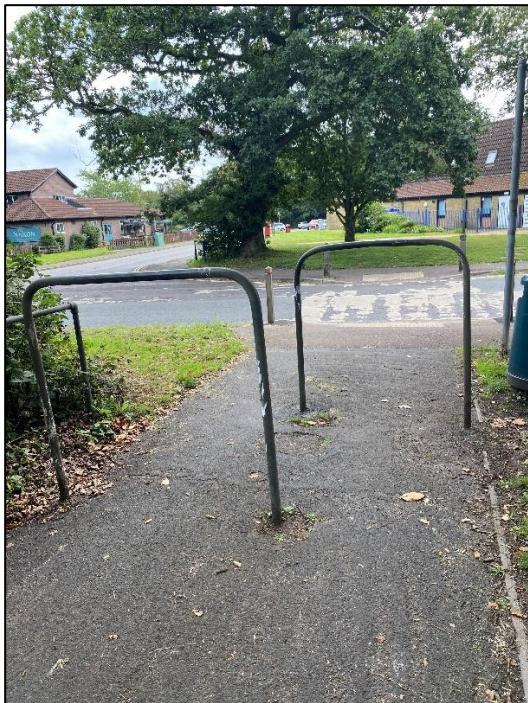
4.6 Calmore Road benefits from 2m wide footways flanking either side of the carriageway for its duration. Circa 250m south of the Pauletts Lane/Cook Lane/Calmore Road junction, a footpath is provided connecting Calmore Road to Calmore Drive. The footpath is tarmacked and has streetlights, creating an attractive route for pedestrians. It should be noted however, that one house has vehicle access via this footpath. The existing conditions along Calmore Road and the footpath are demonstrated in Photographs 10 – 15.

Photograph 10: Existing conditions along Calmore Road

Photograph 11: Existing conditions along Calmore Road

Photograph 12: Conditions on footpath from Calmore Road to Calmore Drive

Photograph 13: Conditions on footpath from Calmore Road to Calmore Drive

Photograph 14: Conditions on footpath from Calmore Road to Calmore Drive

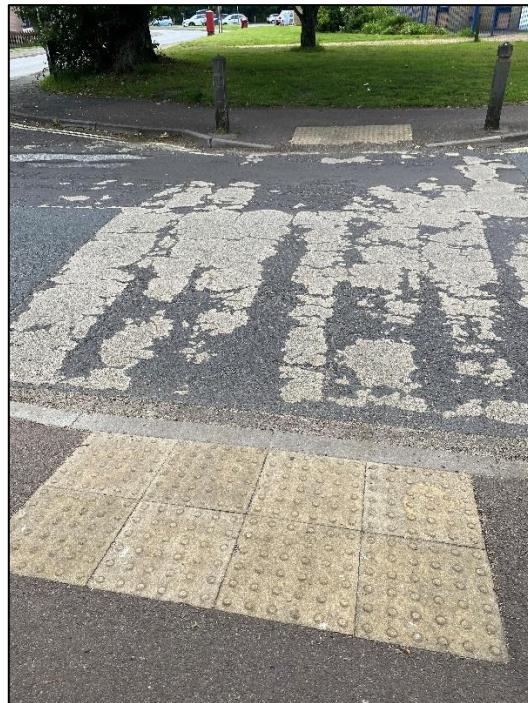
Photograph 15: Dropped kerb crossing with tactile paving across Calmore Drive

- 4.7 At the end of the footpath, a dropped kerb crossing with tactile paving is present, facilitating the movement of all non-motorised users in the area (**Photograph 15**). The route then continues along Nutshalling Close before reaching the facilities.

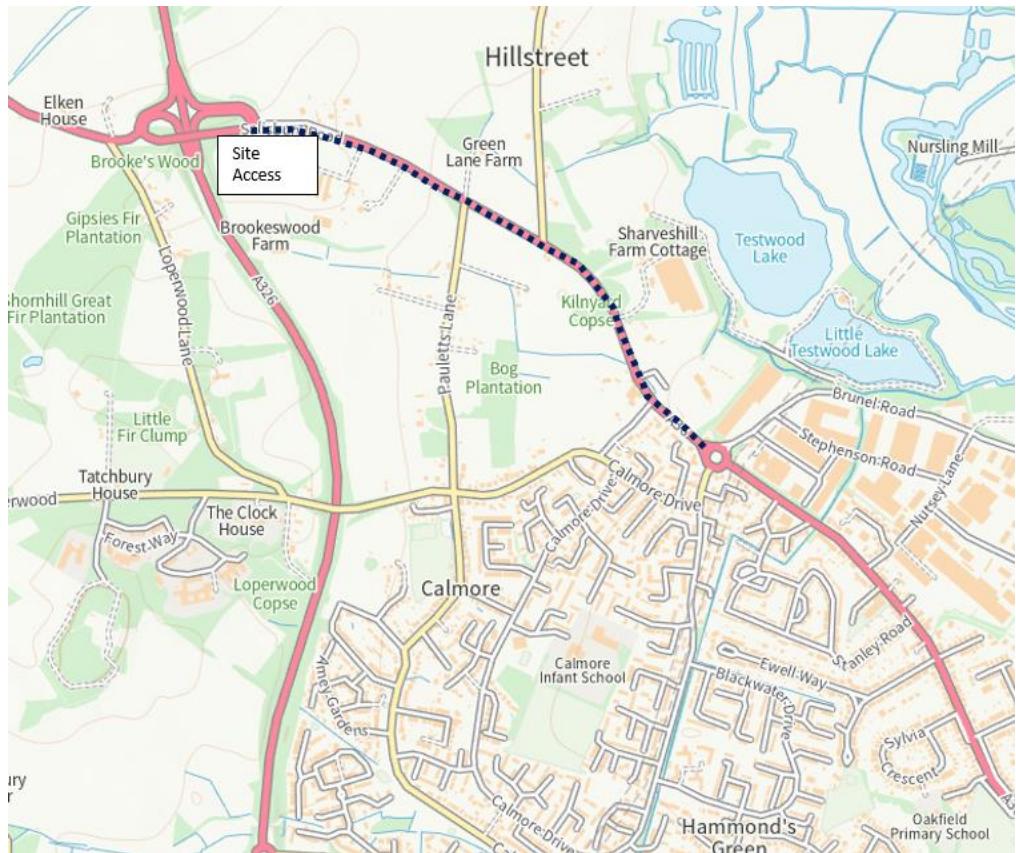
Figure 7: Route to Testwood Facilities

- 5.1 As aforementioned, the site is within a circa 20-minute walk (or 5-minute cycle) of Testwood and its facilities. The route to the Testwood facilities utilises the previously detailed route via Salisbury Road (within **Section 3**) and on to the junction with Pauletts Lane. As such, this section summarises the route thereafter.

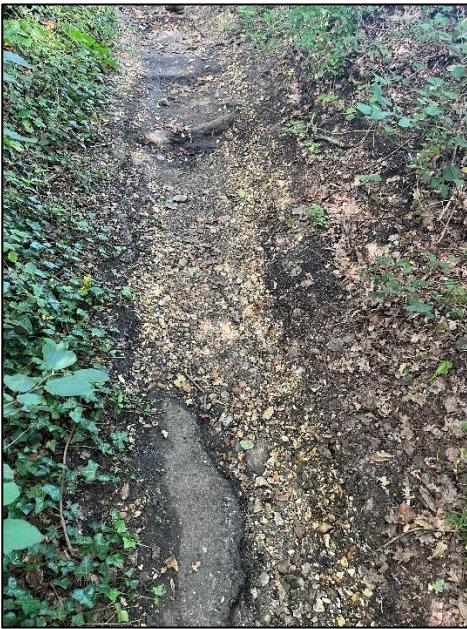
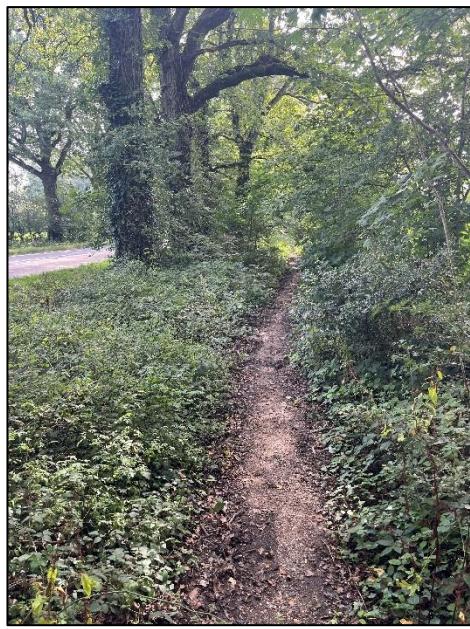
- 5.2 The improvements to be delivered through the Bloor Homes approval, will ensure that a continuous route is provided from their site access roundabout to the Pauletts Lane junction. At Pauletts Lane, the proposed western footway terminates in a dropped kerb crossing, and then connects to the existing footpath which currently runs south of the A36 (to the east of Pauletts Lane). This footpath is demonstrated in **Photographs 16 and 17**.

Photograph 16: Footway from Pauletts Lane to Hill Street
Bus Stop

Photograph 17: Footway from Pauletts Lane to Hill Street
Bus Stop

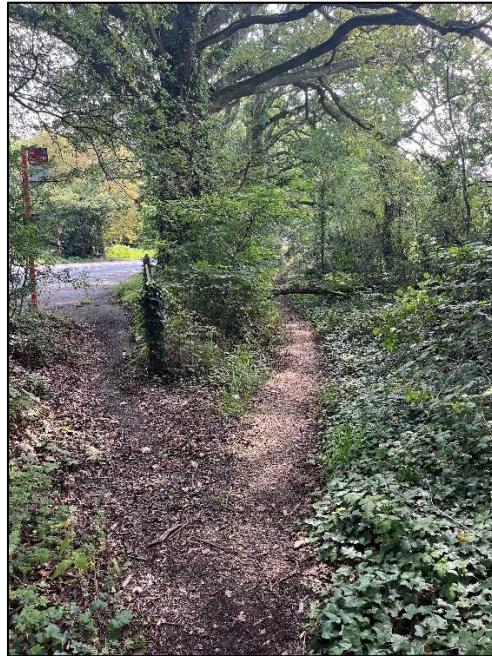
Photograph 18: Footway from Pauletts Lane to Hill Street Bus Stop

- 5.3 This footpath then continues (albeit set back from the carriageway) to the junction with Hill Street, as shown in **Photograph 18**. At this junction, a formalised footway is present, on the southern side of Salisbury Road, which then continues for the rest of the route as seen in **Photographs 19 – 22**.

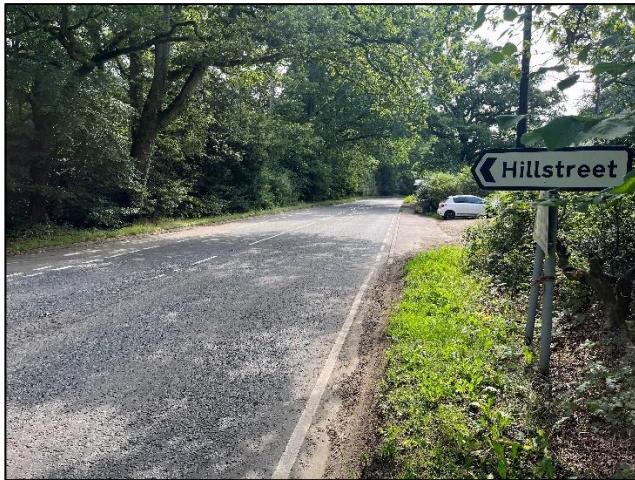
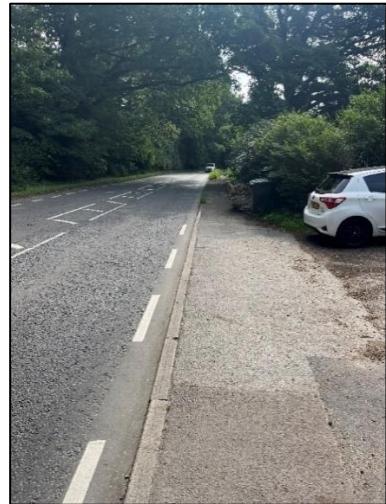
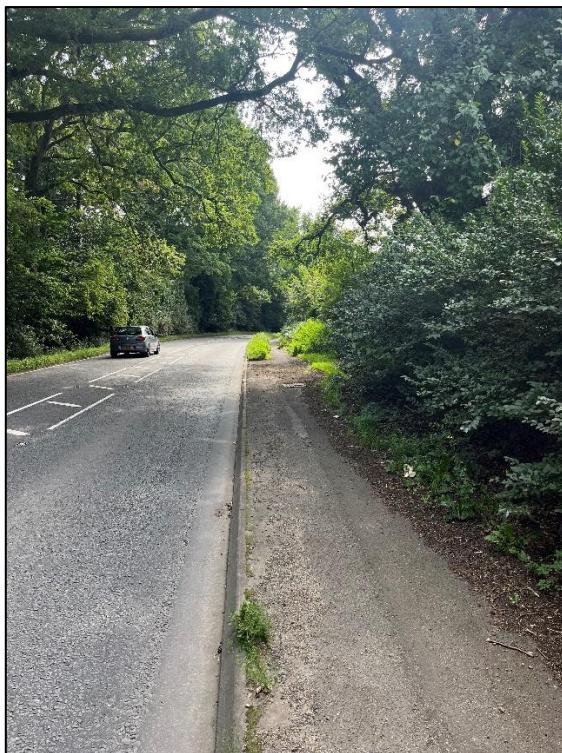
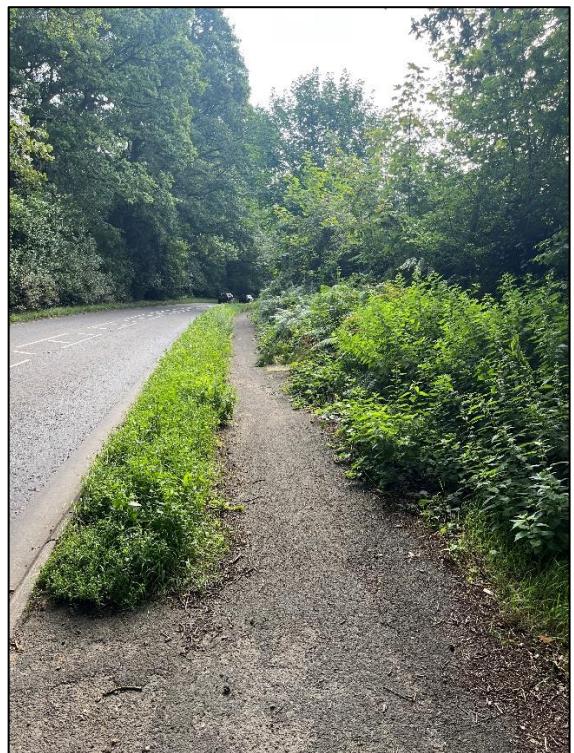
Photograph 19: Existing conditions on Salisbury Road (A36) after Hill Street Bus Stop

Photograph 20: Existing conditions on Salisbury Road (A36) after Hill Street Bus Stop

Photograph 21: Existing conditions on Salisbury Road (A36) after Hill Street Bus Stop

Photograph 22: Existing conditions on Salisbury Road (A36) after Hill Street Bus Stop

- 5.4 This footway continues to the Brunel Road/Calmore Drive/A36 roundabout which leads to the facilities in Testwood. Dropped kerb crossings with pedestrian refuges are provided, where appropriate enabling pedestrians to cross the road.
- 5.5 No improvements are considered to be required for this route.
