Old Poor House

*Deconstruction of garden building &
associated repairs to Brack Mount wall*

January 2024

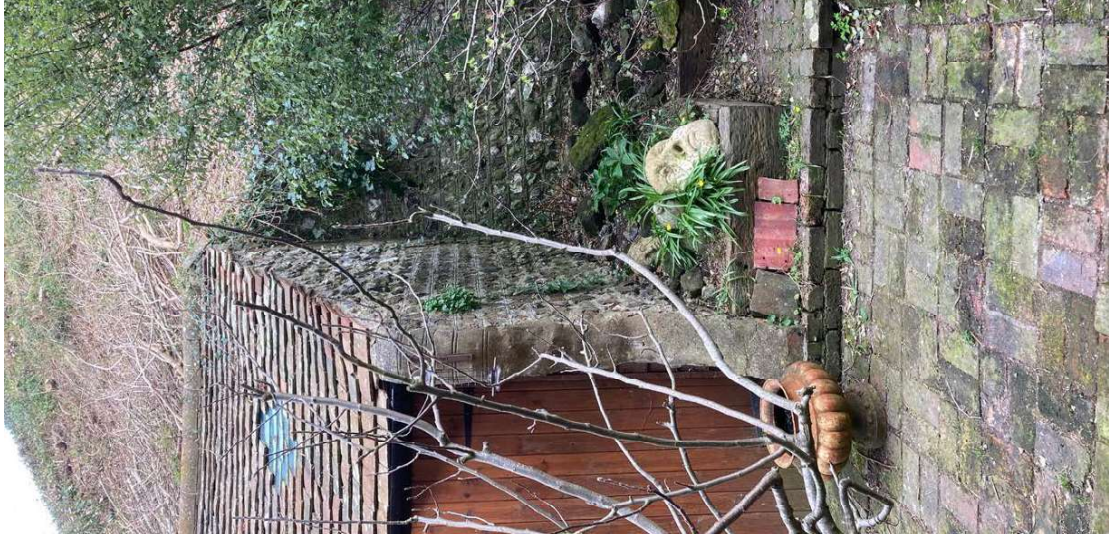
- 1.7 This photo shows the right hand side of the garden building, and the perimeter flint wall that retains Brack Mount.

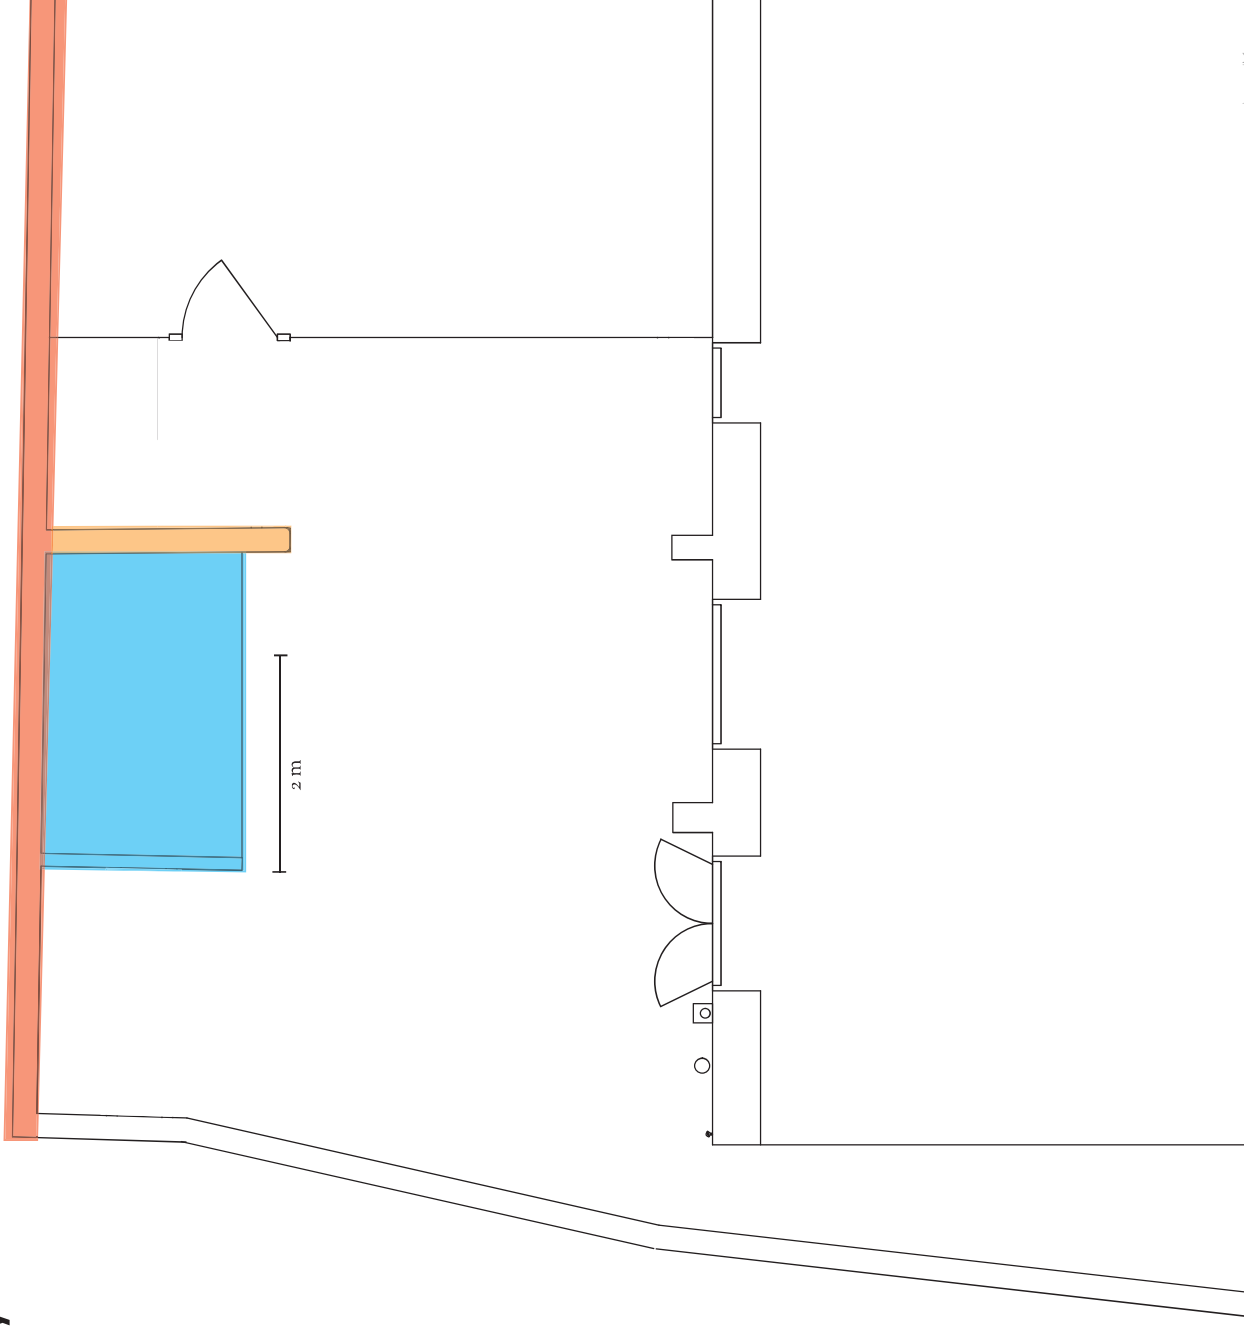
2.1 The drawing on the left shows a plan view of the rear garden.

2.2 The wall marked in red is the perimeter of Brack Mount, and will not be removed. It will be protected during the deconstruction work, and repaired where required using appropriate historic materials and techniques, as outlined later in this document.

2.3 The wall marked in orange is not part of Brack Mount, but is an historic flint and lime wall. This section of wall will be retained.

2.4 The building marked in blue will be carefully deconstructed, and the majority of the masonry materials can be reused within the garden.

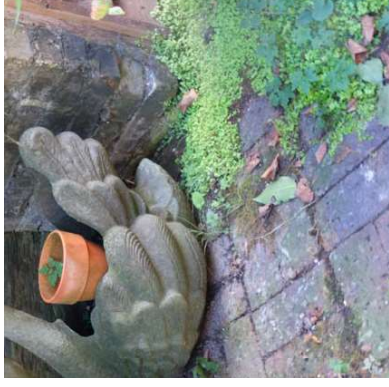
2.8 Image showing the brick paving of the rear garden, and the corner of the garden building.

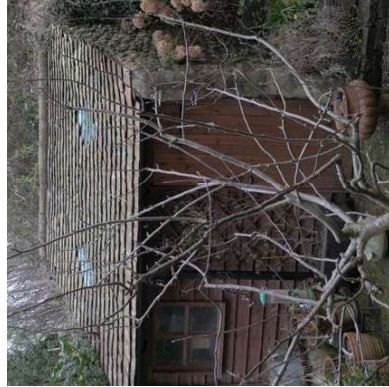
2.6 View from the garden of the garden building, showing the historic flint wall that forms one side of the building.

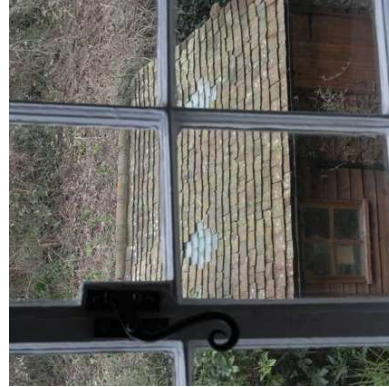
2.7 View from the first floor of the house, showing the roof of the garden building.

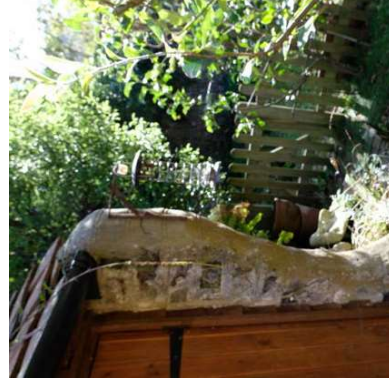
2.10 View of the end of the historic flint wall, that forms one side of the building.

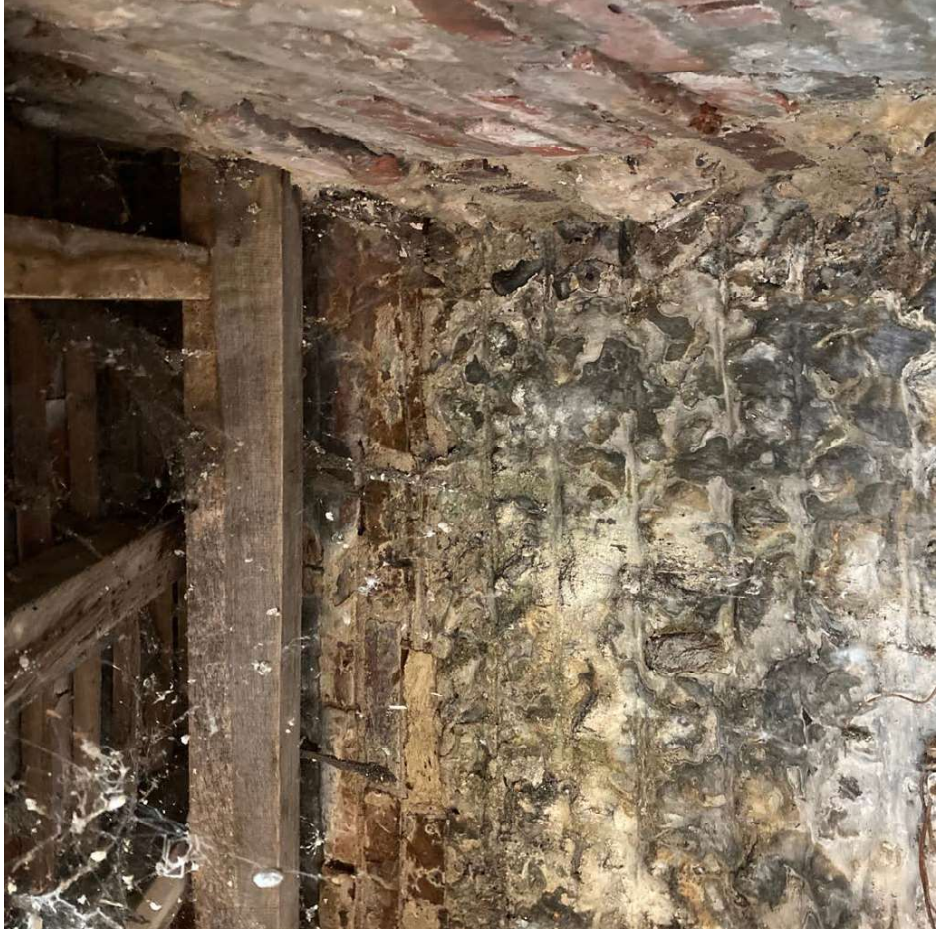
- 3.6 The image on the left shows the inside of the garden building. The horizontal timber forms the ridge of the roof, which is supporting the timber rafters.
- 3.7 Brack Mount wall is the rear wall of the building. It is flint construction, with some top-courses of brick. These may have been added when the building was constructed.
- 3.8 The right-hand wall is to remain, and is a mix of brick and flint masonry.
- 3.9 The image below shows a horizontal timber purlin supporting the rafters, timber tile battens and the underside of the roof tiles. There are 2 'lights' in the roof, made with glass roof tiles.
- 3.10 Once the timber roof structure has been removed, the brick side wall is to be carefully deconstructed brick-by-brick. This is possible due to the lime soft lime mortar.

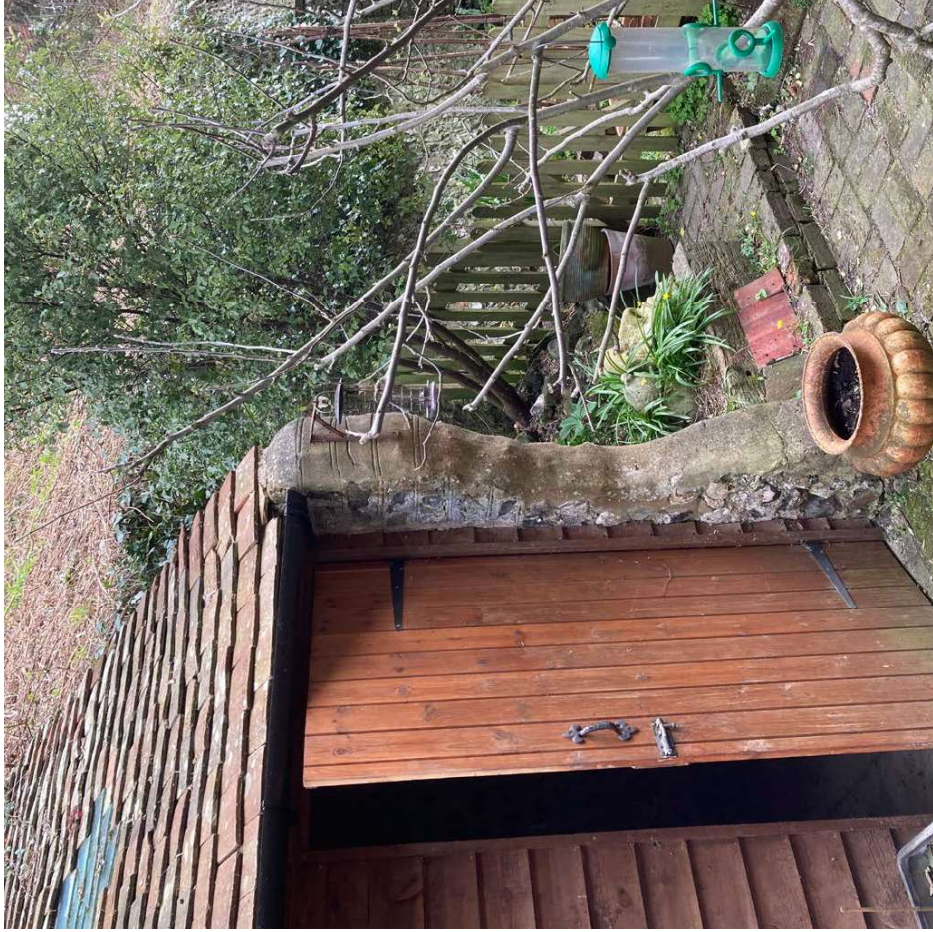
- 3.11 The front of the building is made of softwood timber, and can be carefully taken down and removed.
- 3.12 The image below shows the end of the historic flint wall. This currently has a cement-based mortar finish covering the front broken surface. This could be replaced with a lime mortar detail if required.
- 3.13 All masonry materials: bricks; flint; roof tiles should be cleaned and stored on-site for reuse within the garden. Timber materials: door; weatherboarding should be removed from the site.

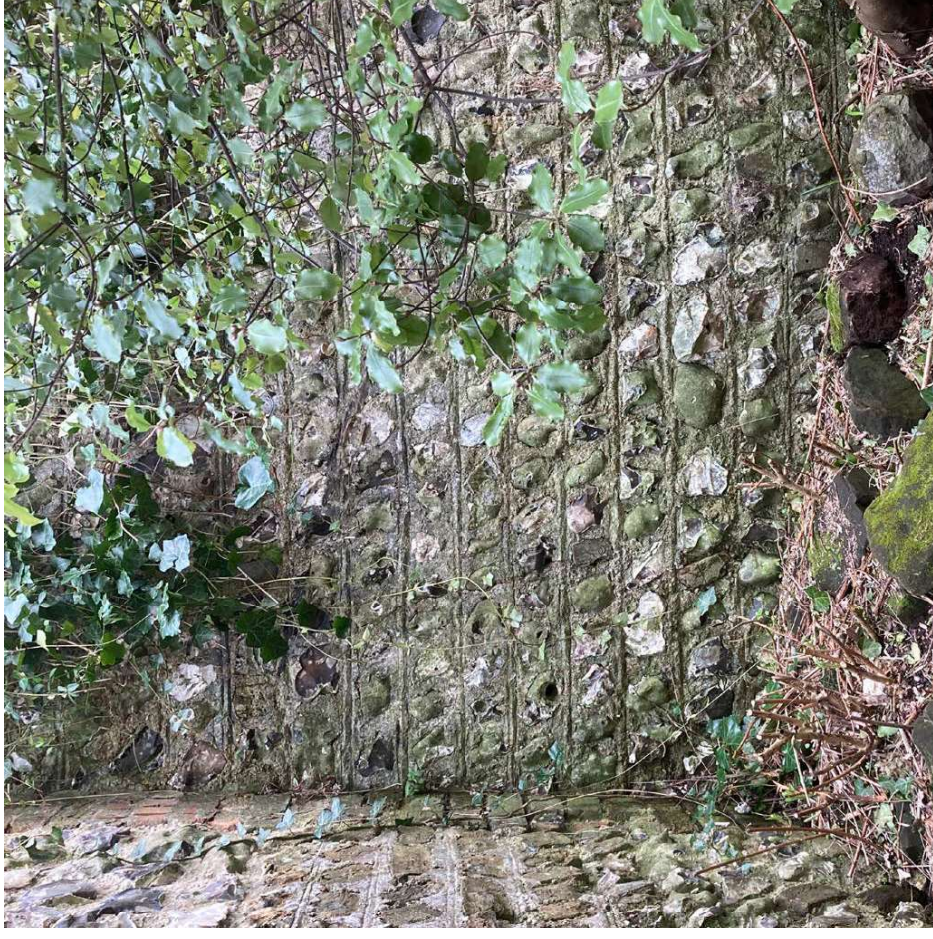
- 4.1 Once the building is removed, repairs should be done to Brack Mount wall and the perpendicular side wall.
- 4.2 The image below shows Brack Mount wall. It is coursed field flint, laid in lime mortar, with incised horizontal coursing. The flints also tend to be laid leaning to the top-left.
- 4.3 Small areas of re-pointing can be filled using lime mortar. Larger cracks in the masonry may require a 'stitch' repair with embedded stainless-steel helifix. The design of these repairs can be made as the wall is surveyed.
- 4.4 The capping of the historic walls is very important to reduce water ingress. Once the building is removed, wall capping should be repaired or added to match the existing detail.

- 4.5 The new lime mortar should be designed to match the original in colour, aggregate size, thickness and style of application and finish.
- 4.6 We would recommend that 2 or 3 trial mixes are made to assess the performance and aesthetics of the mortar, prior to starting the repair.
- 4.7 The following mortar is based on a ratio of 1 : 2.5 (binder:aggregate).

- 4.8 The lime mortar should be finished with exposed aggregates to match the existing material.
- 4.9 Whilst the repair work is being completed the walls should be protected with hessian and waterproof covers. These will also be required for 1-2 weeks after the repair is completed to further protect the lime mortar whilst it cures. Possibly longer if frost is forecast.

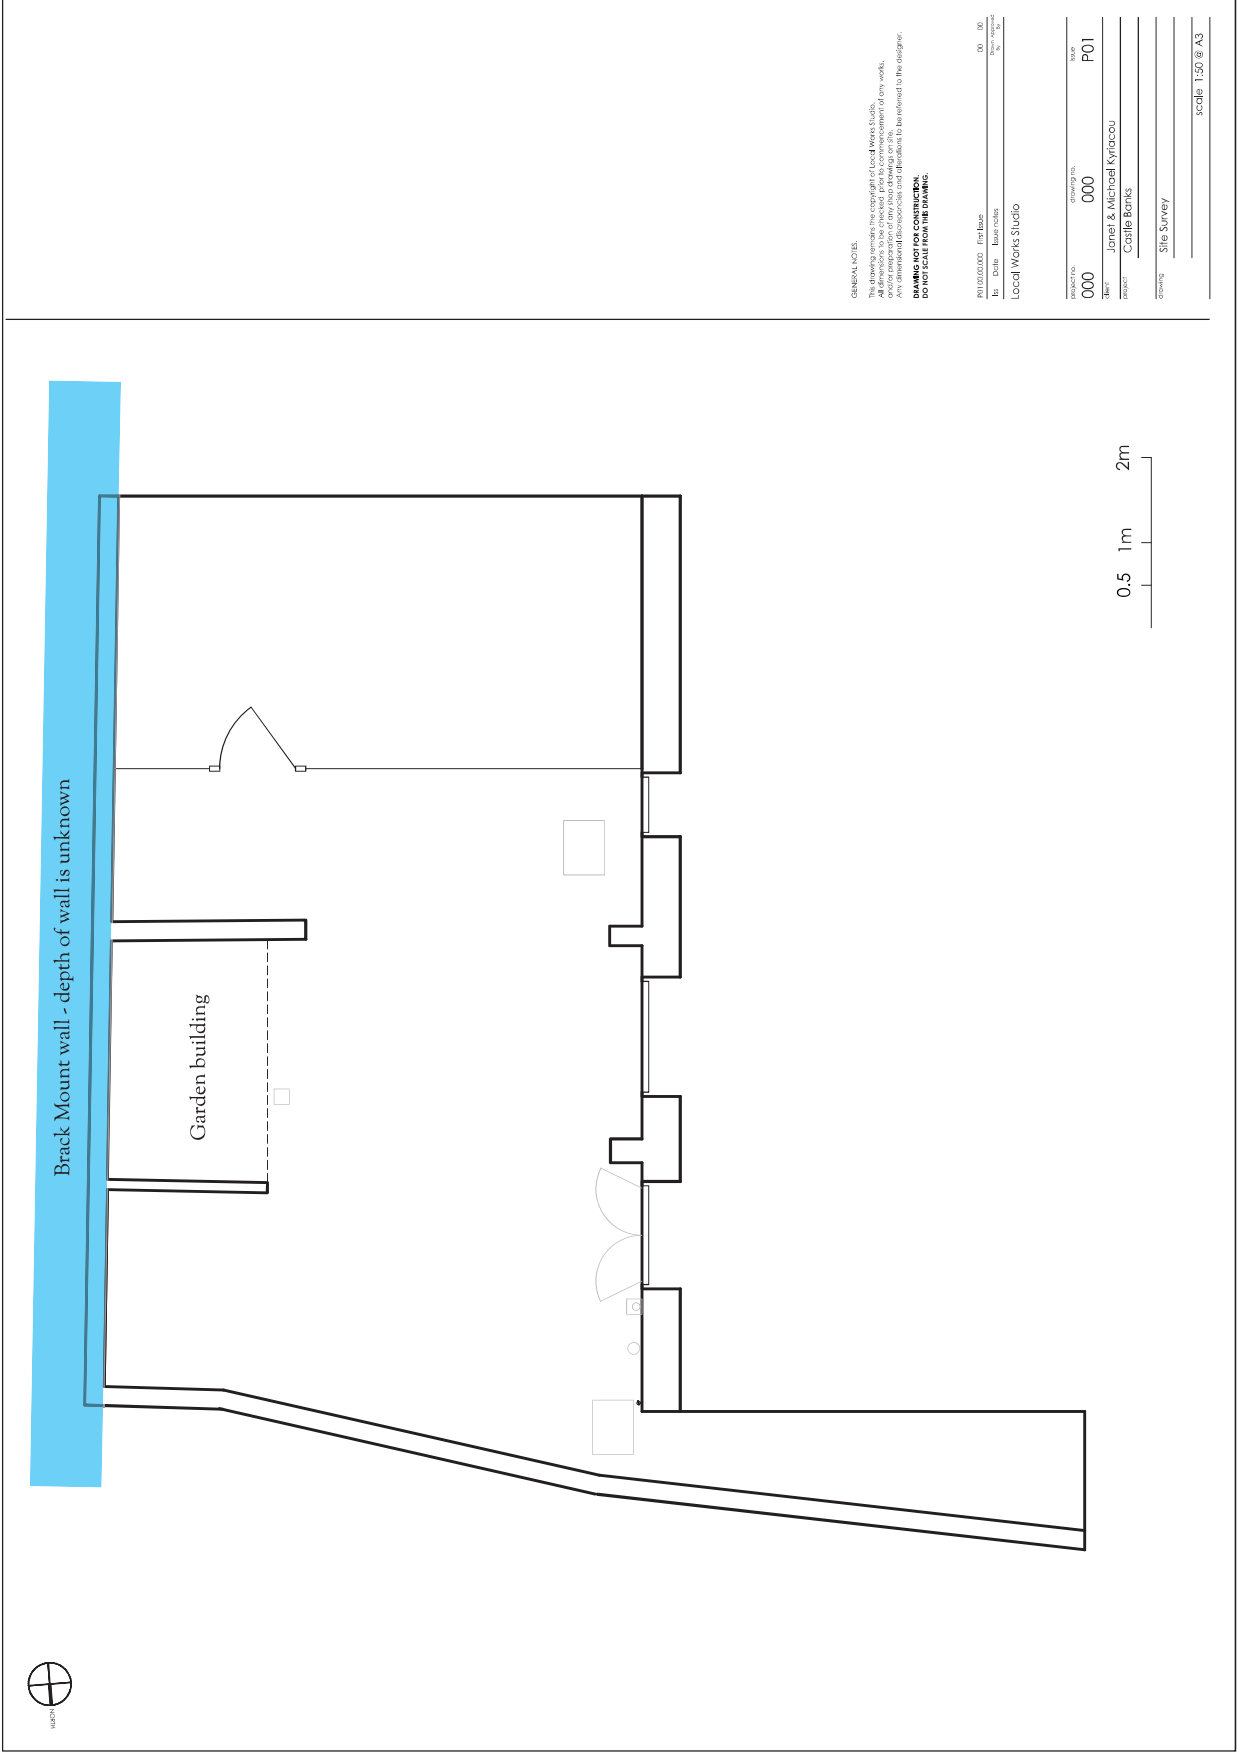
6.1 Drawing of the rear garden of The Old Poor House, showing Brack Mount wall (in blue) as the rear wall of the garden building
