# **PRELIMINARY ROOST ASSESSMENT**

**The Old Poor House, 7 Castle Banks, Lewes**

<b>Client:</b>	Asher Planning			
<b>Project:</b>	The Old Poor House, 7 Castle Banks, Lewes			
<b>Reference:</b>	LLD3172-ECO-REP-001-00-PRA			
<b>Revision:</b>	<b>Date:</b>	<b>Author</b>	<b>Proof</b>	<b>Approved</b>
00	05/03/23	Fleur Booth MSc, BSc (Hons)	Louise Barker MSc, BSc (Hons)	Louise Barker MSc, BSc (Hons)

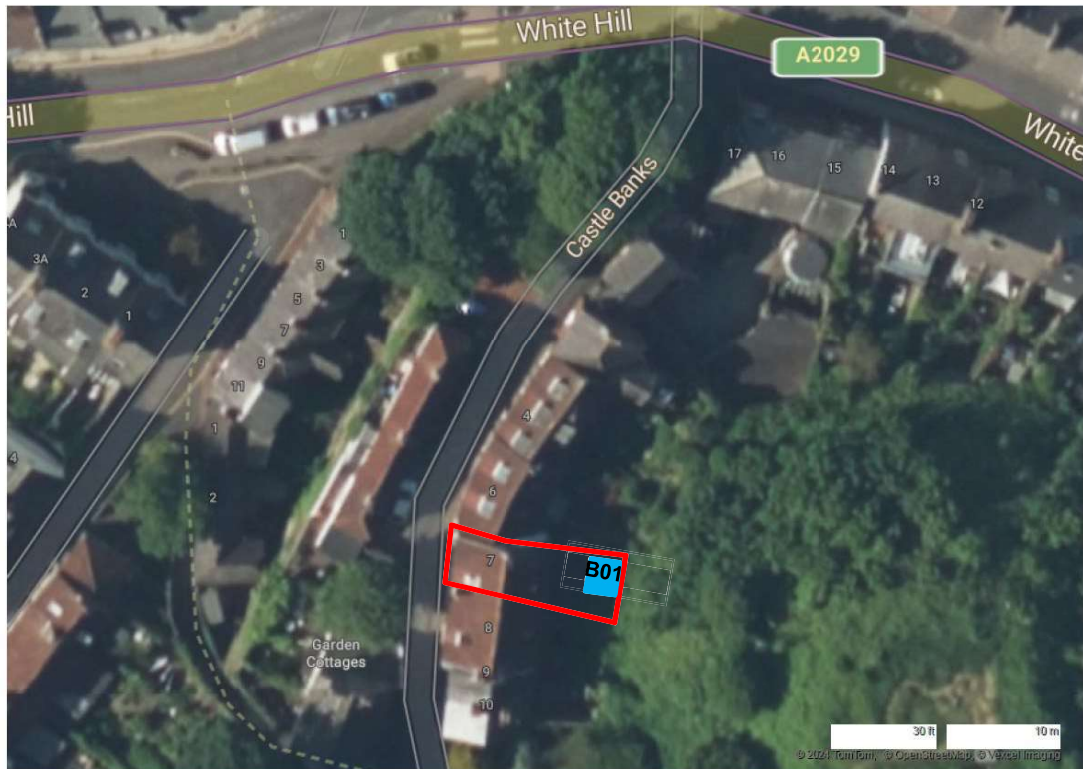
Figure No. 1 – Site Habitat Plan. The site boundary is outlined in red. Lean-to (B01) structure outlined in blue.

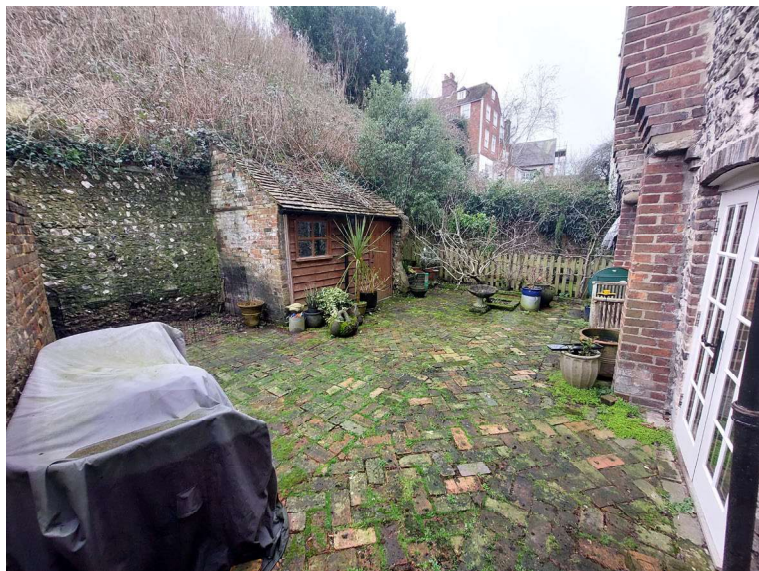
**Image 01 – View of entire site north to south, with lean-to scheduled for demolition in centre of image, residential dwelling to the right of image.**

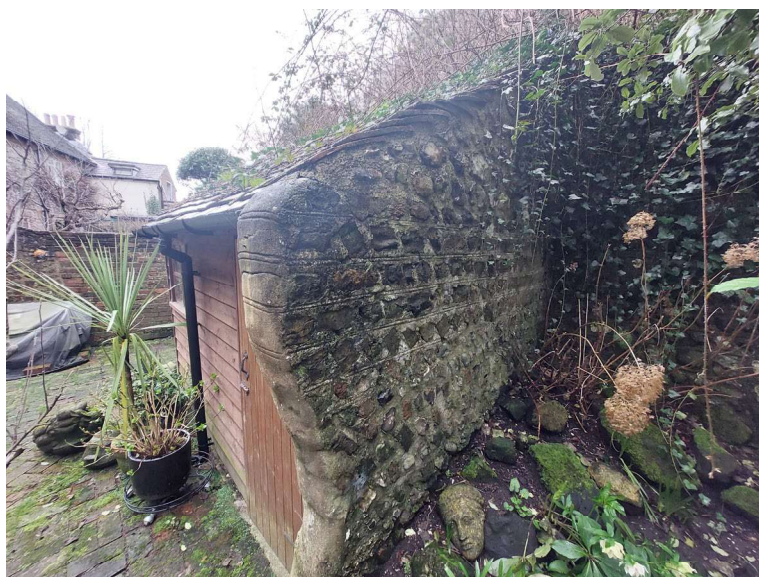
- 3.2.3 The front of the built structure is made of softwood timber panelling which is in good condition and had no warping and so offered no potential roosting features (PRF). Brack Mount wall is the rear wall of the building and had no possible access for bats as it makes up the bank of earth behind the building. The southern side wall is made of bricks and flint. The northern side wall is made of bricks. Both side walls had crevices on the northern and southern facing aspects, as well as the western facing aspect where the brick joins the timber cladding. The roof is a single layer of overlapping clay roof tiles. The tiles are raised and uneven in places, however there is no loft space to offer a roosting feature. There were several holes under the eaves, within the timber structure that also provide a potential roost feature. No evidence such as grease markings or urine stains were found.

**Image 02 – View of historic flint wall.**

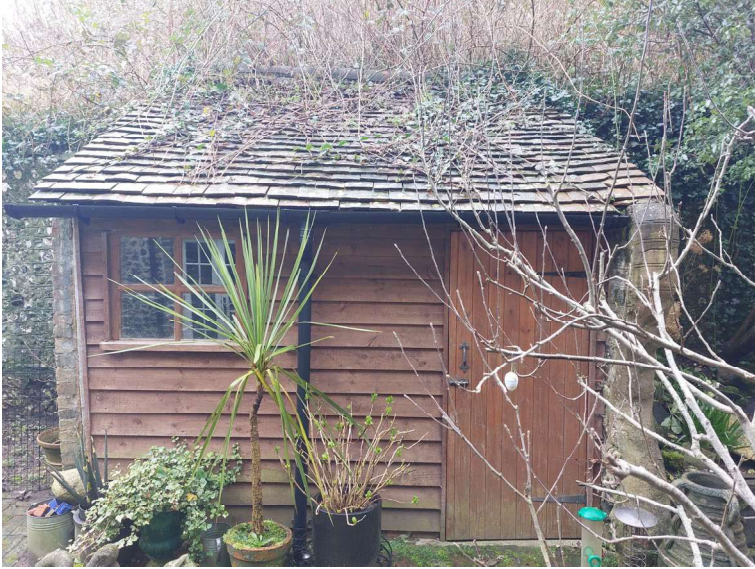
**Image 03 – View of front of B01, showing uneven and raised tiles, and timber cladding front.**

4.2.2 The lean-to shall require 1no. check prior to commencement of works using an endoscope by a licensed ecologist to further investigate the PRFs observed in the preliminary roost assessment. This survey is to be undertaken during the optimal survey season of May to August (Collins, 2023). This shall allow the presence or likely absence of a bat roost to be established. If an active bat roost is found, a European Protected Species Derogation Licence shall be required from Natural England to allow works to progress. Any mitigation measures required as part of any such licence would be determined by the results of the survey work.

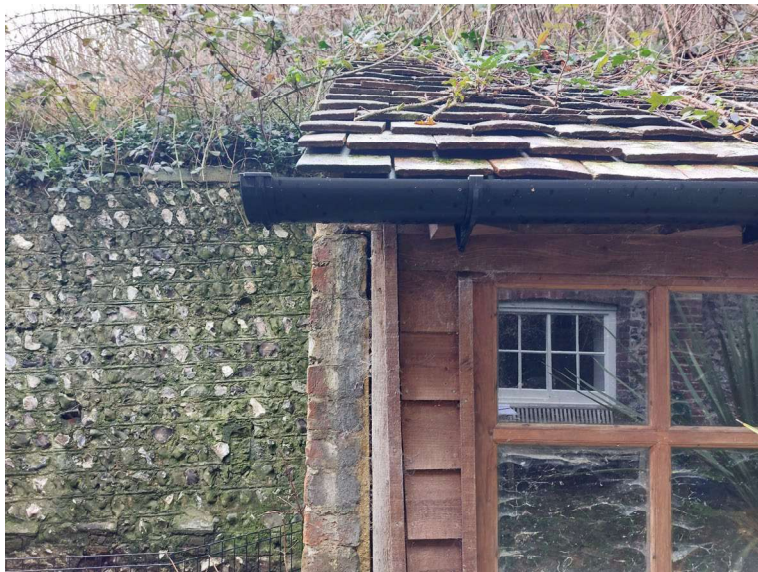
**Image 04 – View of PRF between brick side wall and front timber structure.**

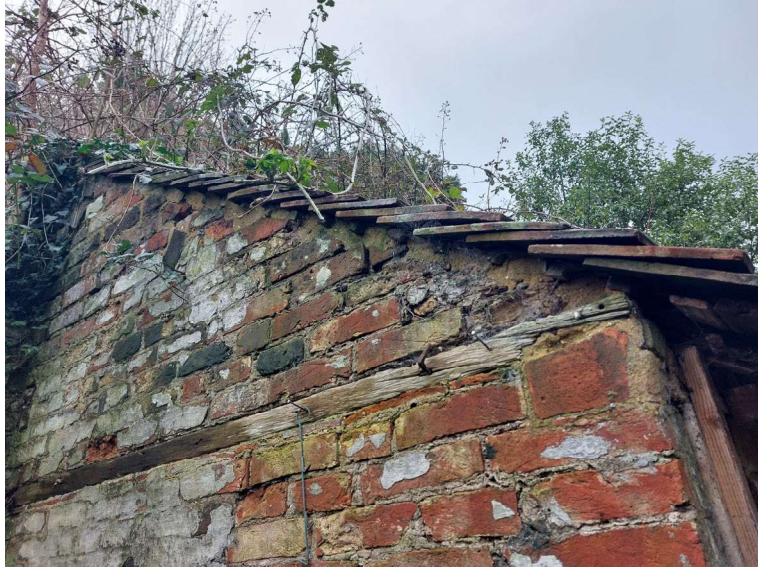
**Image 05 – View of PRFs on northern facing aspect of lean-to structure.**

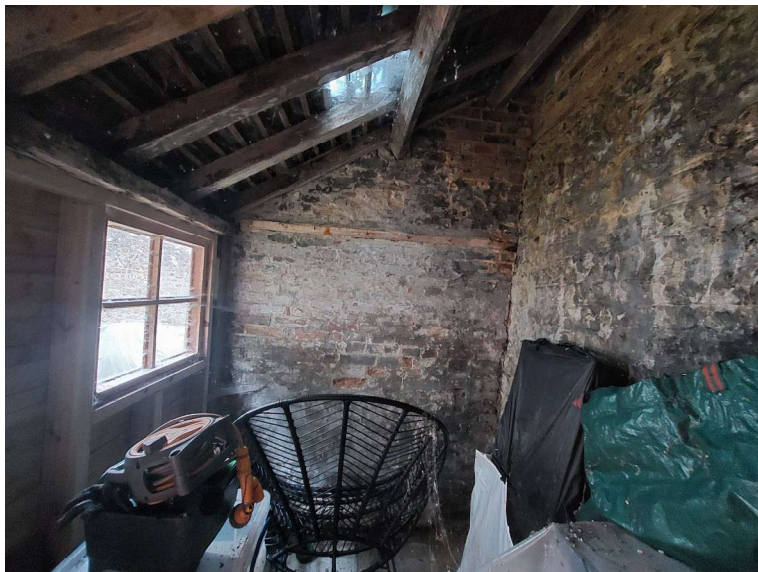
- 3.2.4 The internal of the lean-to had an exposed roof rafter, with timber tile battens supporting the underside of the roof-tiles. The building was being used to store household and garden items which were checked for evidence of bat presence. There were many cobwebs throughout the structure which reflects the lack of suitability for roosting potential for bats. No other evidence of bats such as droppings or feeding remains (i.e. moth wings) were found. Small crevices where the lime mortar had crumbled away exist within the structure and may provide potential roosting opportunities for small species of bat such as pipistrelle.

**Image 06 – View of interior of lean-to structure.**

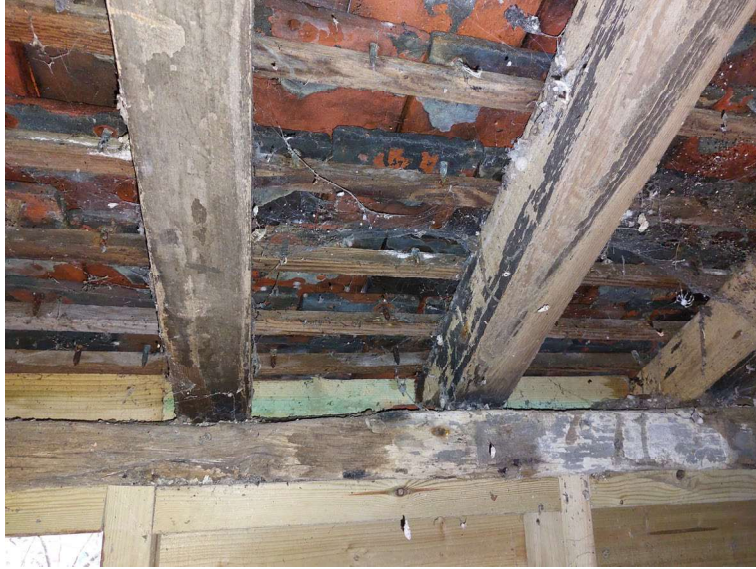
**Image 07 – View of roof tiles from interior of lean-to structure.**
