Revision A

A HERITAGE STATEMENT FOR THE OLD RECTORY, FOLKINGTON,
EAST SUSSEX, BN26 5SD.

Archaeology Services Lewes

Project number: ASL 318-24

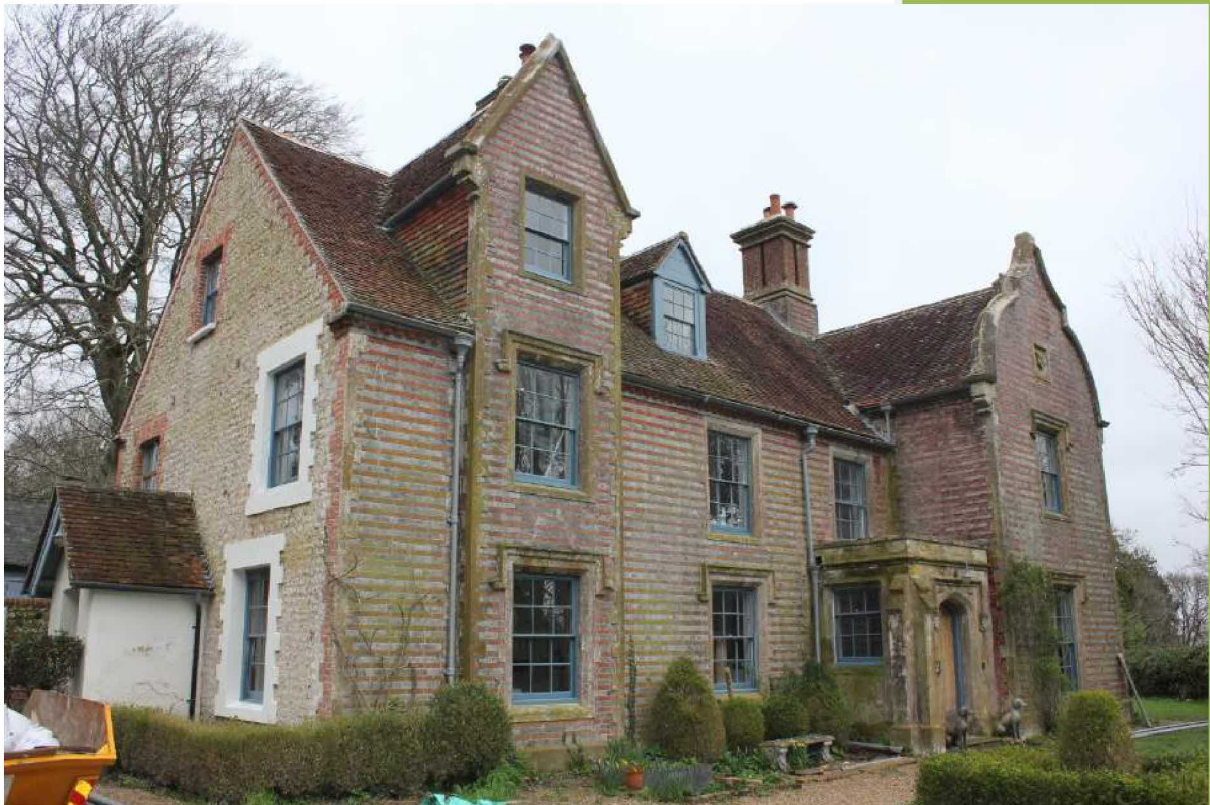
The principal elevation of the Old Rectory, directly facing the church opposite.

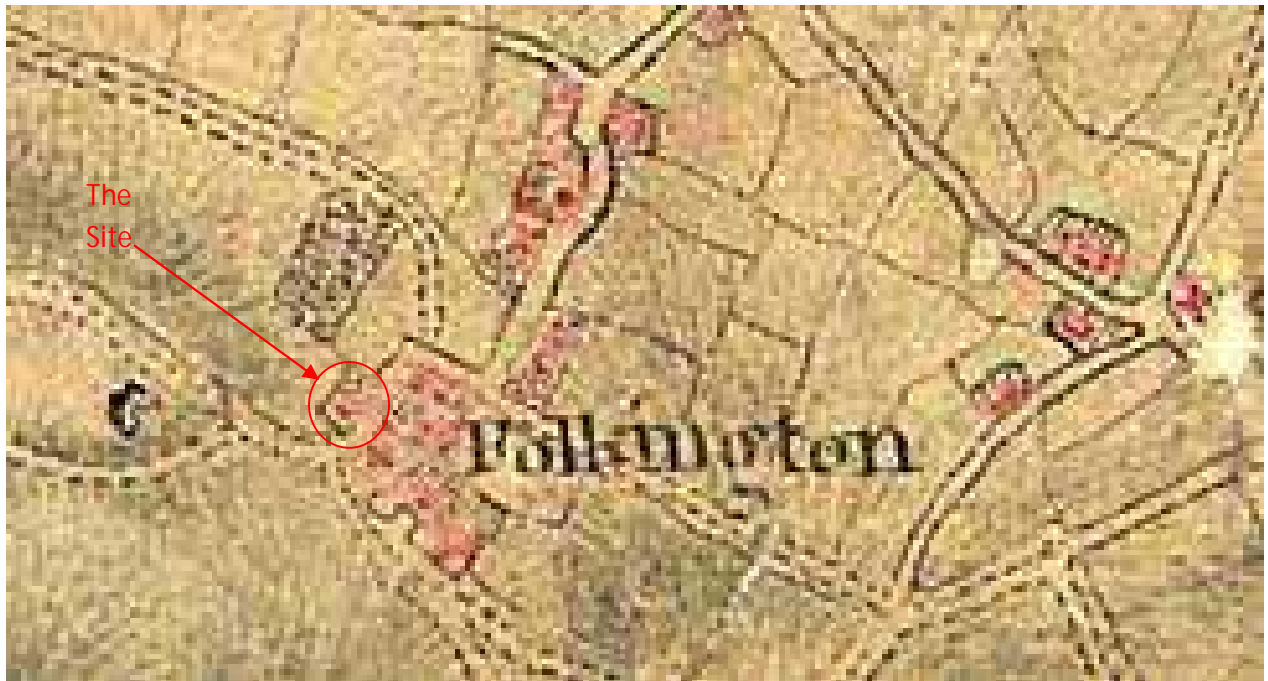
Fig. 3. The Early OS draft surveyors map of 1789.

- 5.1 The Early Ordnance Survey (OS) draft surveyors map of 1789 (Fig. 3) is not drawn in great detail but depicts the building on a rectangular footprint, rather than the current L-shaped plan, directly opposite the church.

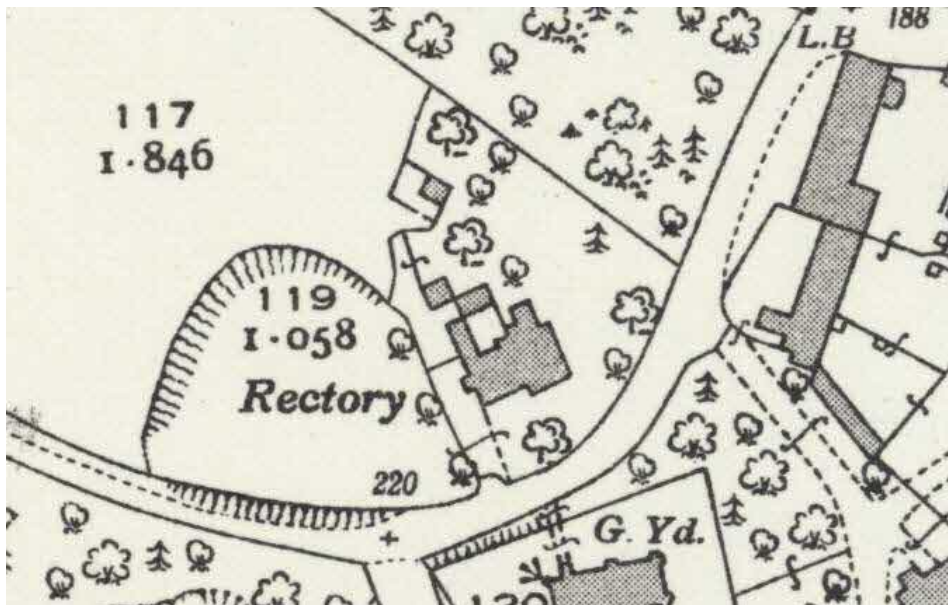
Fig. 10. The OS map of 1937 published 1939.

- 5.7 The OS map of 1925 (Fig. 9: published 1928) and the OS map of 1937 (Fig. 10: published 1939) show no further changes to the Site.

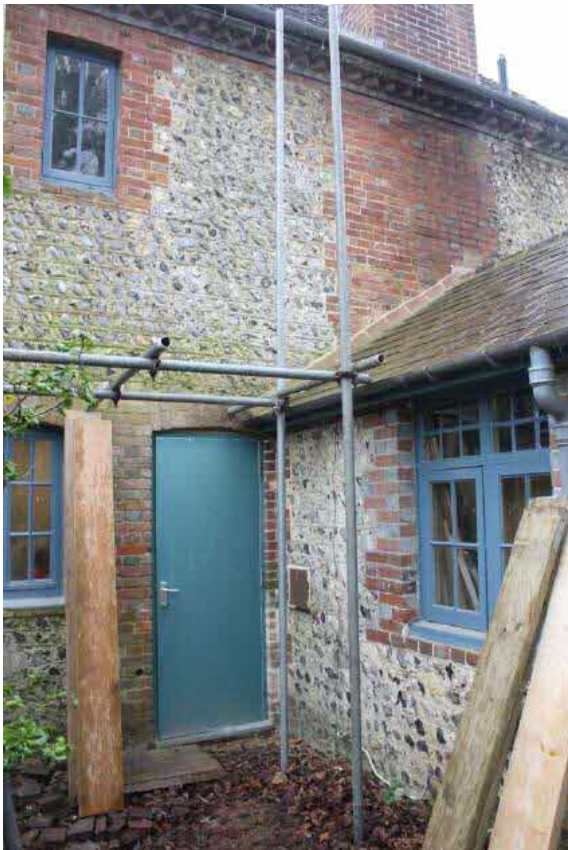
Plate 1. The attached outbuilding

To the rear of the house is a courtyard formed primarily by a single-storey outbuilding attached at right angles to the north-west corner of the house (Plate 1). In addition there is a single-storey outbuilding with attached steps to the north side of the yard (Plate 2) and a late 20th century conservatory to the east side. The yard itself is laid with bricks (Plate 3) which match the bricks of the steps which lead up to the Stable. There is a covered, brick built soak-away centrally located in the middle of the yard.

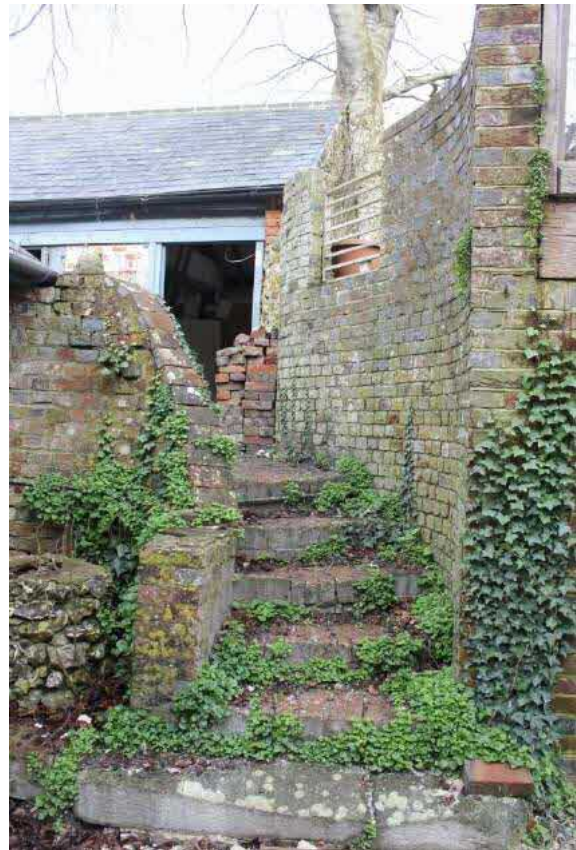
Plate 2. The steps the re-built outbuilding.

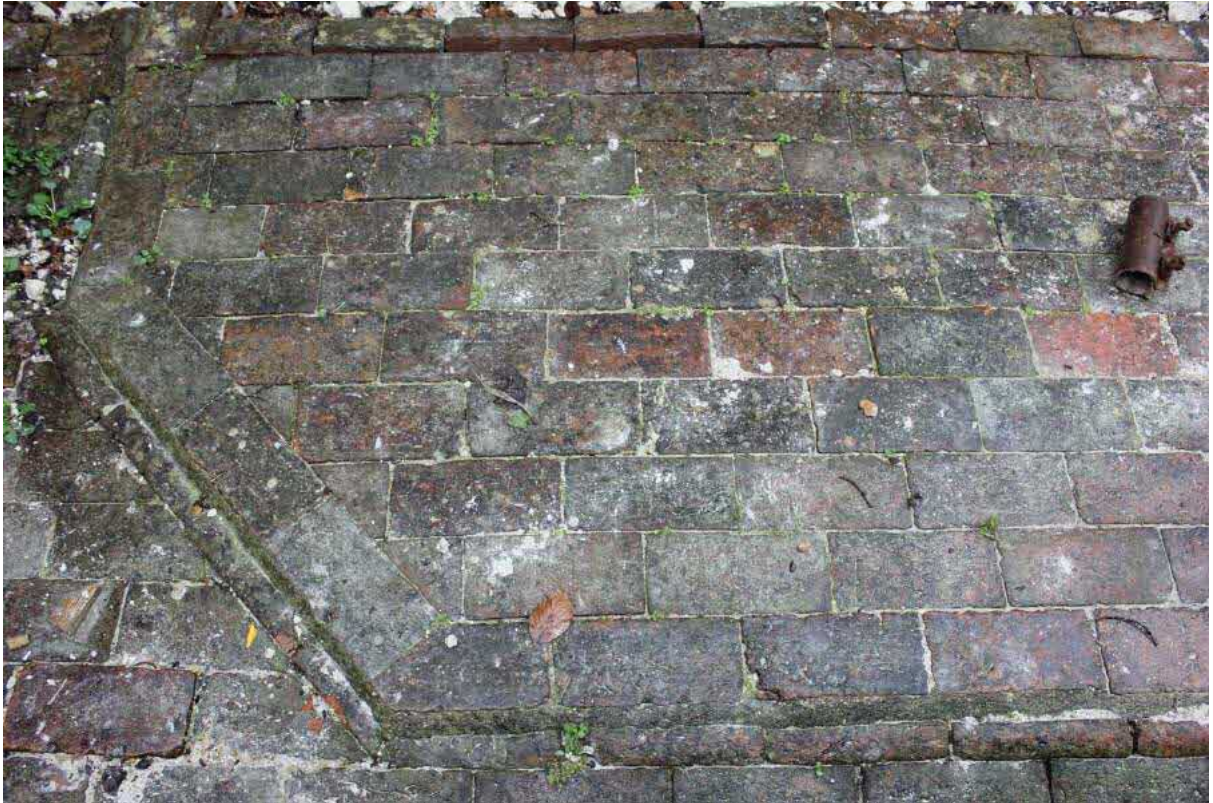
Plate 3. The brick laid surface of the yard.

- 8.4 It is recommended that if the proposals are permitted, then the bricks which form the courtyard should be re-used in the path and steps to the side of the new structure for consistency.

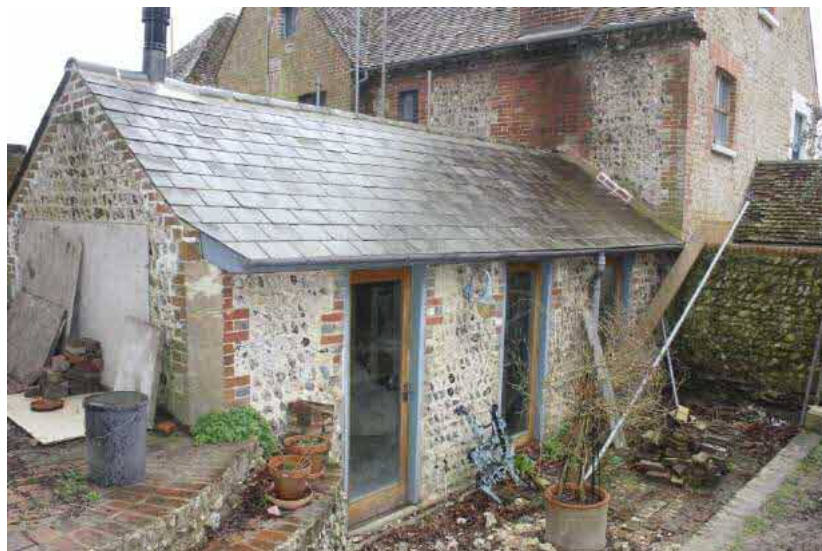
The single storey outbuilding (Plate 4) attached to the rear elevation of the house is constructed from coursed flint with brick dressings, and the roof has recently been re-covered with slate. It first appears on the historic maps between 1839 and 1873.

Plate 4. The west side of the brick outbuilding.

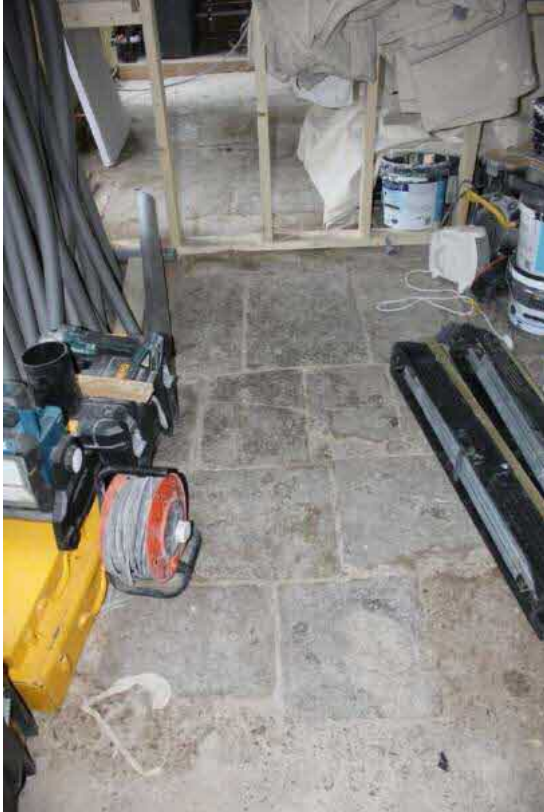
Inside the outbuilding there is a change in the flooring, with a concrete floor scored to look like flagstones to the south side where it attaches to the house which extends for c.1m into the building. There may have been a wall partitioning the

building at this point as the floor beyond is flagstone (Plate 5) which extends to the doorway to the north on the east side. This doorway has brick dressings and is likely to be original although the door is modern (Plate 6) and there are two casement windows in the east wall.

Plate 5. Concrete and flag floor.

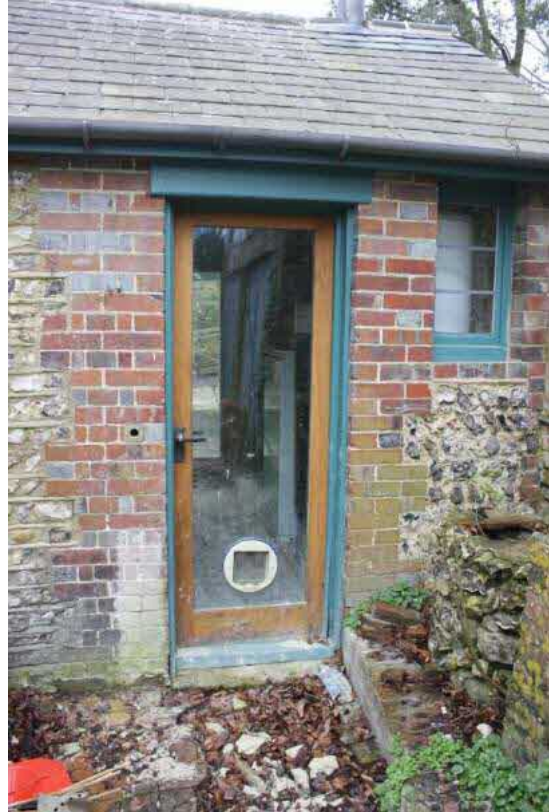
Plate 6. Modern door to the east.

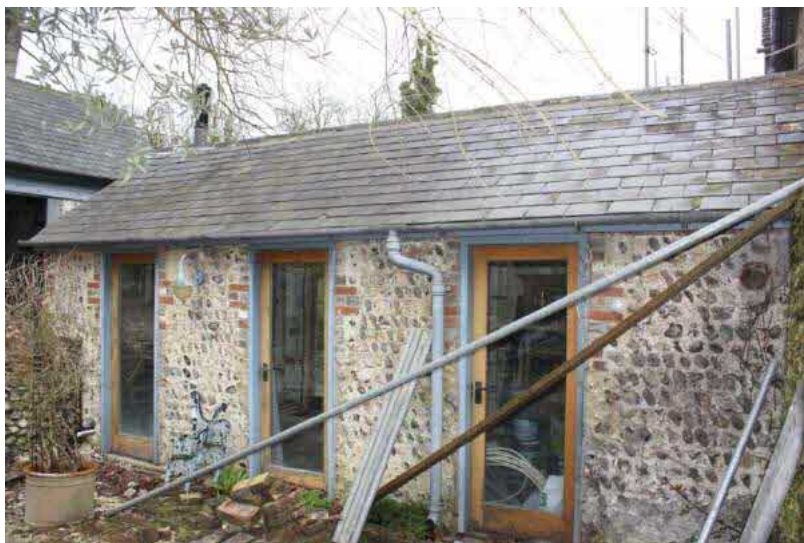
The flooring north of the doorway is then brick. There are three modern doors to the west side (Plate 7) which have been inserted at a later date with no original apertures apparent in this side.

Plate 7. Modern door insertions to the west.

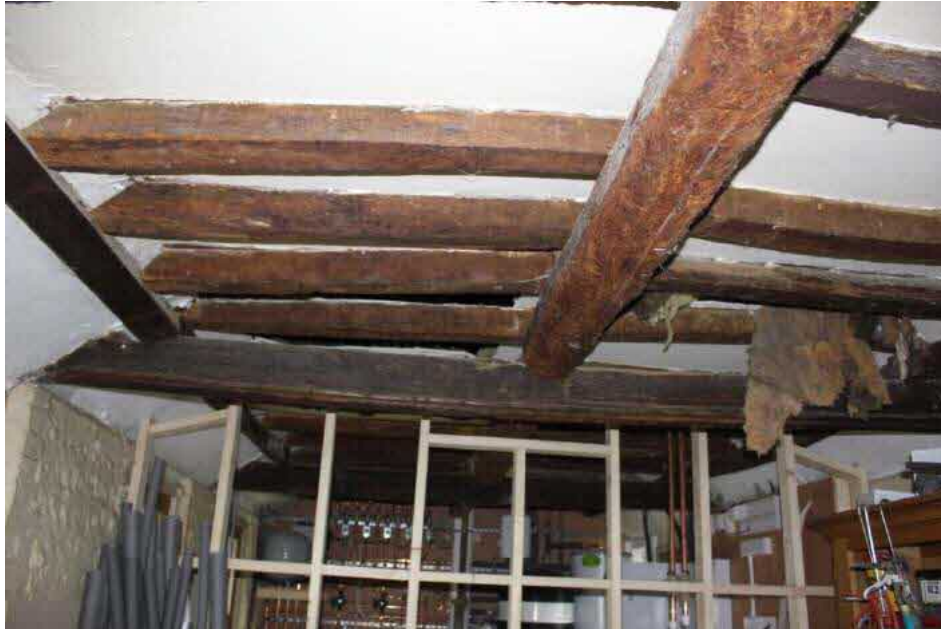
The roof has two tiebeams but no mortices for full height internal, partition walls. The purlins rest directly on top of the tiebeams and the joists sit on the top of the purlins rather than the walls (Plate 8) so they have bowed considerably. The flintwork walls to the east side have been altered as well so it is possible the form of the north end has been changed.

Plate 8. The roof construction of the outbuilding.

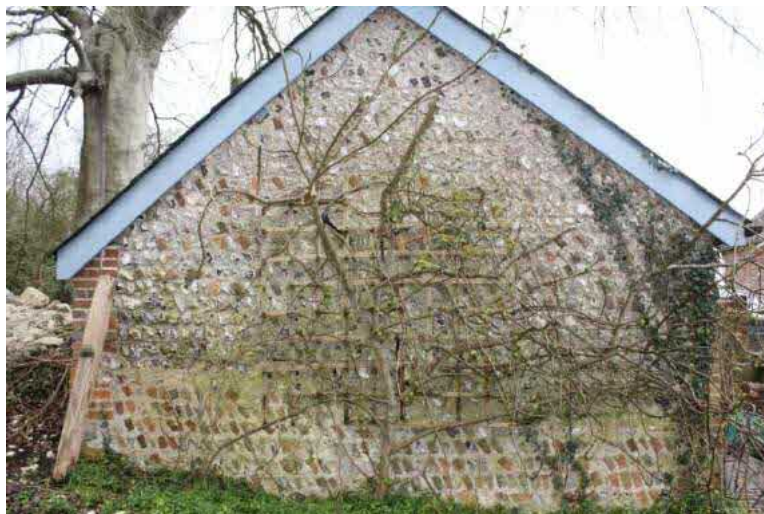
There is a detached Stable block at a higher level to the north of the outbuilding, which is accessed via a set of brick steps which lead to the front entrance of the Stables. This structure is on the tithe map of c.1839, so is likely to date between the late 18th century to early 19th century. The walls are also flintwork with some brick inserted, mainly in the lower courses, so it can be regarded as Bungaroosh (Plate 9) and there is still a horse harness hanging on the walls (Plate 10).

Plate 9. Bungaroosh east wall of the Stable.

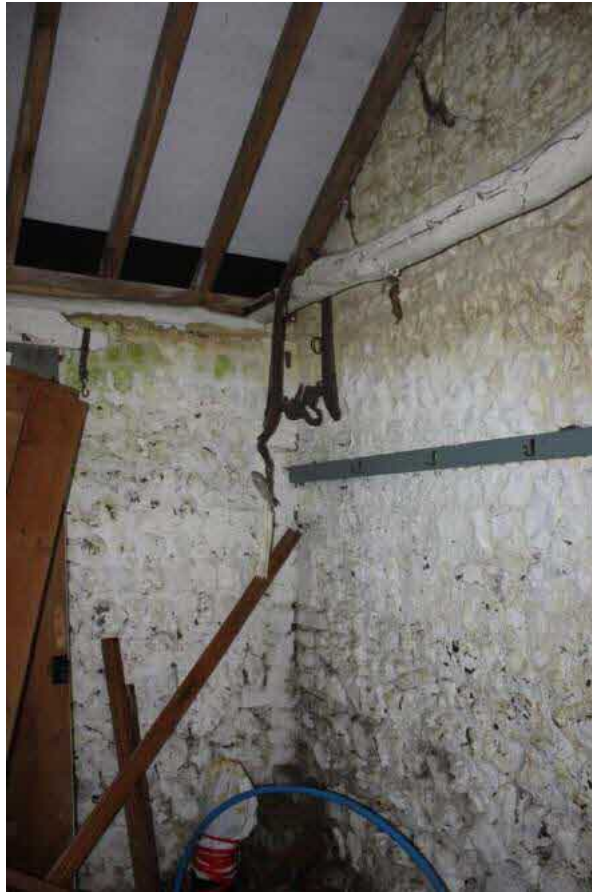
Plate 10. Horse harness hanging on the walls of the Stable.

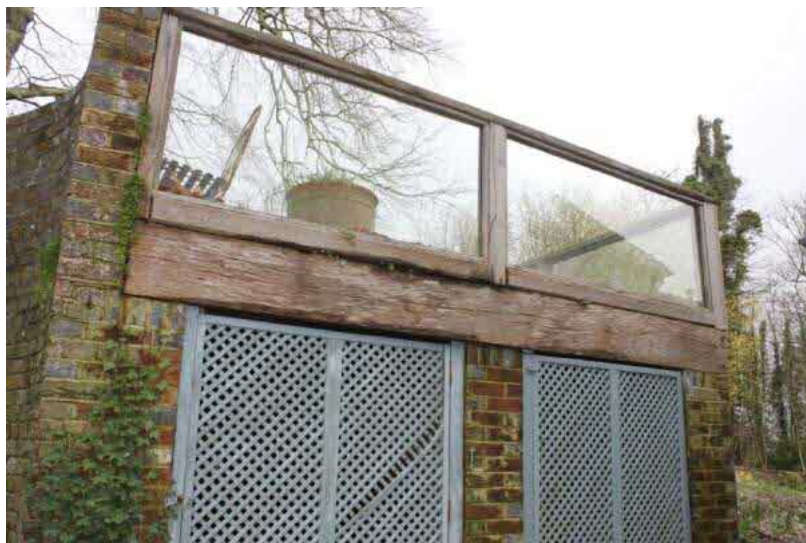
Another detached structure once occupied the space, but this has since been mostly rebuilt when it was partly replaced in the late 20th century (Plate 11). However, the rear wall remains in-situ internally which currently provides structural retention of the garden at the higher level. There is a modern glass balustrade on top of the single-storey structure that remains in place today, with access from the garden.

Plate 11. The re-built outbuilding north of the courtyard.

Permission already exists for the removal of this structure as well as the steps to the side.

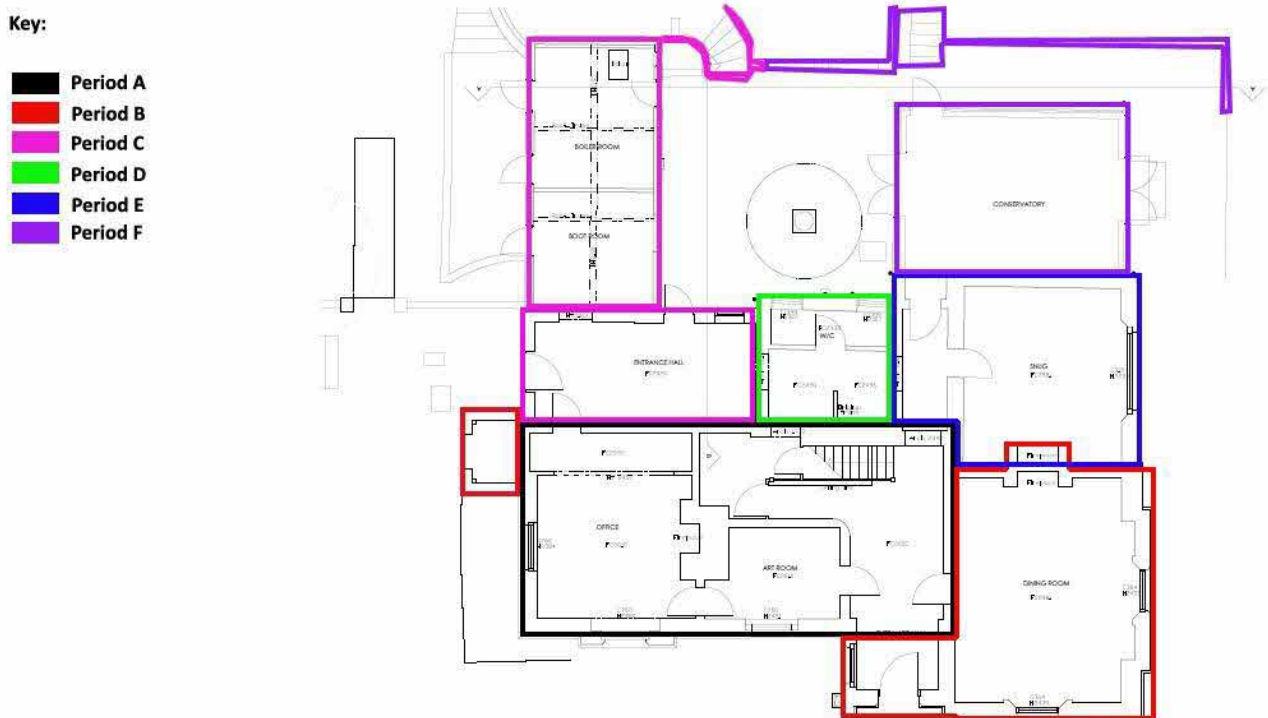
The existing rear wall is not the oldest part of the house, which has several, complex phases of evolution, which is likely to have their origins in the medieval period. However, as this is not a full building survey, this can only be suggested at this stage (Fig. 11) and could only be solved through the undertaking of a full archaeological interpretive survey (AIS). It is suggested that at the core of the building was a much more simple, three bayed timber-framed house. The building was clearly subjected to significant renovations after 1839, but it is not certain if all of the extensions are of different periods; it is possible that some of them were built at the same time, of different designs but it is more likely that only a few years separate the majority of the additions as suggested below.

Fig. 11. Suggested phased floor plan for the Rectory.

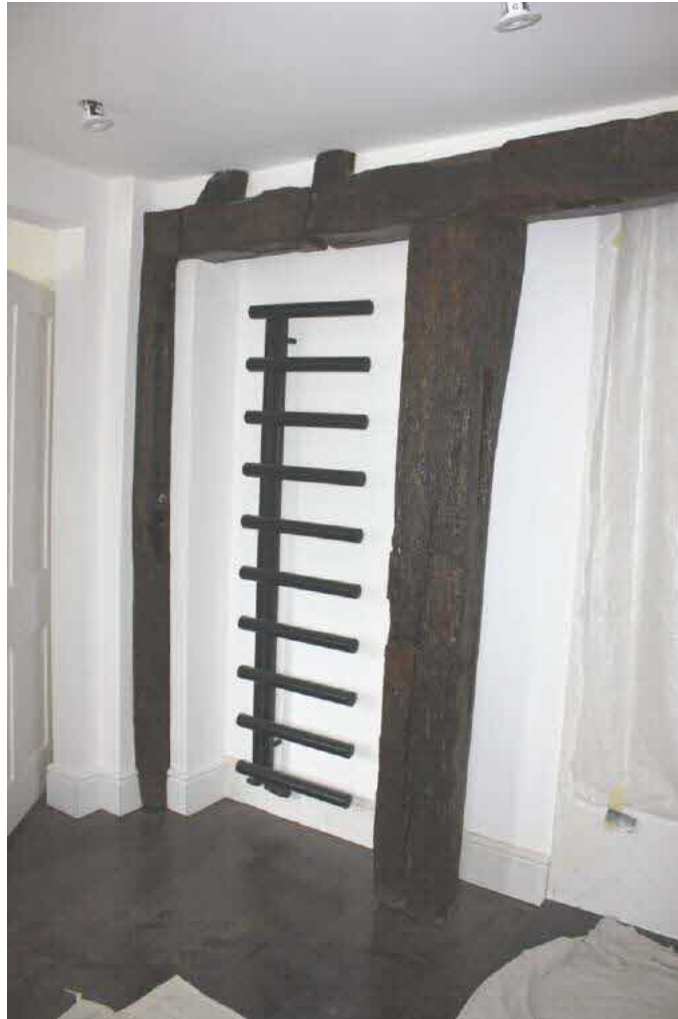
There is some remaining evidence for the earliest phase on the first floor where part of the older frame remains in-situ which is pegged together (Plate 12), suggesting it is the surviving part of what was once a larger frame. The frame appears to have been subsequently replaced, section by section over the years, until this surviving section was hidden behind boarding.

Plate 12. In-situ, pegged framing in the first floor bathroom.

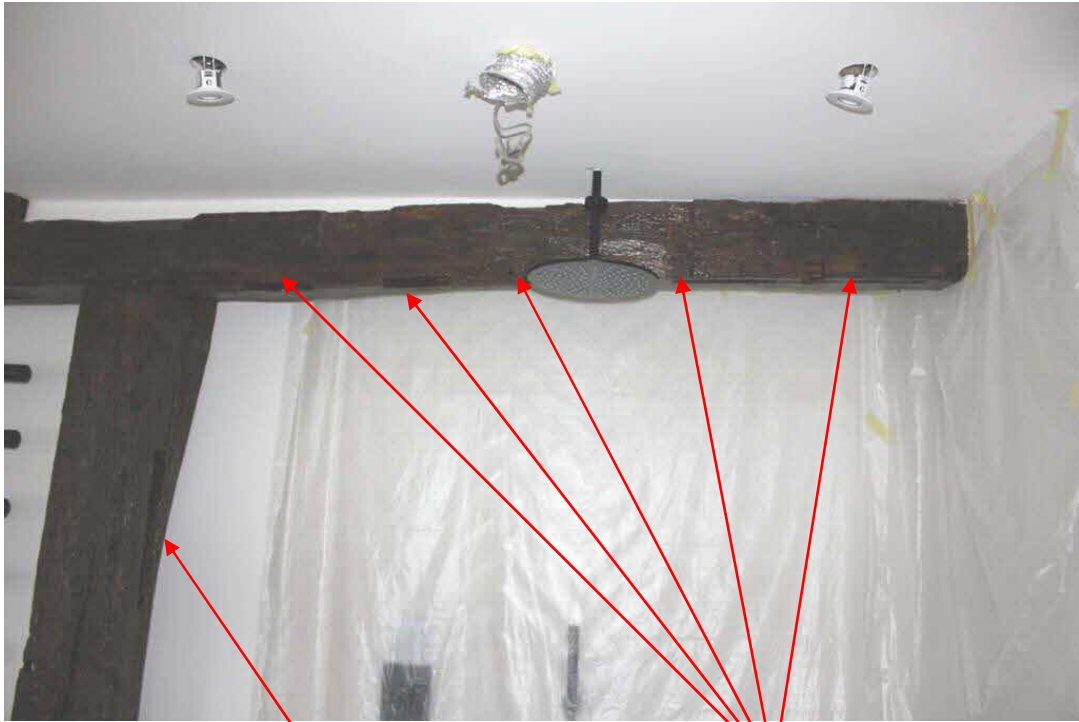
The recent renovations which have taken place as part of an earlier application revealed the hitherto unseen frame, which consists of part of the original side girt, the wallplate, two rafter feet, the top of one post with a swelling jowl and two studs. There is also evidence for a now removed, first floor window up against the post on the east side. The empty pegs and mortice are present for the removed cill as well as the window head and there is a groove in one stud for a former vertical shutter. In addition there are some empty mortices for close studding (not pegged), faced to the rear wall so they would have been flush with the external surface (Plate 13). This is a particularly high status form of framing which is normally restricted, though not always, to the principal elevation. It is a conspicuous sign of status and suggests a date somewhere in the 15th-16th centuries.

Plate 13. Empty mortice for missing foot brace and close studding mortices.

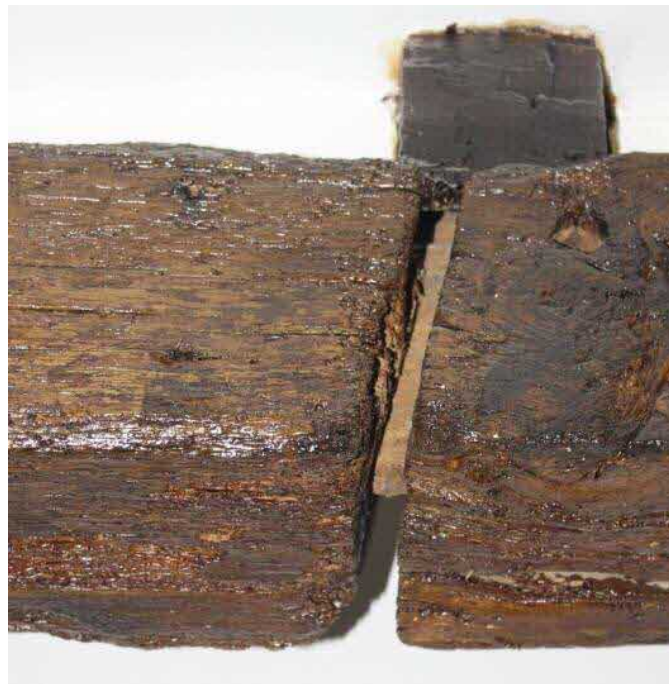
There is also an empty mortice for a foot brace and the form of panels suggest large panel framing rather than smaller panels, which is a later, 16th century design. The wallplate has a very makeshift lap-joint (Plate 14). Below this at ground floor level are some re-used timbers which form a narrow stud wall which is not original (Plate 15).

Plate 14. Crude lap-joint in the wallplate.

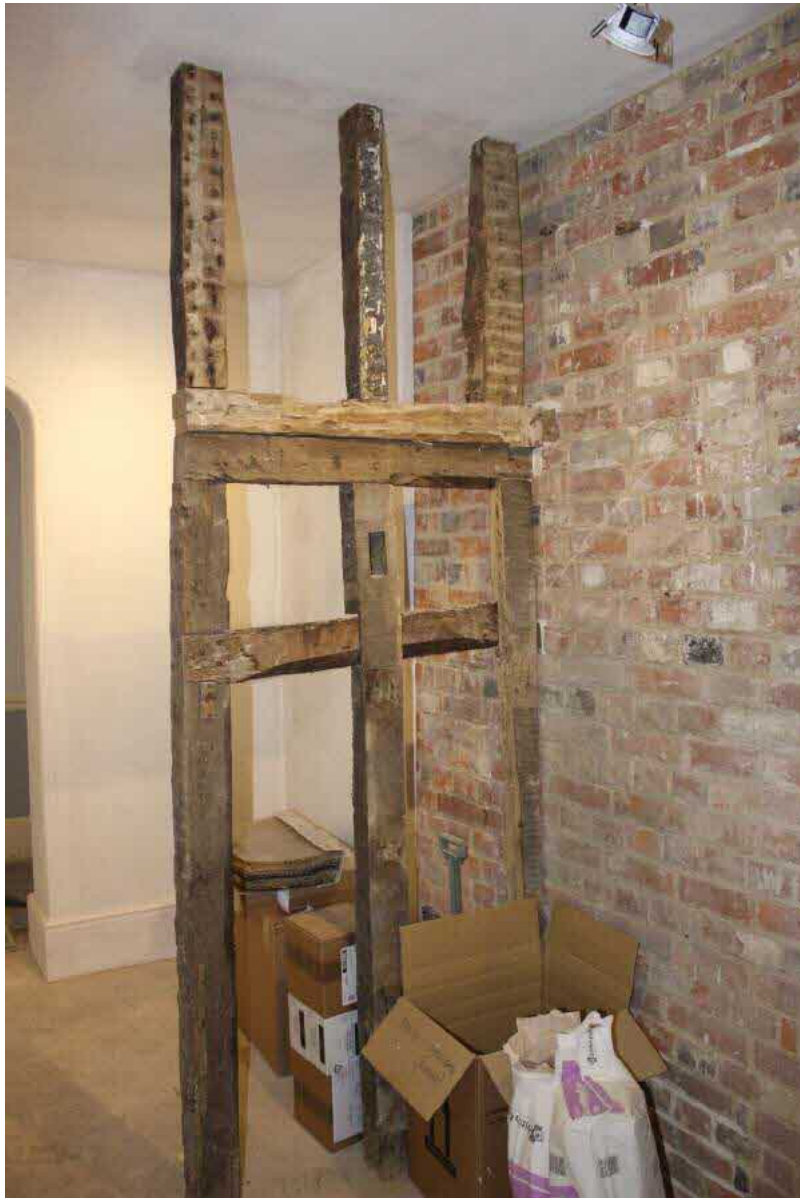
Plate 15. Makeshift stud wall using recycled timbers at ground floor.

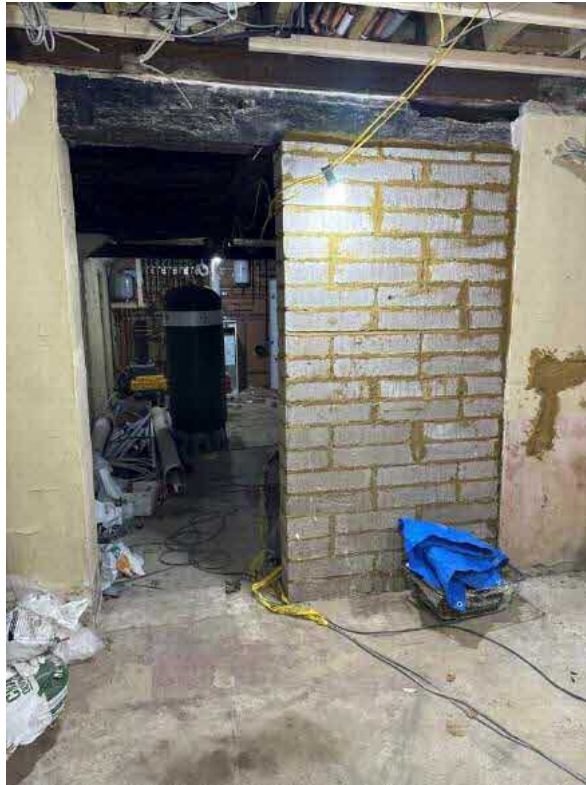
Another exposed beam was seen (Plate 16) but this is not in-situ and is likely re-used from elsewhere, once being part of either a wallplate or side girt which has two peg-holes and a mortice for another foot brace (since removed). There is a steel RSJ above this, which was put in when the wall was recently opened up by the former owners when the attached Period C outbuilding was converted into a kitchen. Part of this space has very recently been infilled and covered over so the beam is no longer exposed.

Plate 16. Probable re-used beam between the rear wall of the house and the outbuilding.

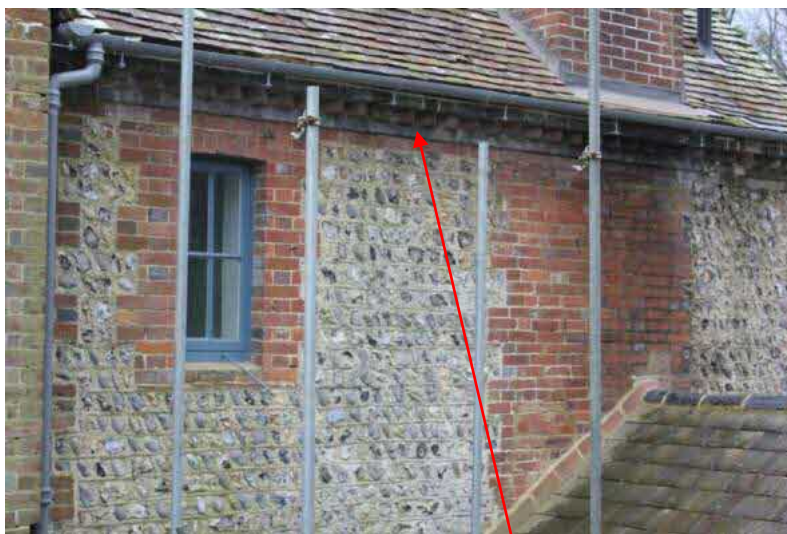
The rear elevation of the house in the north-west side is constructed from coursed flint wall (Plate 17) with brick dressings and lime mortar with a high percentage of aggregate in the mix. There is also a projecting dog's tooth eaves course (diagonally set brickwork) and there are some burnt headers present in the bricks. The chimney stack here is flush to the external wall so is an internal stack built at the same time as the wall, during Period C when the outbuilding was most likely built at the same time. There are segmental arches formed from single header bricks above the modern back door and a Victorian casement to the north of this with another in the single casement window above.

Plate 17. Projecting dog's tooth eaves course.

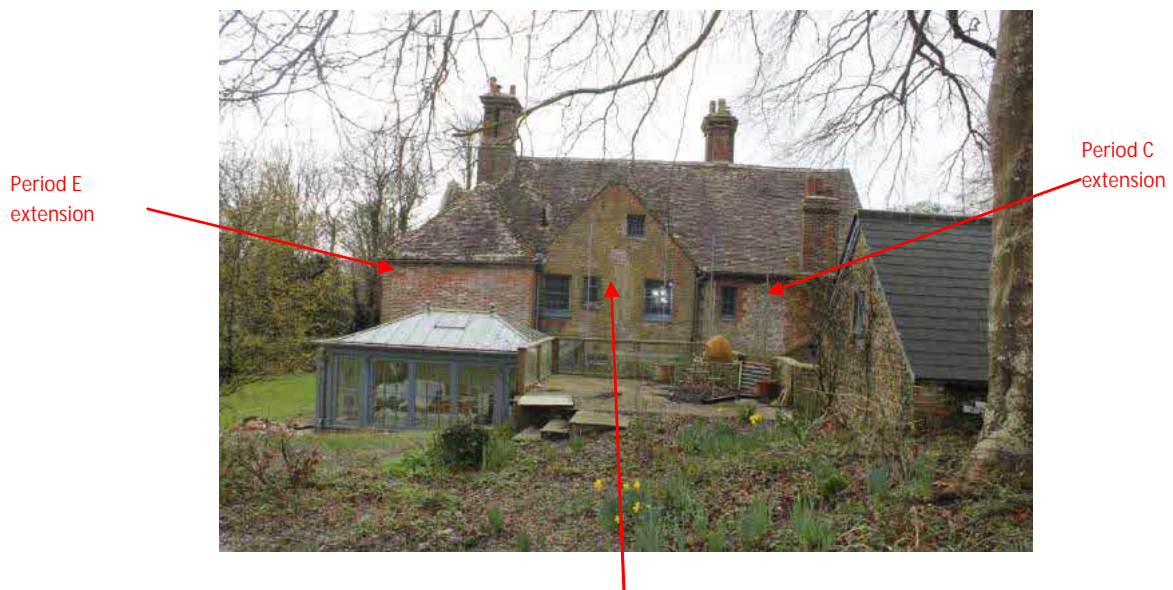
The wall then steps out slightly where the Period D extension was added (Plate 19), probably soon after the Period C alterations were built when the existing house was widened, although as discussed above, the phasing is not immediately clear.

Plate 19. Slightly projecting, central dormer Period D extension to the rear.

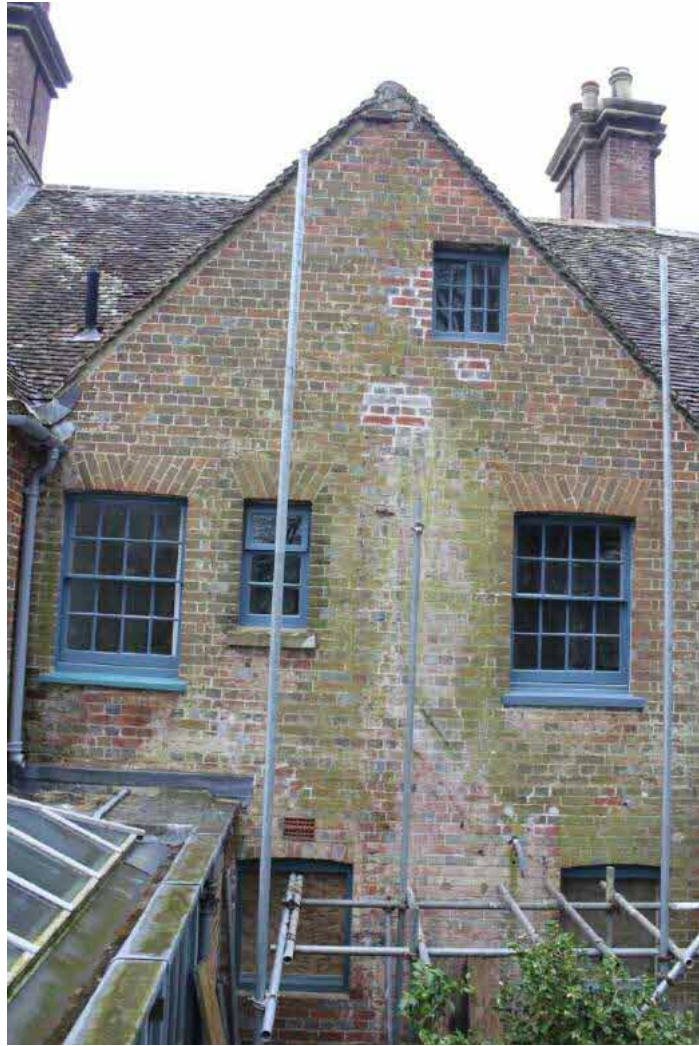
This is essentially a dormer extension providing two storeys, with English Bond brickwork (once rendered). This elevation has different styles of frames and windows; some of the windows have been replaced (Plate 20). At ground floor level there are two three over three sash windows with vertical glazing bars (Plate 21) which have had the frames repaired as part of the existing renovation works. There are two eight over eight sliding sashes on the first floor with gauged arched window heads and an off-centre casement with a top opening. In the roof space is an off-centre sliding Sussex sash with six lights and no lintel. Not all of the windows have queen closers on both sides.

Plate 20. Different window styles in the extension.

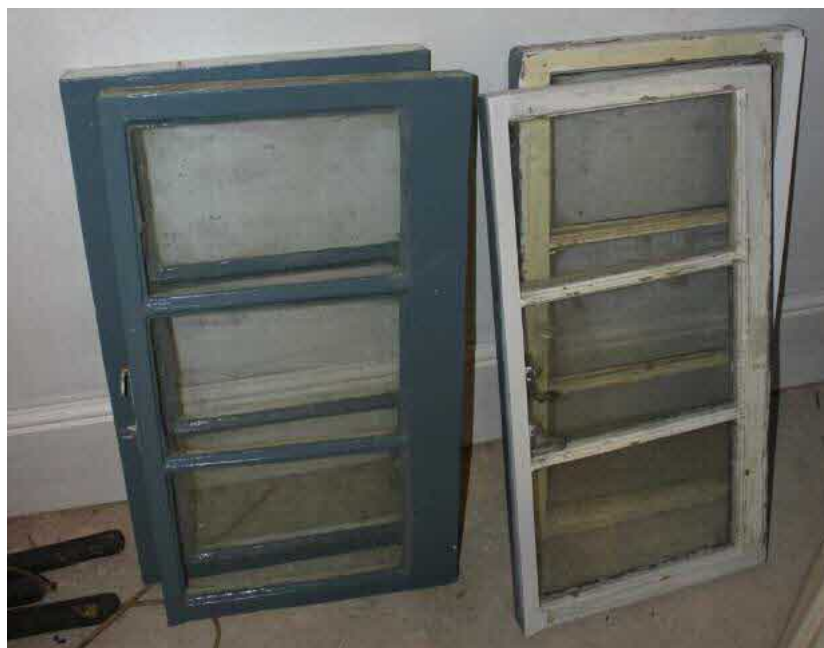
Plate 21. Repaired sashes from the ground floor window.

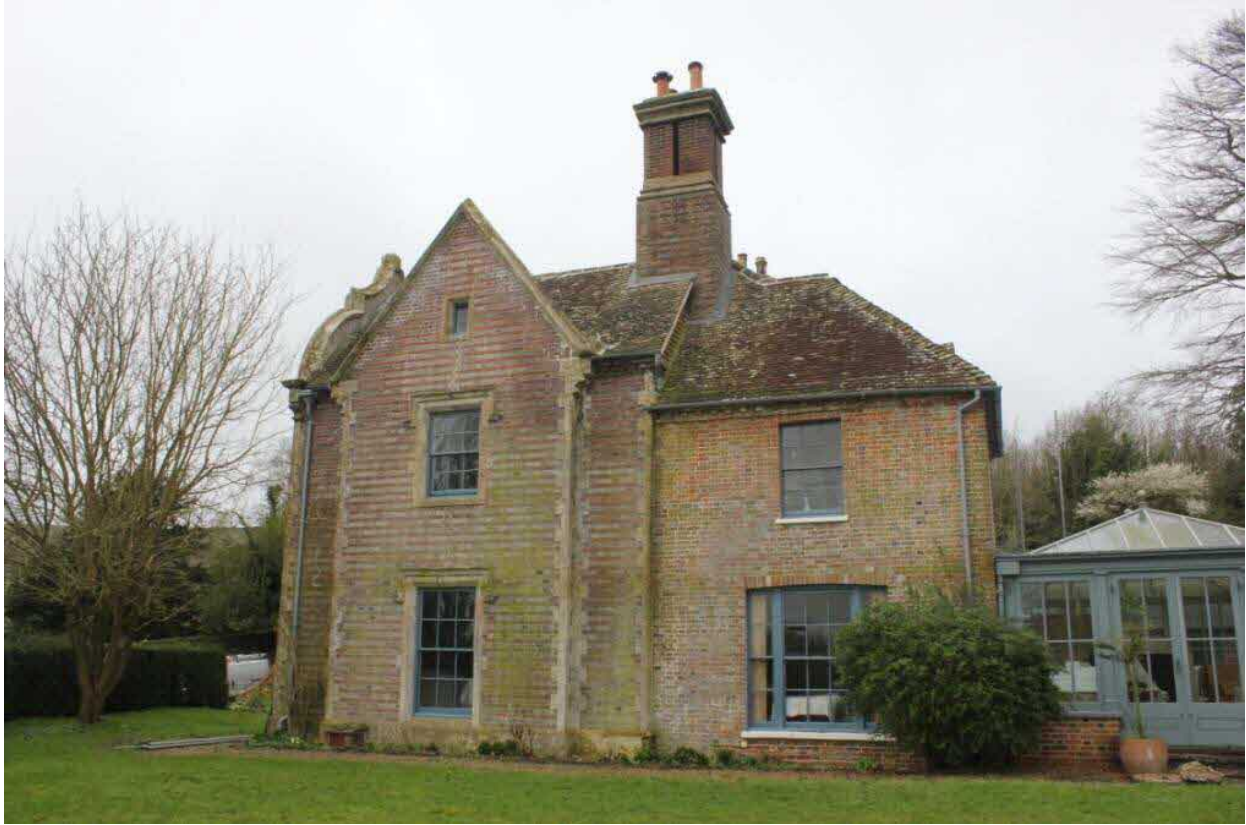
The house is only briefly described, so as to place the proposals into the wider context. A high status side wing was added to east side of the house after 1839 (Plate 22).

Plate 22. High status side wing with later attachment.

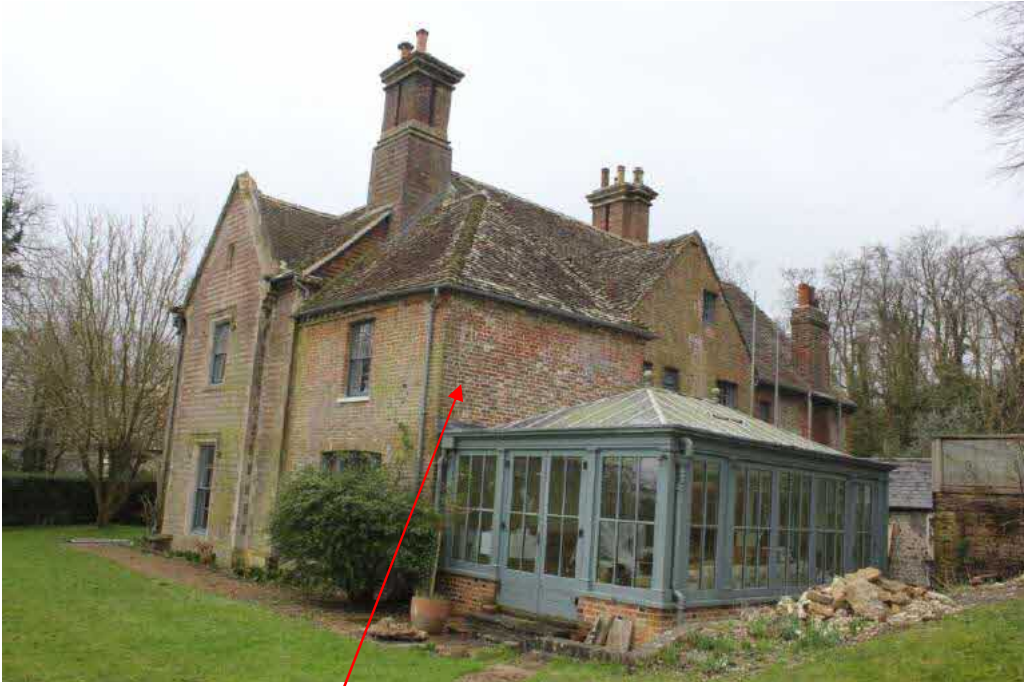
However, the footprint of the rear part of the wing does change slightly after 1873 so it is possible that whatever was present after 1839 may have been demolished and re-modelled for reasons unknown. The existing extension was likely used perhaps as a service block as the quality of the workmanship and materials used is far less superior than the rest of the side wing. The evidence for this being a later addition is borne out in the roof space but can clearly be seen to the north side of the house, although the materials look older so it's possible they are re-used from elsewhere. The brickwork of this later extension is predominantly Flemish Bond with a Dentil style projecting eaves course (Plate 23) so it does not match any of the other walls of the house. The bricks are fairly misshapen and not machine cut and were previously rendered. The roof terminal is lower than the earlier wing and has a hipped terminal. Once again, only a full archaeological survey would improve understanding of this phase. The higher class wing is built with English Bond brickwork with burnt headers throughout and the bricks are finer grained. The dressings at the corners and window reveals are stone slips rather than brick. Stylistically this better class wing is more significant and has better architectural design and materials, which include decorated kneeler stones at the roof edges and label moulds over the windows.

Plate 23. Less superior extension added to the rear of the high status wing.

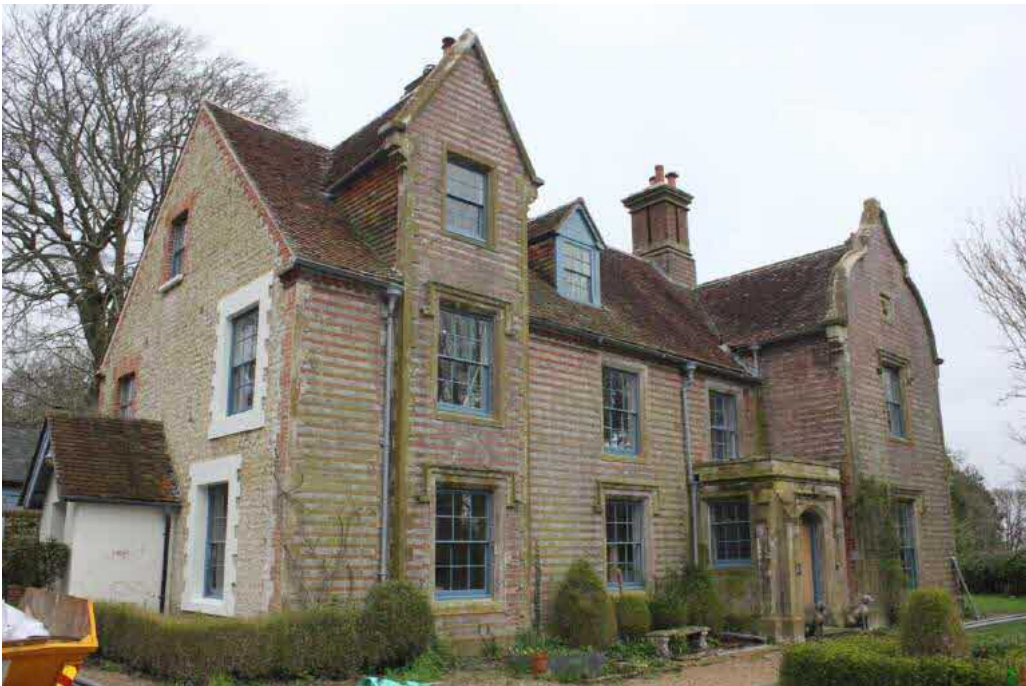
The east elevation has six over six sliding sash windows with fielded panels in the rear, later extension, which is also not mirrored elsewhere in the higher class wing. The front elevation (Plate 24) has a Dutch Gable with a heraldic crest (Plate 25) and a porched entrance. The windows are mostly six over six sliding sashes to all levels and there is a contemporary dormer window in the roof. At the top of the wall are projecting dog's toothed brickwork. There are cast iron downpipes and guttering throughout which have lion's head detailing on the hoppers and brackets.

Plate 24. The front elevation facing the church.

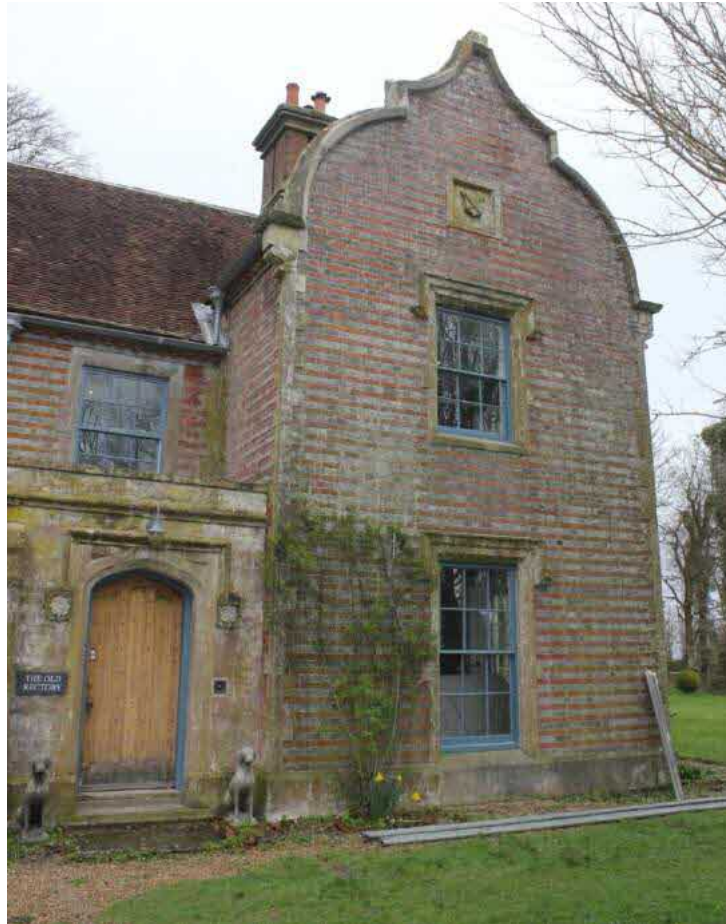
Plate 25. The Dutch gable with heraldic crest.

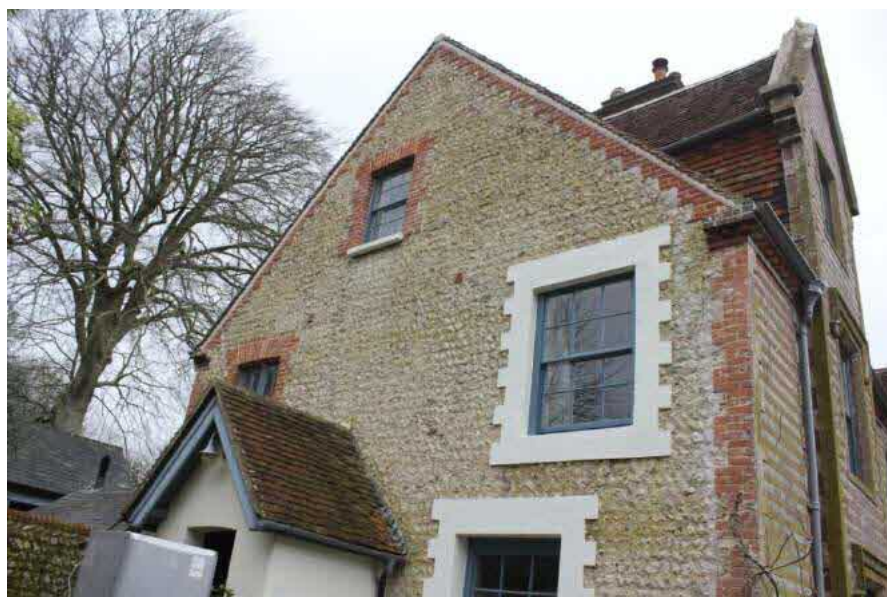
The west wall (Plate 26) is coursed flint with rendered Greek keyed surrounds to the windows with gauged arched lintels where un-rendered. It is not entirely clear why some surrounds are rendered.

Plate 26. The west elevation.

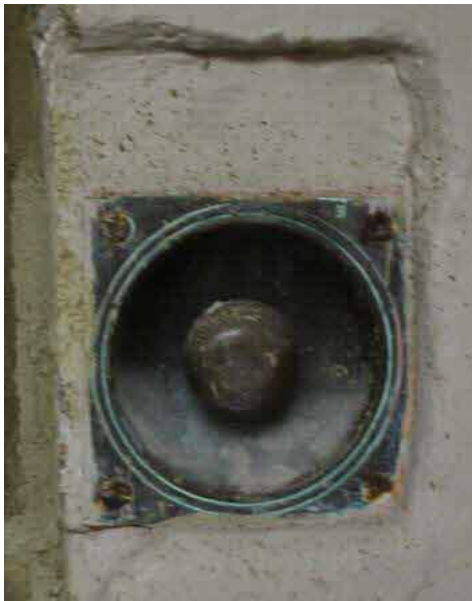
Plate 27. Door pull.

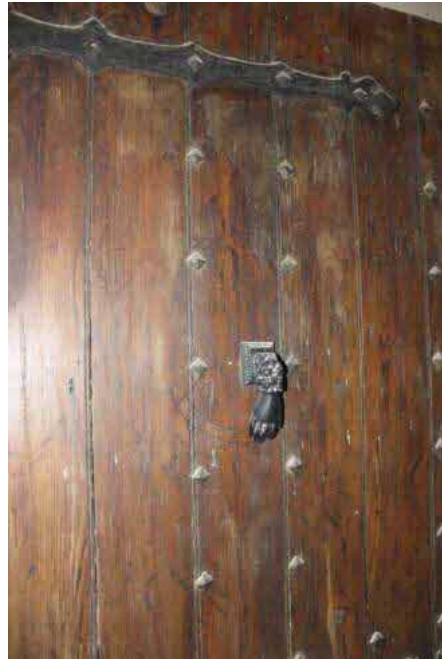
One of the ground floor windows to the north of the side porch has been extended to create a new side doorway. The porch next to this is probably Victorian with the same flagstone floor as seen in the attached single-storey structure to the rear. The porch walls are rendered brickwork so it is difficult to be precise about the date, although it does appear on the map regression after 1839. There is a copper alloy door pull (Plate 27) and the door is a contemporary Gothic-style pine plank door (Plate 28) set on pintles with thick iron studs.

Plate 28. Gothic decoration on the door.
