Revision A

A HERITAGE STATEMENT FOR THE OLD RECTORY, FOLKINGTON,
EAST SUSSEX, BN26 5SD.

Archaeology Services Lewes

Project number: ASL 318-24

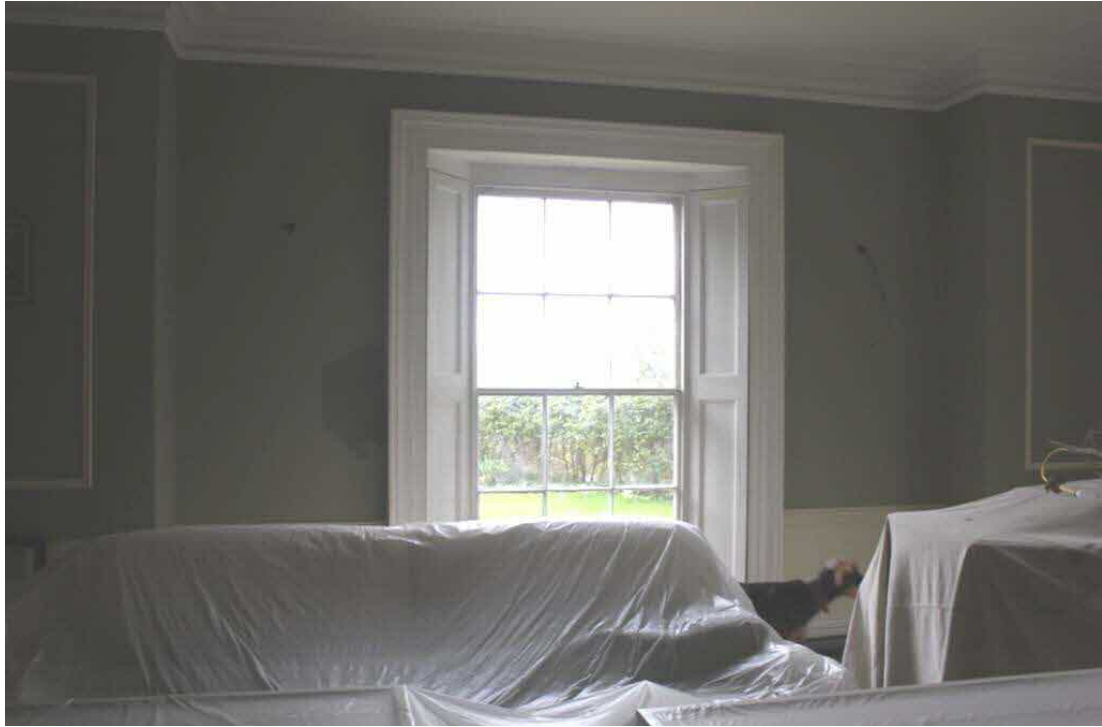
Inside the Period E extension, it is clear that there are only two rooms; one on the ground floor and one on the first floor, with a corridor that likely led to the rear door into the courtyard, which has since been replaced when the conservatory was built. On the lower level the walls are covered with Arts and Crafts style pine panelling and the window with fielded panels has folding shutters. The floorboards are thin and narrow. There is a six panelled door leading in to the drawing room in the high status wing, which also houses only two rooms plus an entrance vestibule. This room which has vertical, folding shutters to the window (Plate 29) and the fireplace surround (Plate 30) is an original pine 'Adams' style surround with swags and tails.

Plate 29. Eastern window with shutters.

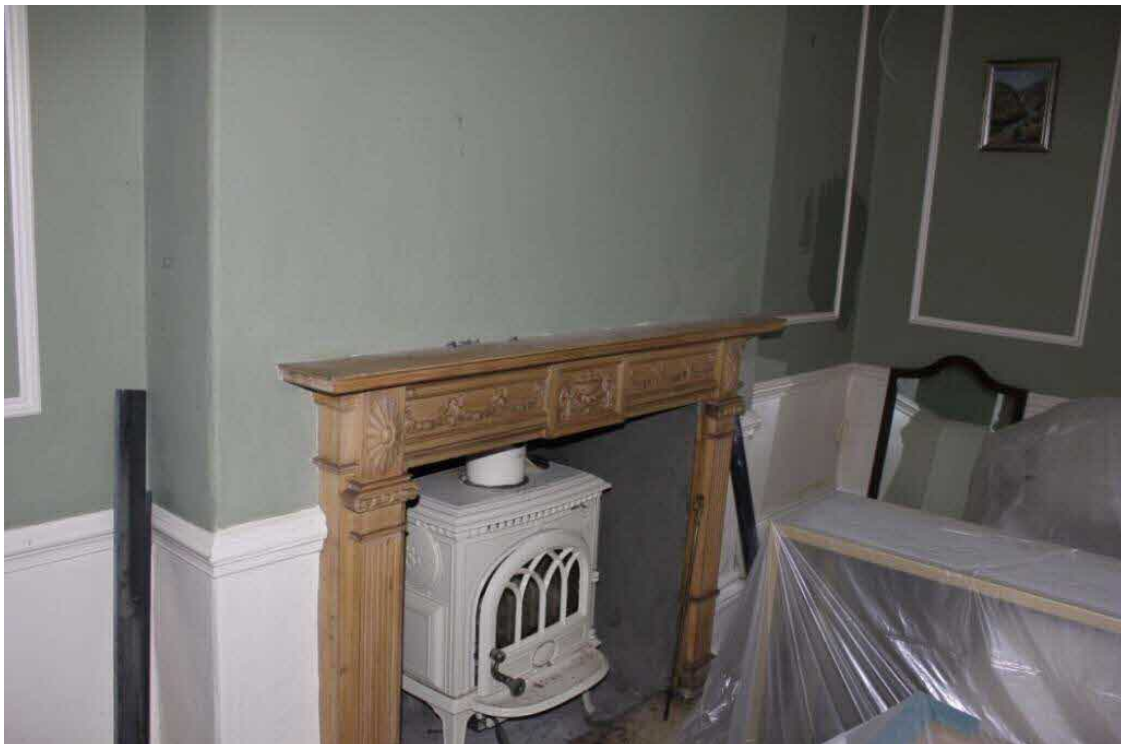
Plate 30. Fireplace surround in the high status drawing room.

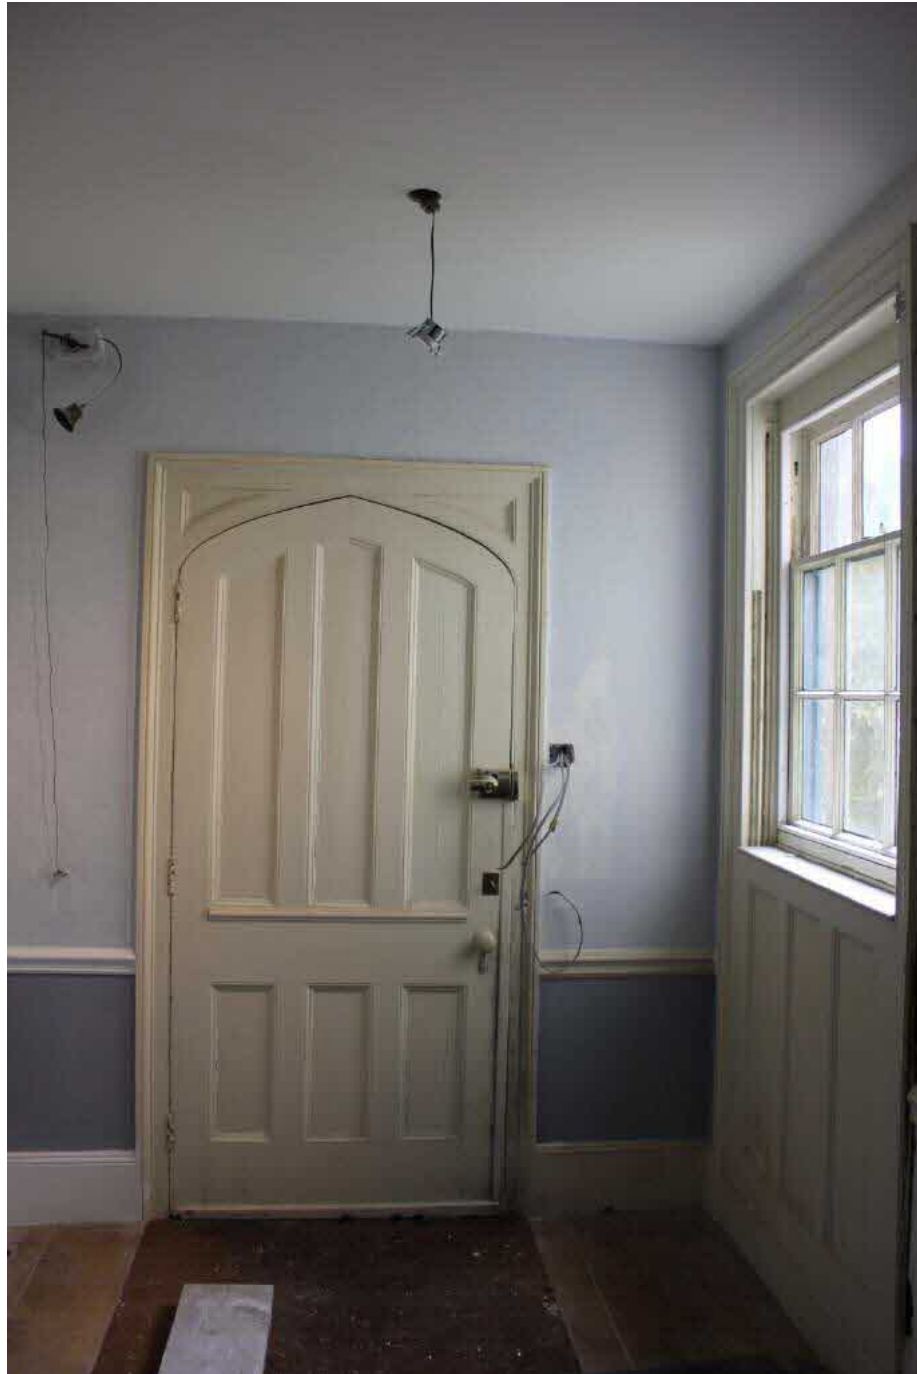
The main entrance door still has the in-situ bell attached to the wall and a Gothic style arched door (Plate 31), which is matched elsewhere in the building.

Plate 31. The main entrance door in the lobby.

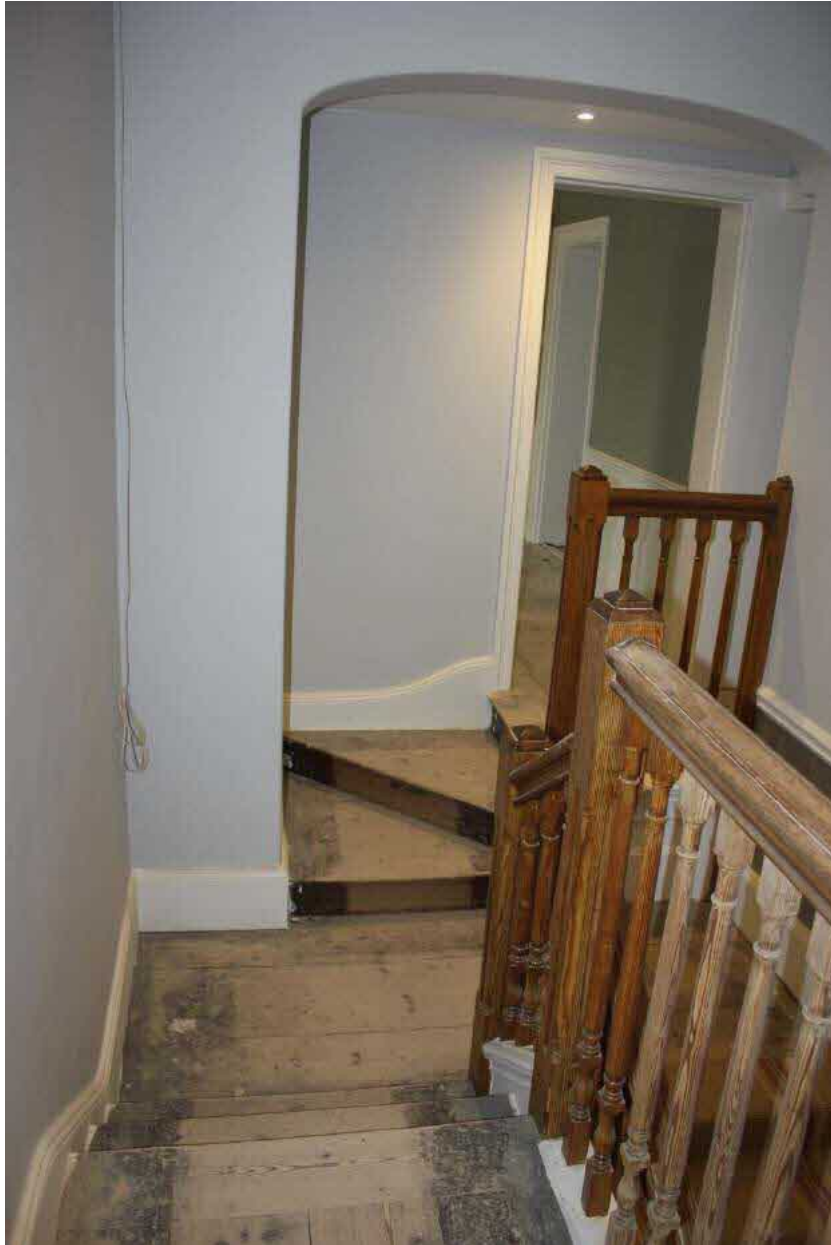
There is a thick stud wall which covers the timber-framed section. This shows as a slightly different alignment to the rooms further west and the side of the stairs fix directly against this so the framing pre-dates the stairs at least. The landing is spilt level (Plate 32).

Plate 32. Split level landing.

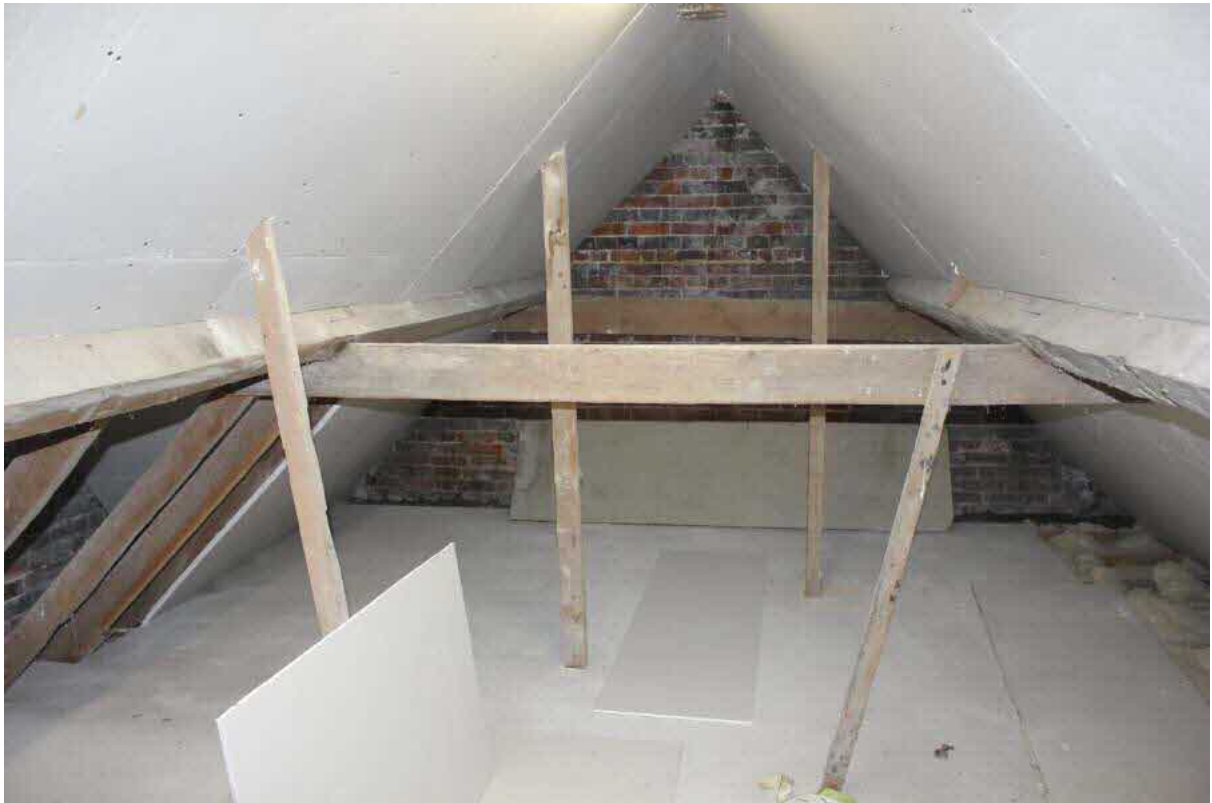
There are many different levels in the roof with raking struts used to bridge the gaps. The roof of the Period B, high status wing (Plate 33) has collar trusses with continuous purlins which are dated in two places; 1852 (Plate 34) and 1853. The Period E later extension is clearly built with machine sawn wood (band sawn) at a lower height around the existing stack (Plate 35), although a much older rafter has been utilized within (Plate 36).

Plate 33. The roof of the high status wing looking south.

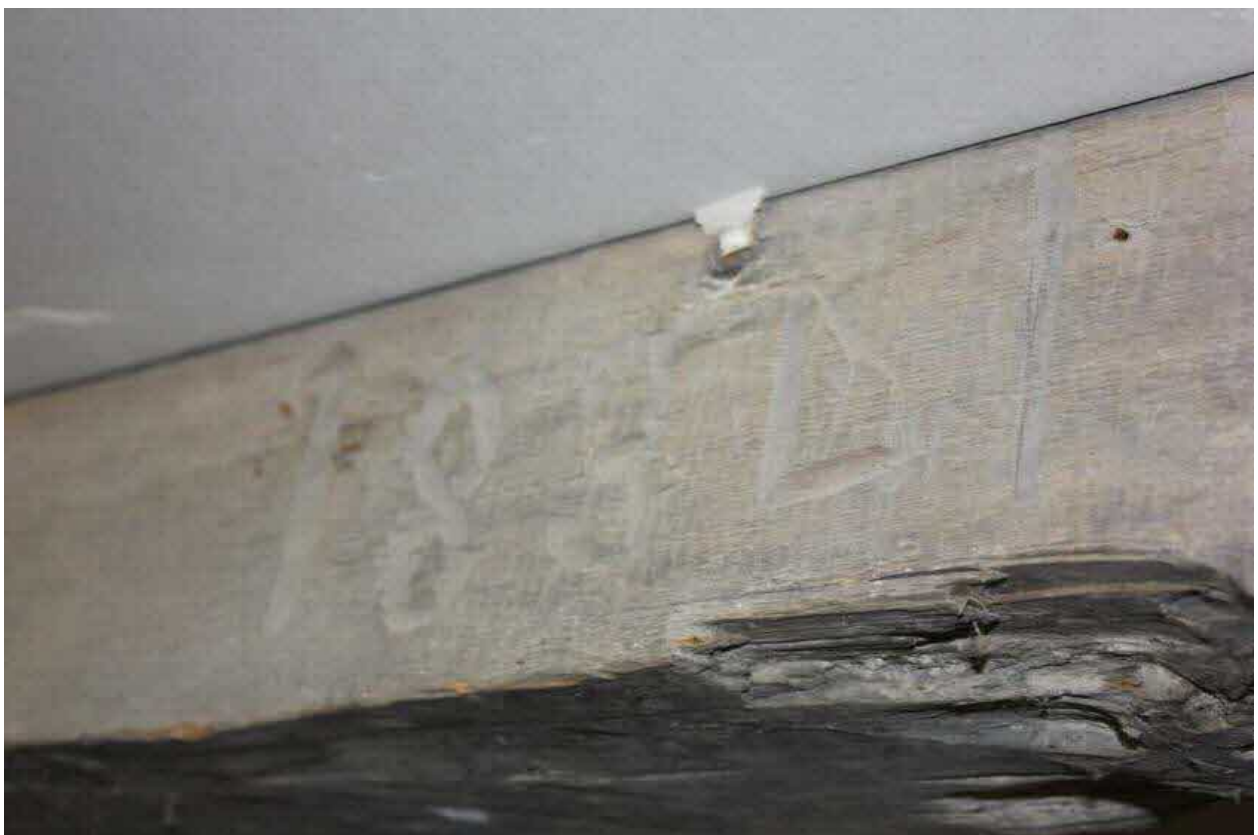
Plate 34. Date carved into the western purlin.

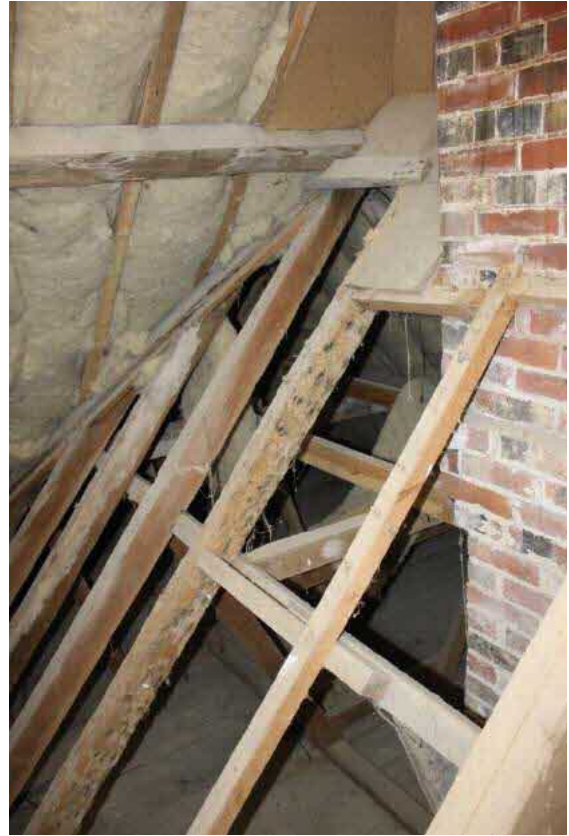
Plate 36. Re-used rafter in the later roof.

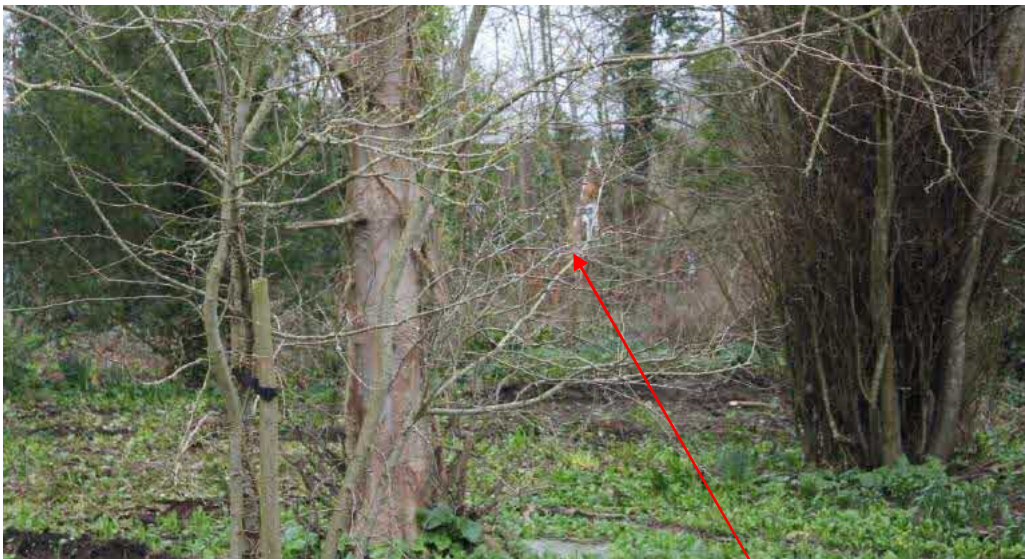
The proposed development will not visible from the wider public viewpoints from Folkington Lane as the development is contained to the rear and set down below the rising ground levels to the north and east sides of the Site. There are no clear views from nearby properties looking over the Site. There may be minimal glimpses from another house to the east side on Folkington Lane, although there is a small area of shrubs and mature trees here that essentially block the view, even during winter when the deciduous trees have dropped their leaves (Plate 37).

Plate 37. Dwelling east of the Rectory on Folkington Lane.

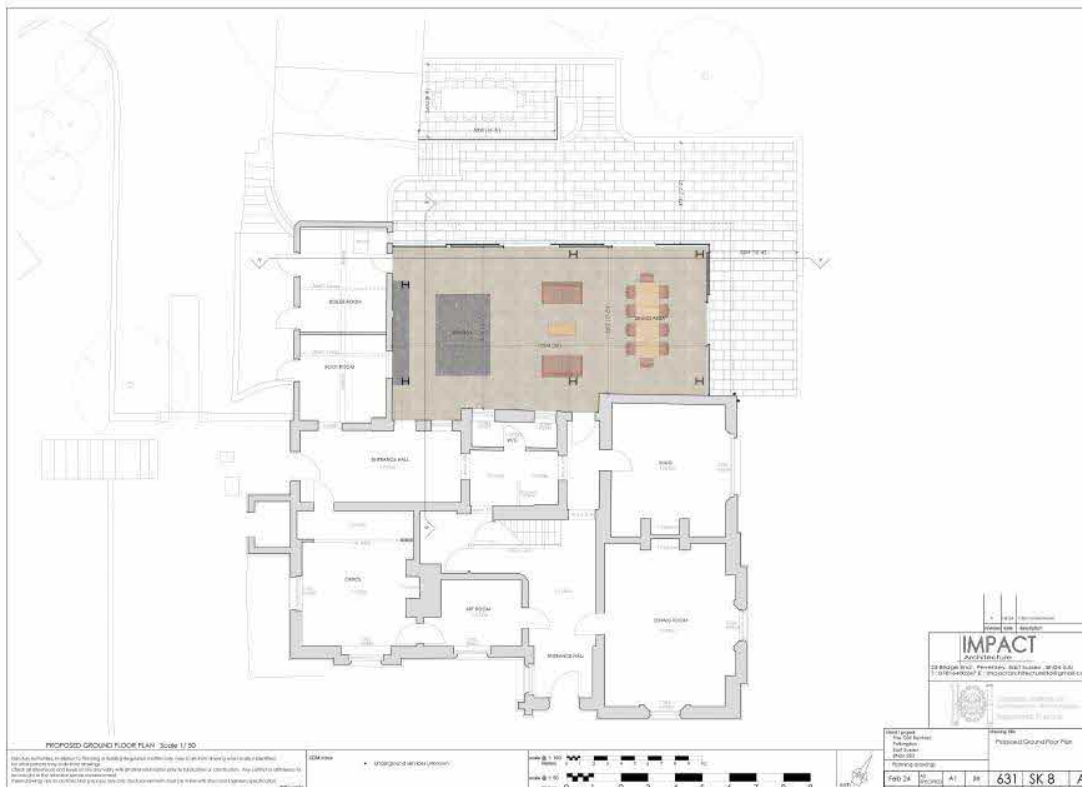
According to information provided by the Agent, the proposed extension (Figs 12-16) will maintain the existing rear elevation, complete with exposed brick and all windows to be retained in-situ. This will preserve the legibility of both the historic fabric as well as the original plan form to some extent. Although it is acknowledged that the former courtyard will be built over, the design will not eradicate the understanding of the former use of the space. The use of large glazed panels will also ensure that the more immediate setting of the rear part of the Site will have less physical barriers than the existing conservatory, so could be seen as an enhancement. The simple rectangular plan form also reflects the existing courtyard form.

Fig. 12. Proposed ground floor plan ©Impact Architecture February 2024 drawing number SK8 revision A.

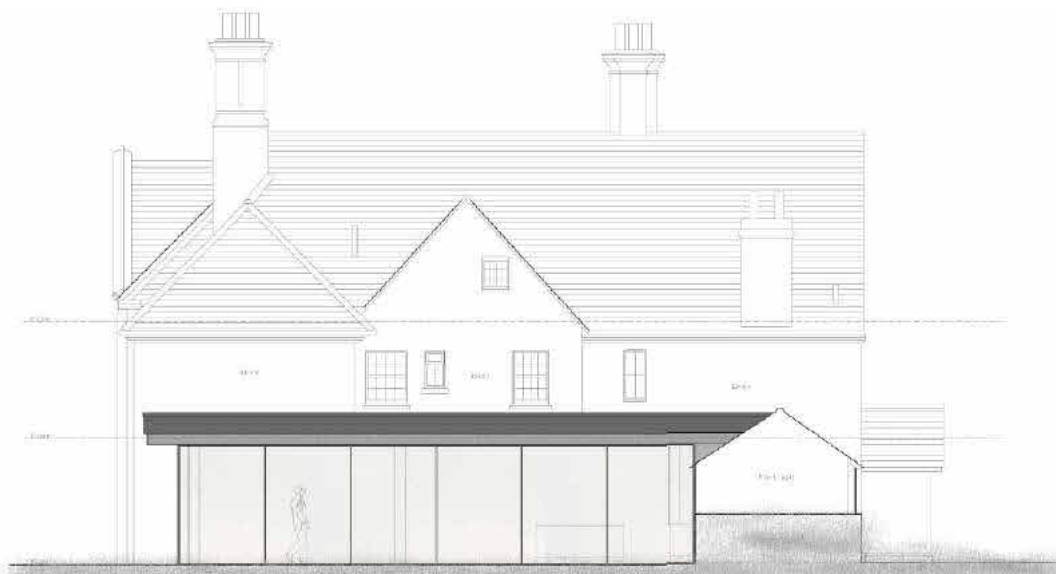
Fig. 14. Proposed north elevation ©Impact Architecture February 2024 drawing number SK12 revision A.

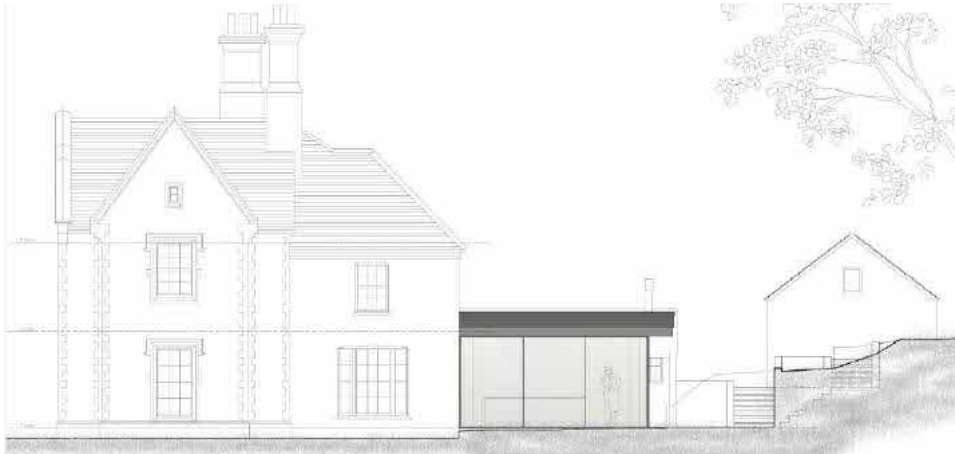
Fig. 15. Proposed east elevation ©Impact Architecture February 2024 drawing number SK12 revision A.

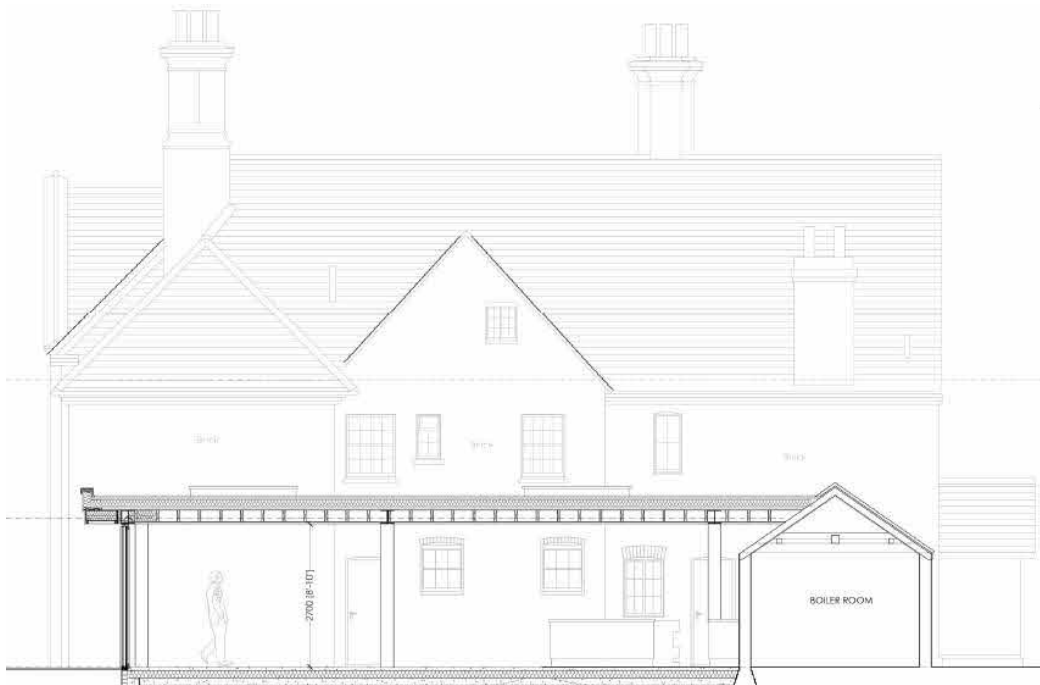
Fig. 16. Proposed cross section ©Impact Architecture February 2024 drawing number SK12 revision A.
