Edge Grove School, Aldenham, Hertfordshire

Former stable block: Addendum to the Heritage Statement

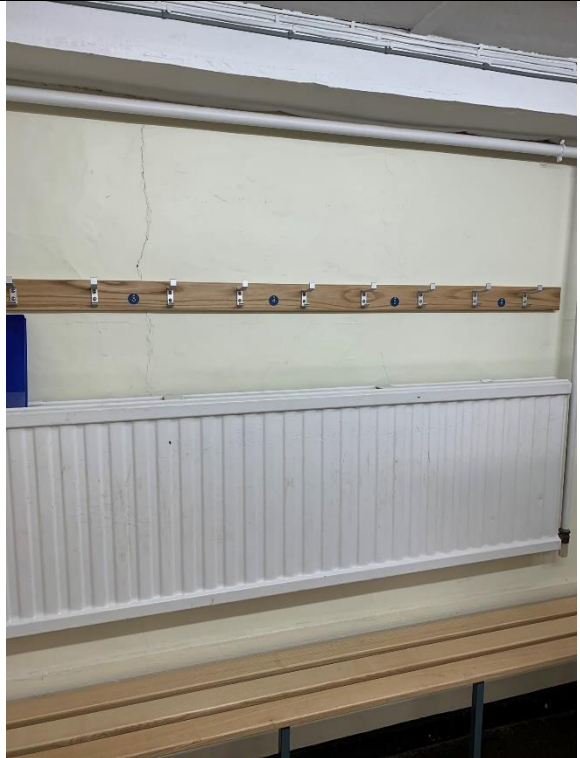
Item	Query	Response
Ground floor		
1	Proposed new door opening: <i>What age/value is this fabric? Was there a previous opening here to inform location of new opening?</i>	<p>The seemingly blank walls to the rear of the old stable block are original to it, and thus of 18th-century date. There is clear evidence of a former opening in this location, comprising vertical cracks in the rendered and painted wall face (now within the changing room) running down to floor level. Tap testing confirms that there is an audible change from the solid masonry to the sides with a 'hollowness' in the area between the cracks. The blank masonry is of limited significance/value despite its age (it is to the rear of the building, away from visibility from the house. The evidence for a former opening provides a good context for establishing the new one here, which will aid the utility of the original building as it relates to the proposed extension.</p>

<p>View of item/area 1 with clear cracking in the wall surface, extending into the plinth at the bottom on the left-hand side at least.</p>
2	Re-use of existing door: <i>What age/value is this fabric? Why is the new wall not on the alignment of the structure?</i>	<p>As with area 1, the blank wall was original 18th-century fabric. The door is late 20th-century and was cut through when the changing room was built. The house was listed in 1985; it is likely that listed building consent would not have been required when the extension was built and the door was knocked through. The angled wall just inside the door is unusual and, in my</p>

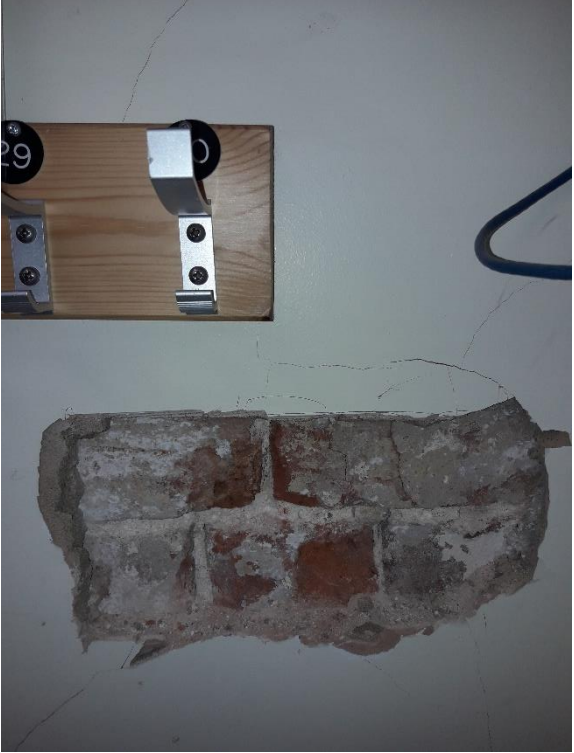
Item	Query	Response
		<p>opinion, modern (ie contemporary with the door). Its alignment makes no sense and it has been cut into the rear wall of the stables. It is of little or no heritage value. The opening up carried out in October 2020 is inconclusive: it did not reveal any phasing to the brickwork, and it is difficult to assess its date – but the crispness of the arisses clearly suggests a modern rather than 18th-century date.</p>

<p>Opening up: brickwork of the angled wall in classroom SB5.</p>
3	<p>Proposed new door opening: <i>What age/value is this fabric? Was there a previous opening here to inform location of new opening?</i></p>	<p>The seemingly blank walls to the rear of the old stable block are original to it, and thus of 18th-century date. There is clear evidence of a former opening in this location, comprising vertical cracks in the rendered and painted wall face (now within the changing room) running down to floor level. Tap testing confirms that there is an audible change from the solid masonry to the sides with a ‘hollowness’ in the area between the cracks. The blank masonry is of limited significance/value despite its age (it is to the rear of the building, away from visibility from the house. The evidence for a former opening provides a good context for establishing the new one here, which will aid the utility of the original building as it relates to the proposed extension.</p>

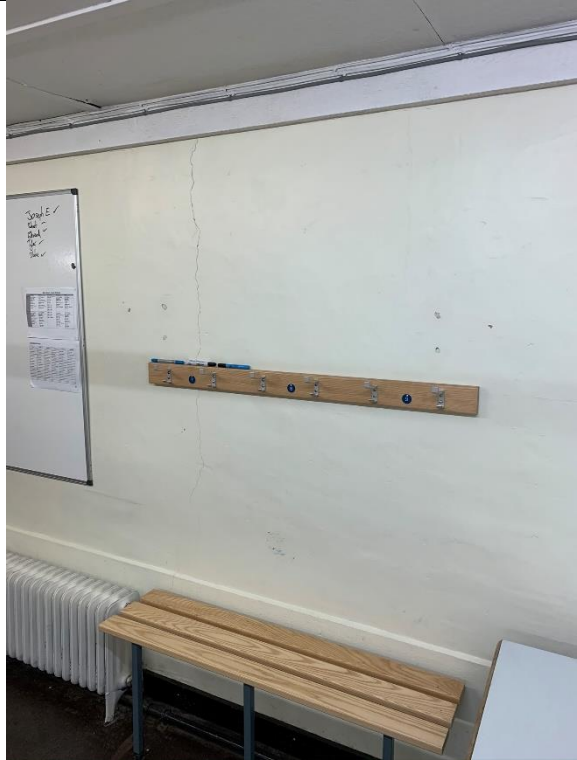
<p data-bbox="810 994 1388 1128">View of item/area 3 with clear cracking in the wall surface, extending into the plinth at the bottom and to the floor on the left-hand side at least.</p>
4	Small area of match boarding: <i>How will match-boarding be retained?</i>	<p data-bbox="810 1135 1388 1346">This is a small, isolated area of late 19th or early 20th-century boarding. It may be possible to retain it, but all agreed on site that its heritage value has been so diminished that removal would be acceptable if the plans for this area could not be altered.</p>

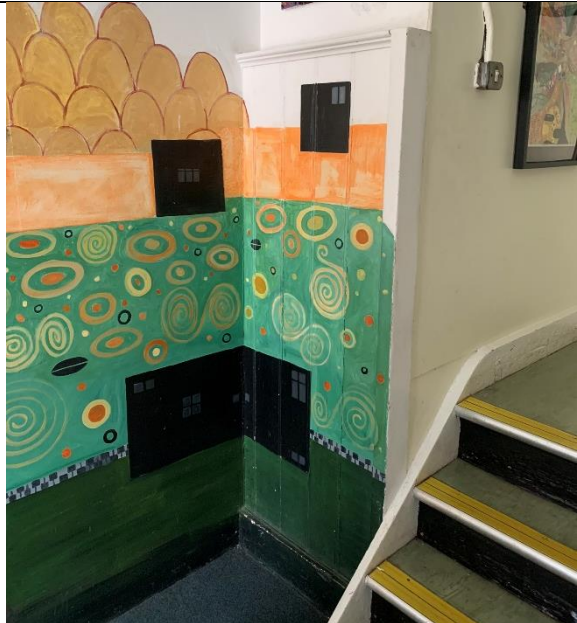
<p data-bbox="810 1973 1388 2036">Area of vertical match boarding – this is the only fragment in the room.</p>

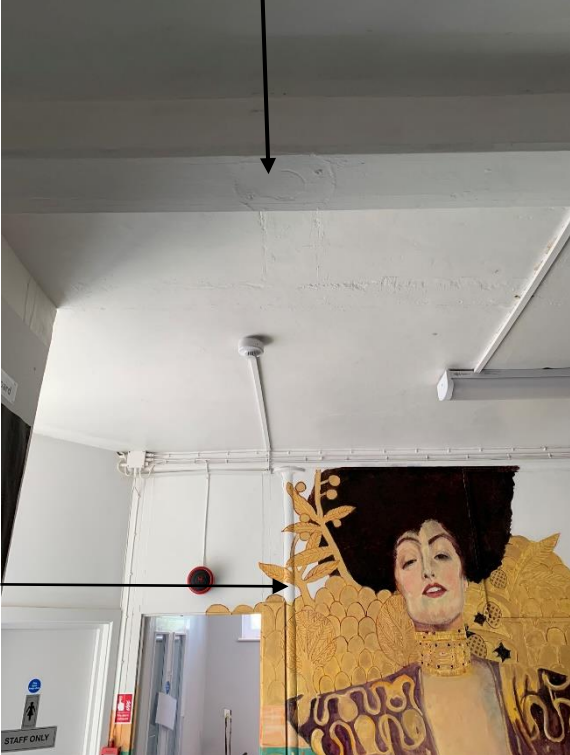
Item	Query	Response
5	Iron column currently encapsulated in a modern stud partition: <i>How will iron column be retained?</i>	LSH to review how iron column can be retained – it should be feasible to do so.

<p data-bbox="815 1104 1386 1272">Late 19th-century cast-iron column now within modern stud partition (arrowed from left). Note evidence for the former position of a matching column on the ceiling beam, arrowed from the top.</p>
6	Re-arranged interior/offices. <i>Appears all walls are to be lined?</i>	This is a matter for LSH.
7	Location of new staircase and lift. <i>What age/value is the ceiling fabric?</i>	The ceiling is modern and of no heritage value. It is suspended off the floor above, which is late 19 th /early 20 th century and also of low heritage value (see item 18).

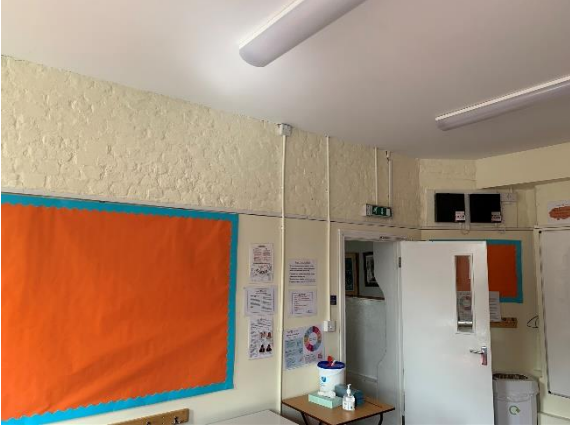
<p data-bbox="815 1933 1386 1986">Modern suspended ceiling in classroom SB5. Note angled wall (item 2) to the right.</p>

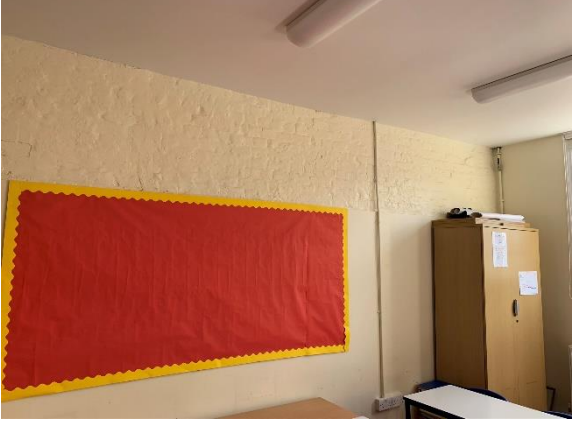
Item	Query	Response
8	New door. <i>What age/value is this fabric? Was there a previous opening here to inform location of new opening?</i>	The masonry here appears to be original 18 th -century fabric. It is plain and featureless, of low heritage value because of this. All agreed that a door would be an acceptable intervention given the advantages of access and circulation it provides.

<p data-bbox="815 887 1391 943">Blank brick masonry visible in the south-eastern corner of classroom SB5.</p>
9	New kitchen. <i>What interventions are needed to make this a kitchen? Lining of walls? Extractor fans? Bins? Storage?</i>	This is a matter for LSH.
9a	Store cupboard wall. <i>What is the age and significance of boarding? Check ceiling structure above, architect and client to consider retention of boarded partition.</i>	Boarding appears to be late 19 th -early 20 th century, resting on a sole plate set within the interior of the former stable. Probably put in to make a corridor across the back of the stables to the small extension (contemporary) at the north-east corner of the building. The top part of the partition within the cupboard is modern chipboard or similar, continuing above the false ceiling. There is also a modern opening (but blocked with board) at the east end of the wall. Opening up shows that this extends above the false ceiling up to a modern timber with the positions of former fixtures (hooks?) evident, and stencilled numbers between them (67-70 at least). This is at high level, immediately below what appears to be a rendered ceiling. The opening up confirms that the upper ceiling is of tongue-and-groove boards immediately to the west of this, entirely modern. The render must have been applied to this locally because it was within the corridor and rooms in use at the time. All the other partitions in this area are modern as well. The boarding has some value but will be vulnerable if retained here - may be better re-used elsewhere in the

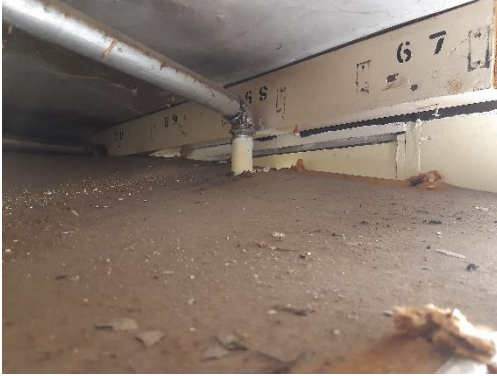
<p data-bbox="300 685 788 813">Opening up: view above the false ceiling at the end of the cupboard with blocked opening and numbered timber exposed.</p>

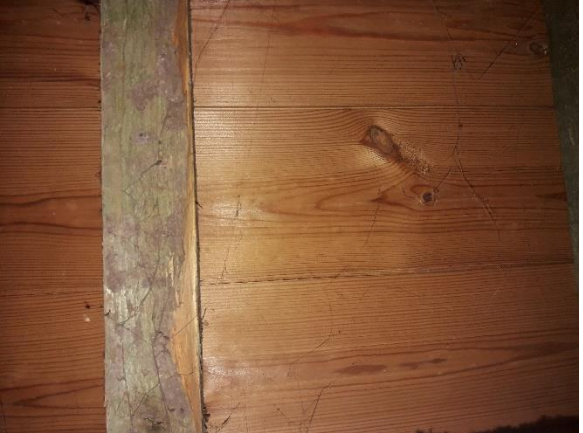
<p data-bbox="815 741 1366 813">Opening up: modern joist and floor boards on the first floor above the store cupboard.</p>
10	Office matchboarding. <i>How will this [office] structure be encapsulated?</i>	Match boarding within existing to be retained office. LSH to consider door position. Either through and retaining match boarding with a jib door, or through the external wall outside the office immediately to the west.
11	Lean-to addition to late 19 th -century extension. <i>What age/value is this fabric? Heritage statement notes it wasn't inspected.</i>	Historic OS maps show this as a post-World War II addition. Inspection of the interior confirms that the brick walls and timber roof structure are 2 nd half of the 20 th century. To be retained and re-used.

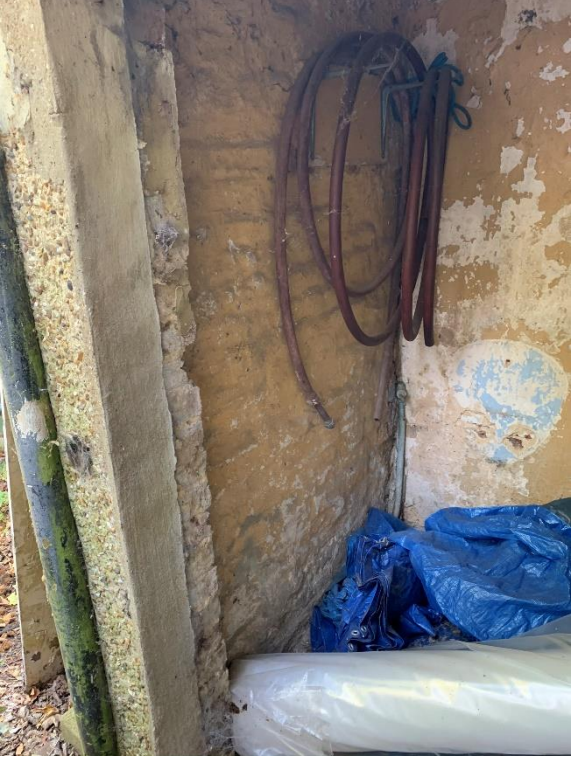
<p data-bbox="815 1946 1378 2004">North wall of modern lean-to addition off west side of late 19th-century extension.</p>

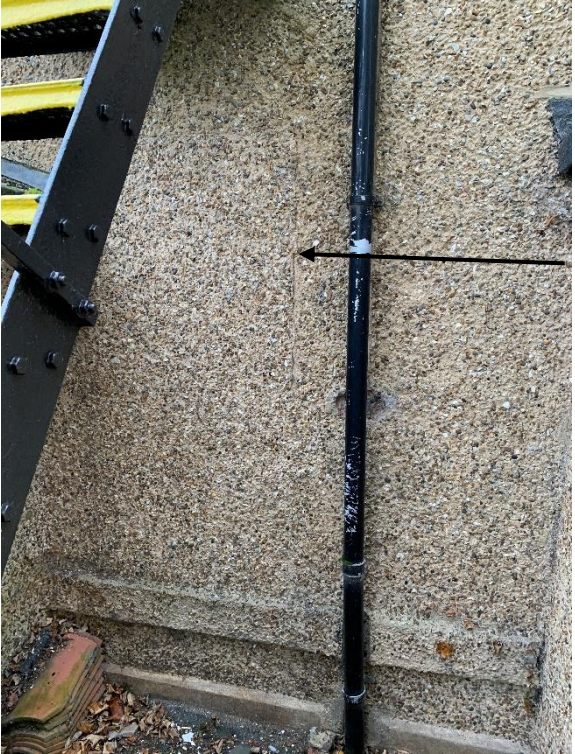
Item	Query	Response
12	New door. <i>What age/value is this fabric? Was there a previous opening here to inform location of new opening?</i>	<p>The seemingly blank walls to the rear of the old stable block are original to it, and thus of 18th-century date. There is clear evidence of a former opening in this location internally and externally, comprising vertical cracks in the rendered and painted wall face on the inside and very obvious disruption in the roughcast render outside. As with locations 1 and 3 it is clear that there was an opening in this location historically. The blank masonry is of limited significance/value despite its age (it is to the rear of the building, away from visibility from the house). The evidence for a former opening provides a good context for establishing the new one here, which will aid the utility of the original building as it relates to the proposed extension.</p>

<p>Vertical joint in the external roughcast showing where an opening once existed in this wall.</p>
13	Removed door to store cupboard, and door to adjacent classroom. <i>What age/value is this fabric? What's the justification for the loss of fabric and divergence from plan form?</i>	<p>The west end wall of the store is an obviously modern stud partition, with a door of the same age. No heritage value. The wall immediately to the south is original, however, and retains a lintel set high in the masonry. This is of medium heritage value. This fabric to be retained.</p>

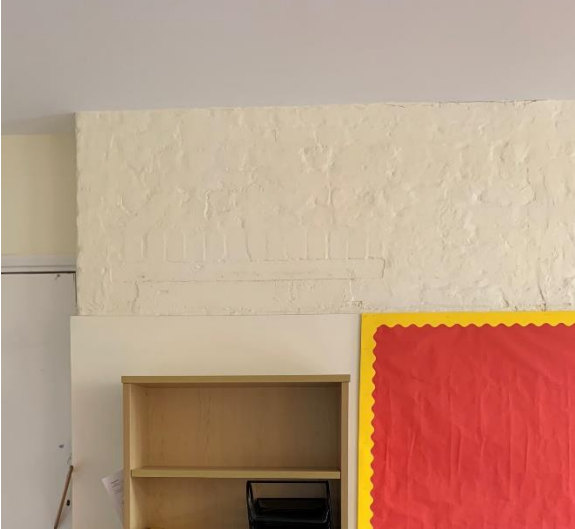
<p data-bbox="815 797 1375 898">Lintel of existing door (locked shut from the other side) in classroom SB5. The partition and door to the left are modern.</p>
First floor		
14	Alteration to doorway, new steps. <i>What age/value is this fabric? How will this relocated stair impact upon fabric and ground floor?</i>	The foyer/doorway into this classroom are modern and of no heritage value. The steps (not a stair) are confined to the first floor and has no impact on the ground floor below. It may be possible to dispense with the steps if the floor and ceiling heights in the classroom can be raised to provide level access through to the central bay and the new staircase there.
15	New partition. <i>Plans appear to over-board this wall and to subdivide window.</i>	LSH to consider amending partition to avoid window.
16	Cutting back masonry – continuation of chimney stack from ground floor? <i>Plans show significant alteration to this area without detail or justification.</i>	GK advised there is a significant amount of modern surface treatment and some parts of the wall are probably modern, but the stack may survive within this. LSH to consider removal of modern elements whilst retaining bread oven stack.

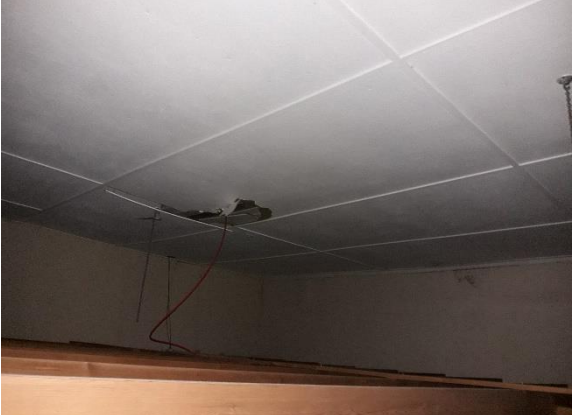
Opening up: Removal of part of the modern suspended ceiling in the first-floor west art classroom shows that there is an earlier ceiling above, c 0.5m above the existing (the timber supports for this can be seen at the bottom of the photo). This ceiling is identical to most on the ground floor and dates to the later 20 th century. This suggests that there is room to raise the floor and ceiling in this room to provide level access to the proposed new stairs and

Item	Query	Response
	lift in the central bay. LSH and School to review.	
17	New steps up to re-used existing door. <i>How will new stair impact upon fabric both upon ground and first floor? Was there a previous opening in this location?</i>	These are steps, not a stair - no impact on ground floor. Steps may not be necessary (see comments immediately above). Door is clearly historic – visible from the central bay.
18	Location of new staircase and lift. <i>What age/value is this floor?</i>	Narrow machine-sawn floorboards, late 19 th or early 20 th century date. Low heritage value. This part of the stable block would have been the coach house, probably open to the roof with at most a corridor at first-floor level to link the two outer bays (though even these might not have been floored).

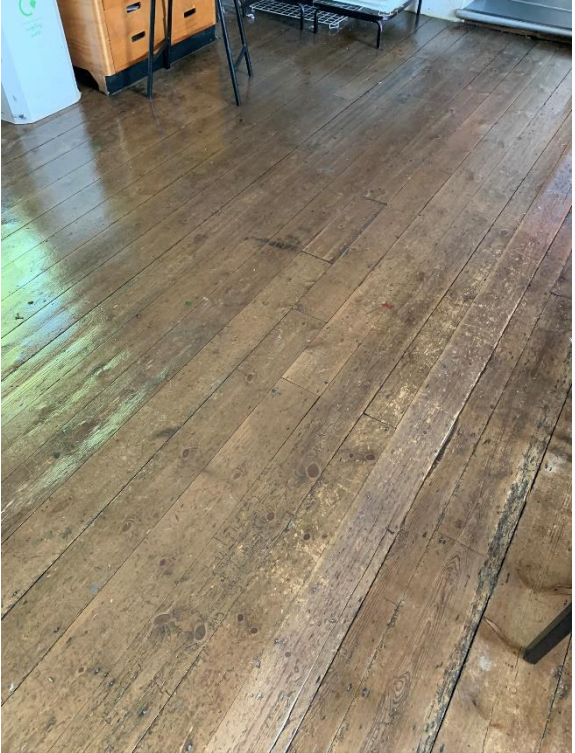
<p data-bbox="815 1496 1391 1559">Narrow, machine-sawn floorboards on the first floor, central bay.</p>

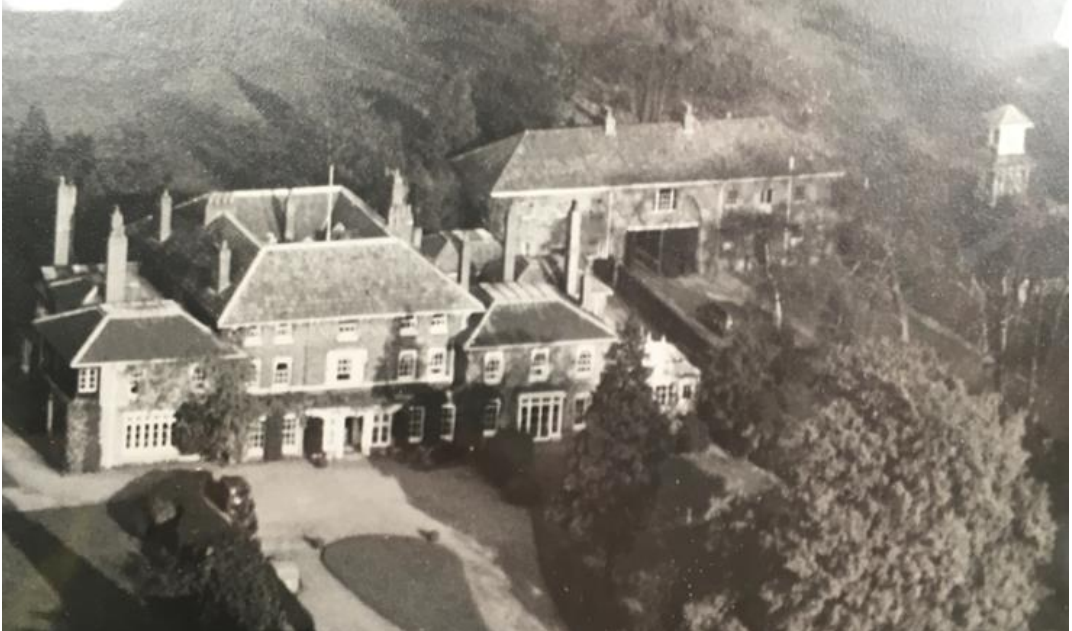
19	Extractor location. <i>What age/value is this fabric? How will extractor impact?</i>	There is no fabric within the classroom in this location at the moment. The roof structure above was inspected during the visit and is of standard truss form, of mid to late 19 th -century machine-sawn timberwork. There is clear photographic evidence for a chimney on the ridge line in this location during the mid-20 th -century at least, with a matching one to the west. The latter appears to be over the stack rising from the existing bread oven on the ground floor (see image below). It is not known when the chimneys above roof level were removed – clearly neither chimney was

Item	Query	Response
		functional by that time. The current design will reinstate the chimneys and thus re-establish the original roof form. This will be an important heritage benefit of the scheme.

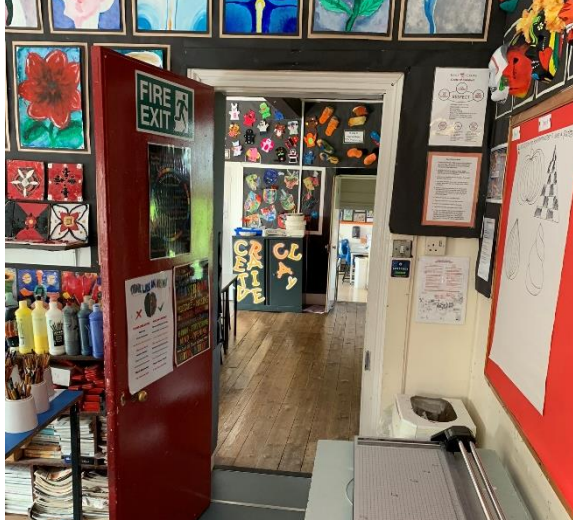
20	Alterations to doorway. <i>What age/value is this fabric?</i>	Doorway and door – the fabric above and to the right is modern studwork, of no heritage value; to the left it is brick masonry.
