**Corner Cottage, High Street,
Bosham, West Sussex**

Preliminary Roost Assessment

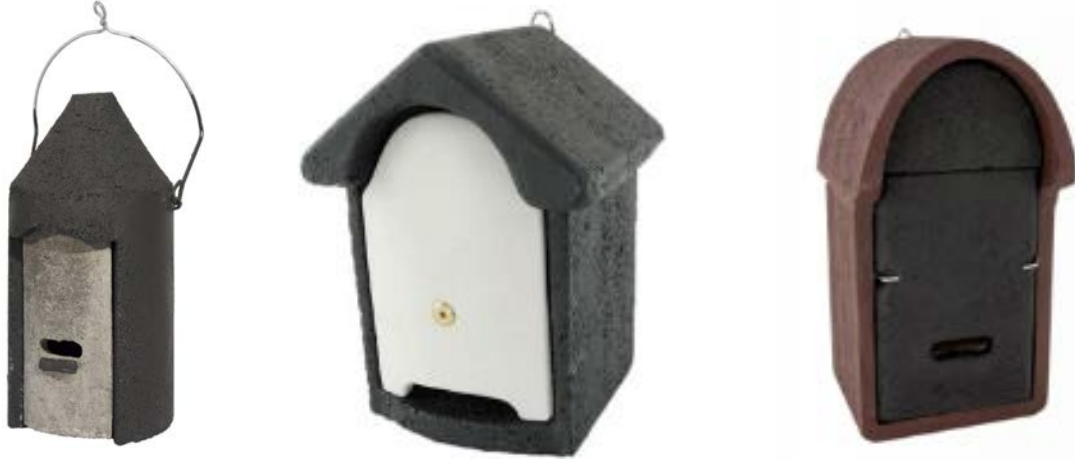
Figure 4: Schwegler Bat Box 2F (left), Vivara Pro WoodStone Bat Box (middle) and Large Multi Chamber WoodStone Bat Box (right)

- Schwegler Bat Box 2F – A general purpose bat box which is ideally suited for bat protection and can provide accommodation to a large number of bats (Figure 4).
- Vivara Pro WoodStone Bat Box – A general purpose bat box that supports a range of species (Figure 4). These can be hung on trees in a variety of heights and aspects in order to provide a variety of micro-climates.

- Large Multi Chamber WoodStone Bat Box – This is a multipurpose box designed for larger colonies and a range of bat species including pipistrelles, noctules and brown long-eared bats (Figure 4).

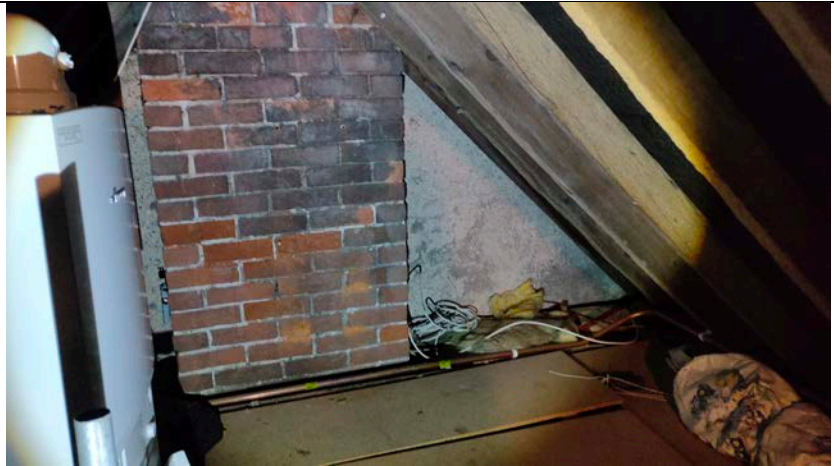
- 3.6 The older section of the house contained a roof void which was timber framed, insulated and had bitumen felt roof lining. There was one section of the lining that was torn revealing the external tiles and was considered a potential access point. An internal inspection did not find any evidence of roosting bats in the form of droppings, insect

Photograph 1: Eastern end of the void in the older section of the house

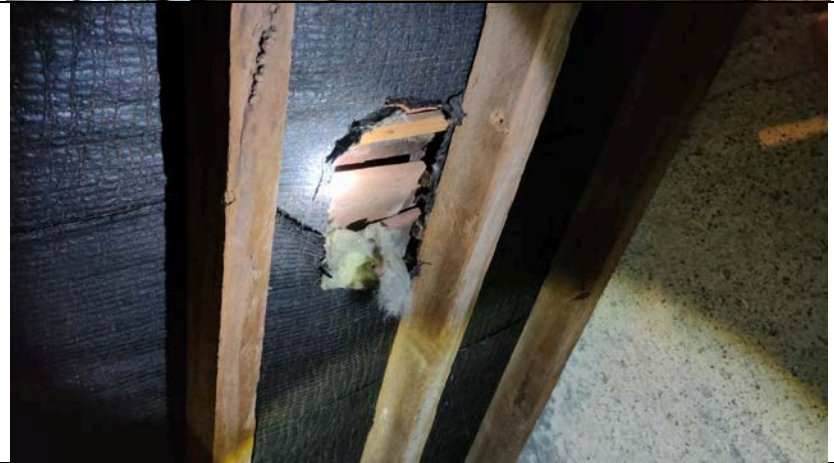
Photograph 2: Photo highlighting a potential access point in the felt to the void.

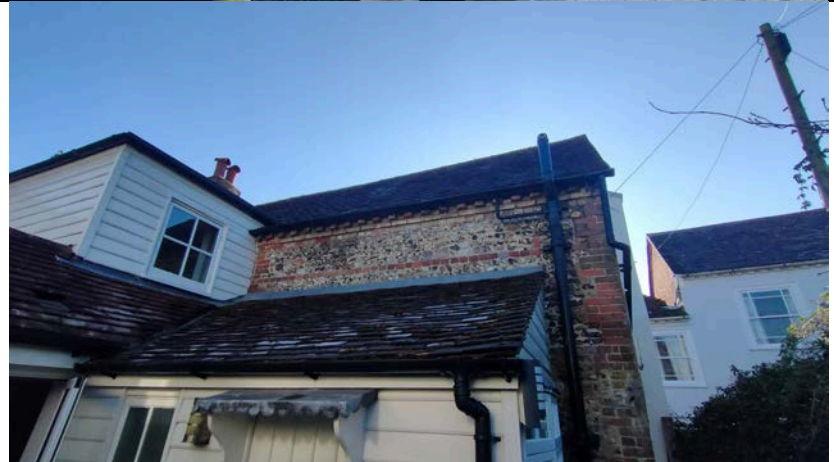
Photograph 3: Overview of the northern aspect of the building showing the lean-to to be demolished

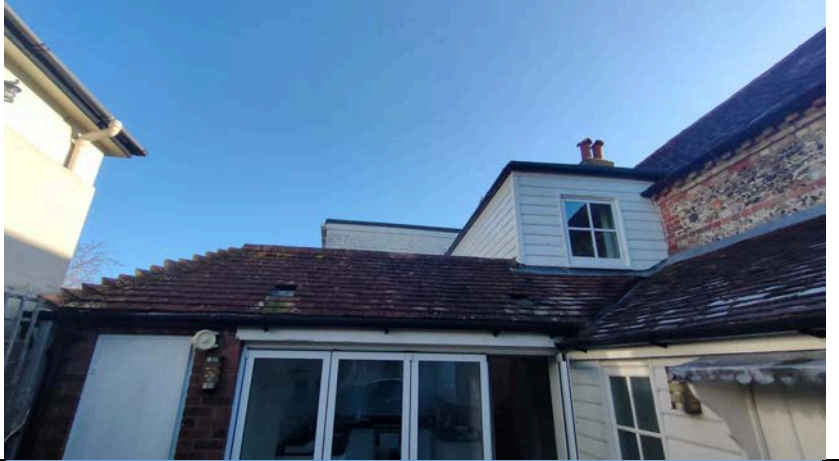
- 3.7 The modern extension sections of the building did not contain voids. Externally, there were sections of tiles which were lifted and provided potential roost space for crevice dwelling species.
- 3.8 The building had a small patio area to the northwest with introduced shrub planting providing low commuting and foraging habitat for bats.
- 3.9 Overall, the building was considered to have 'low' potential for roosting bats due to the presence of multiple lifted tiles across the building.

Photograph 4:
Overview of the western
aspect showing the
existing extension

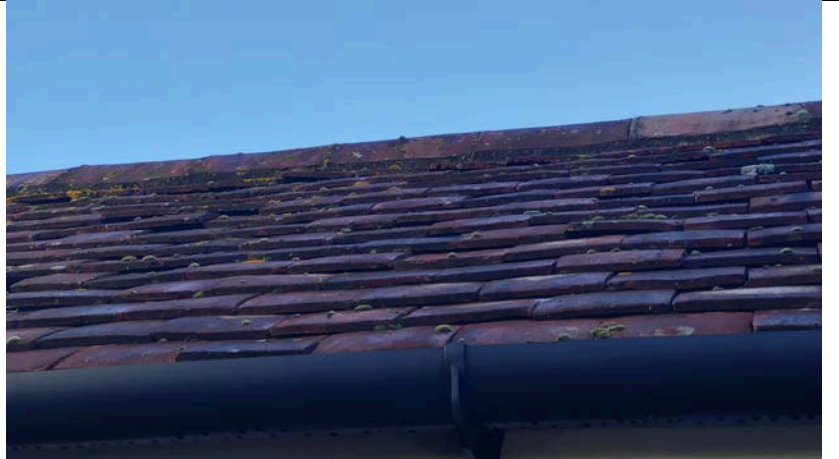
casings or dead bats. Externally, the roof featured multiple lifted tiles on both aspects, typical of handmade tiles, which could provide roosting potential for crevice dwelling species.

- 4.6 The building did not contain any internal evidence of roosting bats within the void of the older section of the house. Externally, there were multiple lifted tiles which were considered to have potential to support crevice dwelling species such as pipistrelle bats. These tiles were present on the section of the roof which will join with the two-storey extension as well as the single storey existing extension which will be demolished. The building was considered to have 'low' potential for roosting bats. As such, it is recommended that a single emergence survey is carried out.

Photograph 5: Close-up
of lifted tiles

- 4.7 Should bats be recorded emerging from the building on this survey then further surveys will be required. The aim of the survey is to determine if bats are using the external features of this building, in addition to the type and number of bats present. If no bats are found to be utilising the building, then works can proceed without a licence. If evidence of bats using the building is identified, then the results of these surveys will inform an application for a Natural England licence to legalise the loss / disturbance to bat roosts should they be present on site and appropriate mitigation.

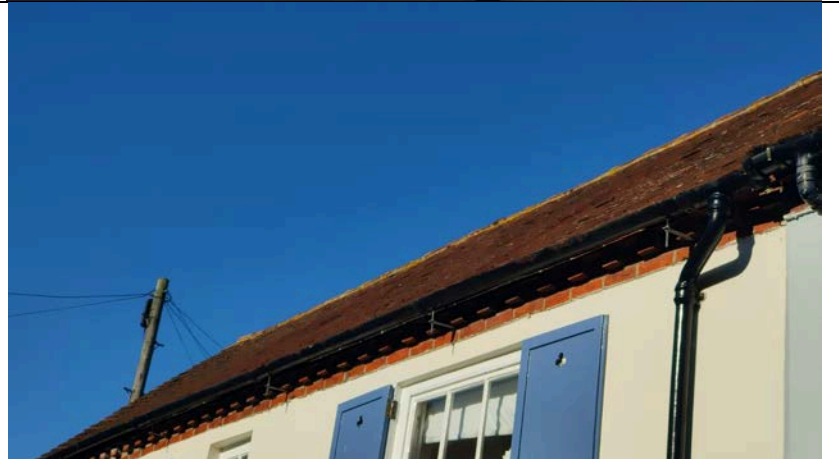
Photograph 6: Southern
aspect of the roof from
street level

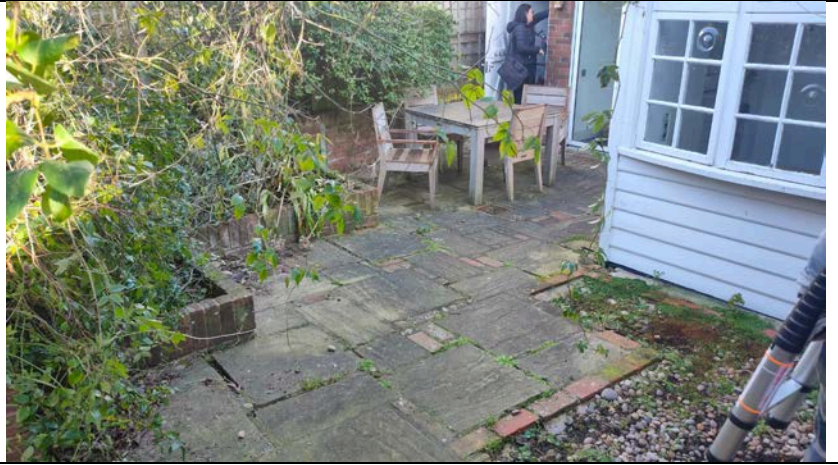
Photograph 7:
Overview of patio and
planting
