Bat Scoping and Emergence Survey Report

Kirdford Village Hall

11th July 2023

Project No: P5217

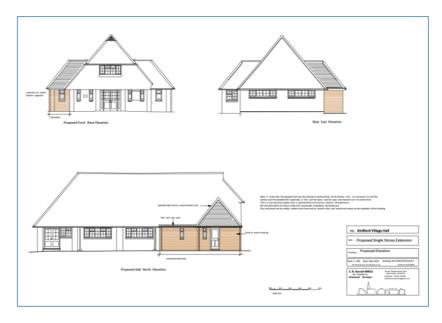
The proposed development/project includes a complete re-roof, incorporating a new storage area into the roof void, as well as extending the village hall on the western side to improve facilities.

Figure 2. Proposed development plans for Kirdford Village Hall, courtesy of S.R. Burrell MRICS, drawing no. 70391/PEL/Draft1, dated May 2023.

The proposed roof restoration and extension requires removal of the current roof and an extension to the western aspect of the building. The loft void will also be turned into storage space, which will cause disturbance to the loft void and potentially impact future roosting potential for bats.

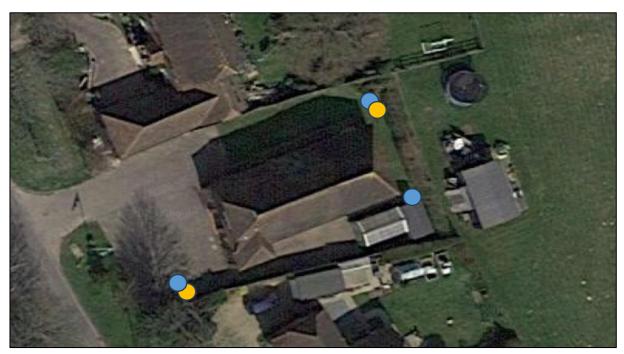
The surveys focused upon the gable ends and gaps in the roof tiles across the property using three surveyors and two infrared cameras positioned according to Figure 3. From these positions, surveyors could see all features potentially suitable for roosting bats that were identified during the initial bat scoping survey.

Figure 3. An aerial image of the site, showing the positions of surveyors (blue dots) and night-vision cameras (orange dots) on 10th May 2023 and 8th June 2023. Images produced courtesy of Google maps (map data ©2023 Google).

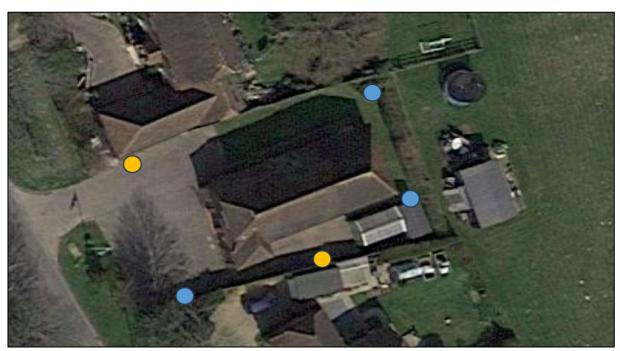
Figure 4. An aerial image of the site, showing the positions of surveyors (blue dots) and night-vision cameras (orange dots) on 24th May 2023. Images produced courtesy of Google maps (map data ©2023 Google).

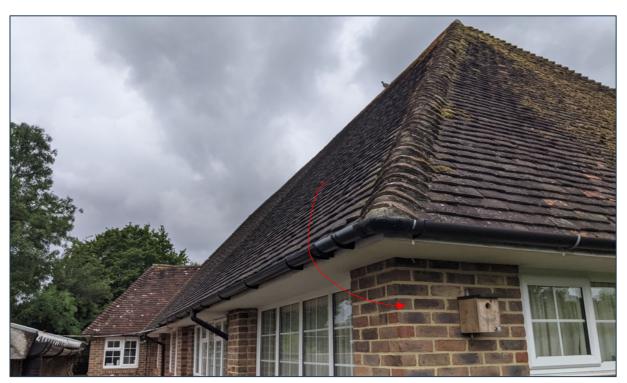
An individual of an unknown species (likely to be a common pipistrelle based on later foraging activity and size of bat seen) emerged from the tiles on the southern side of the building at 21:06 and flew east. There was high foraging activity by common pipistrelle bats *Pipistrellus pipistrellus* throughout the survey.

Figure 6. The pipistrelle (likely common pipistrelle) bat emergence on the 10th May 2023 (red arrow).

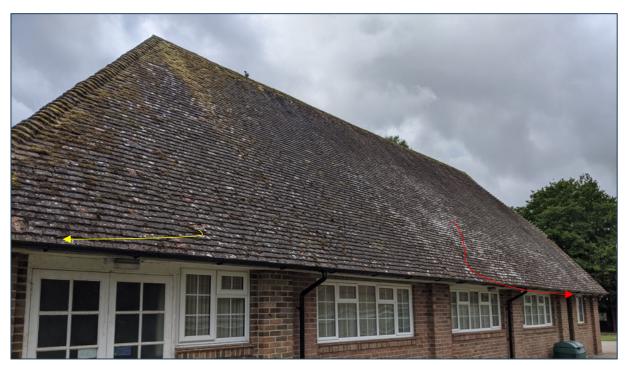
A common pipistrelle emerged from the northern face of the building at 21:36. A single myotis then emerged at 21:40 from the northern face, close to the north-east corner of the building. This bat is believed to be a Whiskered *Myotis mystacinus* bat based on call analysis and surrounding habitat.

Figure 5. The Myotis bat emerging at 21:40 (yellow) and the common pipistrelle bat emerging at 21:36 (red) on the 24th May 2023.

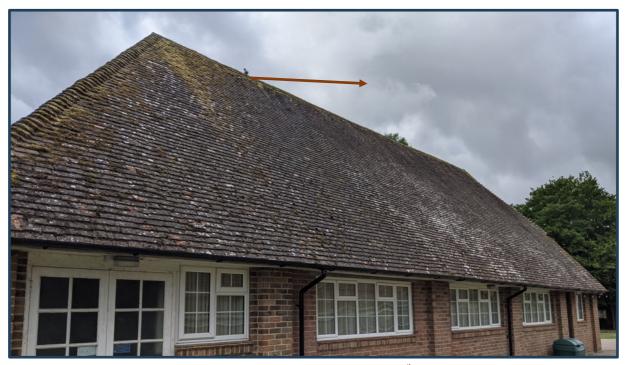
At 22:02 a brown long-eared bat was recorded emerging from under a ridge tile on the northern aspect of the building. A foraging noctule was recorded on the site at 21:40, and a commuting myotis *sp.* was recorded flying south-east across the site at 22:09.

Figure 6. A brown long-eared bat emerging from under a ridge tile on the 8th June 2023.

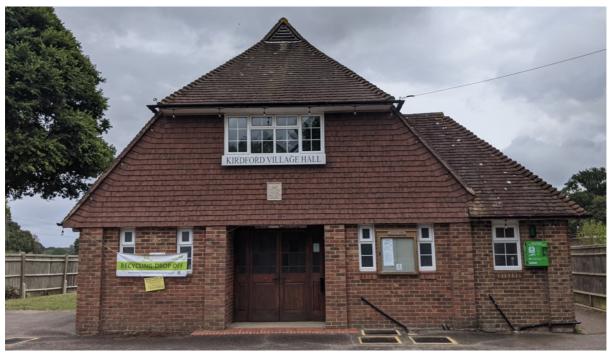
Photograph 1. The western elevation of Kirdford Village Hall.

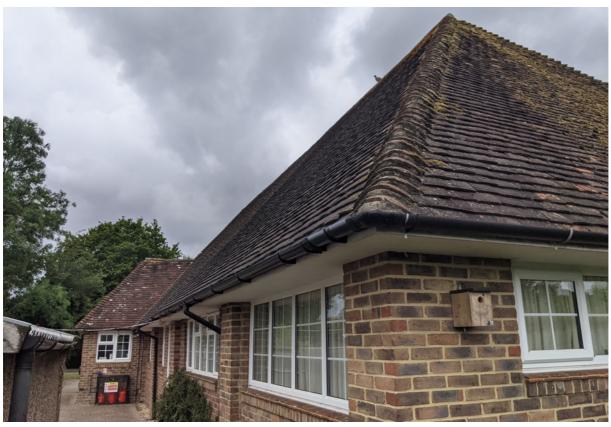
Photograph 2. The southern elevation and eastern elevations of Kirdford Village Hall.

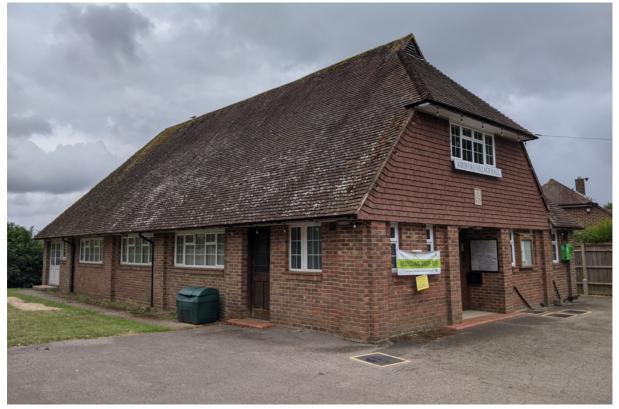
Photograph 3. The northern and western elevations.

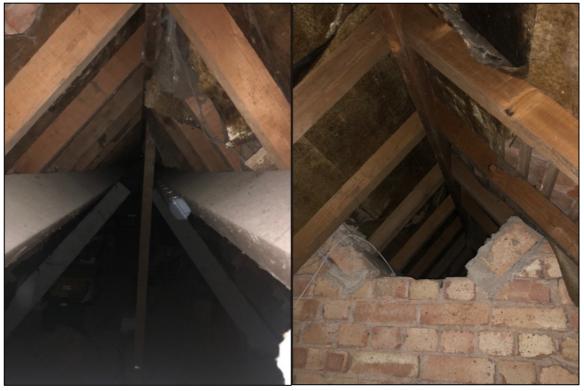
throughout. At the western end of the void is a brick wall which	
	separates the east and west voids although there is a 40cm gap at the	
	apex providing some connectivity. Approximately 60-80 droppings,	
	morphologically similar to long-eared bats, were identified at the	
	western end under the last ridge tile.	
Kirdford Village	This smaller void measures approximately 5m by 5m with a height of	Confirmed roost
Hall – west void	2m. The floor is boarded and the roof lined with bitumen which is torn	
	in several places. Approximately 80-100 droppings were identified,	
	morphologically similar to long-eared bats.

Photograph 4. (Left) Internal view of the larger loft void with torn bitumen lining the roof. (Right) The large gap between the two voids illustrating that for bats the two voids are interconnected.

All hanging/roof tiles should be carefully hand stripped one by one under the direct supervision of a licensed bat ecologist. Any bats found shall be gently captured and placed into bat boxes that have been secured to trees surrounding the site in advance.
