**Gardeners Farm,  
Flowers Lane,  
Plaitford, Romsey,  
SO51 6HH**

Ecological Assessment

Report Number: 0668

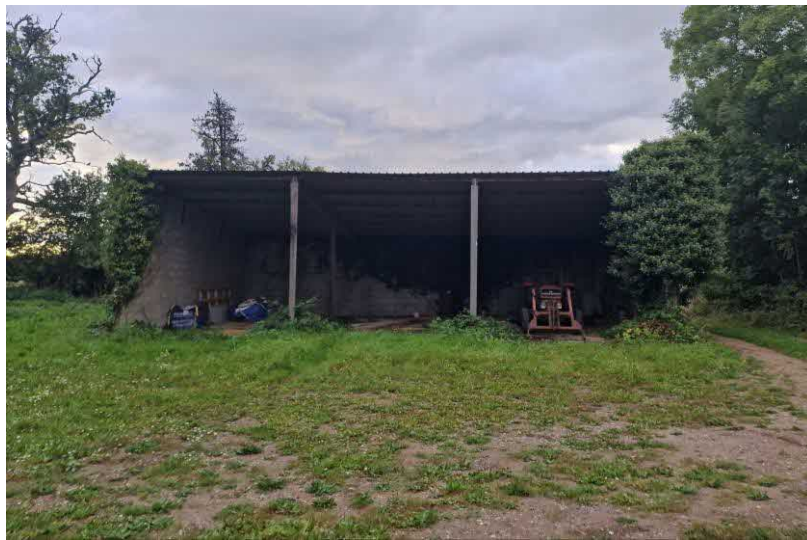
- 4.5 This building is part of a separate application.
- 4.6 The Open Barn on the northwest edge of the site (Photo 1) is constructed of breezeblocks with a corrugated iron roof. The building offers very little opportunity for roosting bats and as such, during the initial inspection was deemed negligible.
- 4.7 One poorly formed nest was evident along a roof truss, likely to belong to a pigeon. The north side of the building has an excessive covering of Ivy (photo 2), this offers an excellent opportunity for other species of bird to nest. Below this ivy a noticeable patch of bird faeces was evident, further enhancing the likelihood that the ivy is used by nesting birds.

**Photo 1:** The front of the open barn, the south-east aspect

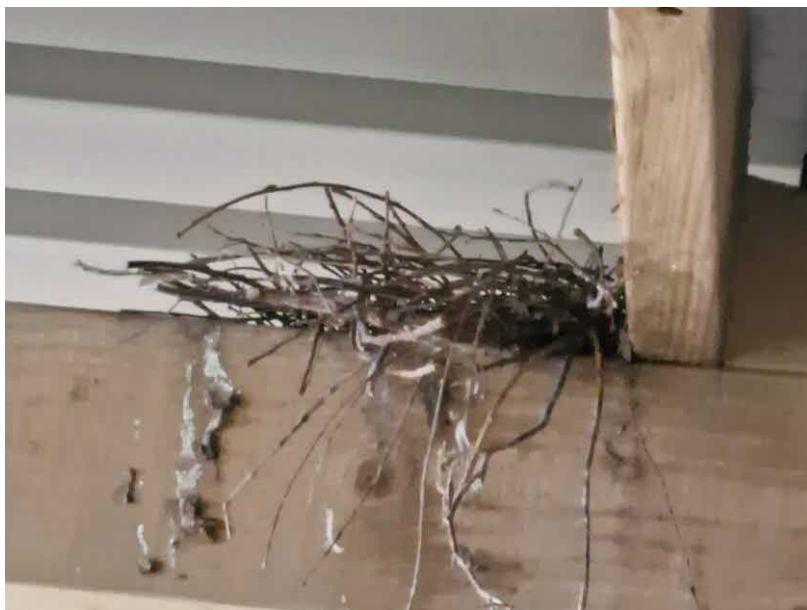
**Photo 2:** Pigeon nest found on roof truss inside the barn.

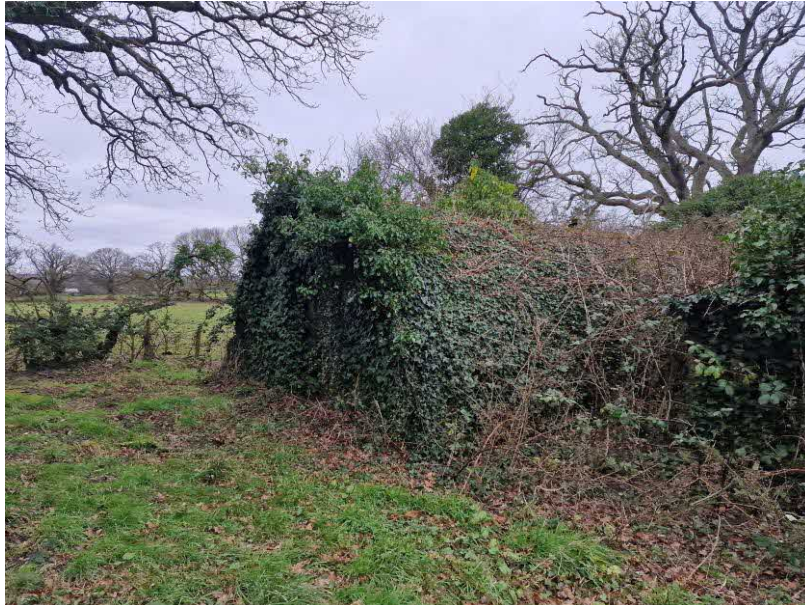
- 4.8 This building is part of a separate application.
- 4.9 The corrugated metal shed is a long semi-circular shape, similar to an Anderson air raid shelter. It has become completely covered with bramble and ivy (photo 3). Internally the shed has been insulated with spray on foam.
- 4.10 There is evidence of rats burrowing in and behind the insulation. Like these gaps are breaks in the ceiling which present opportunities for bats and birds. Due to the height of the building and the limited gaps internally, the building was deemed as having low-negligible suitability for bats. One gap (photo 4) did show signs of having been used by nesting birds with a substantial pile of bird faeces below.

**Photo 3:** Corrugated metal shed covered in bramble and ivy.

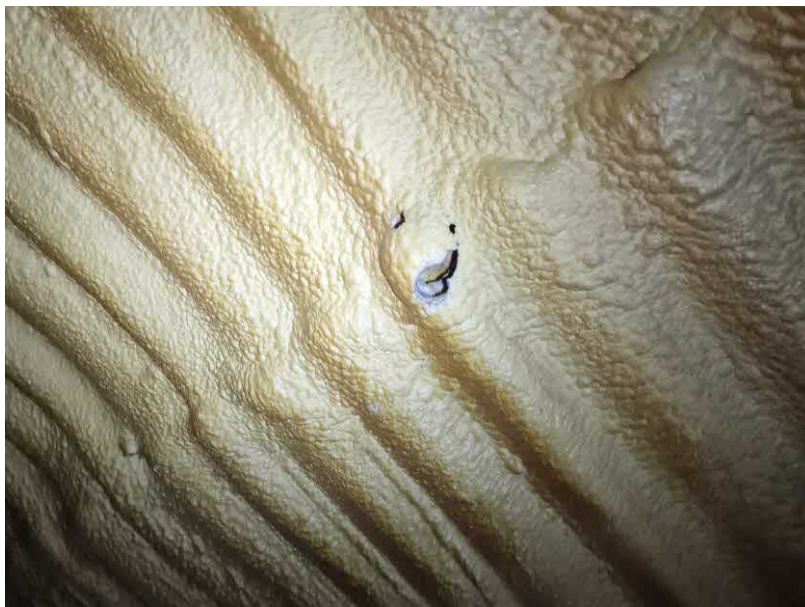
**Photo 4:** Internal break in the insulation having been used by nesting birds.

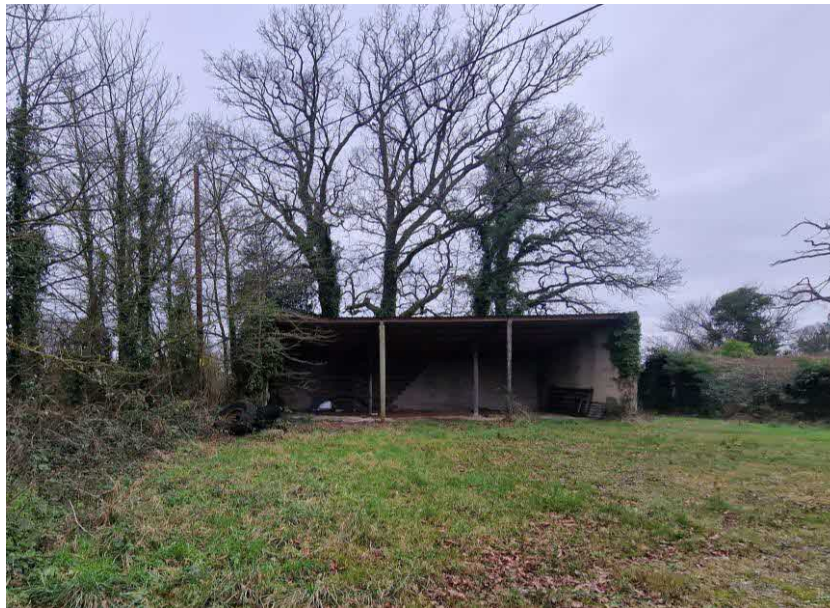
- 4.11 This building is part of a separate application.
- 4.12 This open barn (photo 5), in the southeast corner of the site, is of the same construction as the one in the northwest. It also had limited to no opportunities for roosting bats and as such its suitability was deemed as negligible.
- 4.13 No signs of nesting birds were noted at the time of inspection but, it is as likely as the other barn to be used by birds to nest. A juvenile blackbird was found deceased in the barn though, this is likely to have been left there by a domestic cat.

**Photo 5:** Open barn in the southeast corner of the site, northeast aspect

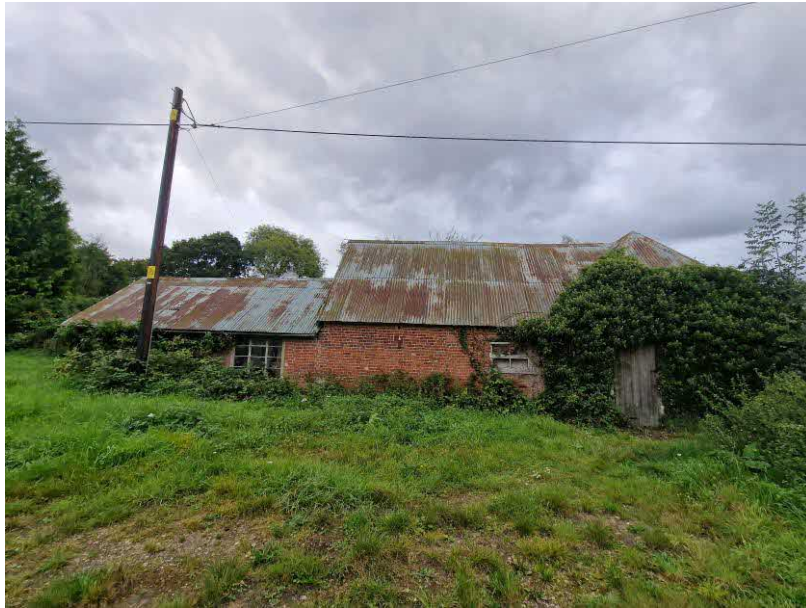
- 4.14 The old stable block (photo 6) is a long L shaped building, constructed of red brick along its western side and breezeblock along the north. The roof is clad in corrugated metal supported by old untreated wood. The roofs cladding is in a state of disrepair creating lots of access point for bats and birds. The internal construction of the roof offers lots of roosting/nesting opportunities (photo 7 and 8). This building was deemed to have moderate to high suitability for roosting bats.
- 4.15 During both inspections, bat droppings were noted throughout the barn without any notable piles indicating a preferred bat roost.
- 4.16 All identified gaps suitable for hibernating bats were checked in January 2024 with no bats found. Two nests used in the previous season were observed in the north corner (photo 9)

**Photo 7:** The old stables showing the brick-built construction, southern aspect

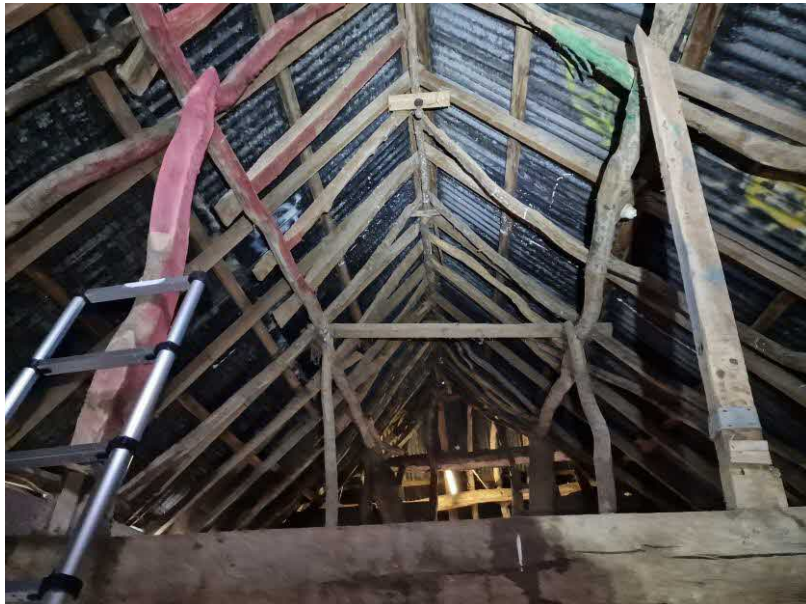
**Photo 8:** Internal view of the old stables showing the variety of old untreated wood used in the roof construction.

A large attic area of minimum dimensions 5mx5m and 2m high from base to apex will be retained in the Stables and this will have suitable access points for bats under six tiles which lead directly into the roost. The attic space along with the current wood supporting the roof will be retained if possible although this will need to be checked for rot by a specialist.

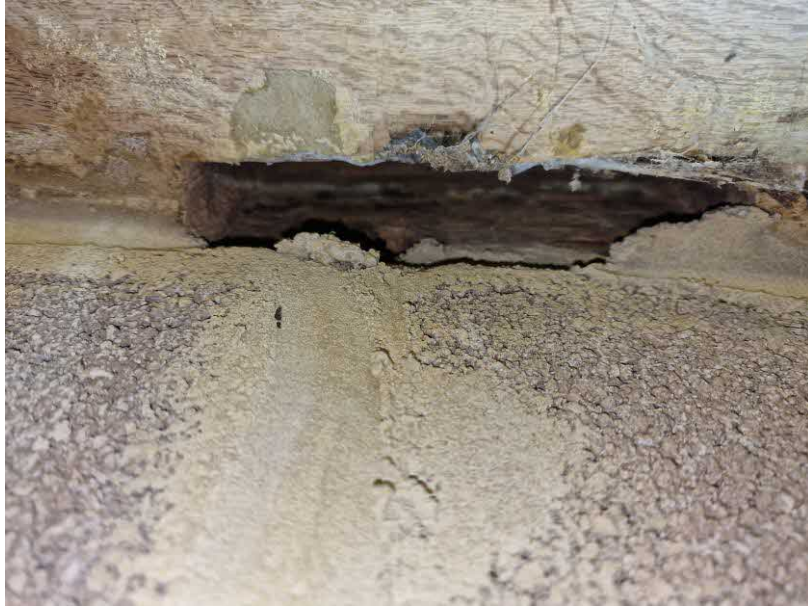
**Photo 8:** A gap between the brickwork and the roof timber with a bat faeces stuck to the wall.

- 5.1 A European Protected Species licence will be required to proceed with the works on the Stables including any work on the roof or internal timbers. An ecologist will be present to oversee any works on the roof, gables, weather boarding, soffits etc.
- 5.2 A minimum of 2 further emergence surveys will be carried out during the 2024 season during the period May to August to fully establish the roosting potential of the Stables – this will be required to support the EPS licence application.
- 5.3 An outline mitigation plan is set out below:

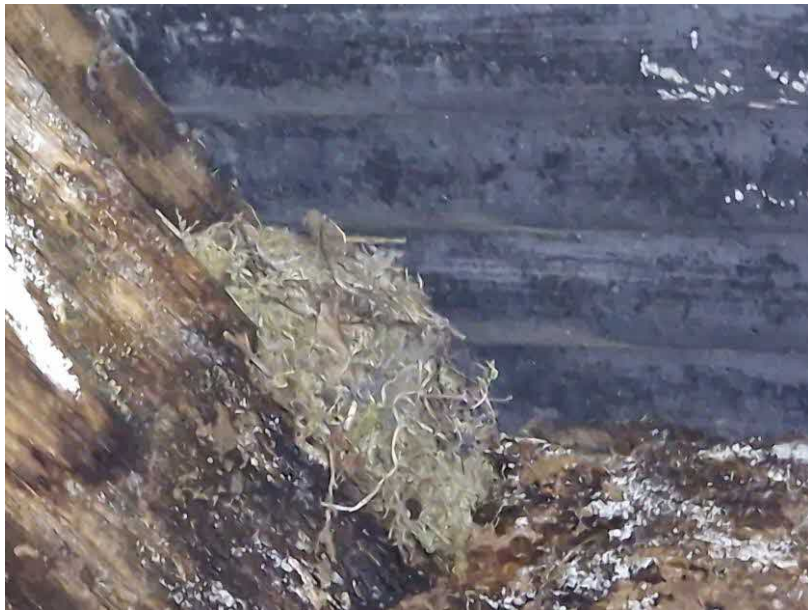
**Photo 9:** One of two nests found in the northern end of the stables.

- 5.4 Impacts on the roofs of the buildings internally or externally will avoid the bird nesting from March – August inclusive, unless it can be shown by an ecologist that there are no nesting birds present. Similarly, all vegetation removal will be undertaken outside the bird nesting season or alternatively under ecological supervision.
- 5.5 A feature for nesting swifts and sparrows will be integrated into the building.

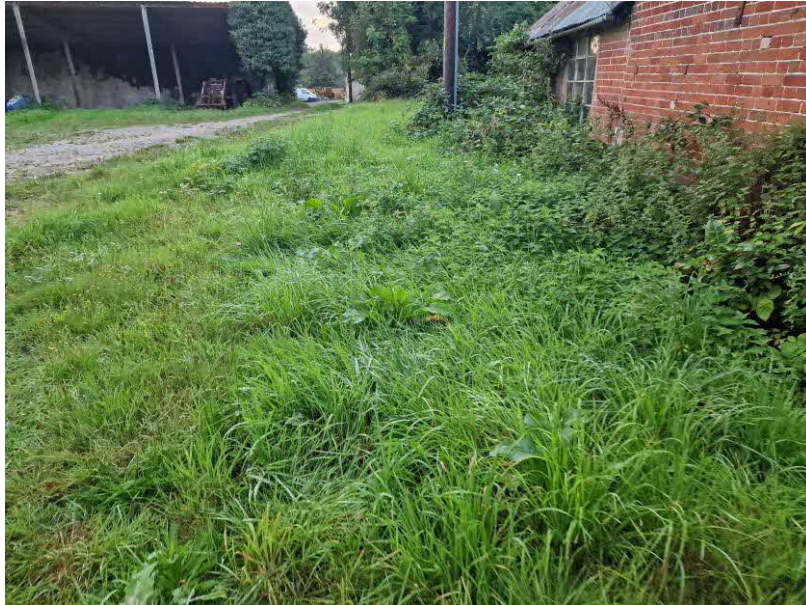
- 4.17 The grass on site (immediately to the south and west of the barn) is dominated by broad leaf species (*Holcus Lanatus*, *Anthoxanthum odoratum*, *Pleum pratense*, etc.) due to the courtyard having lower levels of use currently (photo 10). Large parts of the grassland have previously had gravel and hard core laid to aid farm traffic through the site, this has led to patches of bare ground (photo 11) and areas dominated by pioneer species (*Plantago lanceolata*, *Taraxacum officinale*, *Bellis perennis*, etc.). The grassland on site is therefore considered to have limited ecological value.

**Photo 10:** Grassland dominated by broadleaf species.

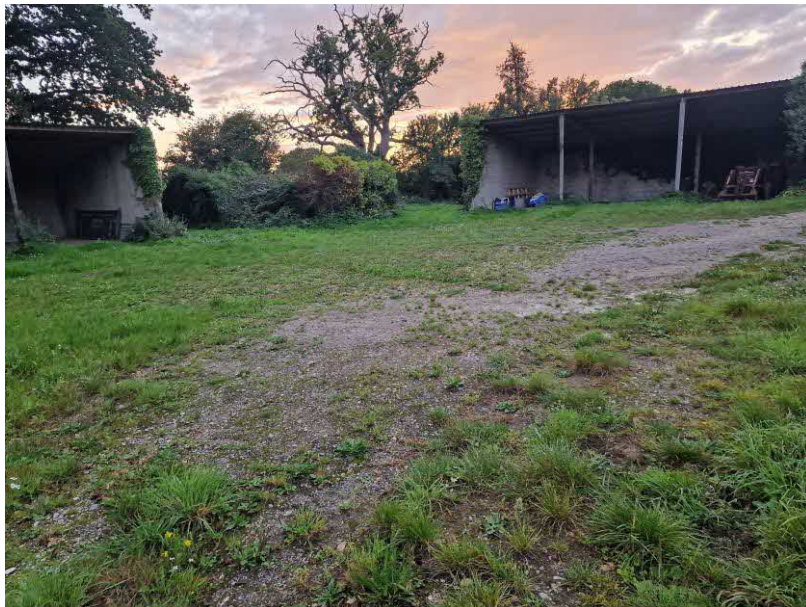
**Photo 11:** Large patches of bare ground showing the gravel that has been historically laid

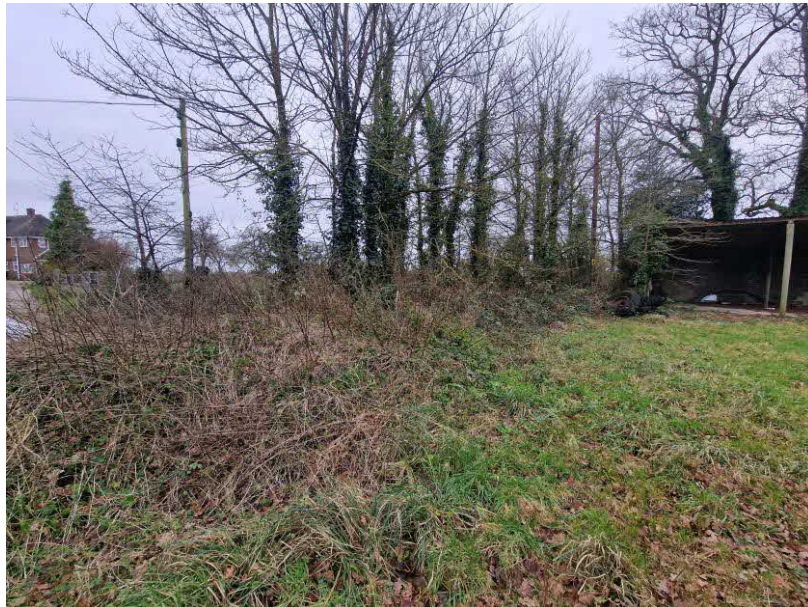
- 4.18 Bounding part of the east and the whole of the south is a hedge of varying quality. Along the south, the hedge is predominantly made up of tall (>5m) Elm with an understory of bramble (photo 12). The hedge along the southern end of the site is largely defunct and punctuated by large Oak trees (photo 13).

**Photo 12:** Line of tall Elm trees making up the eastern hedge

- 4.19 Both hedges have significant ecological value for the site. They offer connectivity to the wider landscape, important foraging opportunities and roosting/nesting sites. It would be best to avoid any impact but if any of the plans require work to these hedges, a CEMP would need to be in place to avoid potential impacts to EPS (European protected species) and appropriate mitigation for the loss of habitat would need to be designed. The Elm are proposed to be removed and these will be replaced with a range of native hedgerow species.

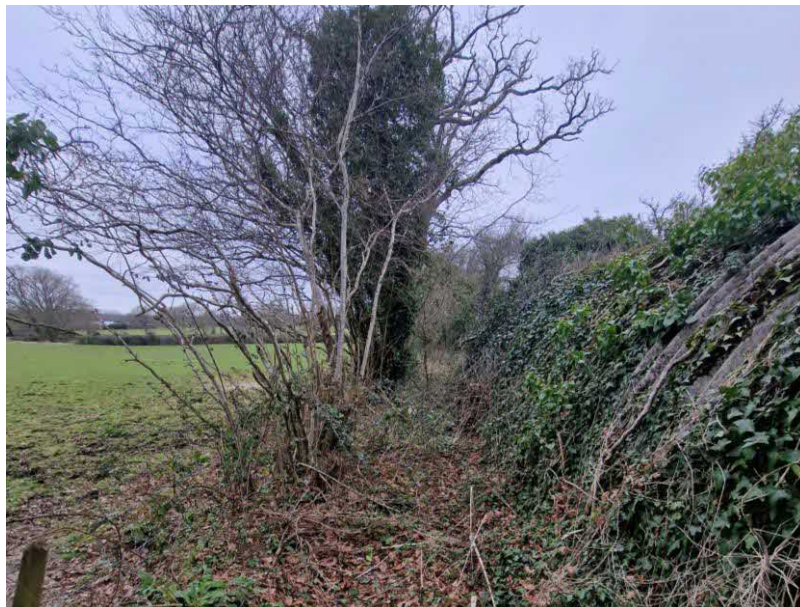
**Photo 12:** Largely defunct hedge along the southern boundary

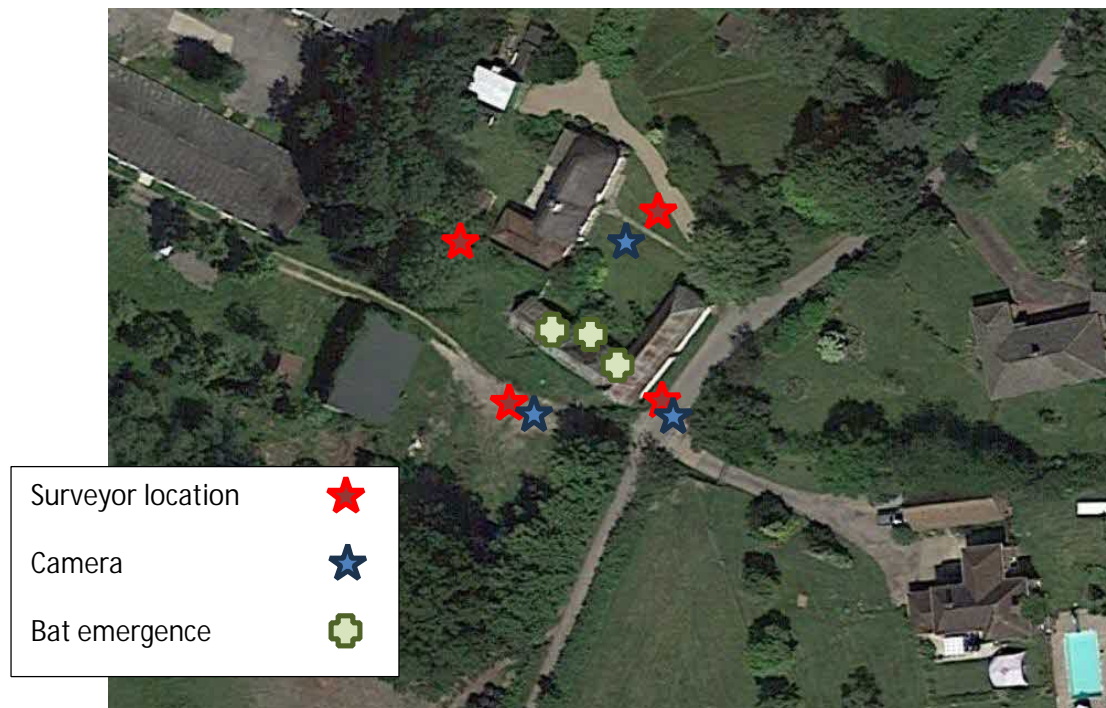
**Plan 1:** Results of first survey

- 4.21 During the first survey Common Pipistrelle were the most commonly recorded bat species, first recorded at 1938 (15 mins after sunset). CR recorded a bat emerging at 1943 and this coincides with Common Pipistrelle recordings. At times it was clear that two bats were present at the same time. A large proportion of the recordings contained social calls. Due to the high number of social calls and the time of the survey, it seems likely that the site is being used for mating.

- 4.22 The next most common species recorded was Barbastelle, first recorded at 1949 (26 mins after sunset). Barbastelle are recorded emerging a mean 24mins after sunset and staying within close proximity for a further 60 minutes. It is likely that there is a Barbastelle roost nearby or onsite – the species is known to use trees and sometimes old barns to roost in.

- 4.23 Brown Long Eared were also recorded on the site at 2029 (66 mins after sunset). These bats echolocation calls are exceptionally quiet and they on average emerge 54 mins after sunset so given the time and number of calls, these bats may also use the site as a day roost.

- 4.24 Two more potential emergences were recorded but remain unconfirmed by the IR cameras.
