# HOME FARM BARN & COTTAGES

Twywell, Northamptonshire

## Historic Building Record

Document No: TJC2023.188  
Planning No: 20/01154/FUL  
OASIS No: thejesso1-398214

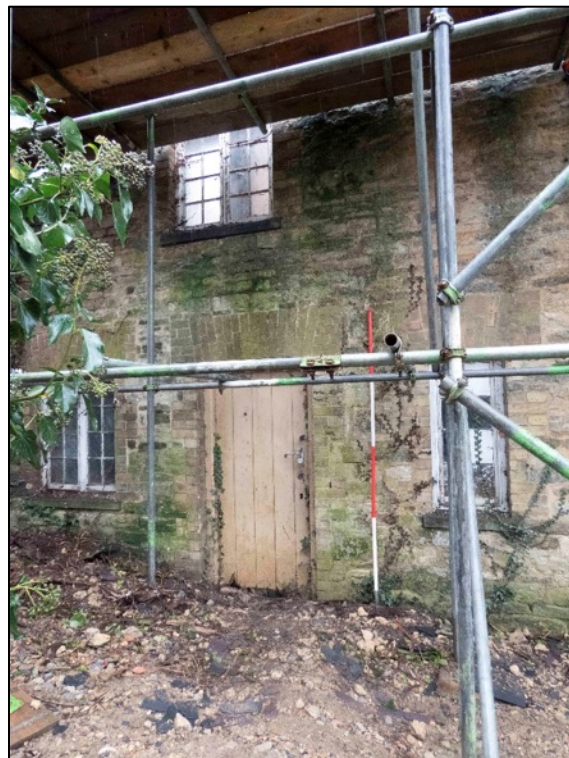
Appendix 2.6 View of north-west elevation of **Cottage I**, looking south-east (2023)

- 5.1.3. The north-west elevation (**Appendices 2.6-2.7**) formed two mirrored bays, each containing a central door between a small single-light casement and two light casement, and with a two-light casement at first floor level above. The jambs and lintels of these openings were of a buff brick with plain protecting sills to the windows. The casements of the windows were of timber construction with each light divided into eight panes. All these openings were inserted.

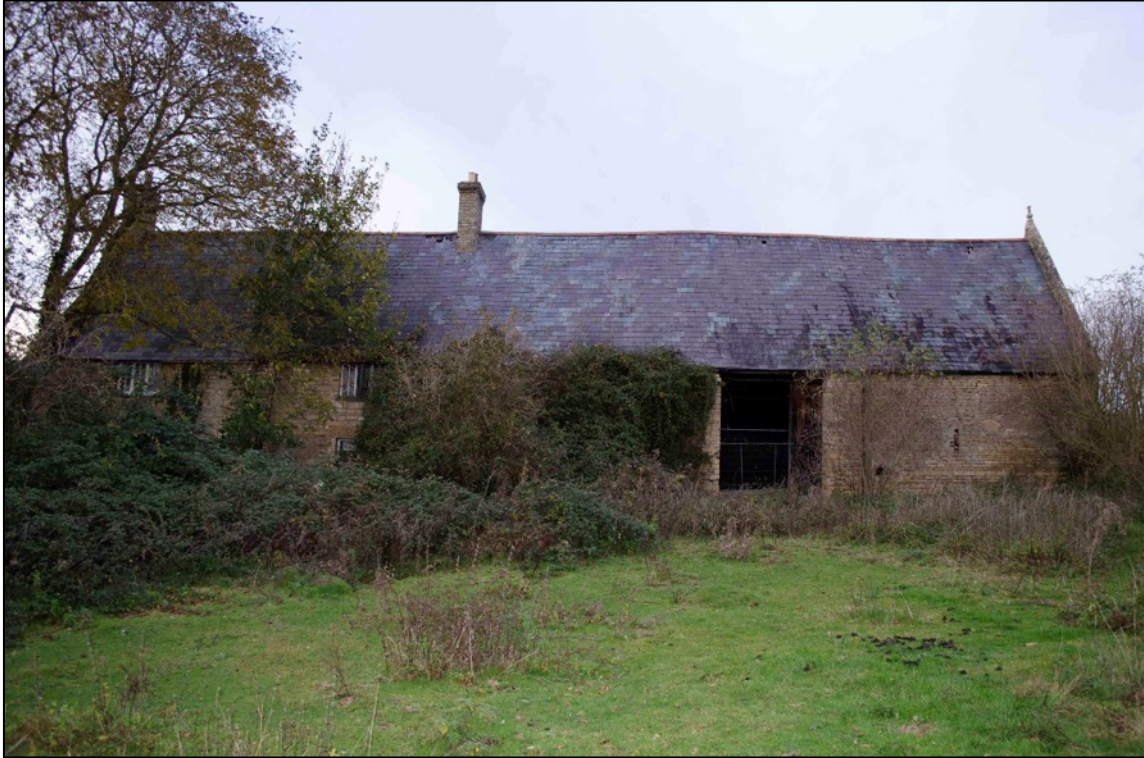
Appendix 2.9 View of Cottages 1 & 2 and Barn 1, looking north-west (2018)

- 5.1.4. The south-east elevation (**Appendices 2.9-2.13**) was similarly divided into two bays, each containing two vertically aligned three-light timber framed casement windows, each light divided into eight small panes, with buff brick lintels & jambs and plain stone sill. All these openings were inserted. Between the bays was a central blocked doorway, the lintel of which had also been removed (**Appendix 2.12**).

5.2.4. The north-west and south-east elevations (**Appendices 2.9 & 2.39**) contained a central wide opening, rising up to the eaves of the roof, with ashlar quoins in either jamb. The walls to either side were predominantly solid except for a single tier of ventilation slits (**Appendix 2.41**). Two further inserted openings, lined with late 20<sup>th</sup> century brick and with iron bars across their openings were observed to the left and right of the entrance in the south-east elevation (**Appendices 2.39-40**).

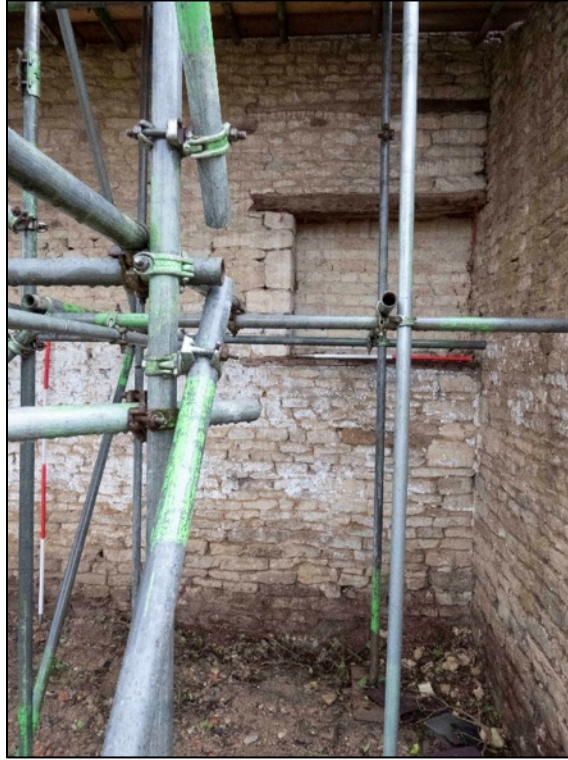
Appendix 2.45 Detail of blocking in south-west wall of room IG9 Barn I (2023)

- 5.2.6. It had an earthen floor, bare stone walls and was open to the rafters above. There only observed feature of note was a high-level blocking in the right side of the south-west wall, evidently an original feature that was later blocked in brickwork (**Appendix 2.45**). Its function was unclear.
