**Phase 1
Land Contamination Assessment**

**Flambeau, Manston Road,
Ramsgate, Kent CT12 6HW**

Reference: EES 23.182.1

Date: 8th February 2024

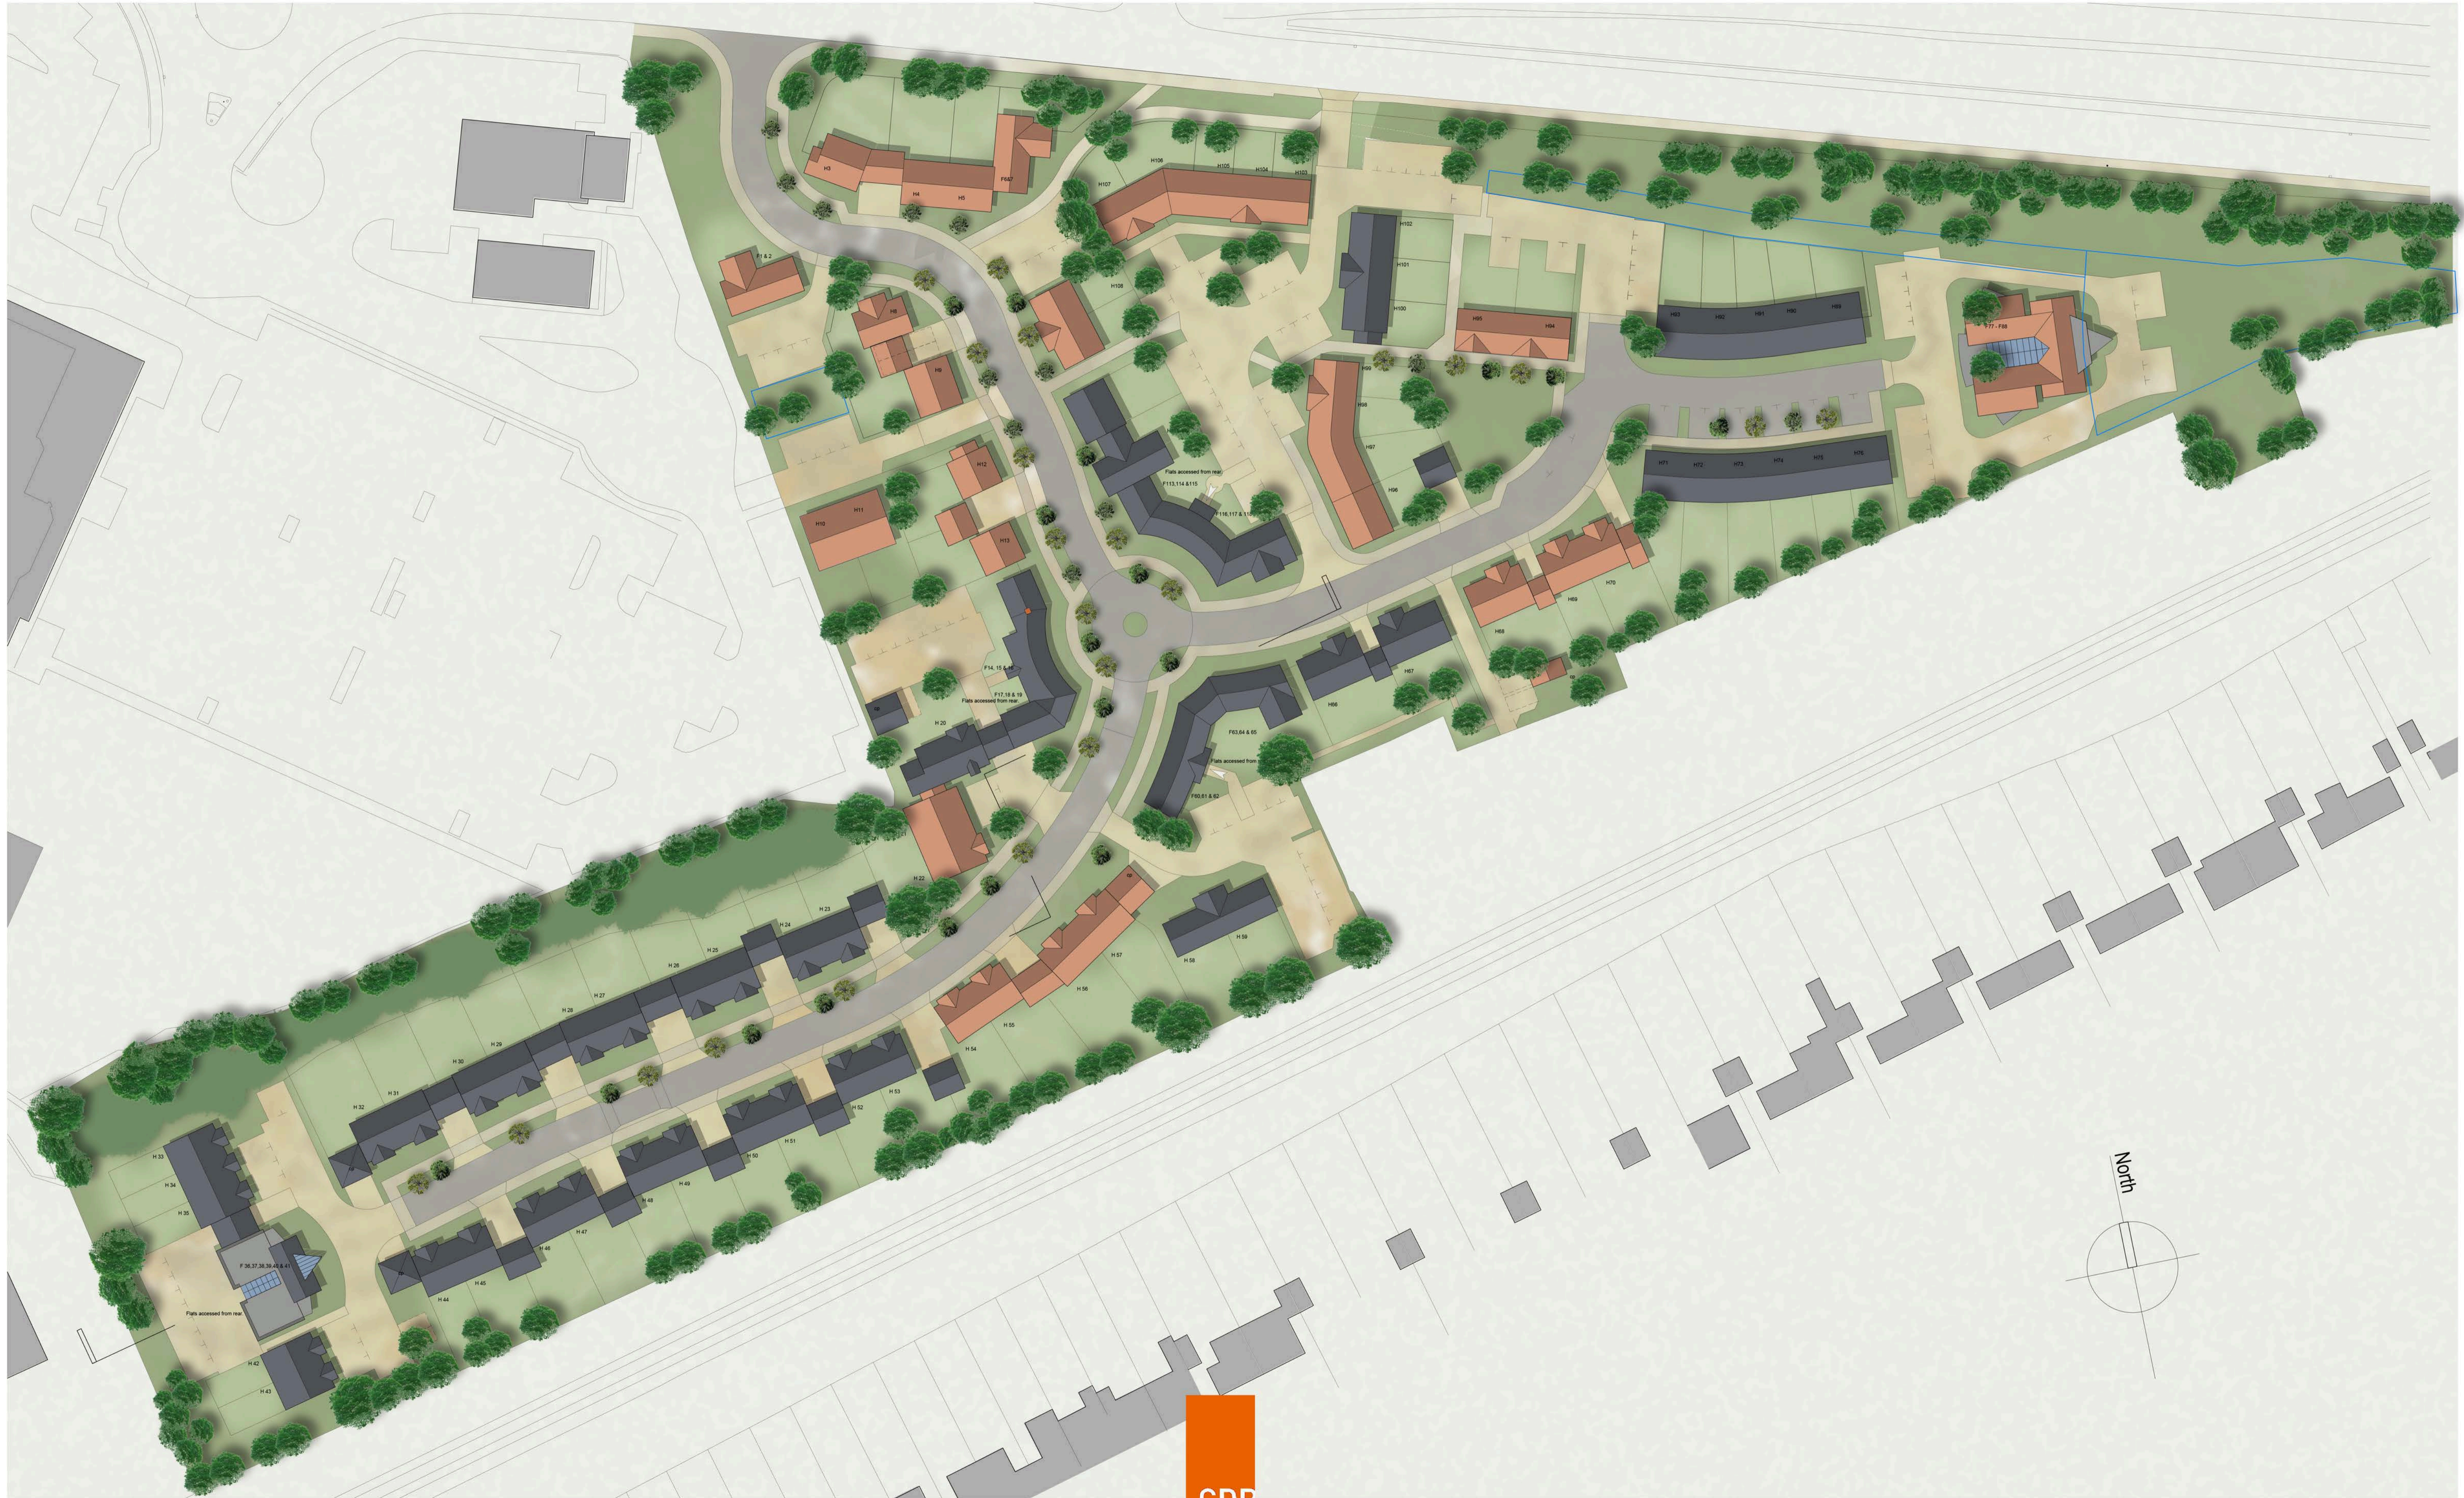
Proposed Site Plan 1:500

From information provided by the Client, it is understood that the current Site redevelopment comprises the construction of 118No. residential units with associated soft and hard landscaping areas.

The redevelopment plan is included in [Appendix I](#) for reference.
