Appendix A.4 – Site Investigation Report undertaken by EPS

Ground Investigation Report

Flambeau EuroPlast Ltd

EPS Project Reference: UK23.6529

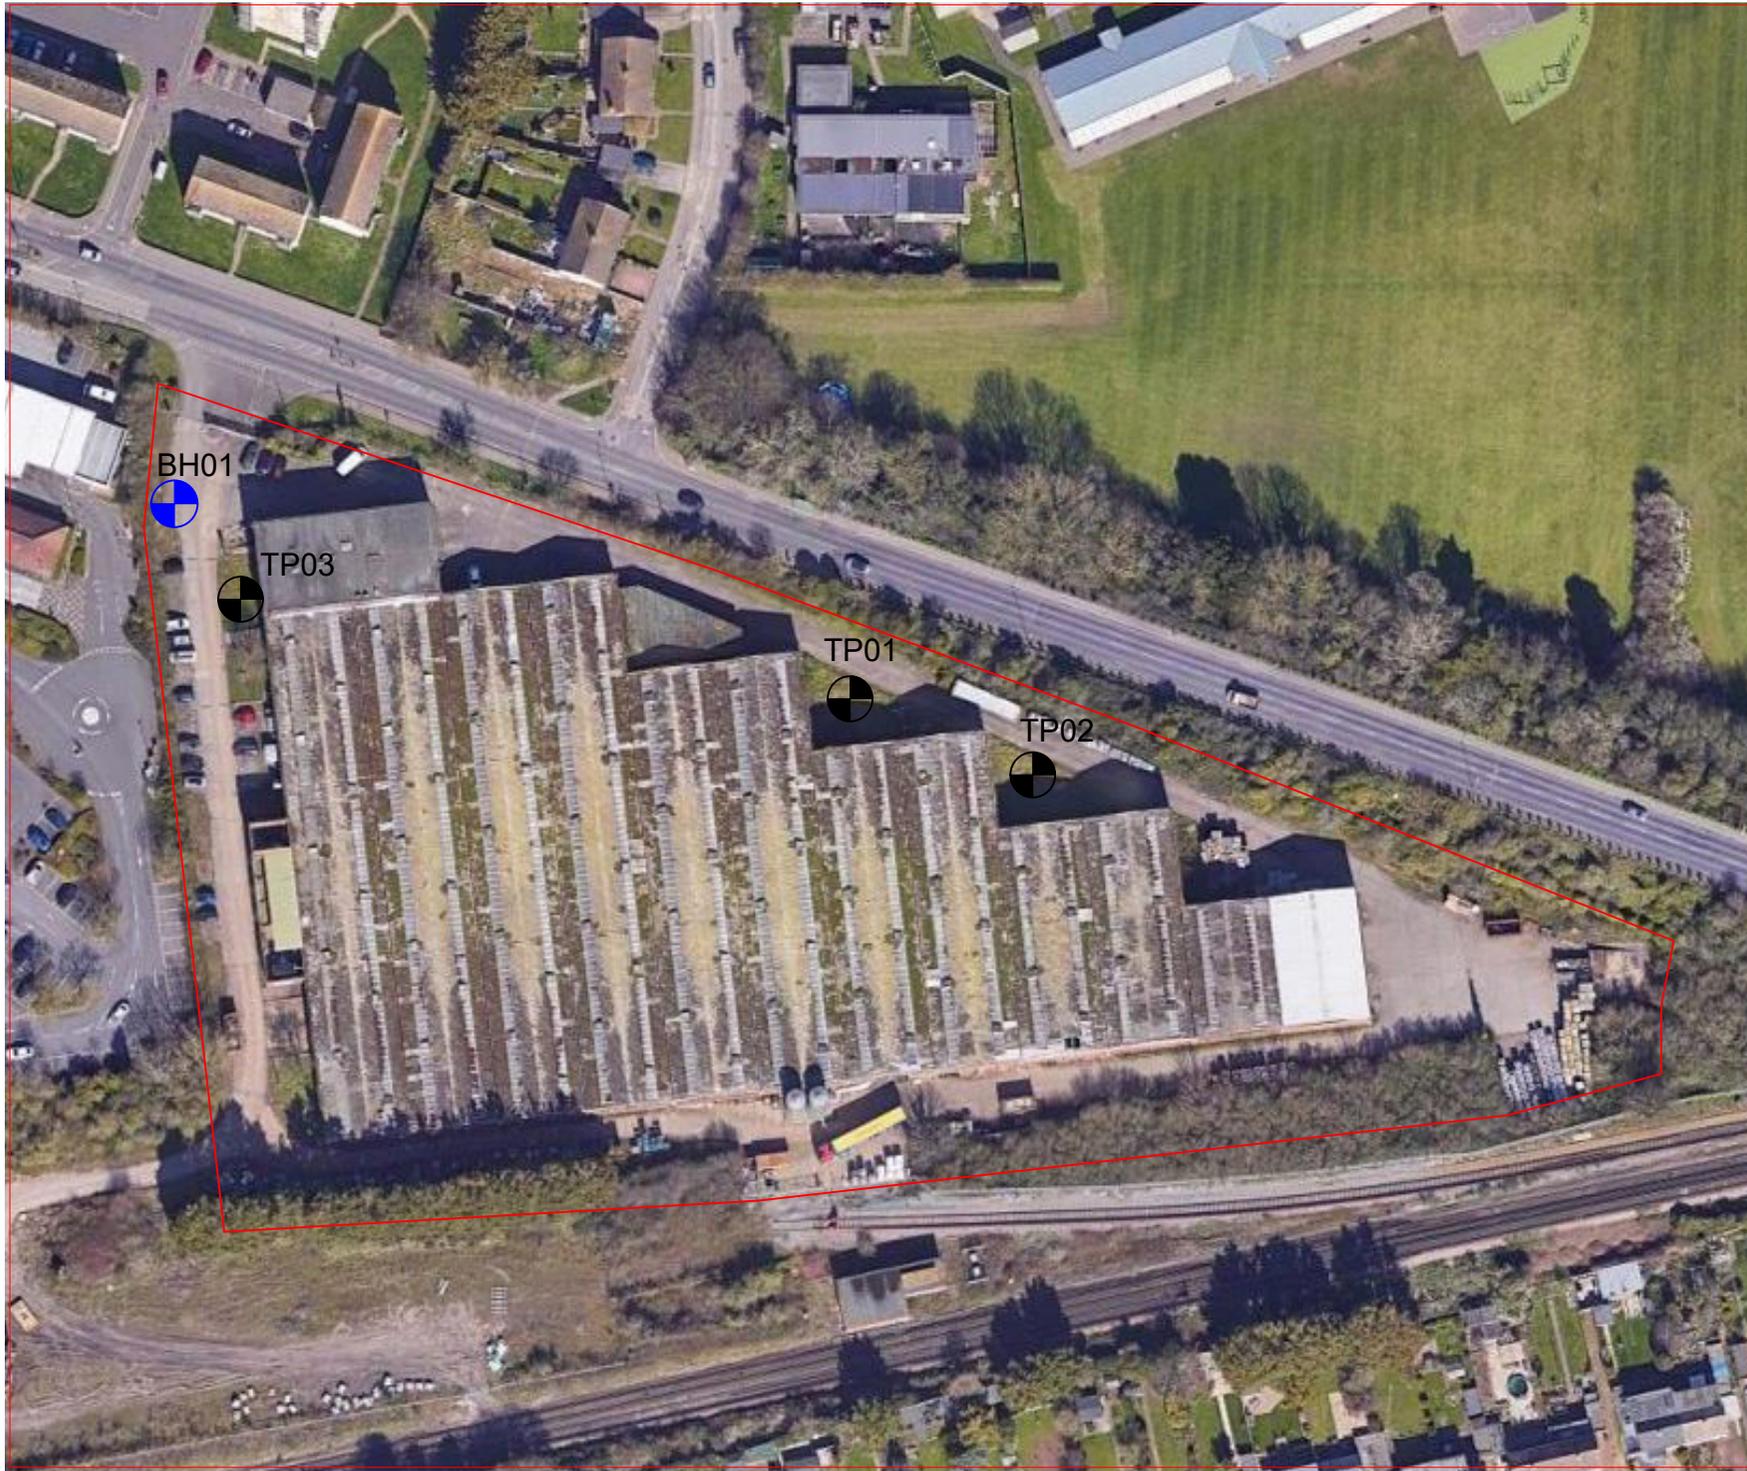
Title
 Figure 2 - Intrusive Investigation Location Plan

- KEY:
- SITE BOUNDARY
 - EPS TRIAL PIT LOCATIONS
 - EPS CABLE PERCUSSION BOREHOLE

Upon completion all positions were backfilled with compacted soil arising's and levelled at the surface. The location of the intrusive works are shown on the location plan included as Figure 2.

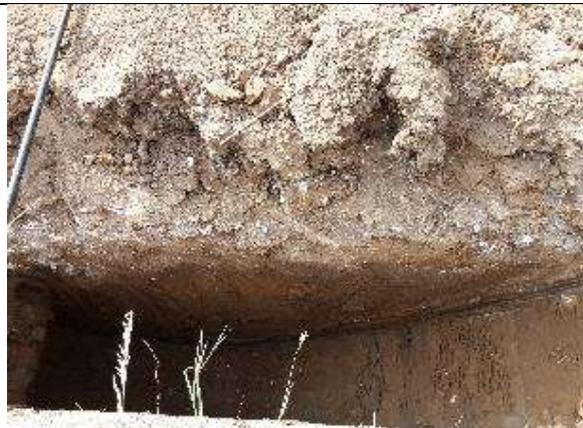
Photo 1: Image showing the material encountered at TP01.

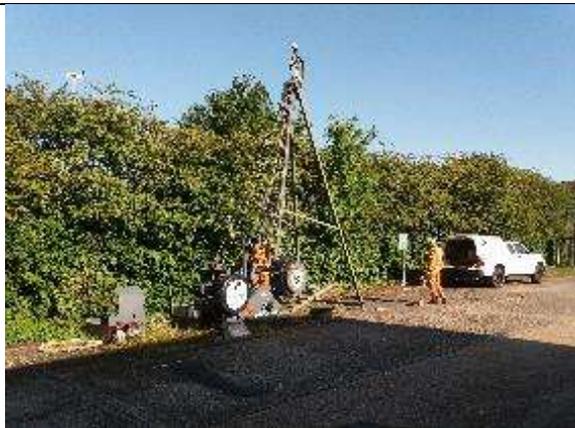
Photo 2: Image showing the location of BH01.

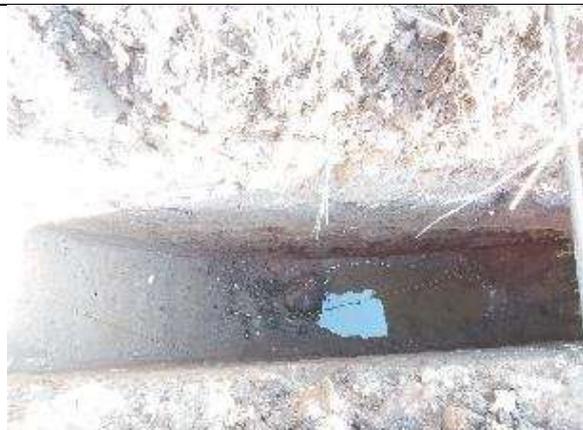
Photo 3: Image showing TP01 after running the infiltration test overnight.

The first tests for TP01 and TP02 were left to run overnight within the superficial Head Deposits and reached full completion, with calculated rates of $1.68 \times 10^{-6} \text{m/s}$ and $1.59 \times 10^{-6} \text{m/s}$ respectively. However, both of the second tests in these locations were slower, and failed to reach the same stage during the allotted time period. Therefore, the rate for the repeat test in TP01 was extrapolated based on at least 50% being achieved, but the second test in TP02 failed to reach this marker and therefore calculating a rate to a reasonable degree of accuracy was not possible. This was similar in TP03, which despite technically being formed within the chalk bedrock, the trial hole was formed in the upper weathered section of this strata (recovered as clay), and no rate was calculable based on data recorded from this location either.

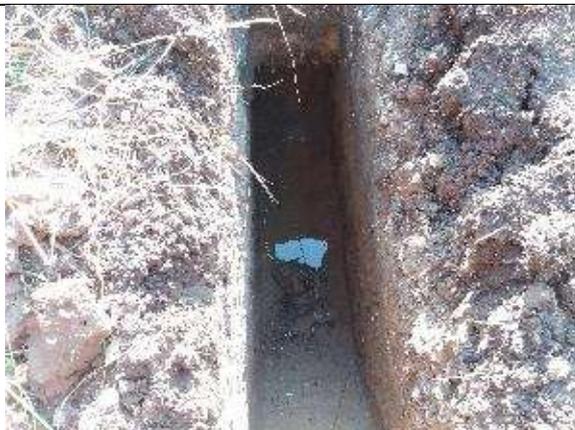
Photo 4: Image showing TP02 after running the infiltration test overnight.

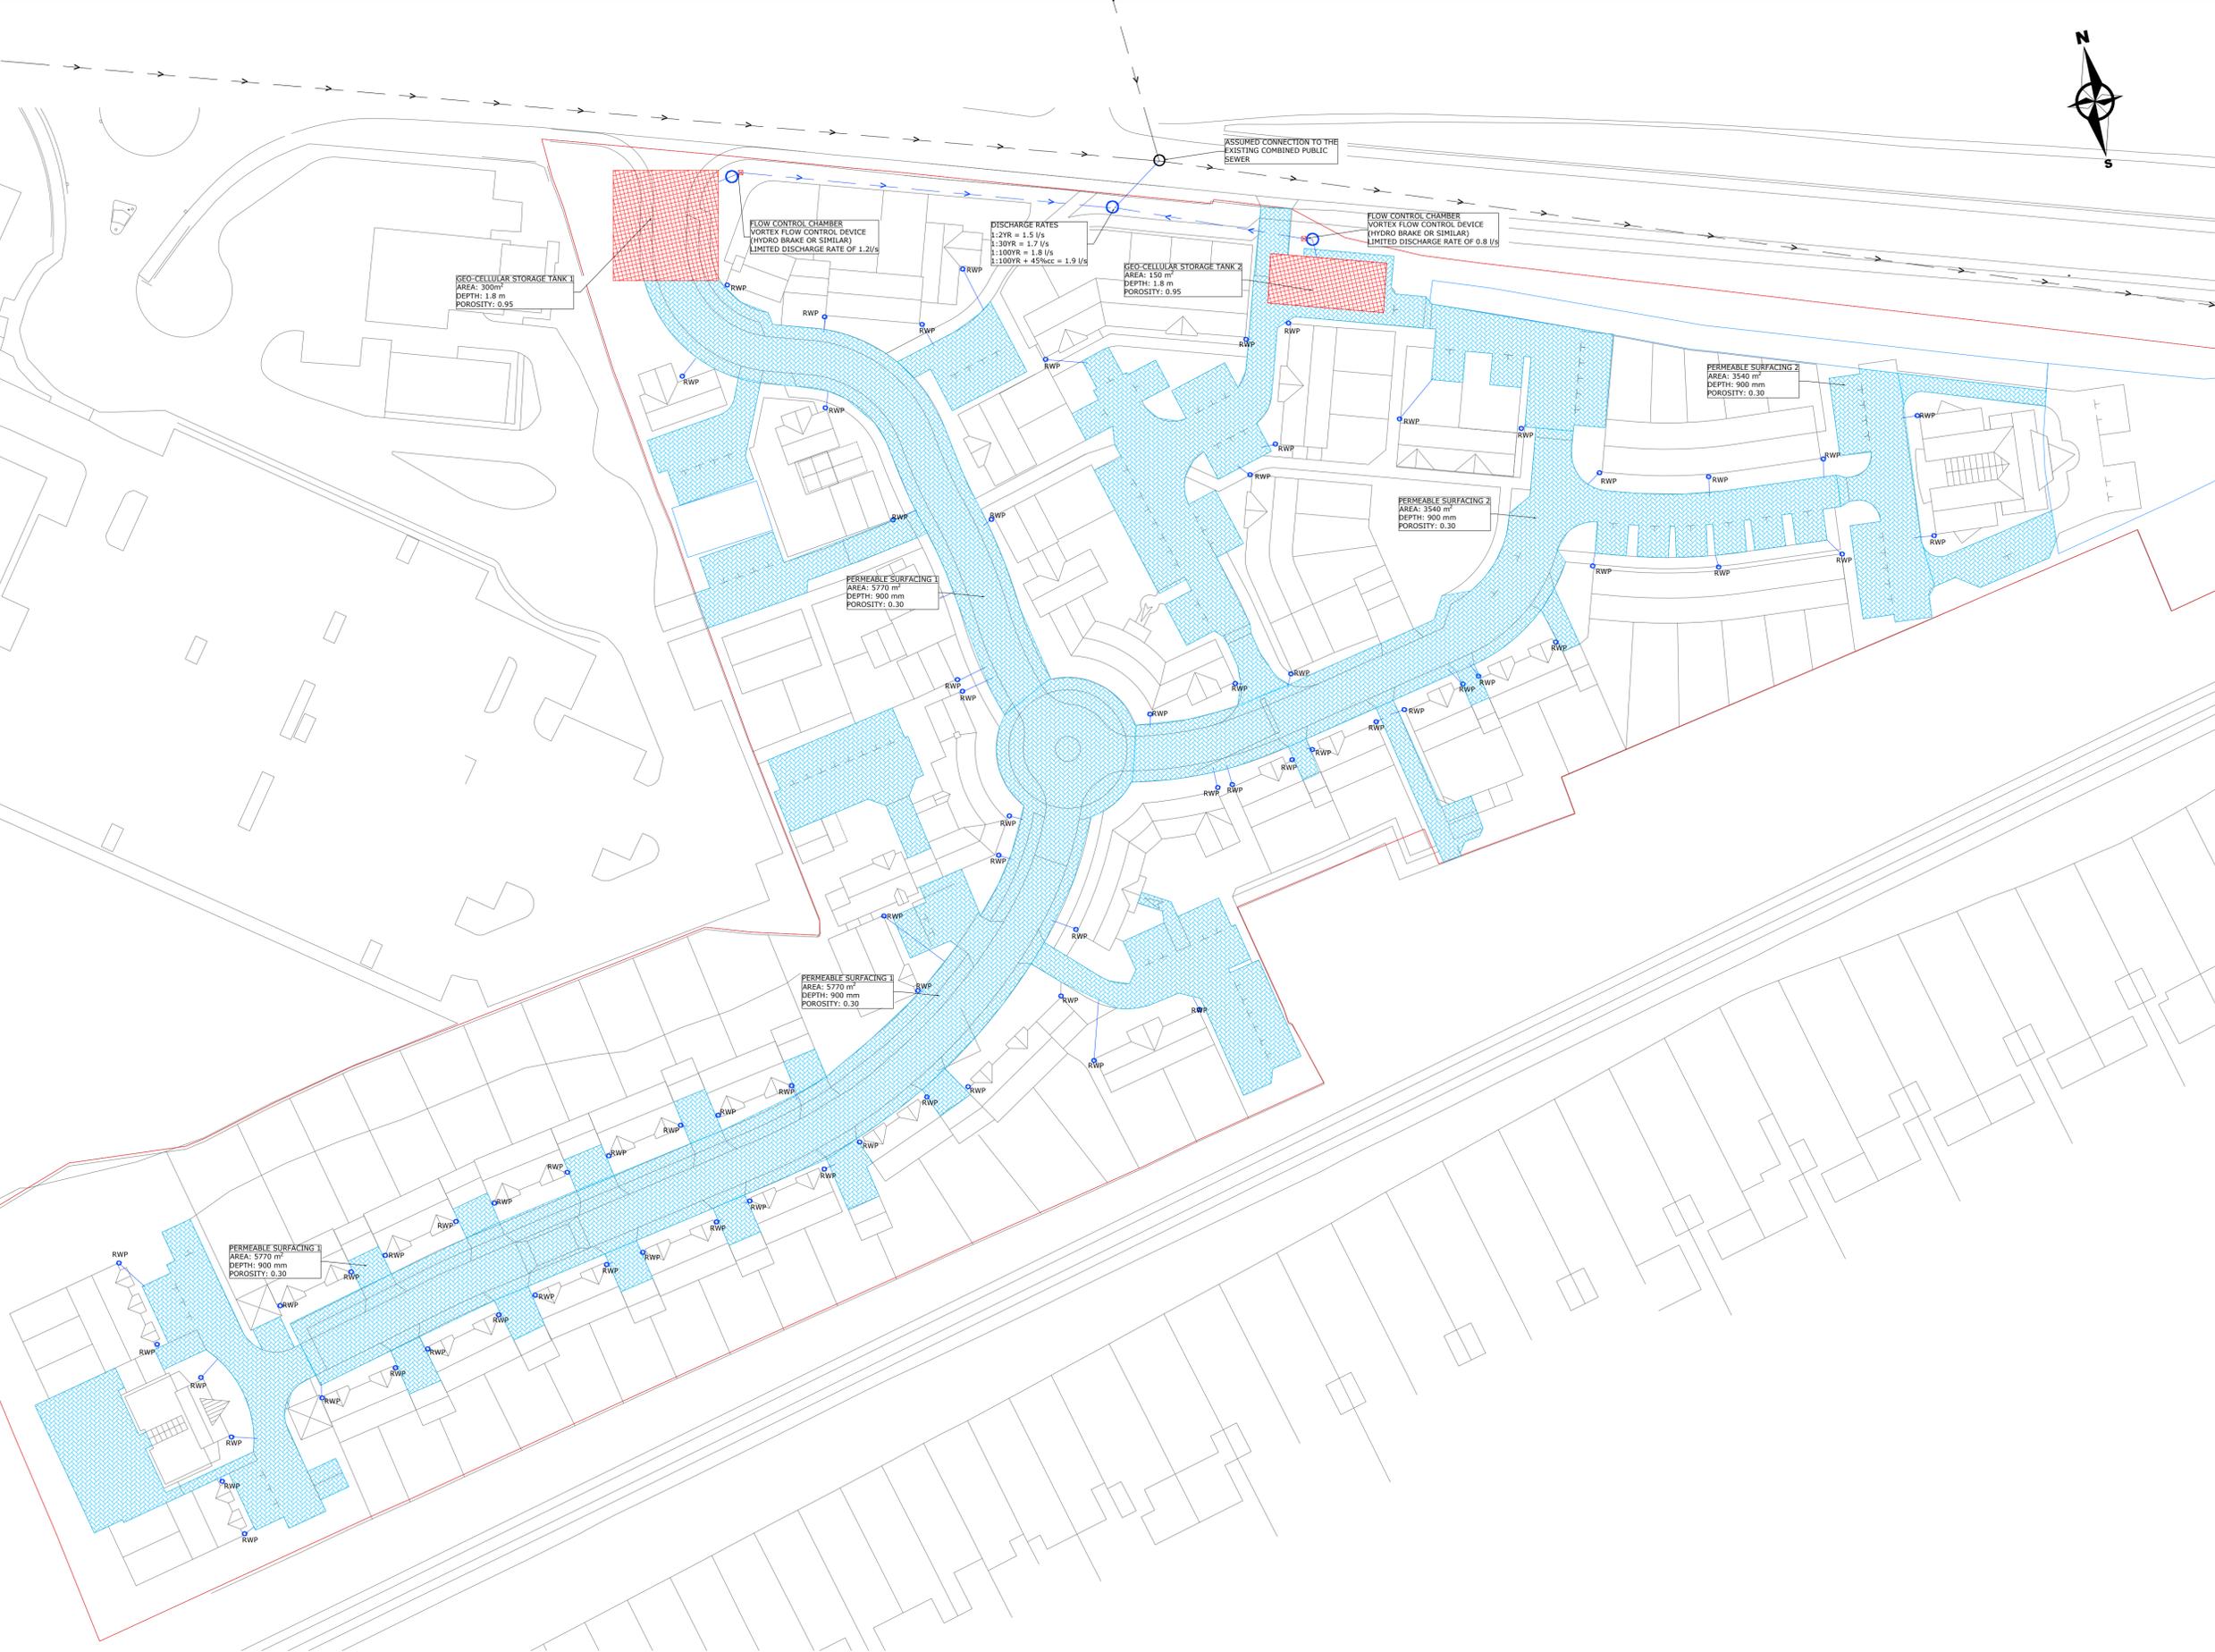
- EXISTING COMBINED SEWER
- EXISTING COMBINED SEWER CHAMBER
- SURFACE WATER DRAIN
- MH SURFACE WATER MANHOLE
- RWP RAINWATER PIPE
- ⊠ FLOW CONTROL DEVICE
- ▨ PERMEABLE SURFACE
- ▨ GEOCELLULAR STORAGE
