LIME KILN HOUSE, CLAYDON

PRELIMINARY ROOST ASSESSMENT (PRA)

MARCH 2024

DATE ISSUED: MARCH 2024
JOB NUMBER: BE10986
REPORT NUMBER: 0001
VERSION: V0.1
STATUS: FINAL

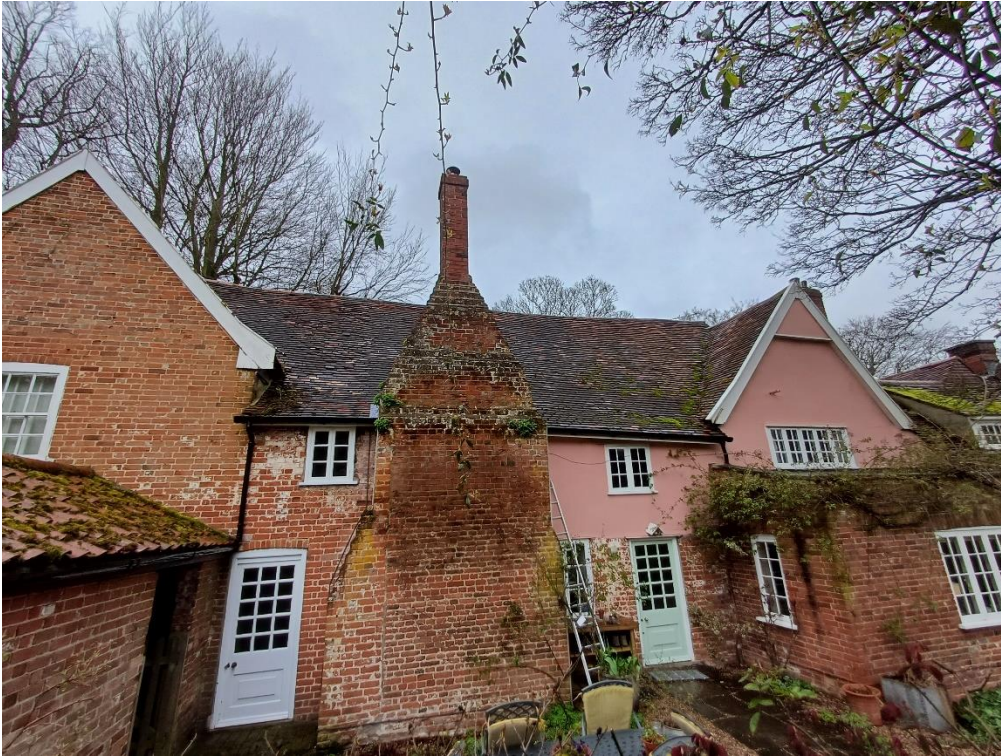
Photograph 1 – Lime Kiln House

1.2.1 The proposed works are understood to consist of works to the roof of the kitchen extension (see photograph 1 in appendix 1) to install roof windows. The plans used to determine the likely impacts were “Lime Kiln House Proposed and Existing Plans”, Drawing No. 3044_100/101/200/300/400, dated October 2023, which was produced by Beanland Associates Architects Limited.

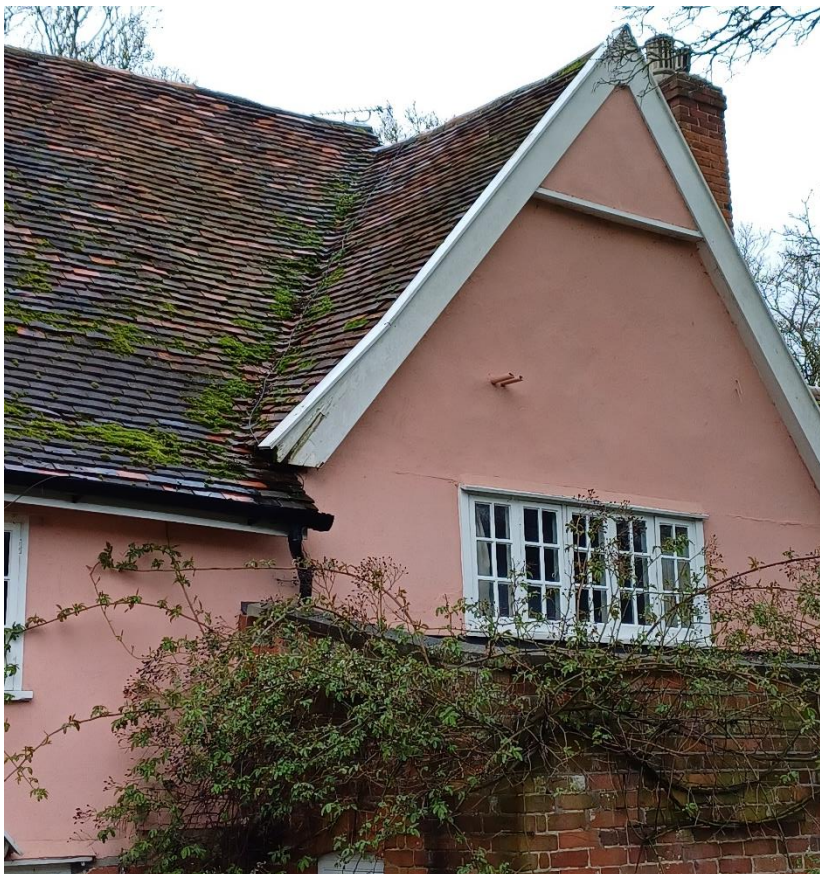
Photograph 2 – Kitchen Extension with flat roof.

- 3.2.1 The external walls and roof of the flat roof kitchen extension were checked for crevices or gaps within the roofing material that could offer bat roost potential (See photograph 2 in appendix 1). There were no roof void or tiles on this section of the house. No bats, droppings or any other evidence of bats were found. Several crevices under tiles of the adjacent wall/roof gable/apex above the flat roof of the kitchen were inspected with an endoscope, however no bats, droppings or any other evidence of bats were found.

- 4.2.1 The area of extension roof and adjacent wall of the house that would be directly impacted by the proposed works contain no features suitable for roosting bats, so no direct impact on bats are likely.

- 5.1.2 No lighting is to be used in relation to the works.
- 5.1.3 If any scaffolding would be in front of the tiles on either side of the kitchen extension, an ecologist covered by a Natural England bat survey licence will be called out to check the crevices for any signs of bats in case bats have moved in since the check

undertaken for this report. If bats are found to be using those crevices, the design of scaffolding will be adapted to avoid obstructing the roost.
