# BAT SURVEY AND ASSESSMENT

Croxlea, Parsonage Lane, Winford, Bristol. BS40 8DH

## A REPORT FOR MS LYNETTE PORTER

Surveys completed August and September 2023 and Assessment completed January 2024.

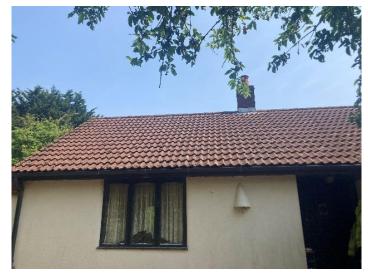
#### Picture 1

The front view of Building 1 residential bungalow property

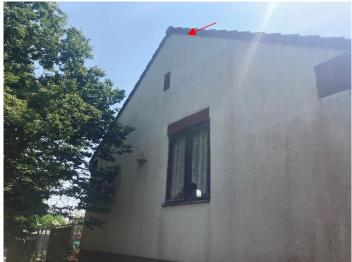
#### Picture 2

- 4.14. **B1** Externally B1 had gaps along the gable ends and some gaps under tiles on the roof. Internally the roof void contained a scattering of old bat droppings (c4) of a size and morphology indicative of pipistrelle bats. This building was considered to have **Low** potential for roosting bats. One emergence/reentry survey is required.
- 4.15. **B2** the roof was in good condition with few access points. The building in general was in good repair. This building was considered to have **Low** potential for roosting bats. One emergence/re-entry survey is required.

- 4.19. No bats were seen or suspected to have emerged from B2.
- 4.20. Five common pipistrelle bats emerged from the northern gable end of B1, these were captured on an Thermal Imaging camera. The first emerged at 20:43, 20 minutes after sunset with subsequent emergences at 21:01, 21:02 (x2) and 21:08 with one bat seen to re-enter the roost at 21:01. This species was then captured foraging around the site until 21:43.

Front gable end of bungalow property (Building 1) with small vent space leading to the internal void. Arrow showing the roost location.

- 6.11. Compensation: The common pipistrelle roost in B1 should be fully compensated for with a replacement feature built into the same elevation and the same height as currently found with the preferred location close the apex of the eaves on the north elevation of the new build. The recommended artificial boxes are either the Schwegler 2FN<sup>6</sup> or the Bat Habitat Box<sup>7</sup>. It is important

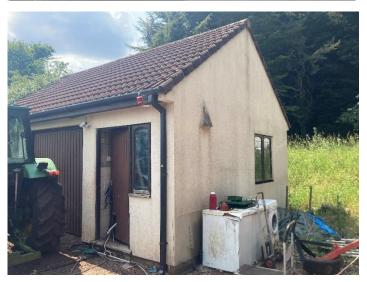
#### Picture 3

- 4.11. **B2** The double garage (Building 2) was of a similar construction to the main bungalow consisted of a double garage with storeroom. The roofing tiles were well sealed and the ridge tiles intact. Guttering was UPVC. The garages were filled with farm materials at the time of the survey.

B2 – Double garage, showing similar structure as the bungalow, B1

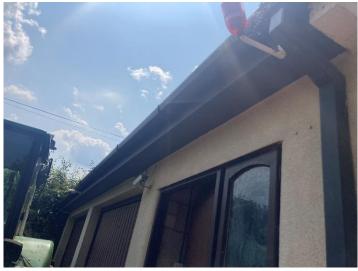
**Picture 4**Soffits and guttering on the double garage, B2

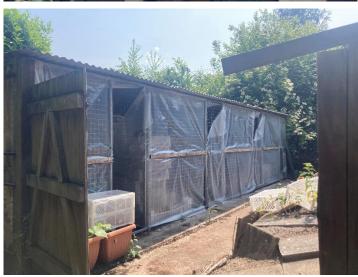
- 4.12. **B3** Dog kennels (Building 3) was present to the rear of the main bungalow property and at the time of the survey they were not in use. This was a single skinned metal and timber open fronted structure with corrugated metal roof. Plastic sheeting covered the fronts providing some weather protection.

Picture 5
B3, Dog kennels and shed. Disused.

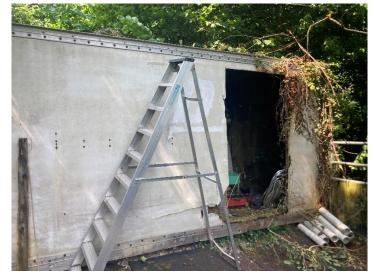
- 4.13. **B4** Porta cabin (Building 4) was of timber and metal structure. It had a flat roof and was missing the door. The structure was overgrown with ivy and full of farm equipment and materials at the time of the survey.

Picture 6
B4 Shed/Porta Cabin located towards the western of the property.

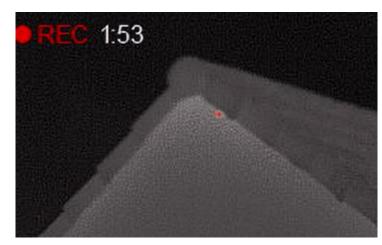
Picture 7
Bat emerging from roost.
