Our reference: RSE R0437 - 22-24 Tolworth Broadway KT6 7HL - Ecology & Bat Survey Report

22-24 Tolworth Broadway, KT6 7HL - Ecology Assessment and Bat Survey

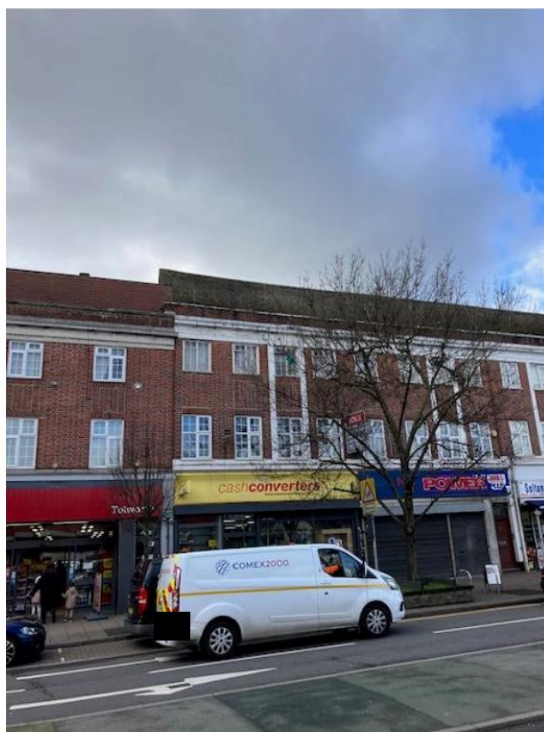
The building is currently a two and three-storey brick building which was predominately flat roofed with a small pitch running from north east to south west on the front elevation onto The Broadway (Figure 1). The building is in a reasonably good state of repair with no major cracks, holes or access points into the building. The pitched section of the roof was generally in a good state of repair with limited gaps beneath tiles recorded. As this is to be mostly retained as part of the proposals a full internal inspection was not deemed necessary. The roof of the main section of the building was flat roofed and covered in bitumen sheeting which was tight fitting and in a good state of repair (refer to Figure 2 and 3).

Figure 1 - Frontage of the building onto The Broadway

No additional surveys for bats or other species are recommended based on the results of this ecology assessment and PRA. However, it is recommended that a suitably experienced and bat-licensed ecologist is on call due renovation works should there be any unexpected discoveries of bats or other wildlife.

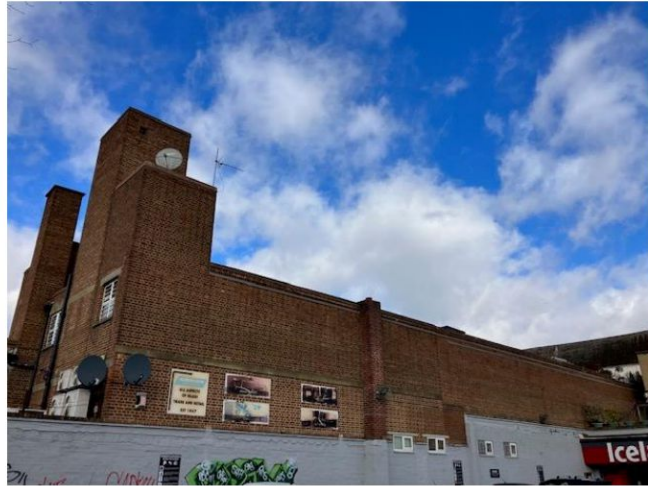
Figures 1, 2 and 3 show the external views of the area of the building to be impacted on by the proposals. The external inspection was completed from ground level using binoculars to assist with inspection at height (Zeiss 10 x 56 binoculars). There were no holes found in the brickwork that are occasionally present on older buildings from removed service pipes and cables. All brickwork was

in good condition with no missing bricks or other large holes. No gaps were found around window frames and the join between brick walls and roof did not show any clear opening large enough for use as bat or bird access points. With the urban location of the structure, and limited gaps beneath the tiles on the roof, it is considered unlikely that these would be used by a roosting bat.

Figure 2 - Building view to rear and south

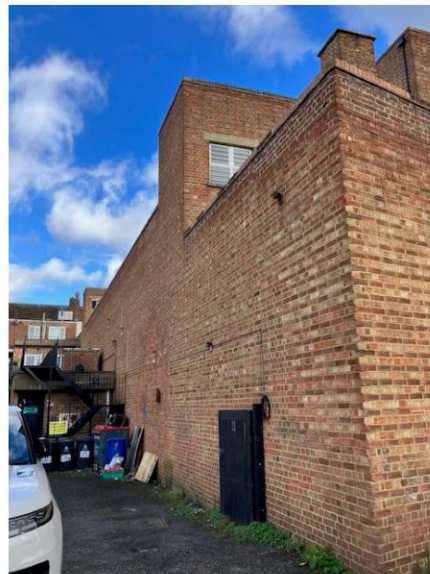
Figure 3 - Building view to rear and north elevation
