# STEVE HOLD CONSULTING CIVIL ENGINEERING

## Removal of a Partition Wall at St. Andrews Llandaff.

This is a brief "letter style" report to cover my site assessment on the 15th December 2023 of the structural implications of removing the partition wall between the kitchen and the dining room at St. Andrews, Llandaff as indicated in my sketch SK/1.

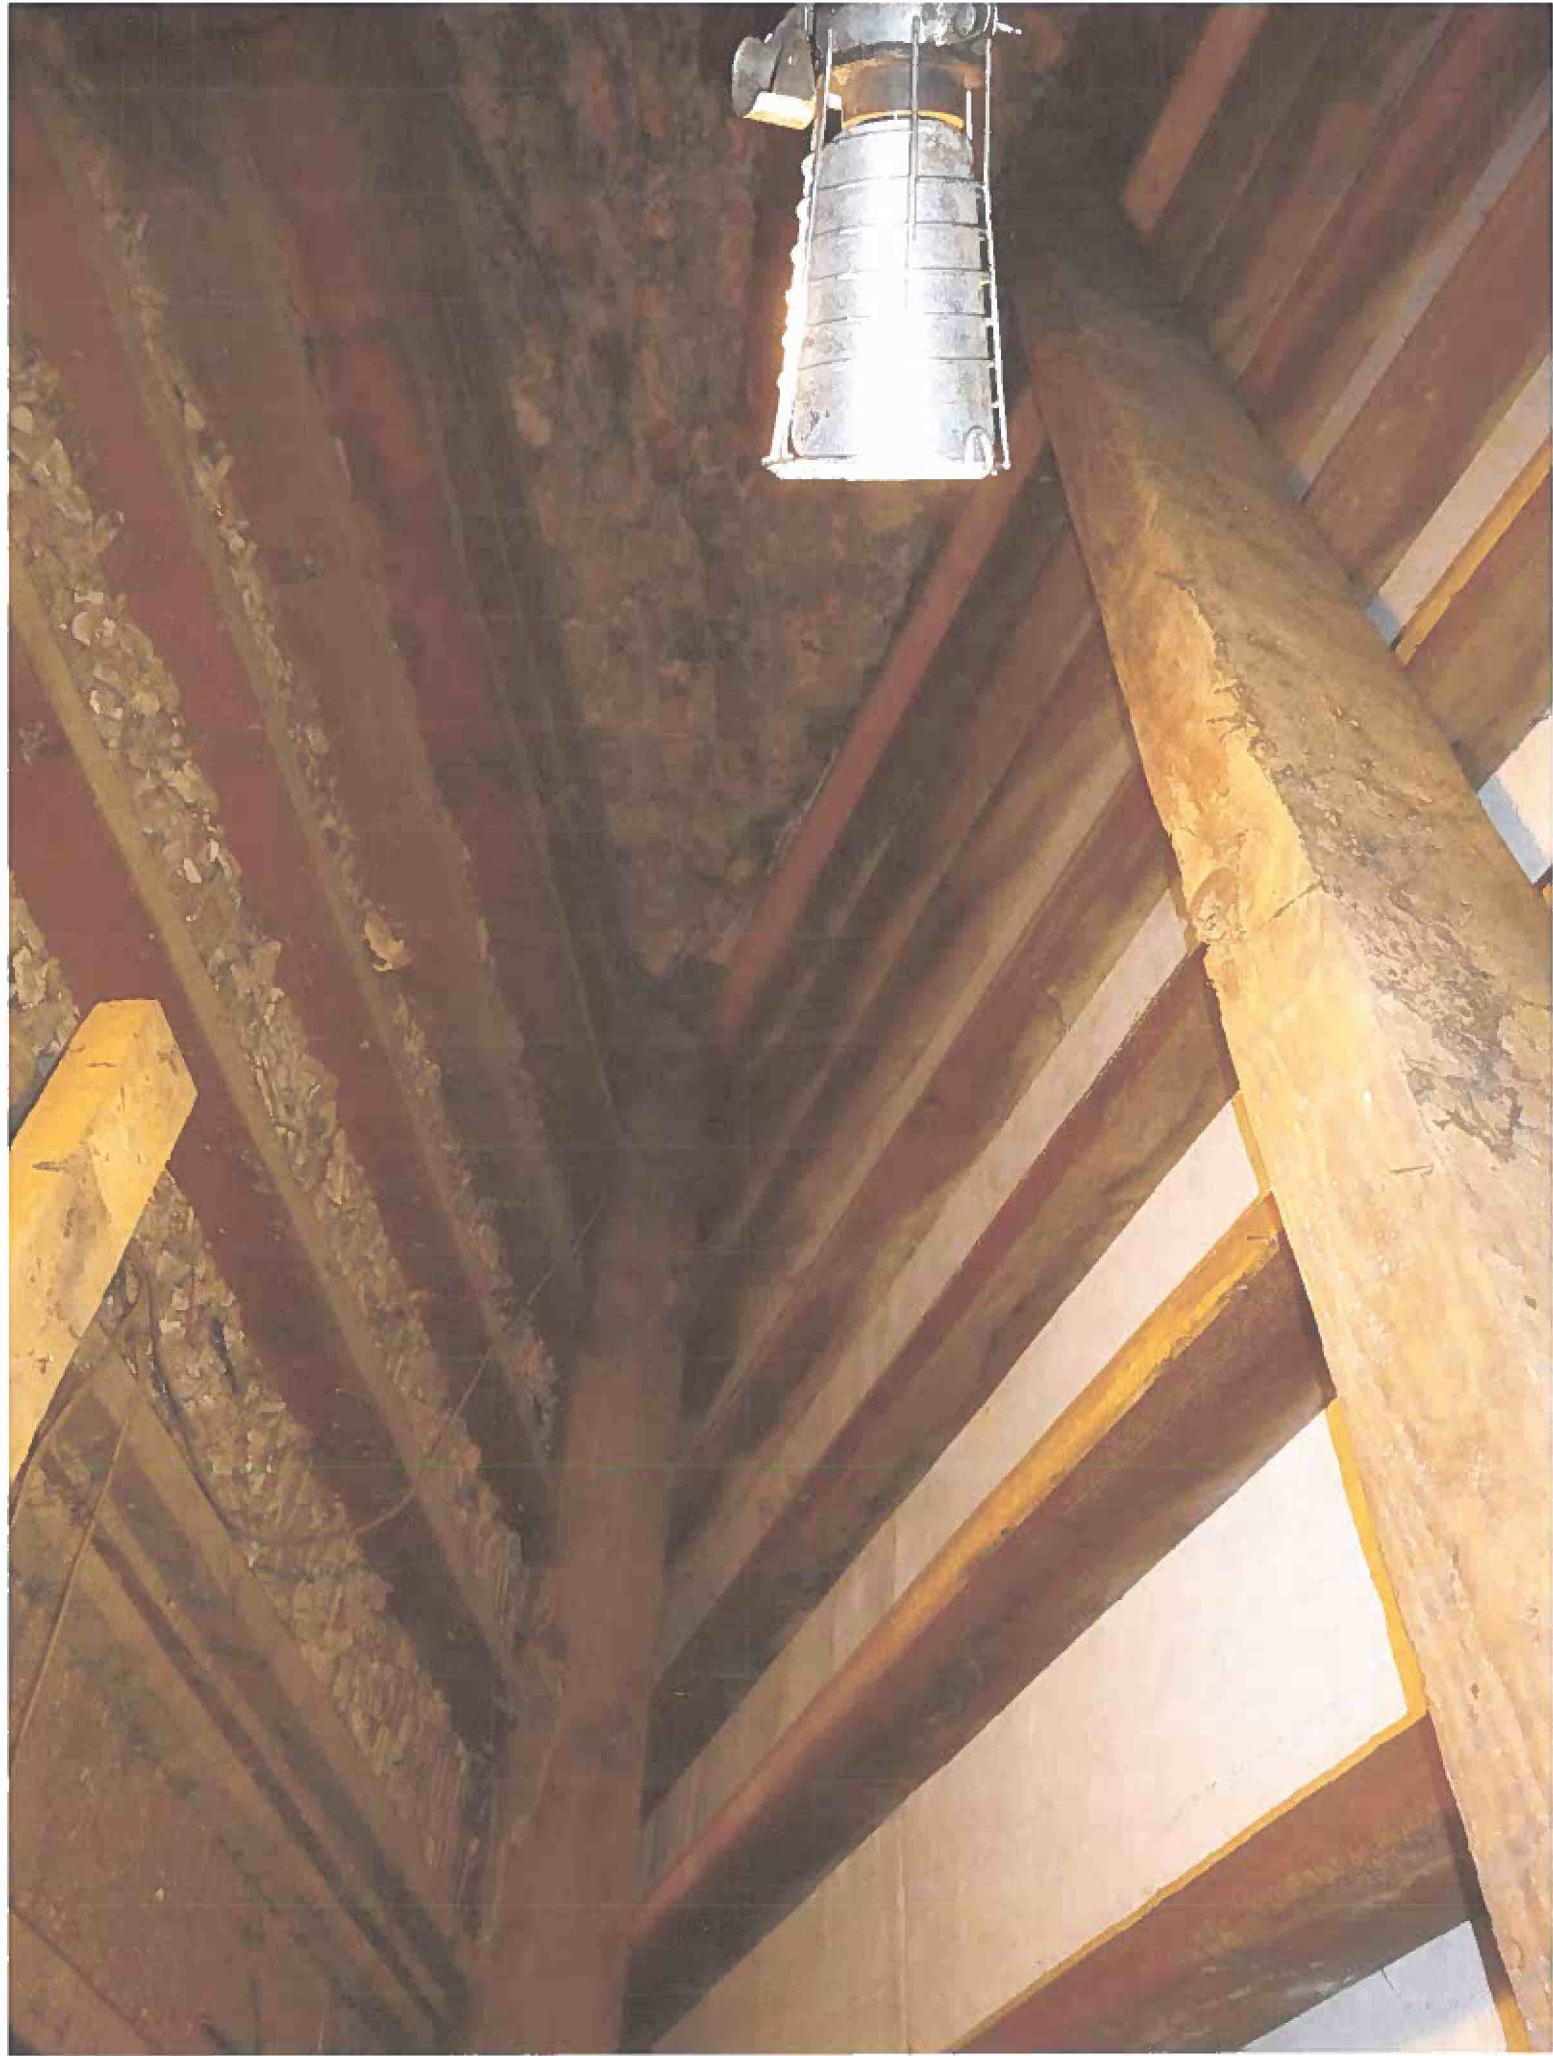
The single pitch roof structure above the kitchen and dining room is approximately at a 30 degree pitch and as you informed me , recently in (around 2010) been re-roofed. This can be seen by the new felt above the rafters and several new rafters either replaced or cut and spliced into the existing timbers. As I said during my inspection that the two large purlins that span the length of the roof provide the main load bearing capability of the roof and despite their length (more than would be designed for today) are in good condition. Figs 1 - 3.

FIG 1. 30° PITCH ROOF, 2 PURLINS, REPLACED RAFTERS

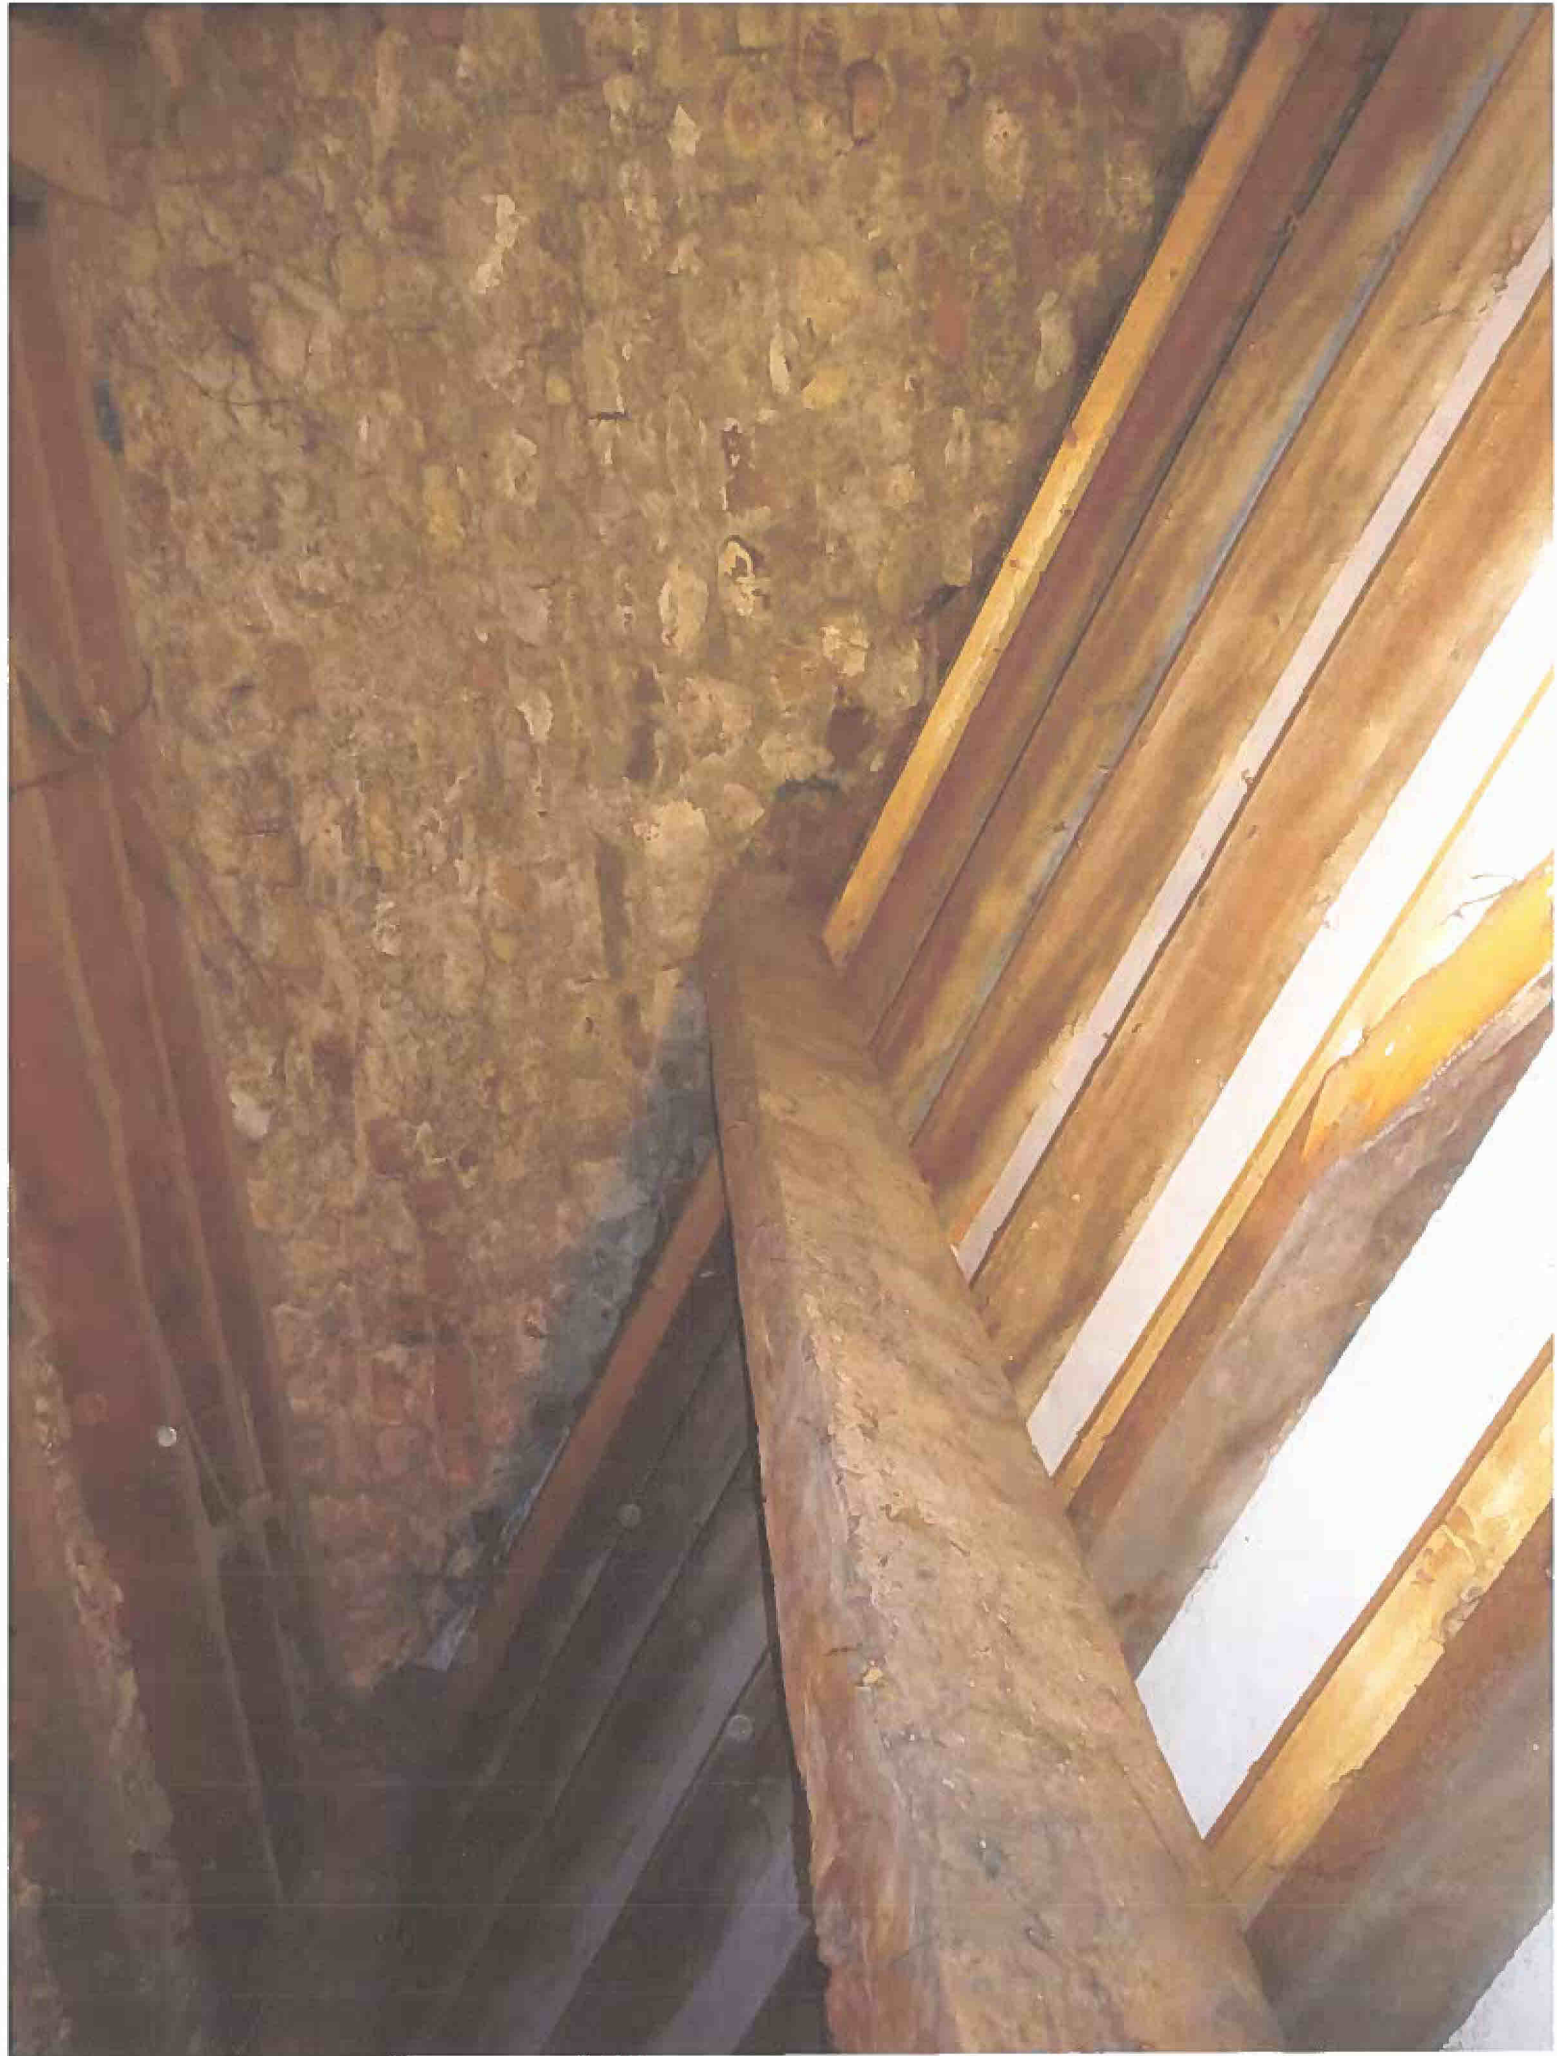
The lath and plaster ceiling arrangement however does require structural consideration to check that the bearing support is sufficient at the external wall where the ceiling has been given an increased pitch from the horizontal beneath the 30 degree pitch of the roof above to more like 45 degrees and is currently obscured and therefore needs to be investigated. Figs 4 and 6. This is because some of the ceiling joists have also been replaced or cut and spliced and the joists spanning onto the external wall have been "notched out" around the lower purlin close to the wall and this may have weakened them. The replacement timbers indicate that either rot or wood worm were found during the roof replacement and could be replaced in the visible accessed areas but these defects may still be present behind the obscured 45 degree pitch ceiling. The evidence of the new timbers that were needed is shown in Fig 2.

FIG 2. PRIMARY SUPPORT PURLINS 'BUILT IN' REPLACED RAFTERS

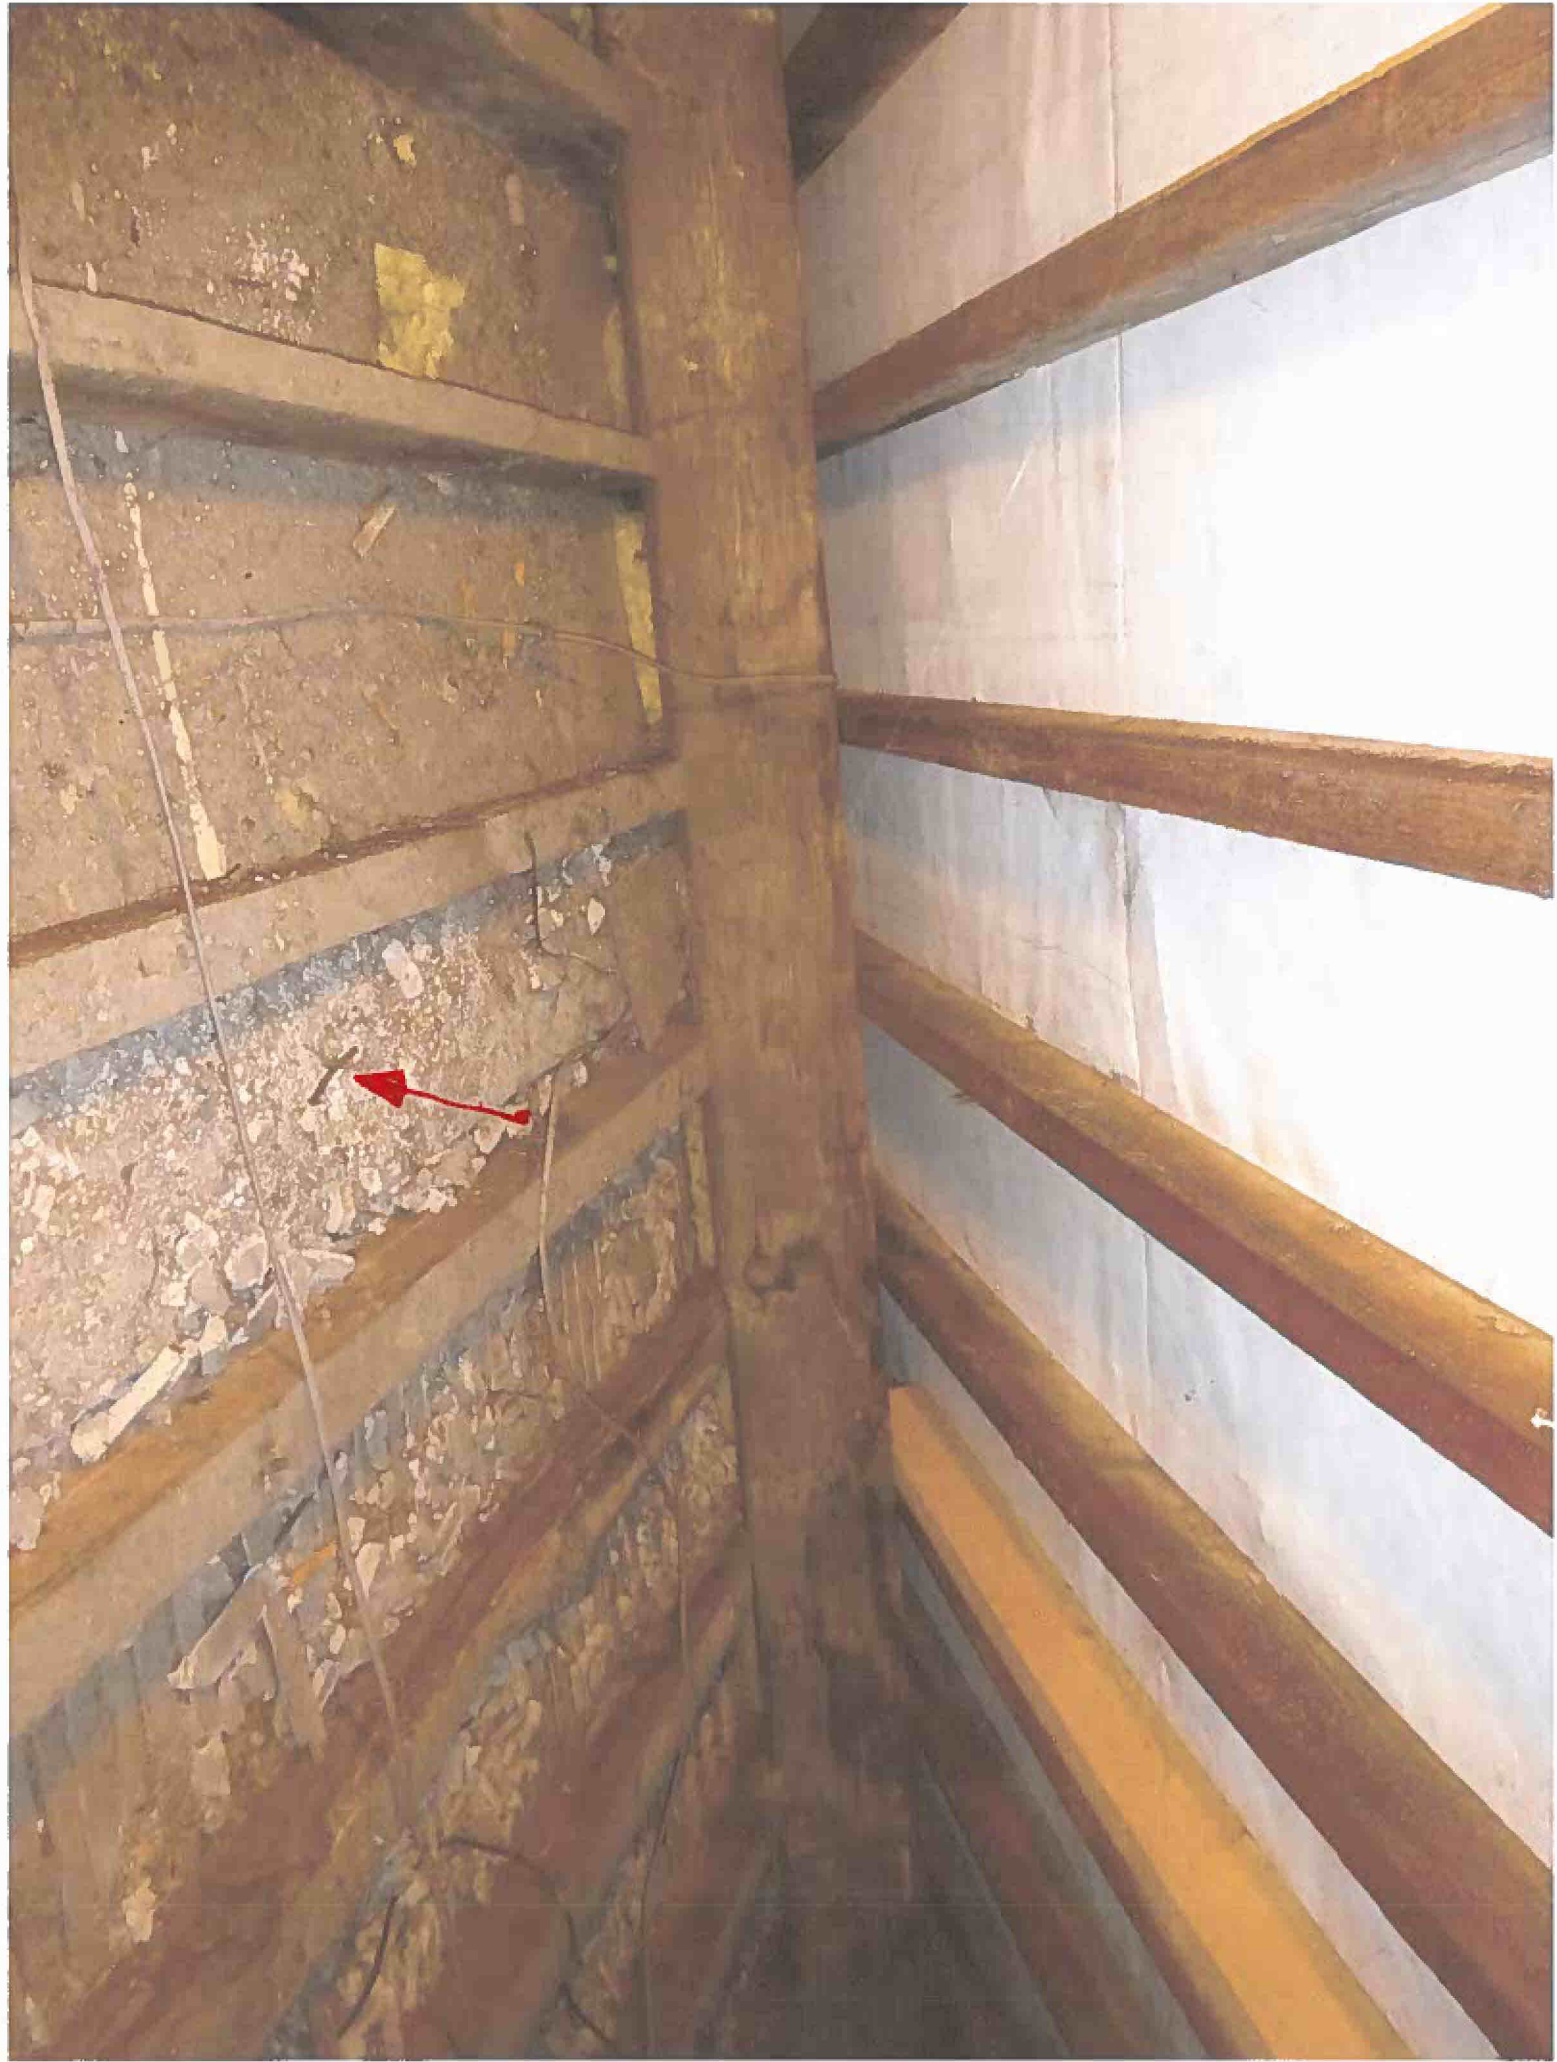
It can be seen that the span of the ceiling joists are parallel to the top of the masonry partition wall in Fig 3. This means that the load from the lath and plaster ceiling is not bearing on this wall and no replacement support beam will be required as the load paths are not changing.

The fragility of the lath and plaster ceiling requires care when removing the masonry between the two ceiling joists at ceiling level and thought needs to be given to the making good of this strip of ceiling. Fig 3.

FIG 3. LOCATION OF WALL TO BE REMOVED, NEW ROOF FELT

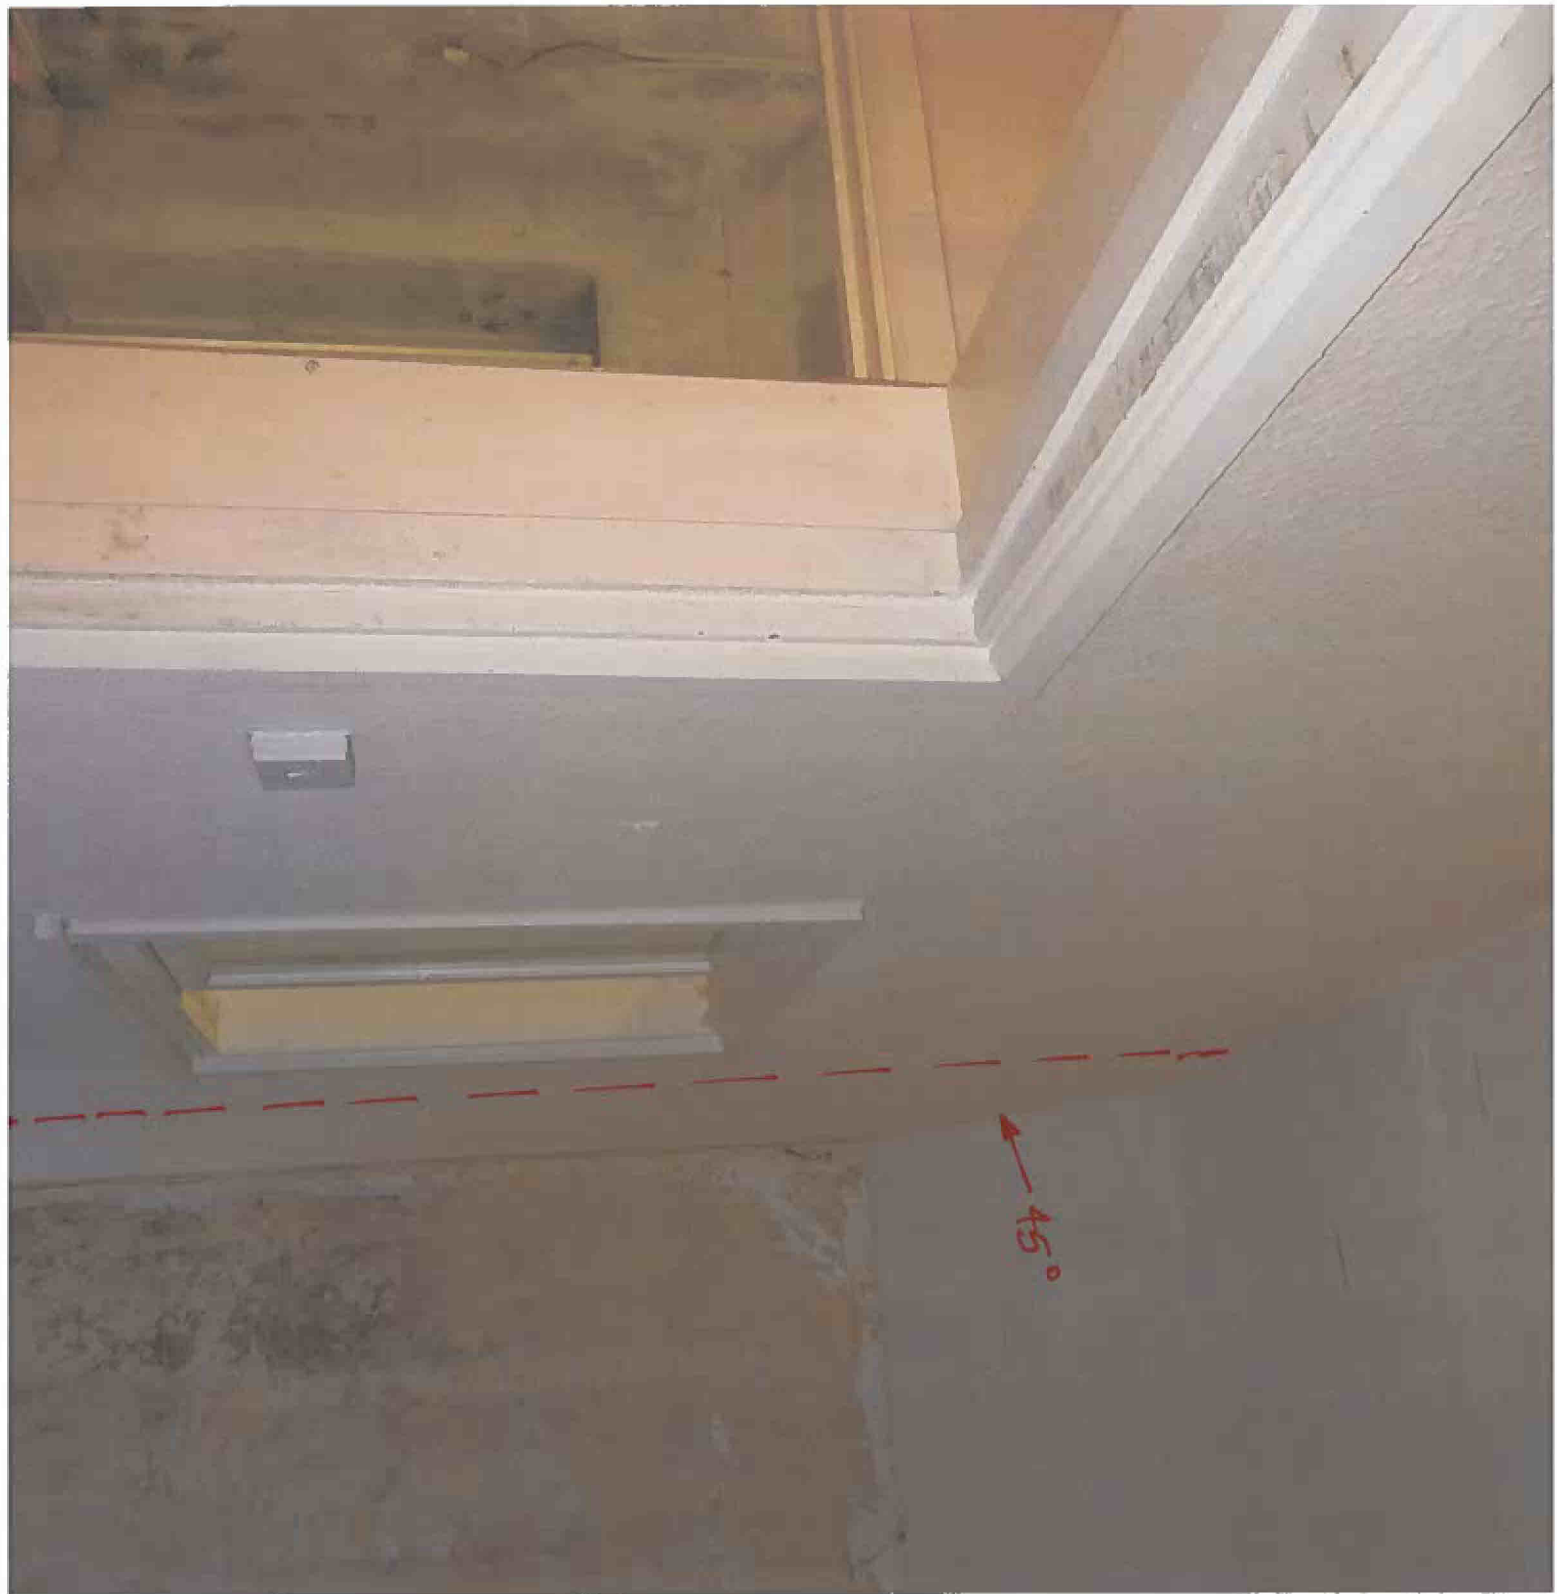
FIG. 4. DOOR OPENING AND HATCH TO WALL, CHANGE OF CEILING

I also noted that the rafter trimming the loft hatch had not been replaced but had both rot and wood worm locally so this timber should also be replaced. This provides an opportunity to enlarge the loft hatch access to provide better access to the space above.

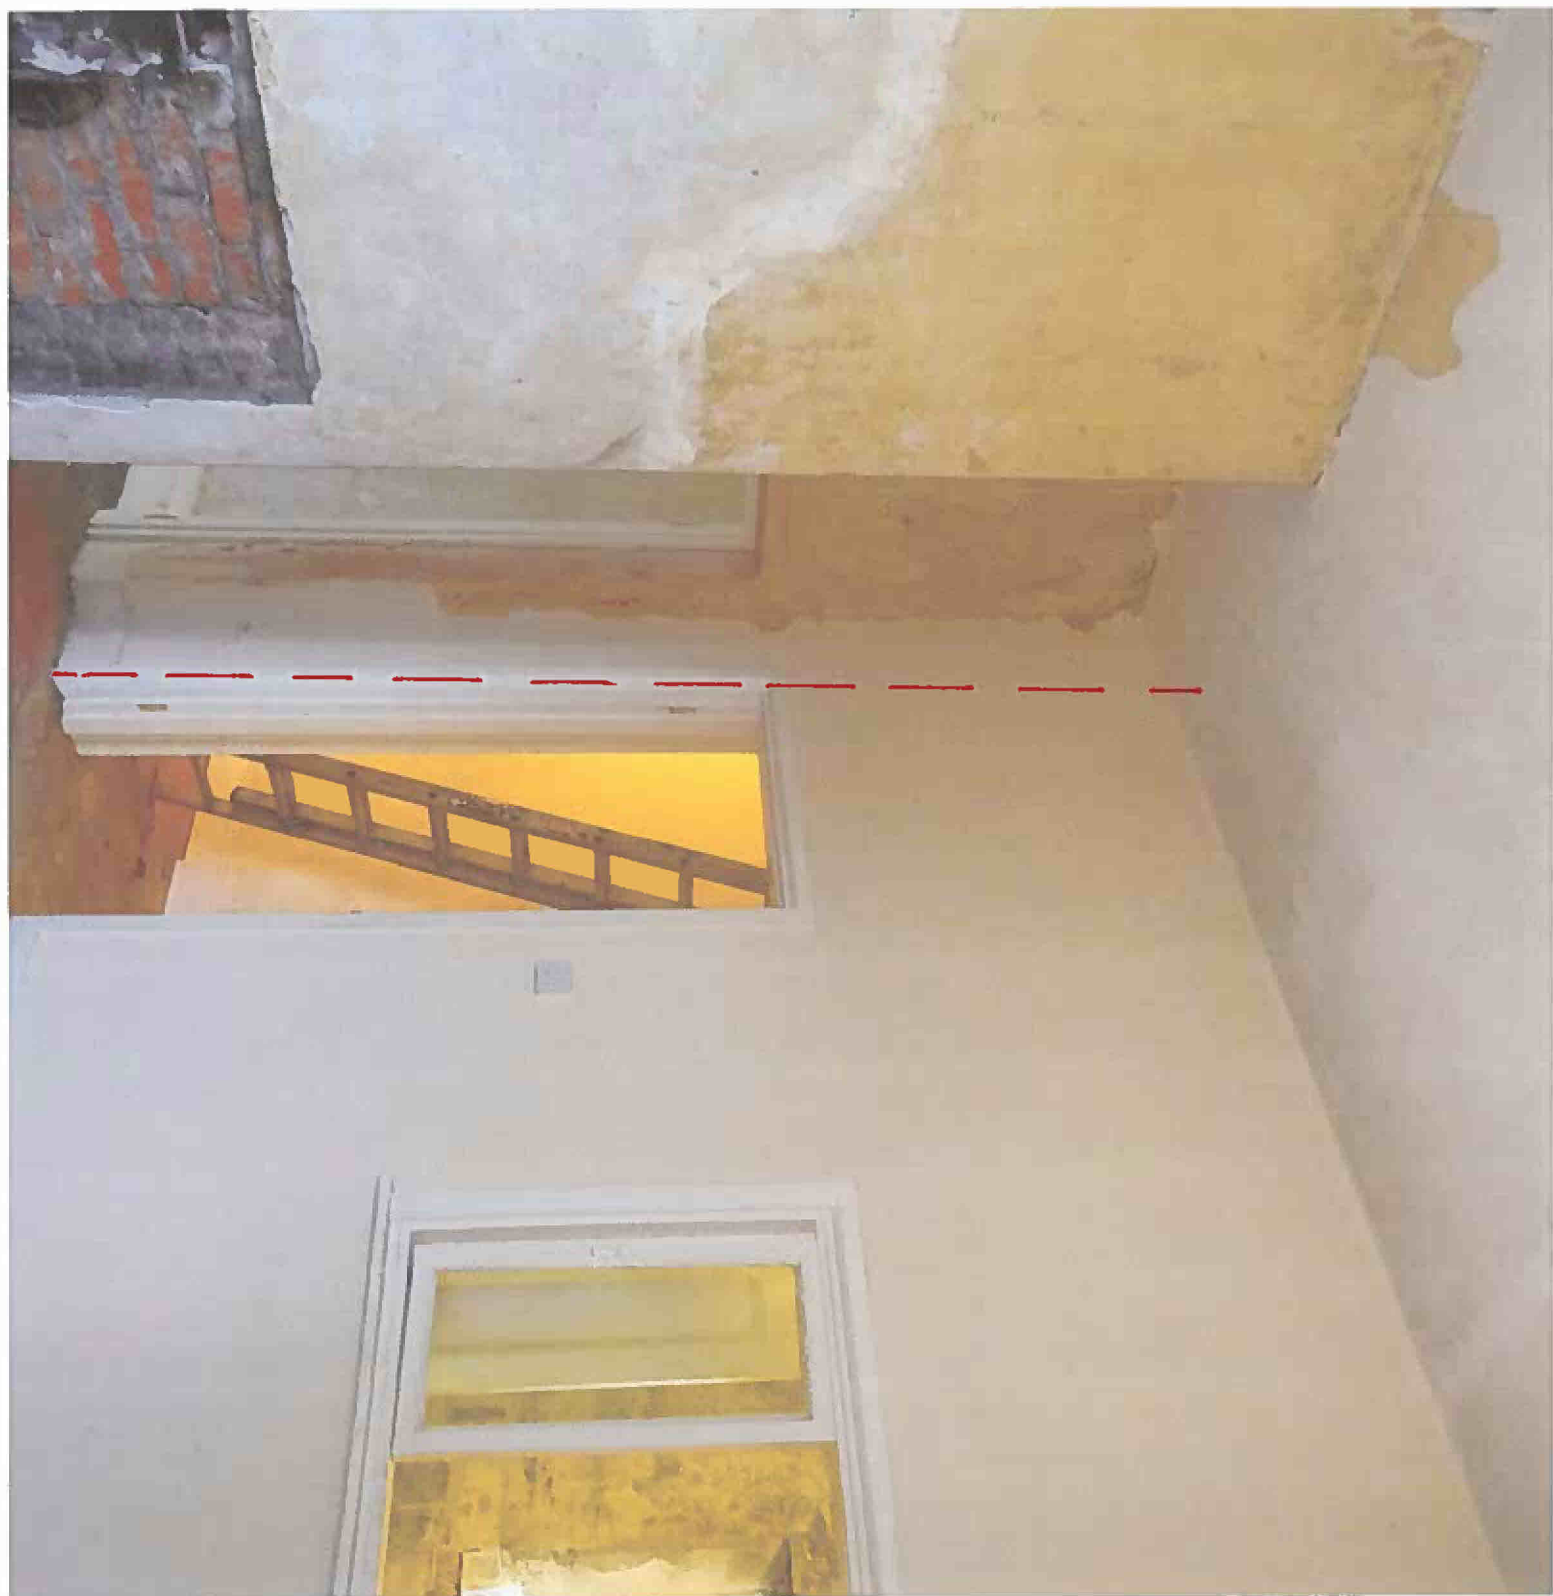
FIG 5. DOOR OPENING AND HATCH IN WALL TO BE REMOVED
