J&M MURDOCH, SHILLFORD

Phase 1 Desk Study & Coal Mining Risk Assessment

Reference: **61045-001**

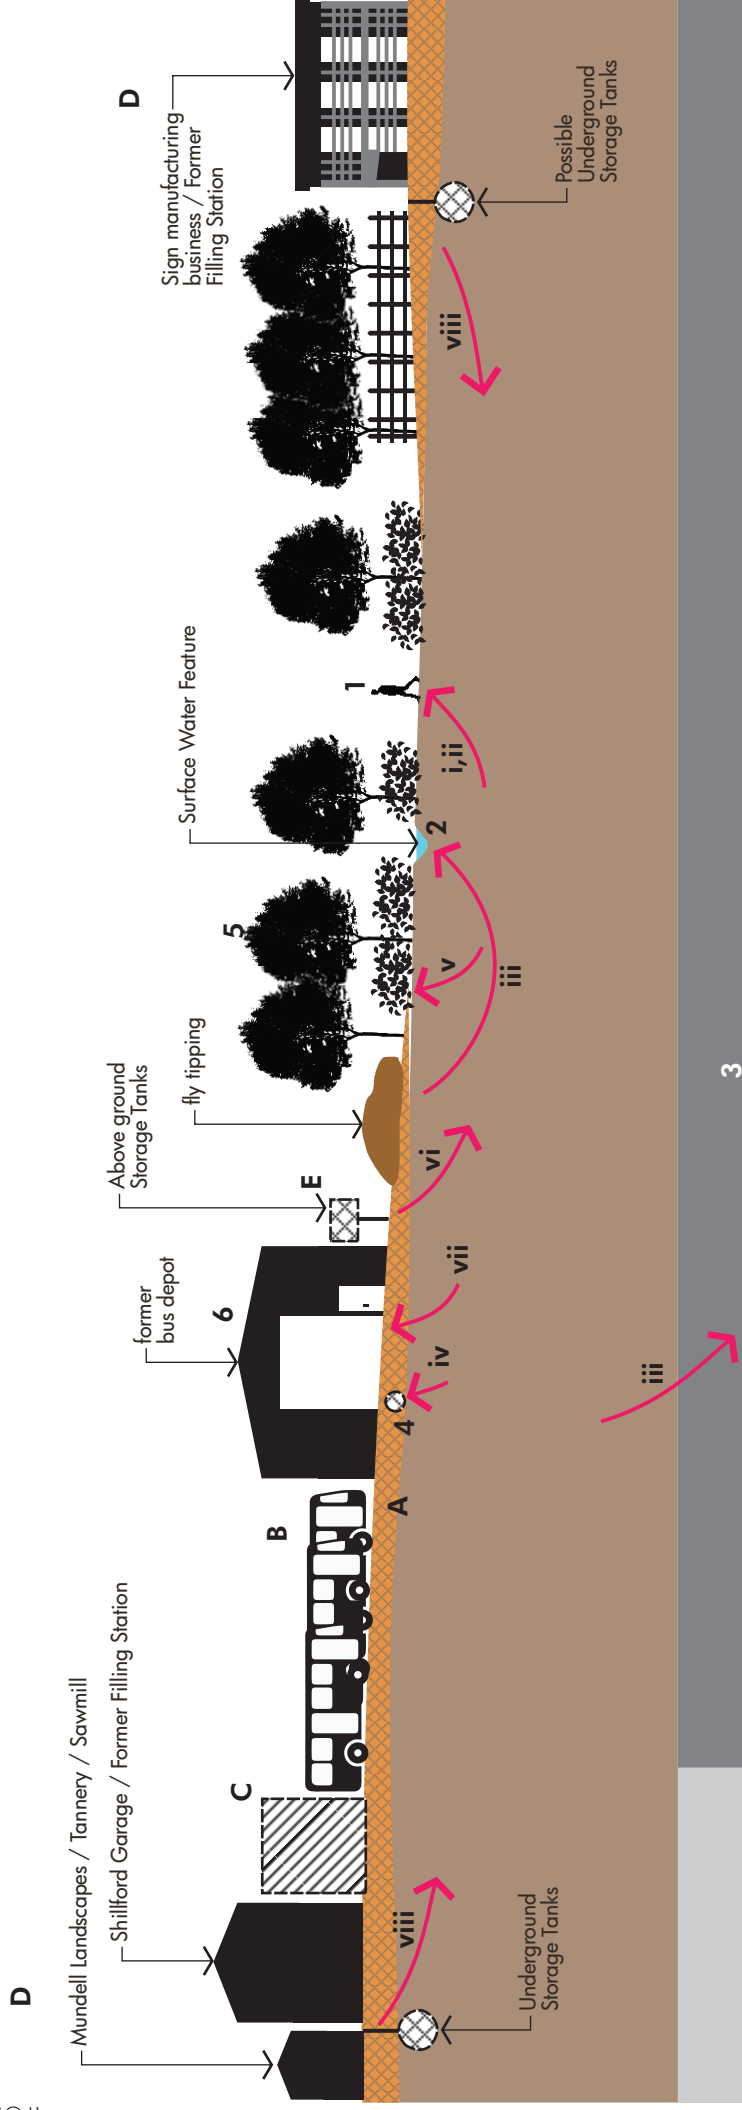
FIGURE 5 INITIAL CONCEPTUAL SITE MODEL

Potential Made Ground
Superficial Soils: Noncalcareous mineral gleys with drift derived from basic igneous rocks and alluvium (possibly limited in thickness)
Bedrock: Neilston Lava Member of the Clyde Plateau Volcanic Formation
Bedrock: Upper Limestone Formation

Potential Sources of Contamination:
A - Potential made ground
B - Former Bus Depot
C - Former Mill
D - Off-site Sources (filling stations, tannery, sawmill, garage)
E - Former above and below ground storage tanks

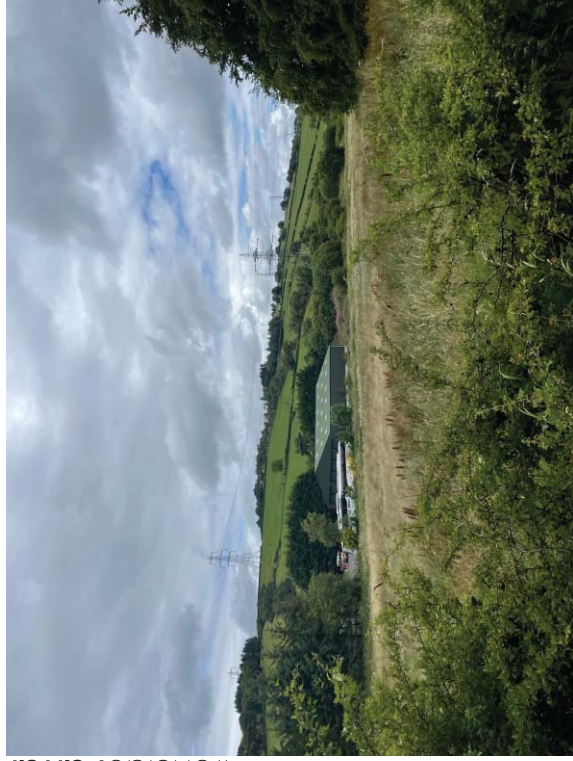
Plate 1: (looking northeast) Unmanaged grassland in majority of site with coach bus depot located in NW of site.

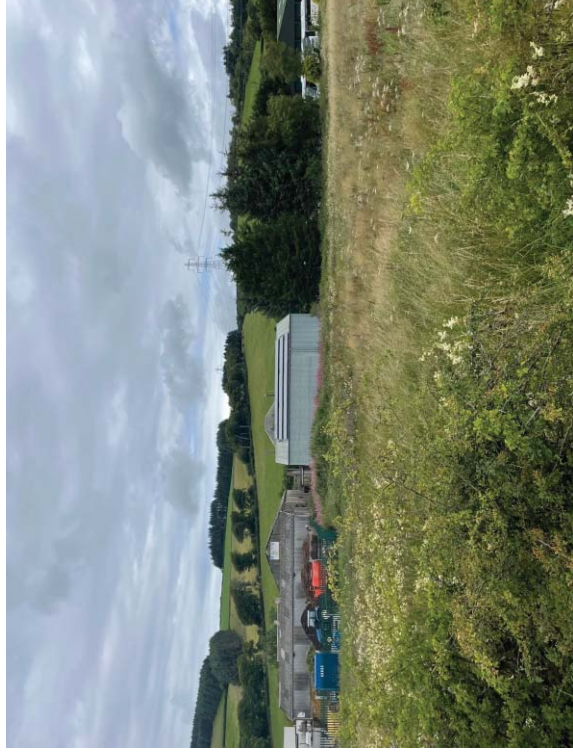
Plate 2: (looking north) Southwestern section of site, located south of adjacent commercial structures.

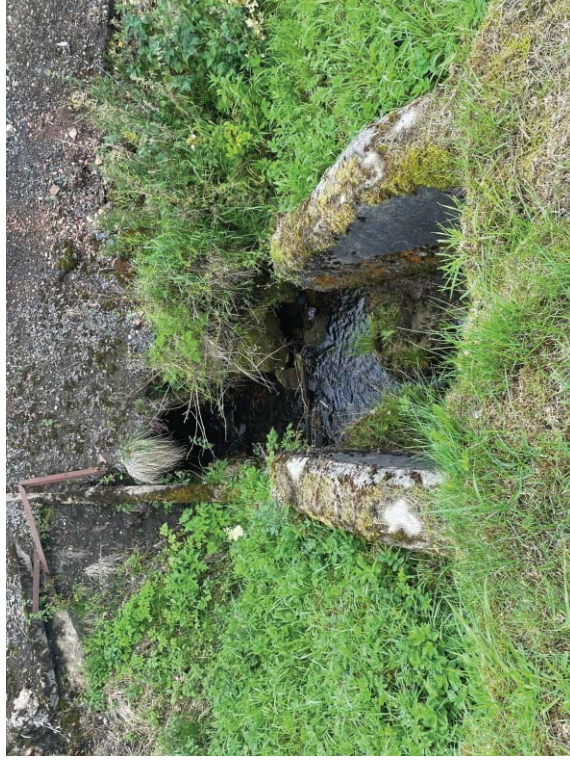
Plate 3: (looking east) Minor water feature entering site from western border, flowing W-E across entire site.

A minor water feature is noted entering the site from the western boundary flowing west-east. While water in the main channel is fast flowing and appears of good quality, drainage features entering the main channel coming from north to south and south to north are stagnant and full of overgrown and dead vegetation. While it is understood that this water feature crosses the entirety of the site, restricted access to the centre of the site meant that full visualisation of the water feature was not possible.

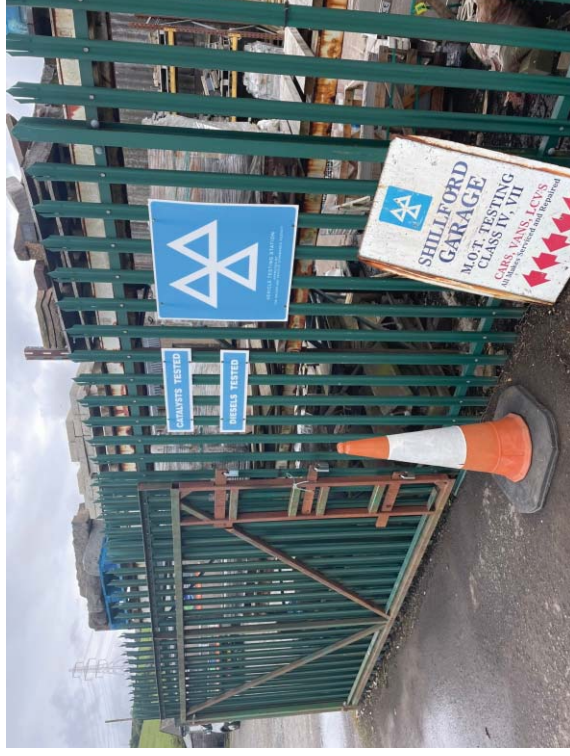
Plate 4: (looking northeast) Shillford Garage immediately adjacent to site's western boundary.

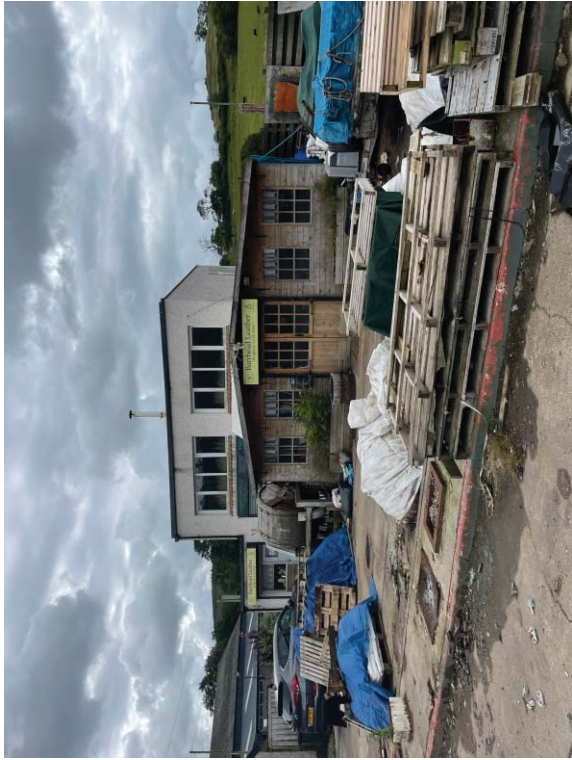
Plate 5: (looking south) Remnants of old filling station located immediately west of site suggesting the presence of underground tanks/pumps.

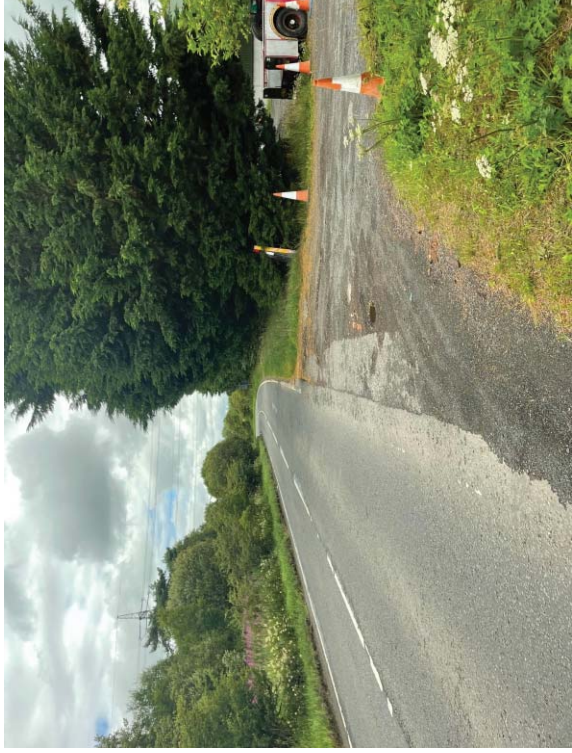
Plate 6: (looking east) Vehicle access point onto site from Lochlibo Road to the north.

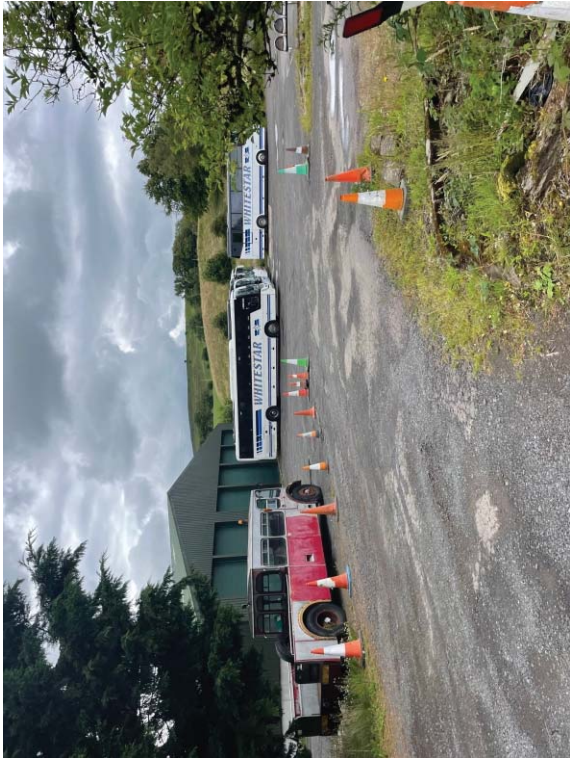
Plate 7: (looking southeast) Hardstanding in northwest of site with coaches and couch bus depot/garage.

The northwestern section of land contains three main buildings and one derelict structure, namely a coach depot, an office associated with the coach depot, and the Shillford Mill house. There is also a garage that extends from the western border of the site, likely associated with the offsite Mundell Landscapes facility. This building was noted to have suspected asbestos corrugated roofing, although this appeared to be in good condition.

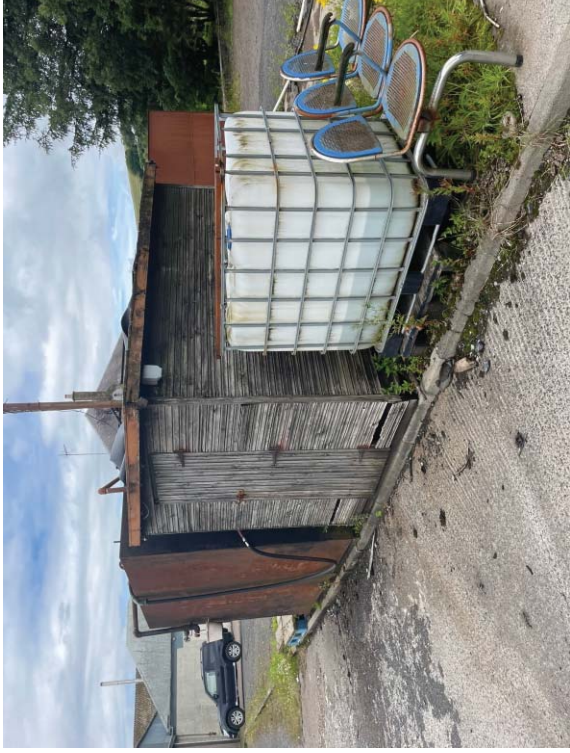
Plate 8: Onsite filling station and tank with pump and underground access.

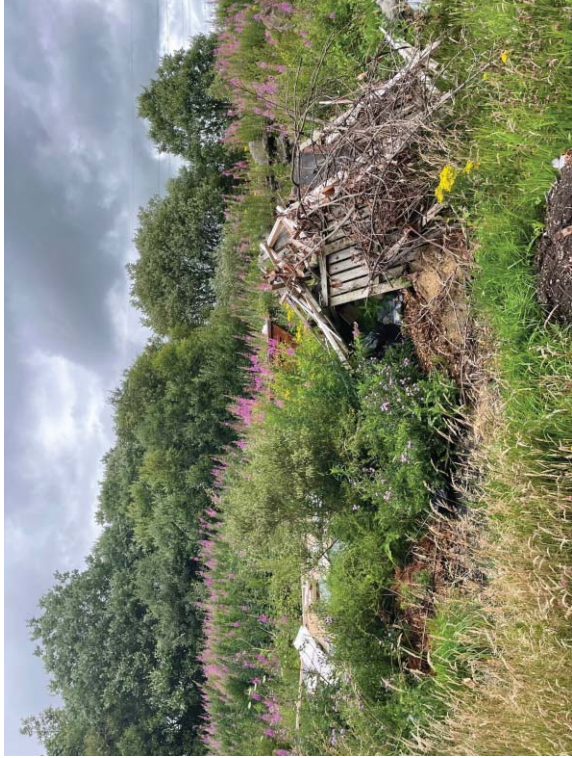
Plate 9: (looking southeast) Fly tipping located east of onsite bus depot/garage and along northern site boundary.

Areas of fly tipping were observed to the east of the coach depot structure, comprised of wooden pallets, old fencing, tyres, gravel and asphalt material and general waste. Small areas of fly tipping were also noted along the northern site boundary.

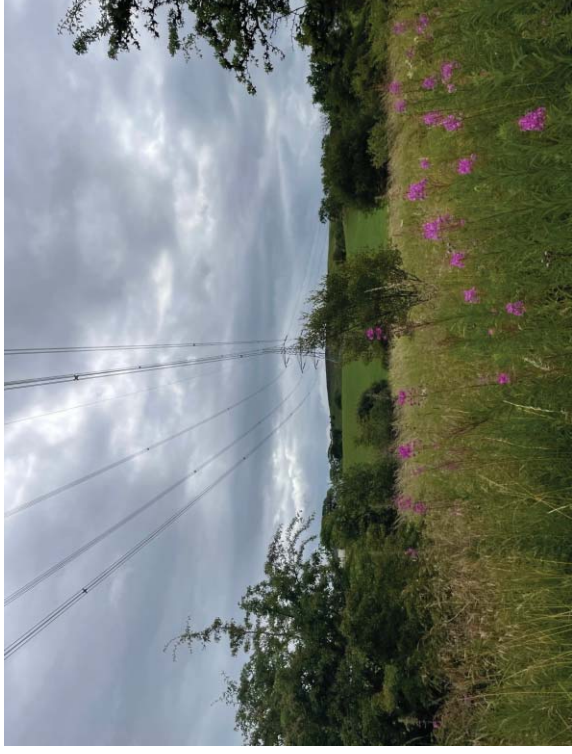
Plate 10: (looking south) Overhead lines crossing eastern section of site.

In the eastern portion of the site there are overhead electricity lines that cross the site north-south, and two manhole covers are noted along the northern border of the site.

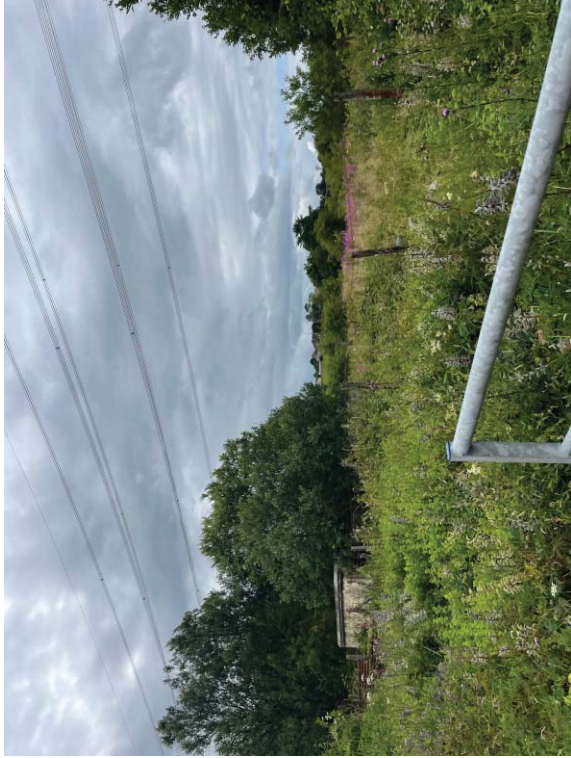
Plate 11: (looking southwest) Small fenced section along eastern border of site with material stockpiles and rubbish from adjacent offsite sign manufacturing company.

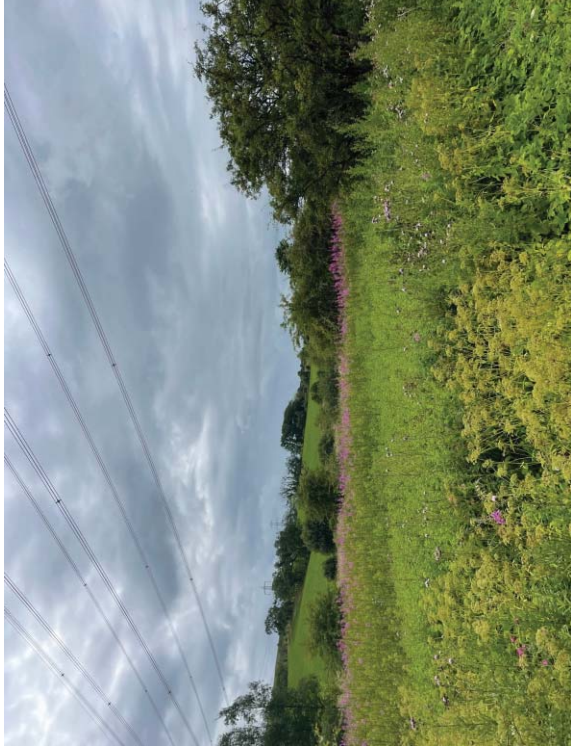
Plate 12: (looking southwest) Overgrown vegetation across majority of site.
