Preliminary Bat & Bird Assessment

Great Treburrick Farm, St. Eval, Cornwall, PL27 7UR

23rd May 2023

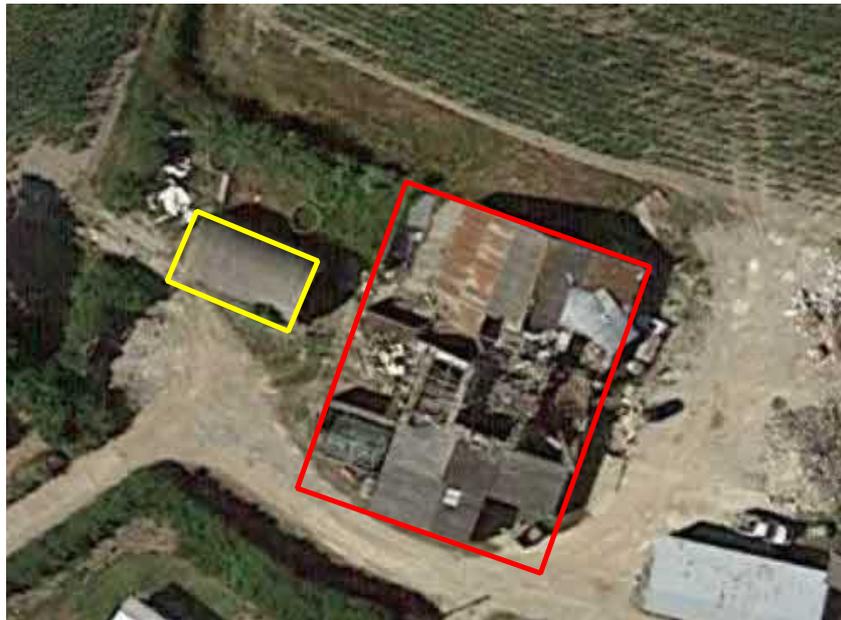
Figure 1: Aerial view of the two barns; the yellow outline is referred to as Barn 1 and the red outline refers to the total area of Barn 2 (though most of the northern section is dilapidated).

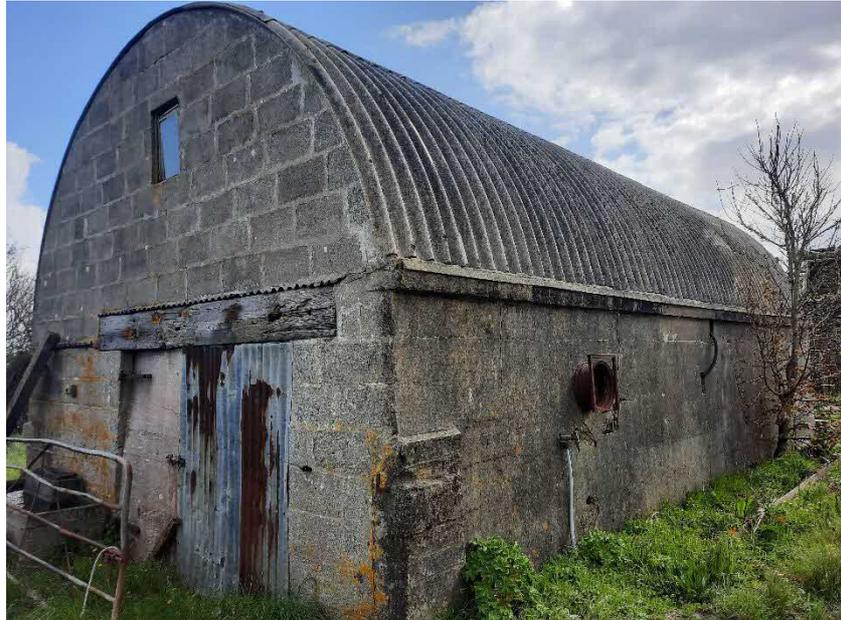
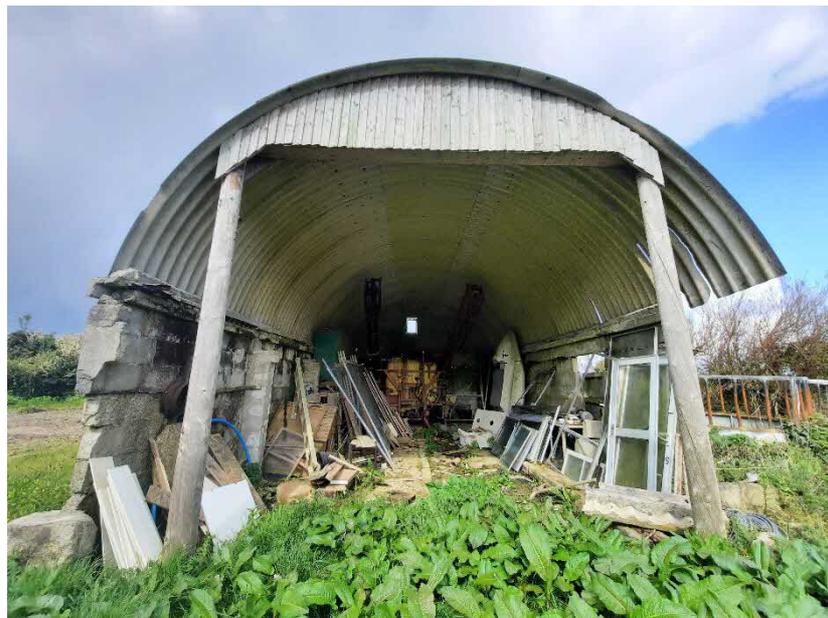
Barn 1 is a detached open fronted barn of part block and part corrugated likely asbestos sheeting (or cement fibre) construction with a curve/ domed roof of the same corrugated material supported by two timber cylindrical posts on the open eastern elevation (Figs 2-3). The exterior is exposed block with no obvious gaps observed within the blockwork. There were wooden and metal sheeting doors on the western elevation; the doors were largely blocked up. One glazed window was observed on the western elevation, the panes were largely tight but gaps were seen beneath the window-sill and blockwork. The roof sheeting appeared to be well joined to the blockwork walls, but the internal walls were wet. There were no fascia boards or guttering or downpipes present. Externally, there were very few features suitable for bat roosting locations.

Internally, the barn was used for storage and was well-lit from the open fronted nature of its design, the interior space was draughty and the walls were wet. No evidence of bats using Barn 1 for roosting was observed; furthermore, the draughty well-lit space and wet walls indicate that it is unlikely to be used for roosting by bats.

No evidence of the use of Barn 1 at Great Treburrick Farm by roosting bats was found and very few external features were observed which have potential to support roosting bats. Overall, Barn 1 at Great Treburrick Farm was assessed as being of negligible suitability for roosting bats.

Figure 2: View of the south and western elevations of Barn 1.

Figure 3: View of the open nature of the eastern elevation of Barn 1.

Barn 1 was assessed as being of 'negligible suitability' for roosting bats.

Although no current evidence of roosting bats was found, absence cannot be assumed. A precautionary approach should be adopted. The building contractors should be made aware that bats can roost unseen within the barn structure. In the unlikely event that a bat is uncovered during works, the bat must not be handled, and works must stop immediately (as soon as it is safe to do so). Advice must be sought from an experienced and licensed bat ecologist (Plan for Ecology Ltd: 01326 218839) or the Bat Conservation Trust (Tel: 0345 1300 228). In this scenario, it may be necessary to obtain a bat licence from Natural England before works are permitted to resume. See Section 1.3 for relevant legislation.

Further surveys for Barn 1 are not recommended as part of this assessment.

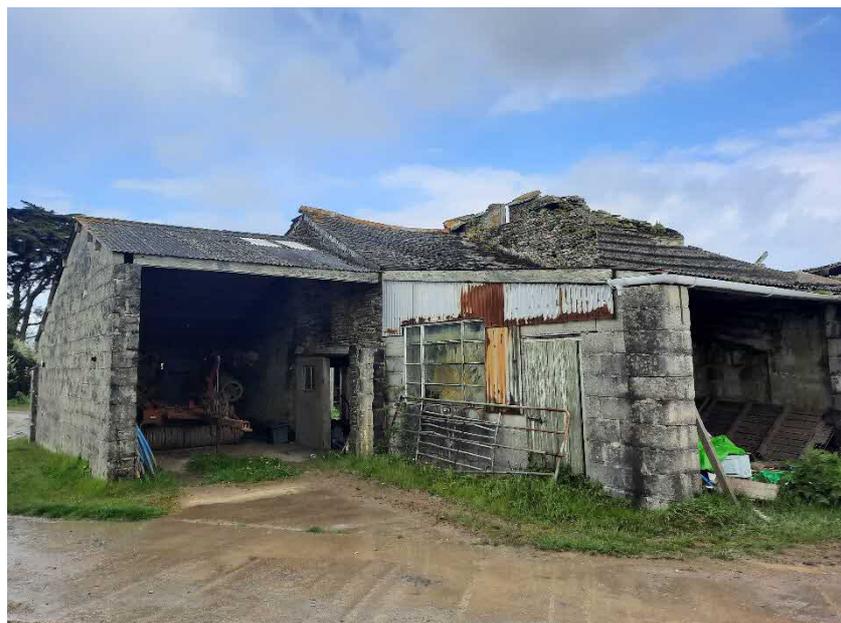
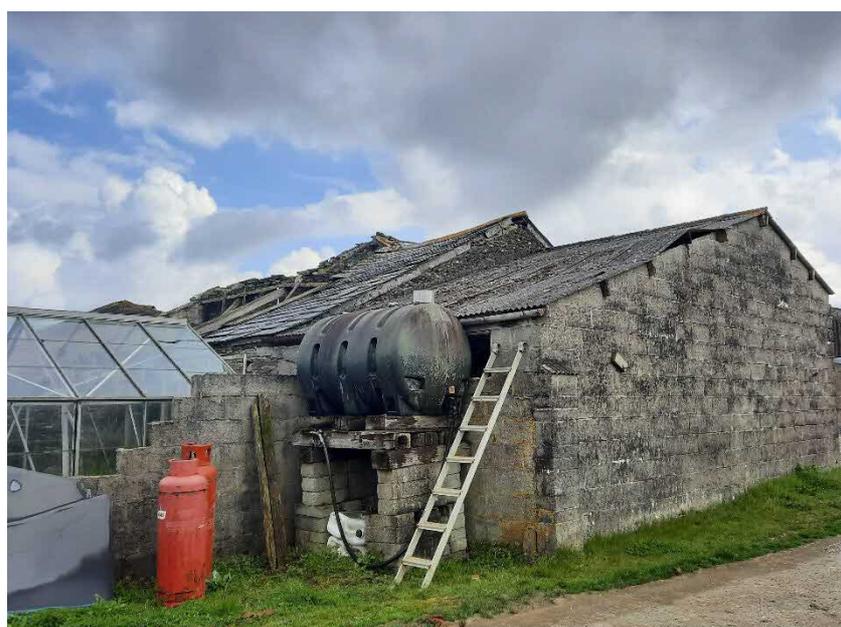
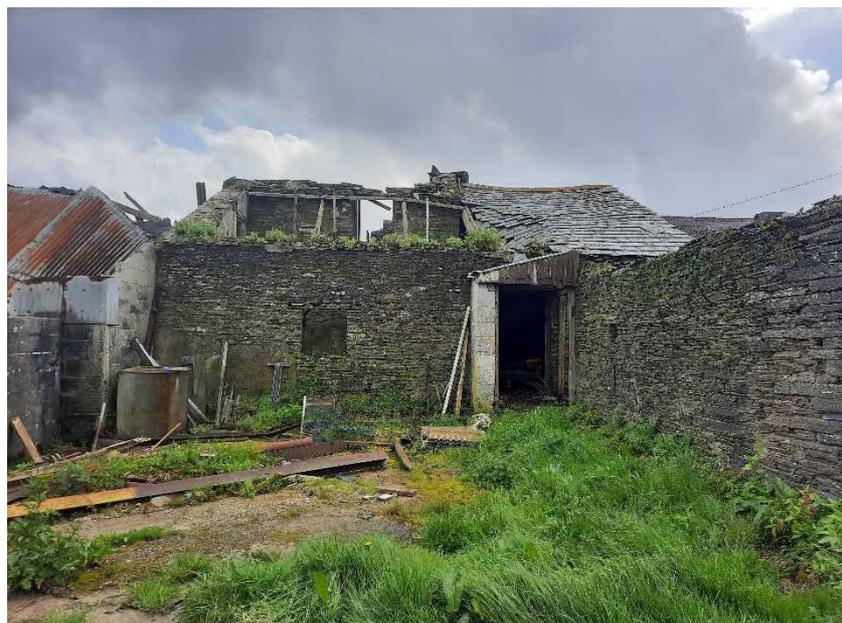
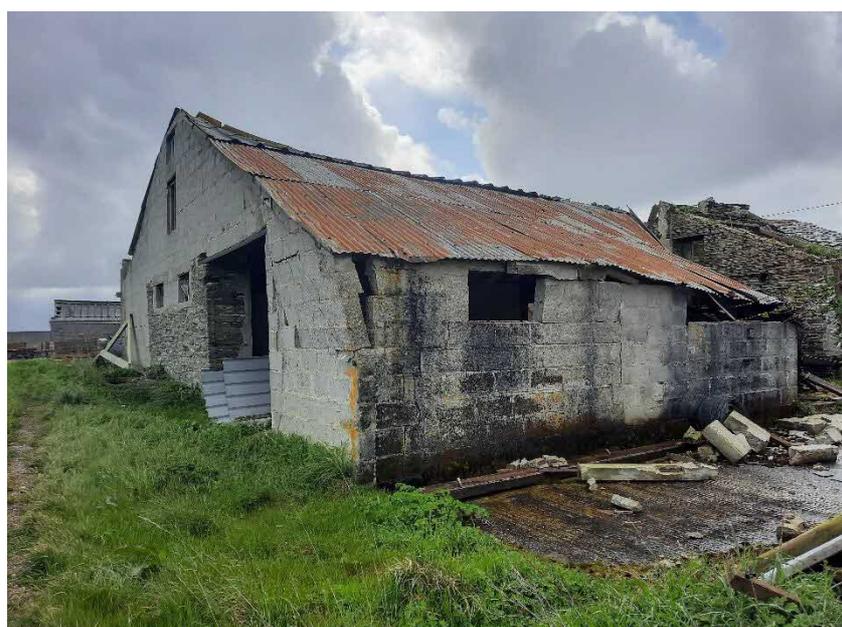
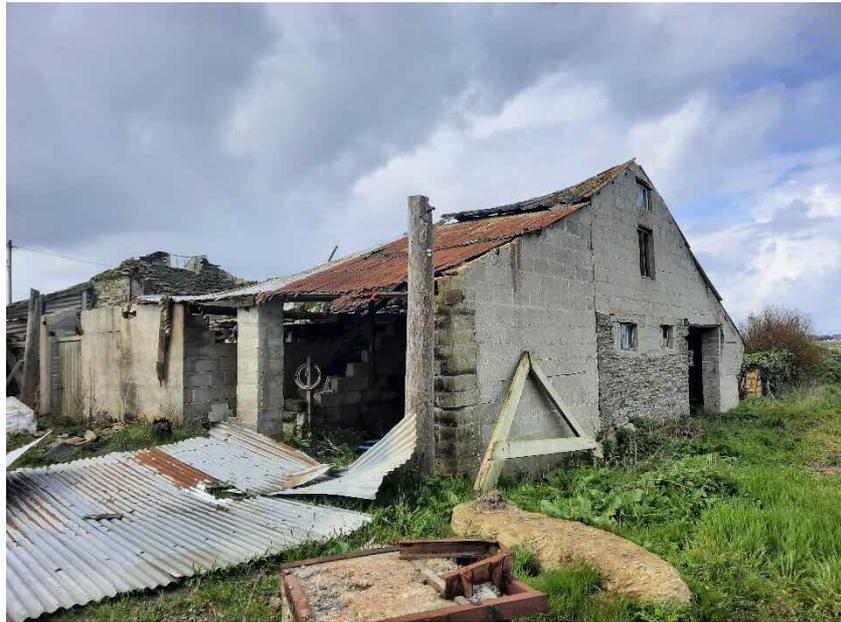
Externally Barn 2 is a detached barn comprising of multiple sections and construction types (Figs 4-8). A likely original stone building (Fig 6) was extended and is connected to block-built sections to the north and south (Figs 4-5, 7-8). The stone-built section has a slate tiled pitched roof with concrete ridge tiles. The northern part of the pitched roof is largely missing and dilapidated, but part of the roof to the south is slightly more intact (Fig 6); here slate tiles and concrete ridge tiles were observed to be lifting in places, creating small gaps beneath which have potential to support roosting bats by providing roosting locations for crevice dwelling bats. The block-built sections to the north have pitched roofs of corrugated metal sheeting (Figs 7-8); the southern block-built section (Fig 4) features a pitched roof of likely asbestos (or other cement fibre) corrugated sheeting material. All corrugated sheeting is supported by timber joists with a metal A-frame, the slate tiles are supported by a timber unlined A-frame. The exterior is exposed and largely dilapidated; on the northern gable end a large gap between the two block walls is present (Fig 7). This part of the building appeared to be structurally unstable. On all elevations, doorways and windows were unglazed and open (previously used to house livestock). The stone-built section features small gaps within the stonework and beneath flaking render (Fig 9); these areas have potential to support roosting bats by providing roosting locations for crevice dwelling bats.

Figure 4: View of the eastern and southern elevations of Barn 2.

Figure 5: View of the southern and western elevations of Barn 2.

Figure 6: View of part of the stone-built section on the western elevation of Barn 2.

Figure 7: View of part of the block-built section on the northwest elevations of Barn 2.

Figure 8: View of part of the block-built dilapidated section on the northeast elevations of Barn 2.

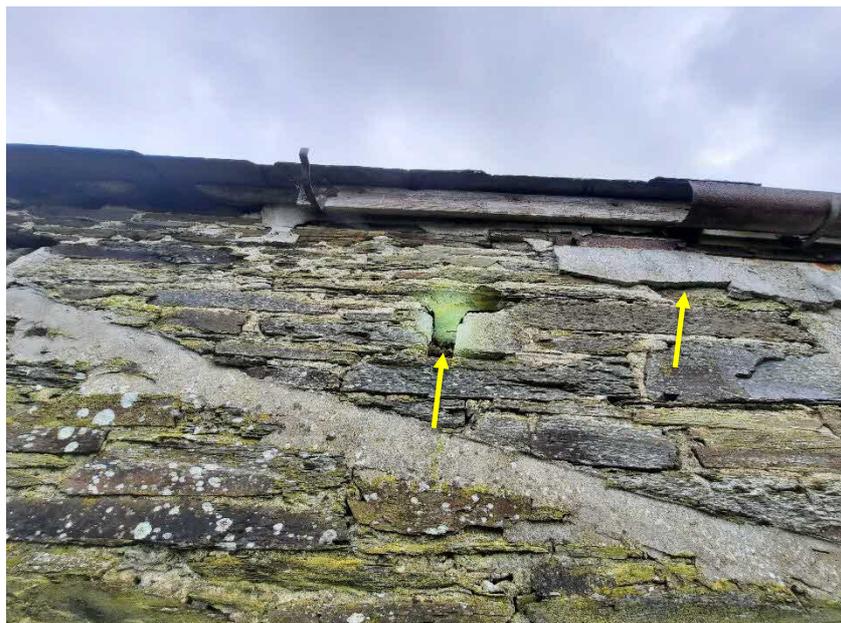
No evidence of bats using Barn 2 at Great Treburrick Farm for roosting was observed. The state of the interior lessens its suitability due to the draughty exposed nature and wet/ dampness from the dilapidated corrugated roofs. Barn 2 does, however, support a small number of external features with potential to support roosting, crevice dwelling bats (gaps beneath lifting slate roof tiles, under ridge tiles and within the stonework of the stone-built section). The rural nature of the site and surrounding landscape makes the site suitable for roosting, foraging and commuting bats. Overall, the Barn 2 at Great Treburrick Farm was, therefore, assessed as being of 'low suitability' for roosting bats.

Figure 9: View of gaps within the stonework and beneath render (shown by the yellow arrows) on the western elevation of the stone-built part of Barn 2.

No evidence of roosting bats was observed within Barn 2, although a small number of exterior features on this barn have some potential to support crevice dwelling bats. The rural nature of the site and surrounding landscape further increases the potential of the site for roosting, foraging and commuting bats.

In accordance with the Bat Surveys for Professional Ecologists: Good Practice Guidelines (Collins, 2016), Barn 2 at Great Treburrick Farm was assessed as being of 'low suitability' for roosting bats, due to the absence of direct evidence of bats, and the presence of only a small number of potential bat roosting locations. A single further survey of Barn 2 is, therefore, required to determine the importance of the barn for bats.

One bat emergence or re-entry survey is required of Barn 2 at Great Treburrick Farm between May and August, to inform the planning application and subsequent building works (Collins, 2016). If a bat is observed to emerge from the barn during this survey, then at least one additional emergence/ re-entry survey (between May and Sept) will be required to inform the planning application. This survey will determine the species, number of individuals, bat access points and timings of usage.

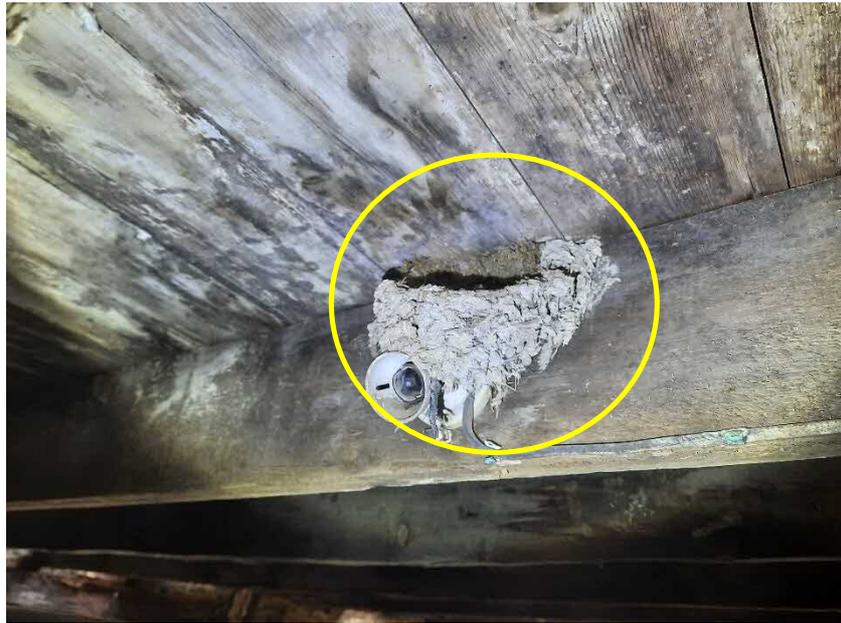
Multiple old barn swallow (*Hirundo rustica*) nests were observed within each barn, both on and under timber joists (Fig 13). Within Barn 2, smaller nests likely created by blackbird (*Turdus merula*) and repurposed by a tit species (*Parus* sp.), were observed at the wall top under timber paneling (Fig 14).

Figure 13: View of an old barn swallow nest (yellow circle) under the timber joists within Barn 2.

Evidence of old barn swallow nests were observed within both barns and a blackbird nest (repurposed by a tit species) was observed within Barn 2. Alternative provision for nesting swallows should be made within the replacement building within the site. Suitable products include three No. 10 Schwegler Swallow Nest. The alternative barn swallow nest boxes must be situated within an alternative outbuilding, garage or partially covered area, such as a porch, with suitable permanent access via e.g. an open door or window. Suitable products are available at <https://www.nhbs.com>, and <https://www.wildcare.co.uk/>.

A precautionary approach should be adopted during works. Works to the barn should be avoided during the bird nesting season (March to September inclusive) or preceded with a thorough search for nests, to be undertaken by an ecologist. If, during works, an active bird nest is uncovered, works must stop immediately (as soon as it is safe to do so) and delayed until nesting activity has ceased. Works are most likely to be delayed between April and July.

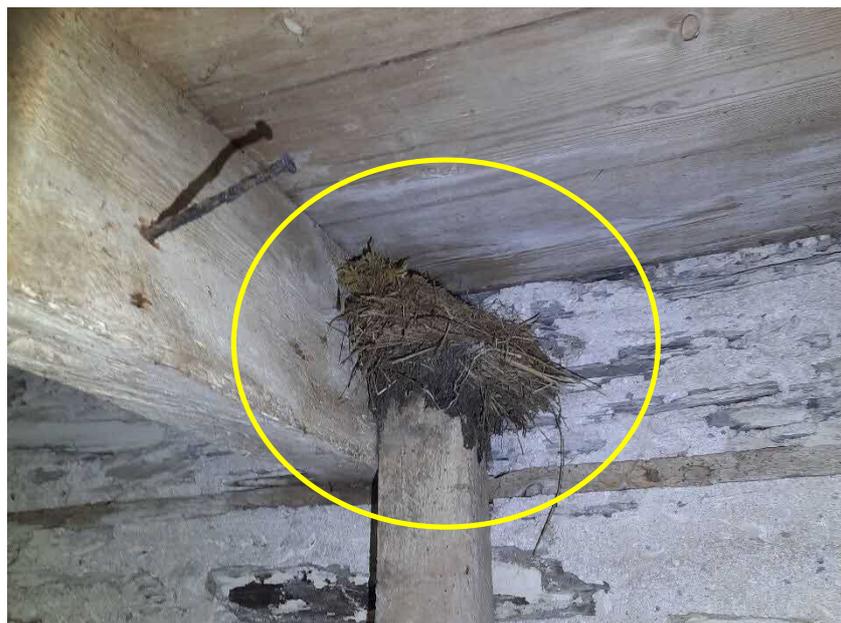
Figure 14: View of an old likely blackbird nest that has been repurposed by a tit species (yellow circle); located under the timber joists at the wall top within Barn 2.
