**BS5837:2012 TREE SURVEY AND  
ARBORICULTURAL IMPACT ASSESSMENT:  
65 Crescent Road, Barnet, EN4 9RD**

Dated: 24<sup>th</sup> November 2023

Our reference: GHA/DS/162350:23

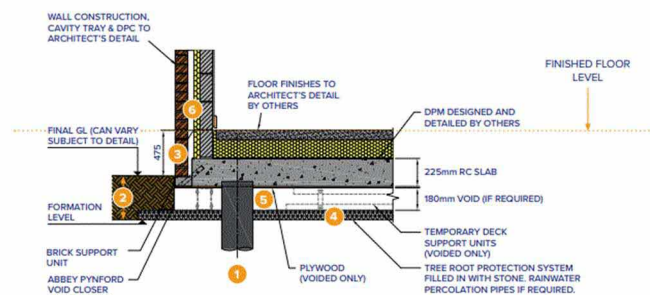
*Below: Treesafe footing details*

Treesafe is a version of our Housedeck ground floor solution. The system allows construction of dwellings or commercial structures close to or within tree root protection zones.

Treesafe utilises an open core working surface to support our lightweight piling rigs, minimising excavation that could potentially cause permanent damage to tree roots.

- 1 Allows construction of buildings within tree root protection zones.
- 2 Significant reduction in excavation.
- 3 Significant reduction in under build.
- 4 Open core deck system in place of piling mat.
- 5 Clear void to mitigate heave risk.
- 6 No venting required.

- 6.6 There is an encroachment into the RPA of G1 from the new structure as shown on the appended plan; thus, the use of traditional strip foundations will not be acceptable as this would cause harm to these trees.
- 6.7 The use of systems employing mini piles in conjunction with ground beams will instead be adopted and is now widely accepted. The Abbey Pynford 'Treesafe' system is one such system, which has a proven track record in delivering 'root friendly' foundations and has been successfully used on a number of similar projects.

- 6.8 Localised piles will be positioned (following trial digs) to ensure that any significant roots (over 25mm) that are present in the area where the new building will sit can be retained and protected to coexist with the new structure.

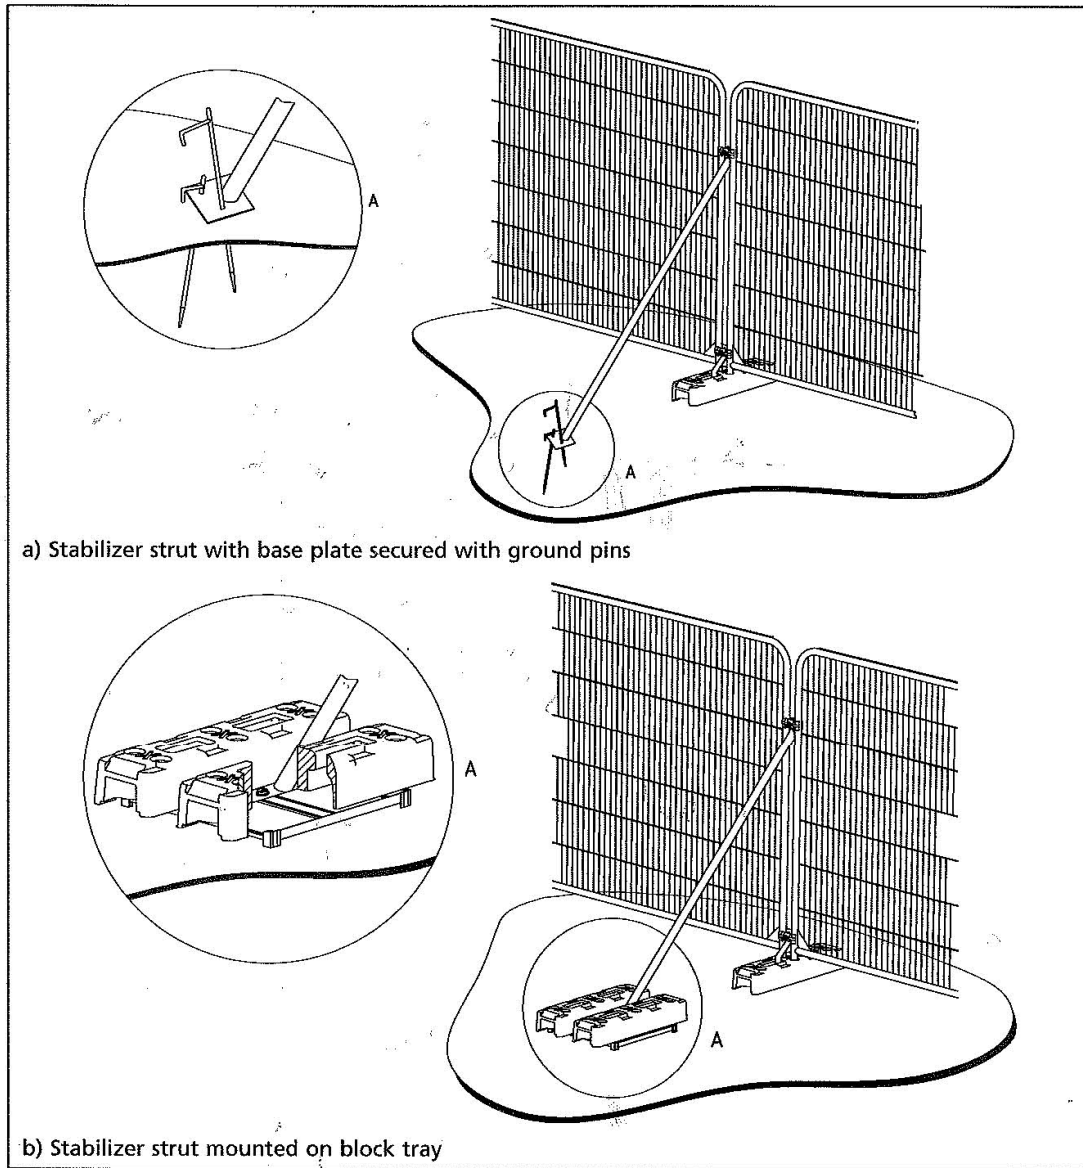
Figure 3 Examples of above-ground stabilizing systems

Appendix C  
TREE FENCING DETAIL

It is essential for the future health of the trees to be retained on site, that all development activity is undertaken outside the root protection zone of these trees. The position of the fence **MUST** be marked out with biodegradable marker paint on site and agreed with appropriate representatives from the LPA and contractor. The fencing **MUST** be erected **prior** to any works in the vicinity of the trees and removed only when all development activity is complete. The protective fencing **MUST** be as that shown in BS 5837 (see Appendix C). The herras panels

**MUST** be joined together using a minimum of two anti-tamper couplers which **MUST** be installed so they can only be removed from the inside of the fence. The panels **MUST** supported by stabilizer struts, which **MUST** be installed on the inside and secured to the ground using pins or appropriate weights.
