Heritage Impact Assessment

Longwood
Church Field,
Walberswick,
Cart Lodge Applicatio

On behalf of
Mr Peter Watson

March 2024

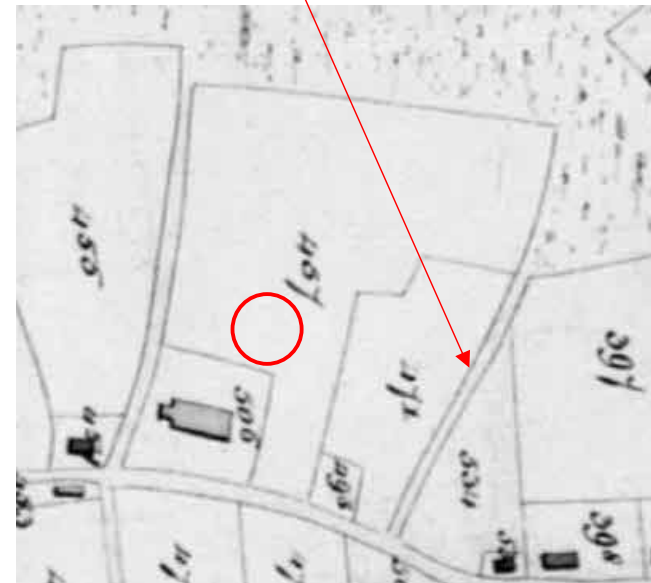
Figure 2 Tithe map 1841, The Genealogist www.thegenealogist.co.uk/

The 1841 Tithe map shows a smattering of houses located along The Street. The church can be seen, as can the common (located north of the church). Palmers Lane can be seen at this time.

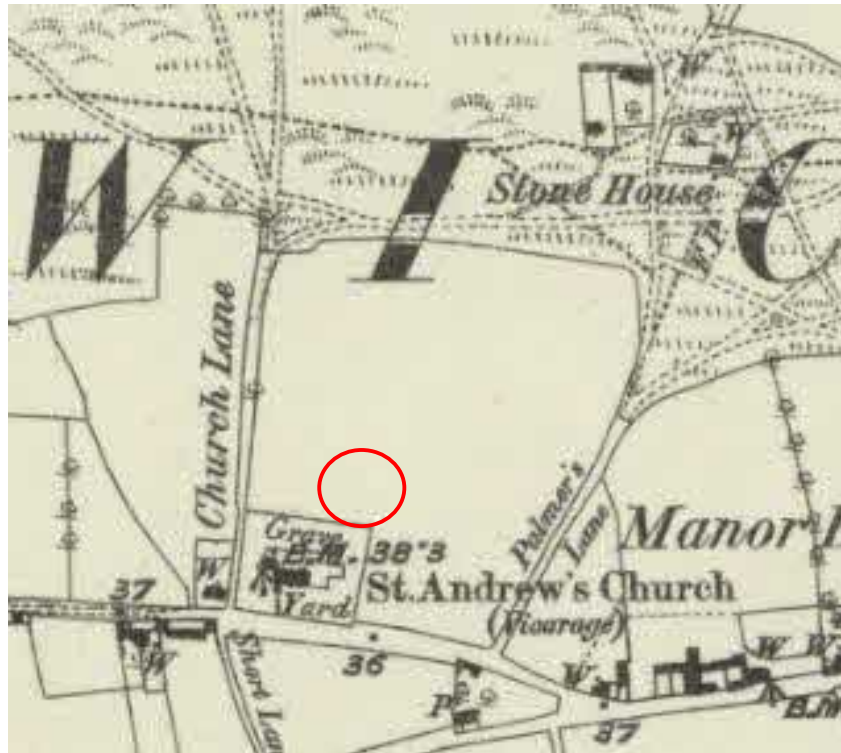
Figure 3 1884 OS map, 6 inch, National Library of Scotland

The amount of development during this period is limited. The 1884 OS map shows several buildings along the main road. Development continued along the main road up towards the harbour.

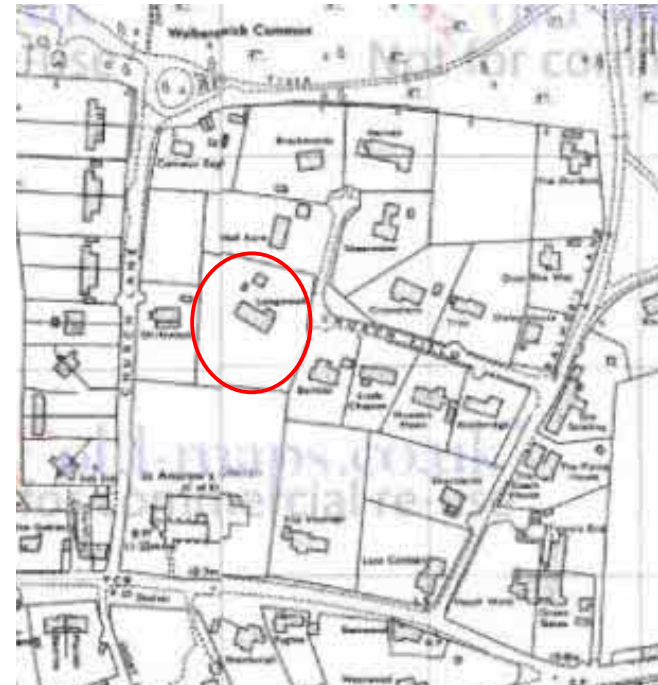
Figure 8 1976 OS map, from previous application's heritage report, website used is no longer available

The 1976 OS map, copied from another report, is no longer available. However, it does demonstrate the amount of development allowed north of the church and the Conservation Area. This separated the Church from the Common setting.

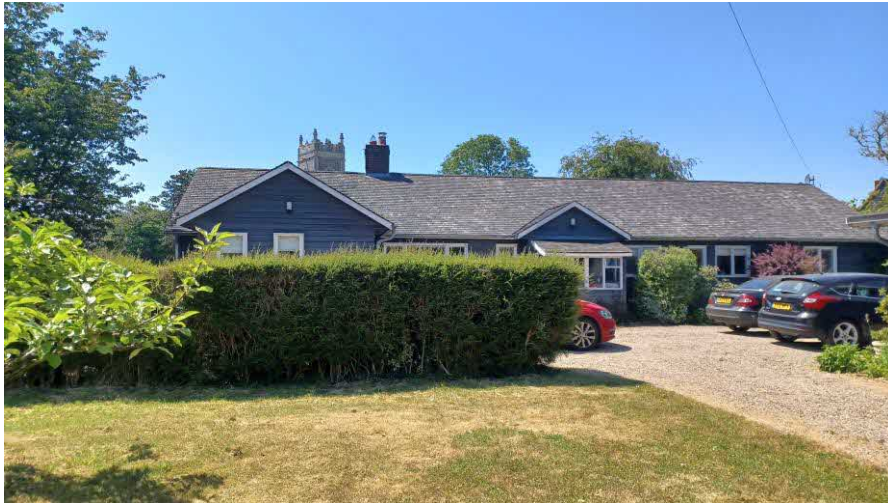
Figure 9 Front elevation, north side, church can be glimpsed in the background

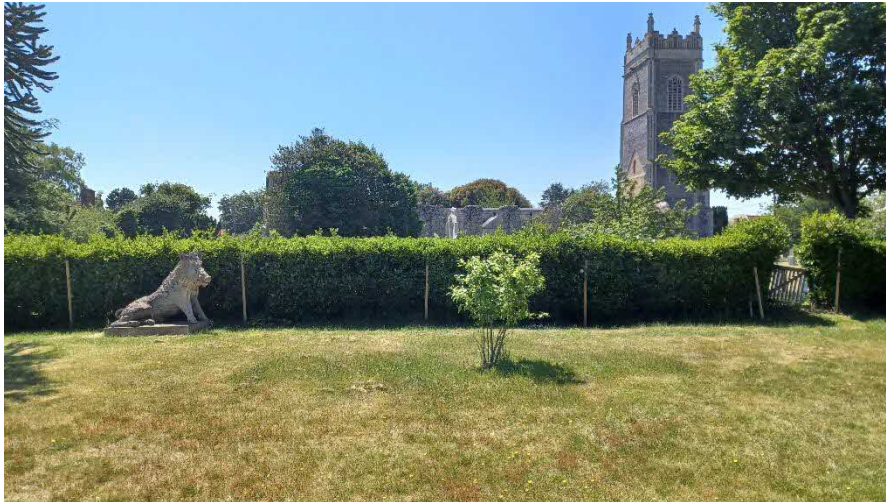
Figure 17 View from inside garden looking towards church, note substantial hedge and fencing in between

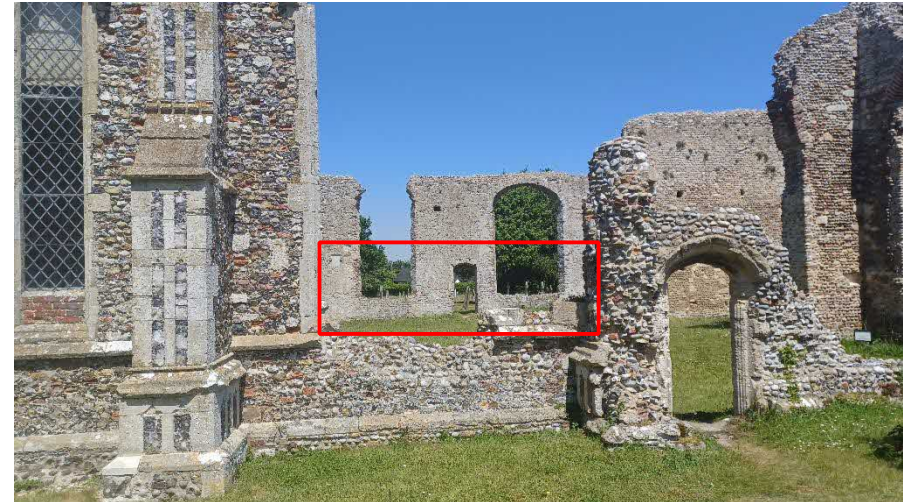
Figure 19 View from in front of ruin/church looking towards Longwood, there is the potential to see Longwoods briefly, but not the proposed cart lodge

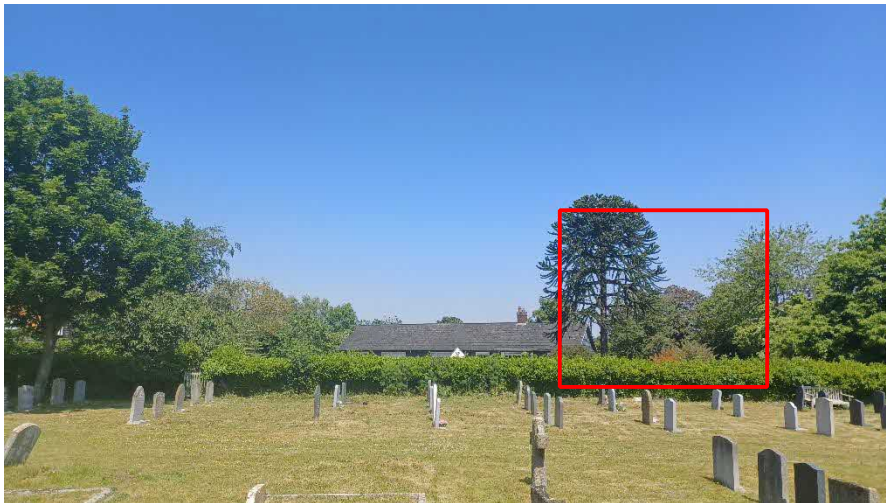
Figure 18 View from within churchyard looking toward Longwood, the roof of can be seen, proposed location of the cart lodge is highlighted

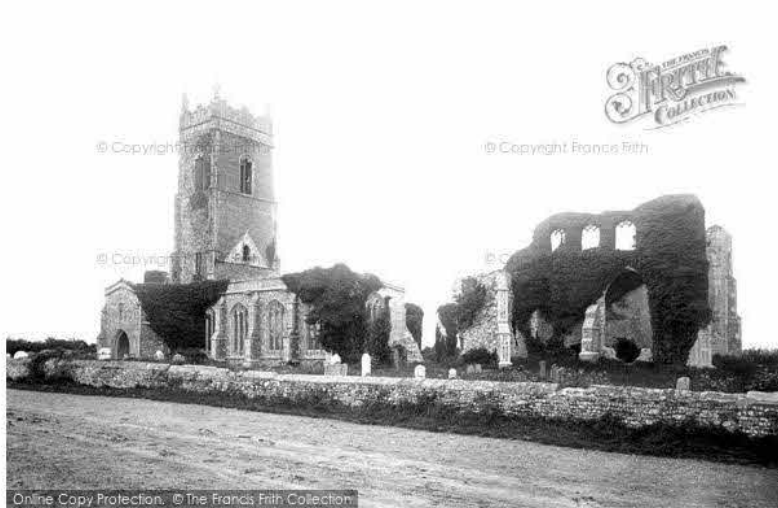
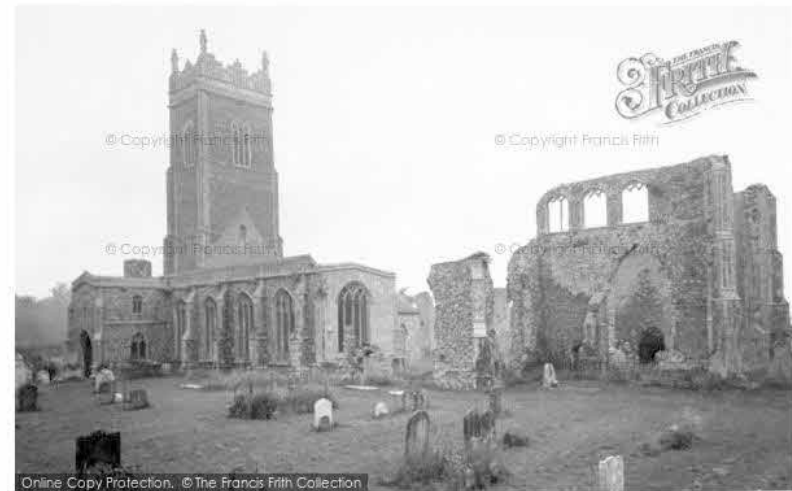
Figures 27 and 28 Images of church and ruins, Francis Frith website

The Francis Frith image from 1891 shows the ruins engulfed by vegetation. The image 1965 showing the building as it stands today, with the ruins actively managed and protected.

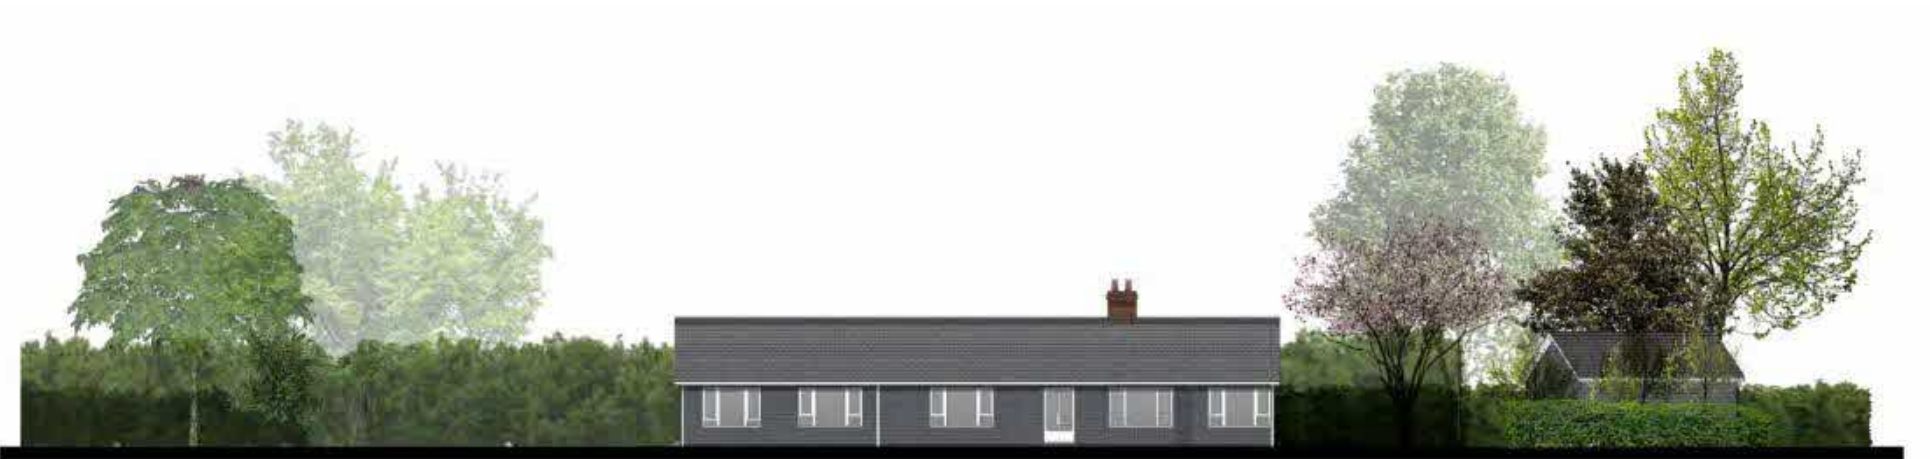
Figure 33 Proposed south west elevation

The proposed cart lodge is to be constructed with materials to match the existing bungalow, such as light red/brown brick, with cedar horizontal boarding painted to match the existing bungalow. It will have matching rainwater goods, and soffits,

fascias and barge boards. The roof will be constructed with natural 'Welsh' slate roof tiles.
