# PRELIMINARY ROOST APPRAISAL (PRA) REPORT

21<sup>st</sup> July 2023

8 Solent Drive, Barton on Sea, BH25 7AW

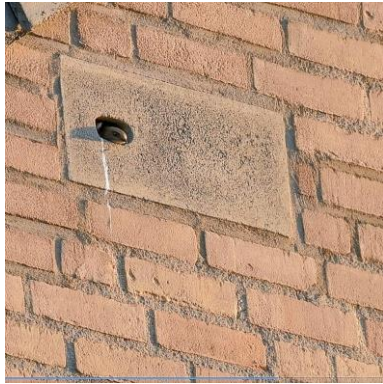
One (in addition to the above compensatory swift nest box) 'PRO UK Rendered Build-In Swift Box' (<https://www.nhbs.com/vivara-pro-rendered-build-in-swift-box-uk-brick-size>) will be installed in the new dwelling. The nest box will be installed on the northern elevation and must be installed as close to eaves level as possible and is maintenance-free with an integrated design, ensuring the box is secure in the long-term. These boxes will benefit species such as swifts (and have been shown to be used by other species such as house sparrows) and will be installed between 60cm to 1m apart per brick; swifts are colony nesters and therefore the boxes must be installed within the same area to benefit this species.

- Two 'PRO UK Rendered Build-In Swift Box' (<https://www.nhbs.com/vivara-pro-rendered-build-in-swift-box-uk-brick-size>) will be installed in the new dwelling. The nest box will be installed on the northern elevation and must be installed as close to eaves level as possible and is maintenance-free with an integrated design, ensuring the box is secure in the long-term. These boxes will benefit species such as swifts (and have been shown to be used by other species such as house sparrows) and will be installed between 60cm to 1m apart per brick; swifts are colony nesters and therefore the boxes must be installed within the same area to benefit this species.
