St Martin Church, Baler, Ringwood

PROPOSED SOUTH DOOR

Ref - 22CHURCHREPAIRS08

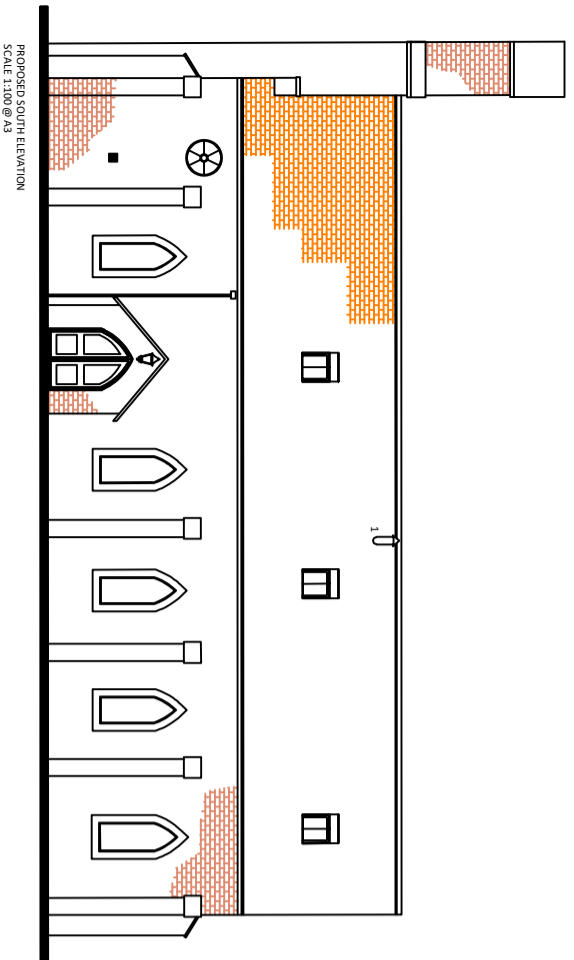
Existing Doors formed from plywood and in poor condition. Doors are not original (ply), so a repair would not be ideal. Door is rotten. Replace with solid timber doors and new glazing (double to match existing), painted black. New door handle and locks. New black ironmongery to match existing.
